## Phase One Environmental Site Assessment

1144 St. Pierre Street, Ottawa, Ontario

Pulse Societies Ltd.

OTT-25016073-A0

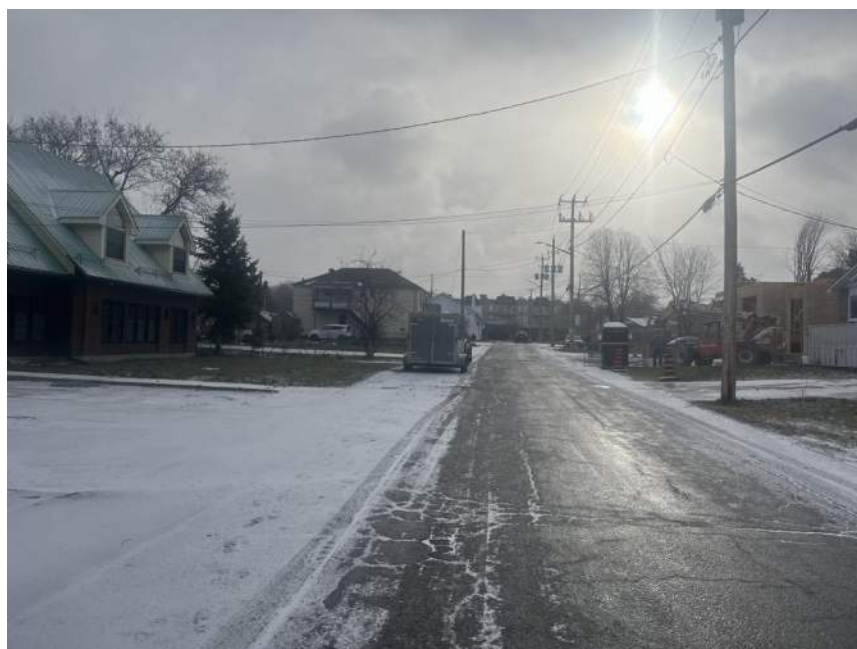
**Photograph No. 2**

View adjacent residential properties.

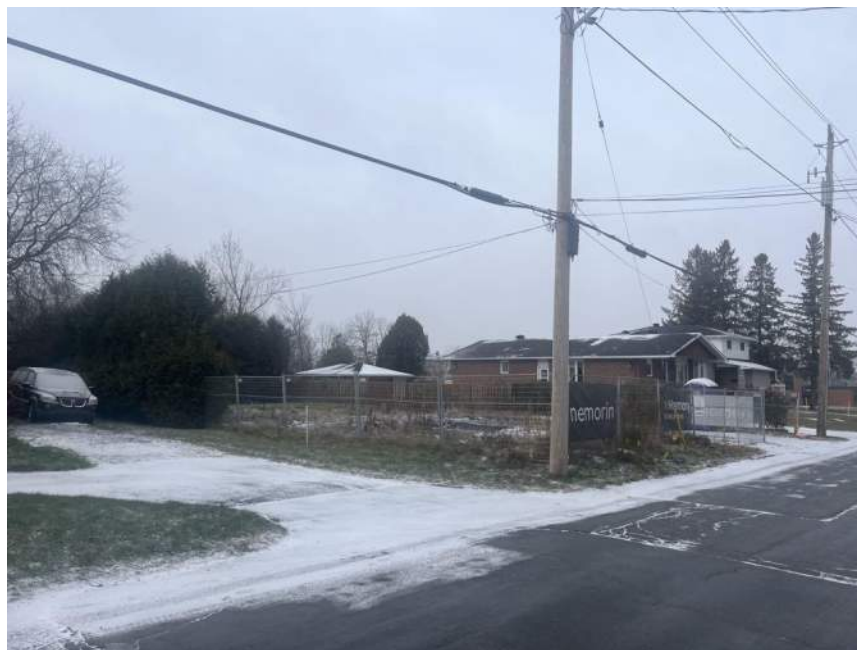
**Photograph No. 3**

View of adjacent residential properties.
