August 11, 2025  
File: PE4546-LET.13

Subject: **Phase II - Environmental Site Assessment Update**  
**280 Montgomery Street**  
**300 Montgomery Street**  
**2 Montreal Road**  
**3 Selkirk Street**  
**Ottawa, Ontario**

Further to your request, Paterson Group (Paterson) carried out a Phase II - Environmental Site Assessment (ESA) Update for the aforementioned property. This report updates a Phase II-ESA prepared by Paterson Group entitled "Phase II-Environmental Assessment Update, 3 Selkirk Street, 2 Montreal Road, 280 Montgomery Street, and 300 Montgomery Street, Ottawa, Ontario" dated August 9, 2024. This report is only used to update the site conditions for the purposes of filing a Record of Site Condition (RSC) on the property.

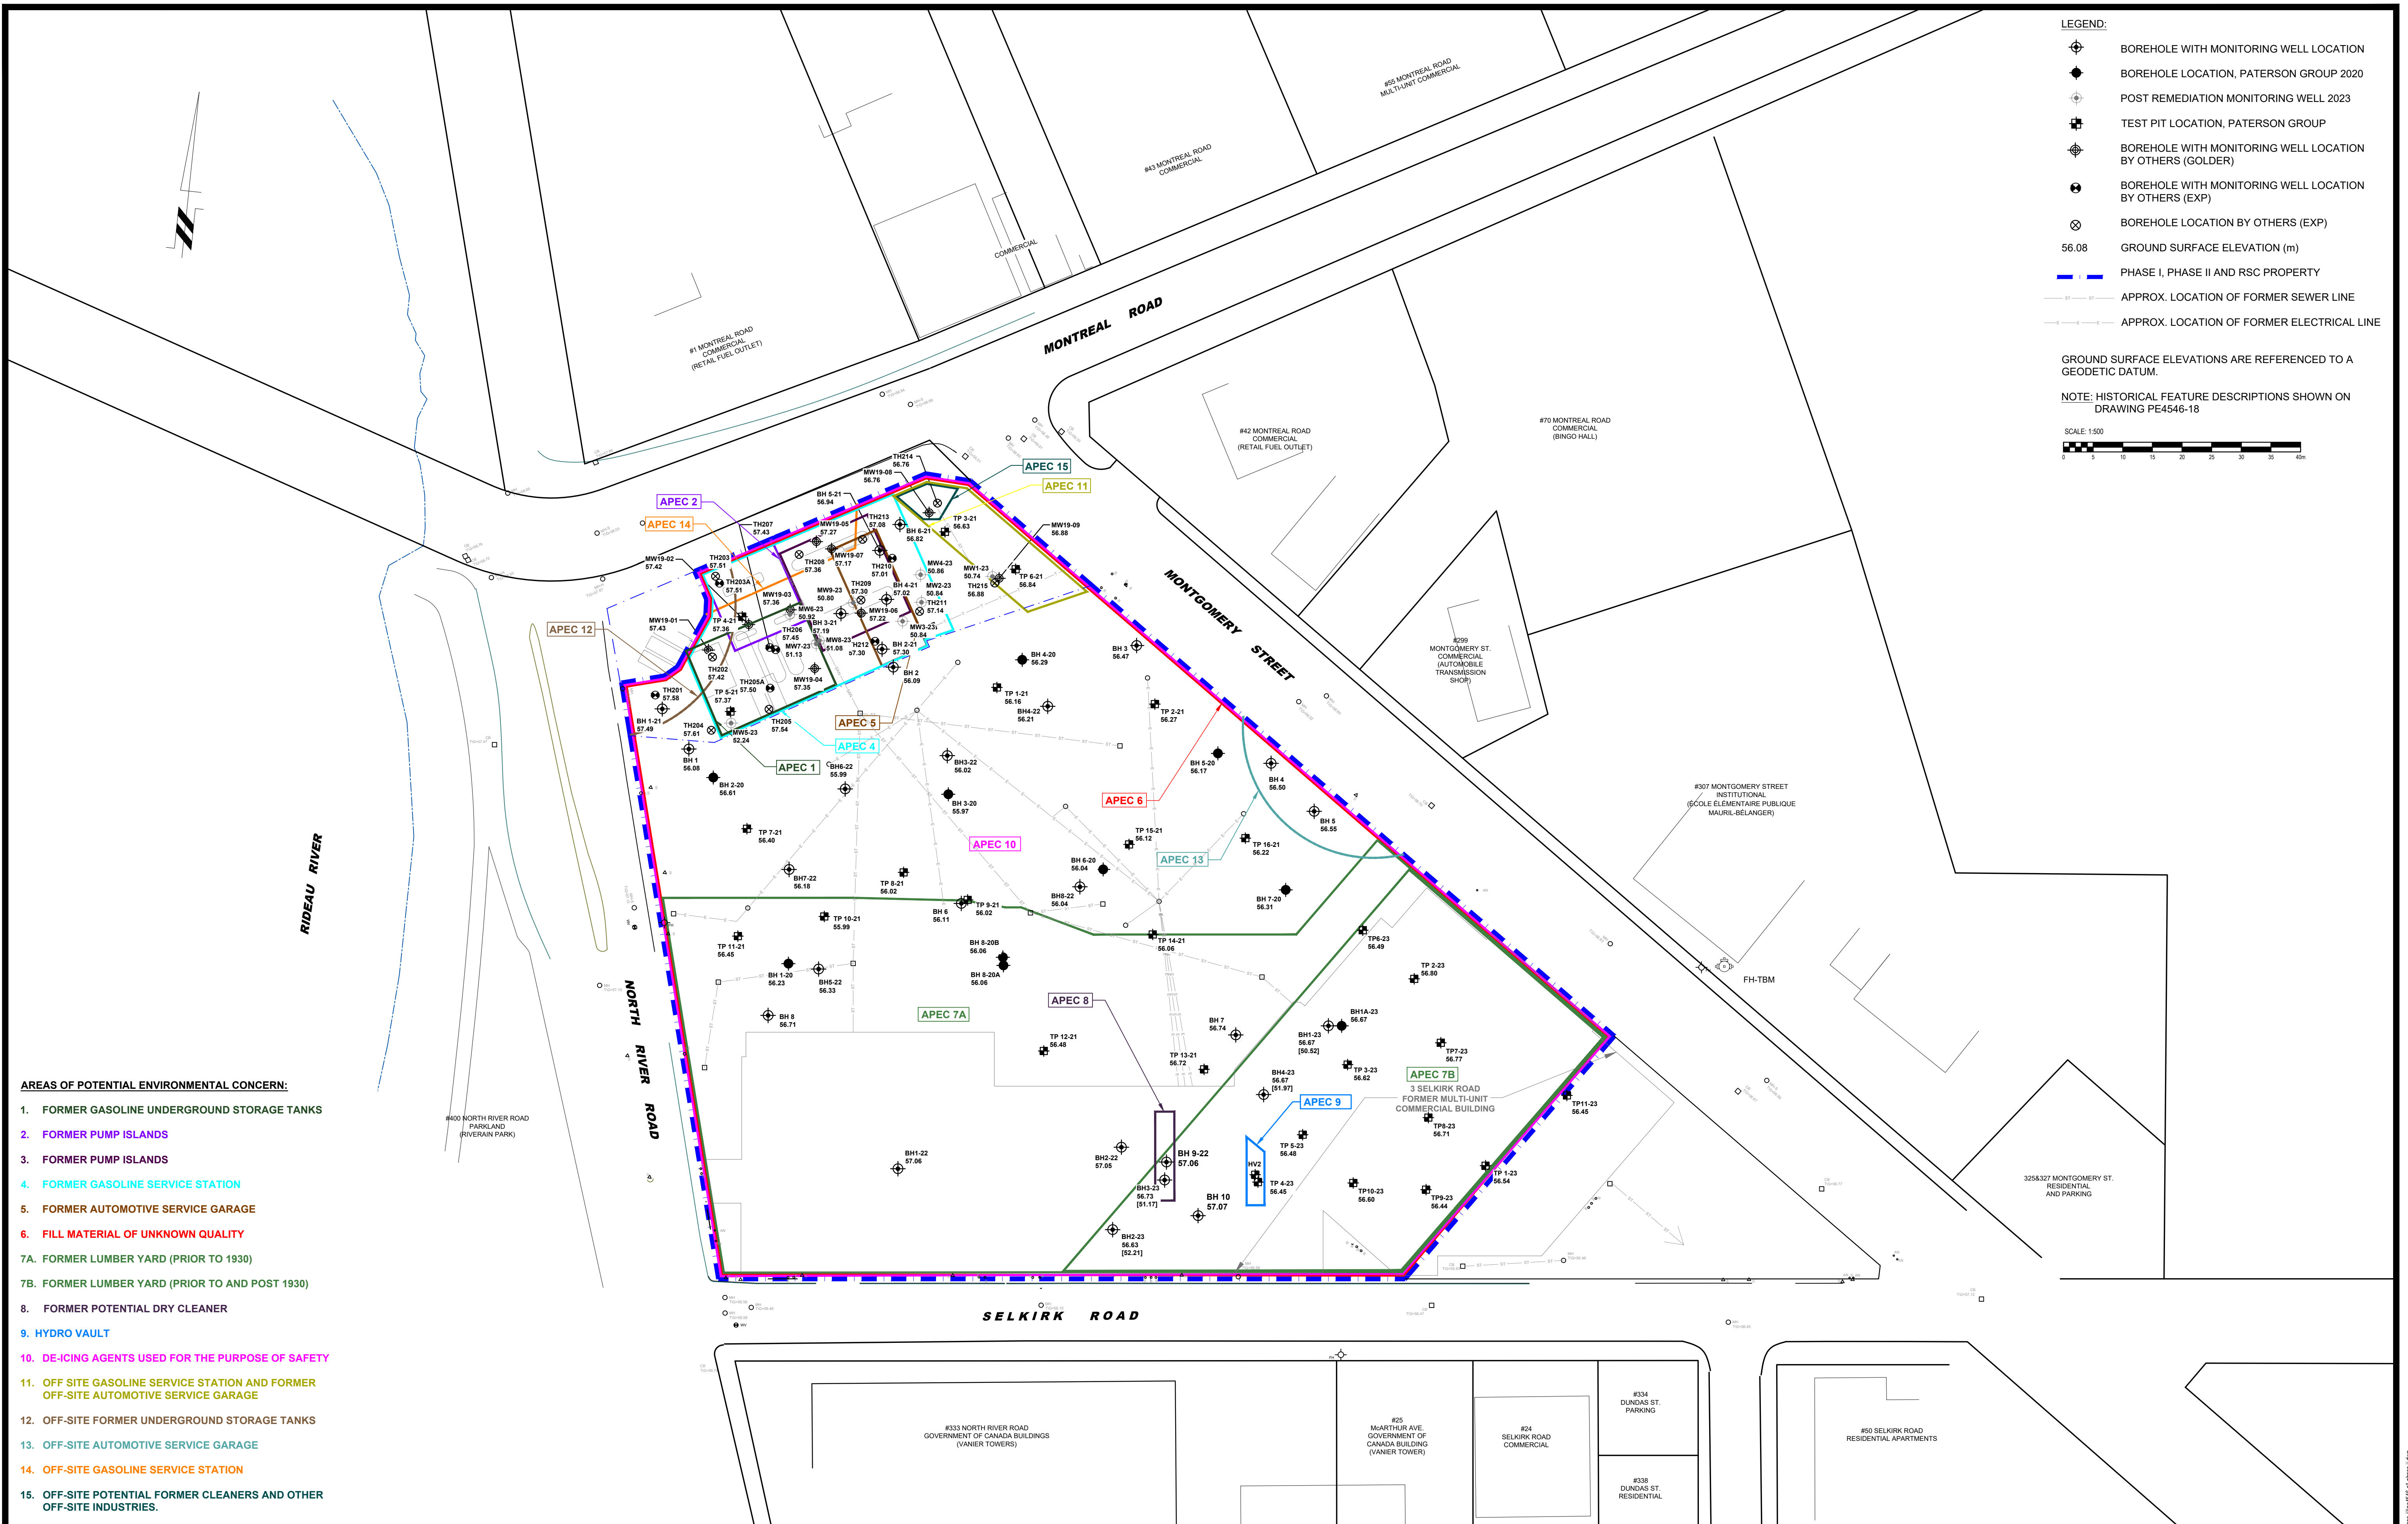
**AREAS OF POTENTIAL ENVIRONMENTAL CONCERN:**

1. FORMER GASOLINE UNDERGROUND STORAGE TANKS
2. FORMER PUMP ISLANDS
3. FORMER PUMP ISLANDS
4. FORMER GASOLINE SERVICE STATION
5. FORMER AUTOMOTIVE SERVICE GARAGE
6. FILL MATERIAL OF UNKNOWN QUALITY
- 7A. FORMER LUMBER YARD (PRIOR TO 1930)
- 7B. FORMER LUMBER YARD (PRIOR TO AND POST 1930)
8. FORMER POTENTIAL DRY CLEANER
9. HYDRO VAULT
10. DE-ICING AGENTS USED FOR THE PURPOSE OF SAFETY
11. OFF SITE GASOLINE SERVICE STATION AND FORMER OFF-SITE AUTOMOTIVE SERVICE GARAGE
12. OFF-SITE FORMER UNDERGROUND STORAGE TANKS
13. OFF-SITE AUTOMOTIVE SERVICE GARAGE
14. OFF-SITE GASOLINE SERVICE STATION
15. OFF-SITE POTENTIAL FORMER CLEANERS AND OTHER OFF-SITE INDUSTRIES.

Based on the results of the Phase I ESA and Phase I ESA Updates completed for the RSC Property, Potentially Contaminating Activities (PCAs) were identified to represent Areas of Potential Environmental Concern (APECs) with respect to the RSC Property. The APECs on the RSC Property are summarized in the table below with their respective Contaminants of Potential Concern (CPC). Areas of Potential Environmental Concern are illustrated on Drawing PE4546 – 1 – Site Plan.

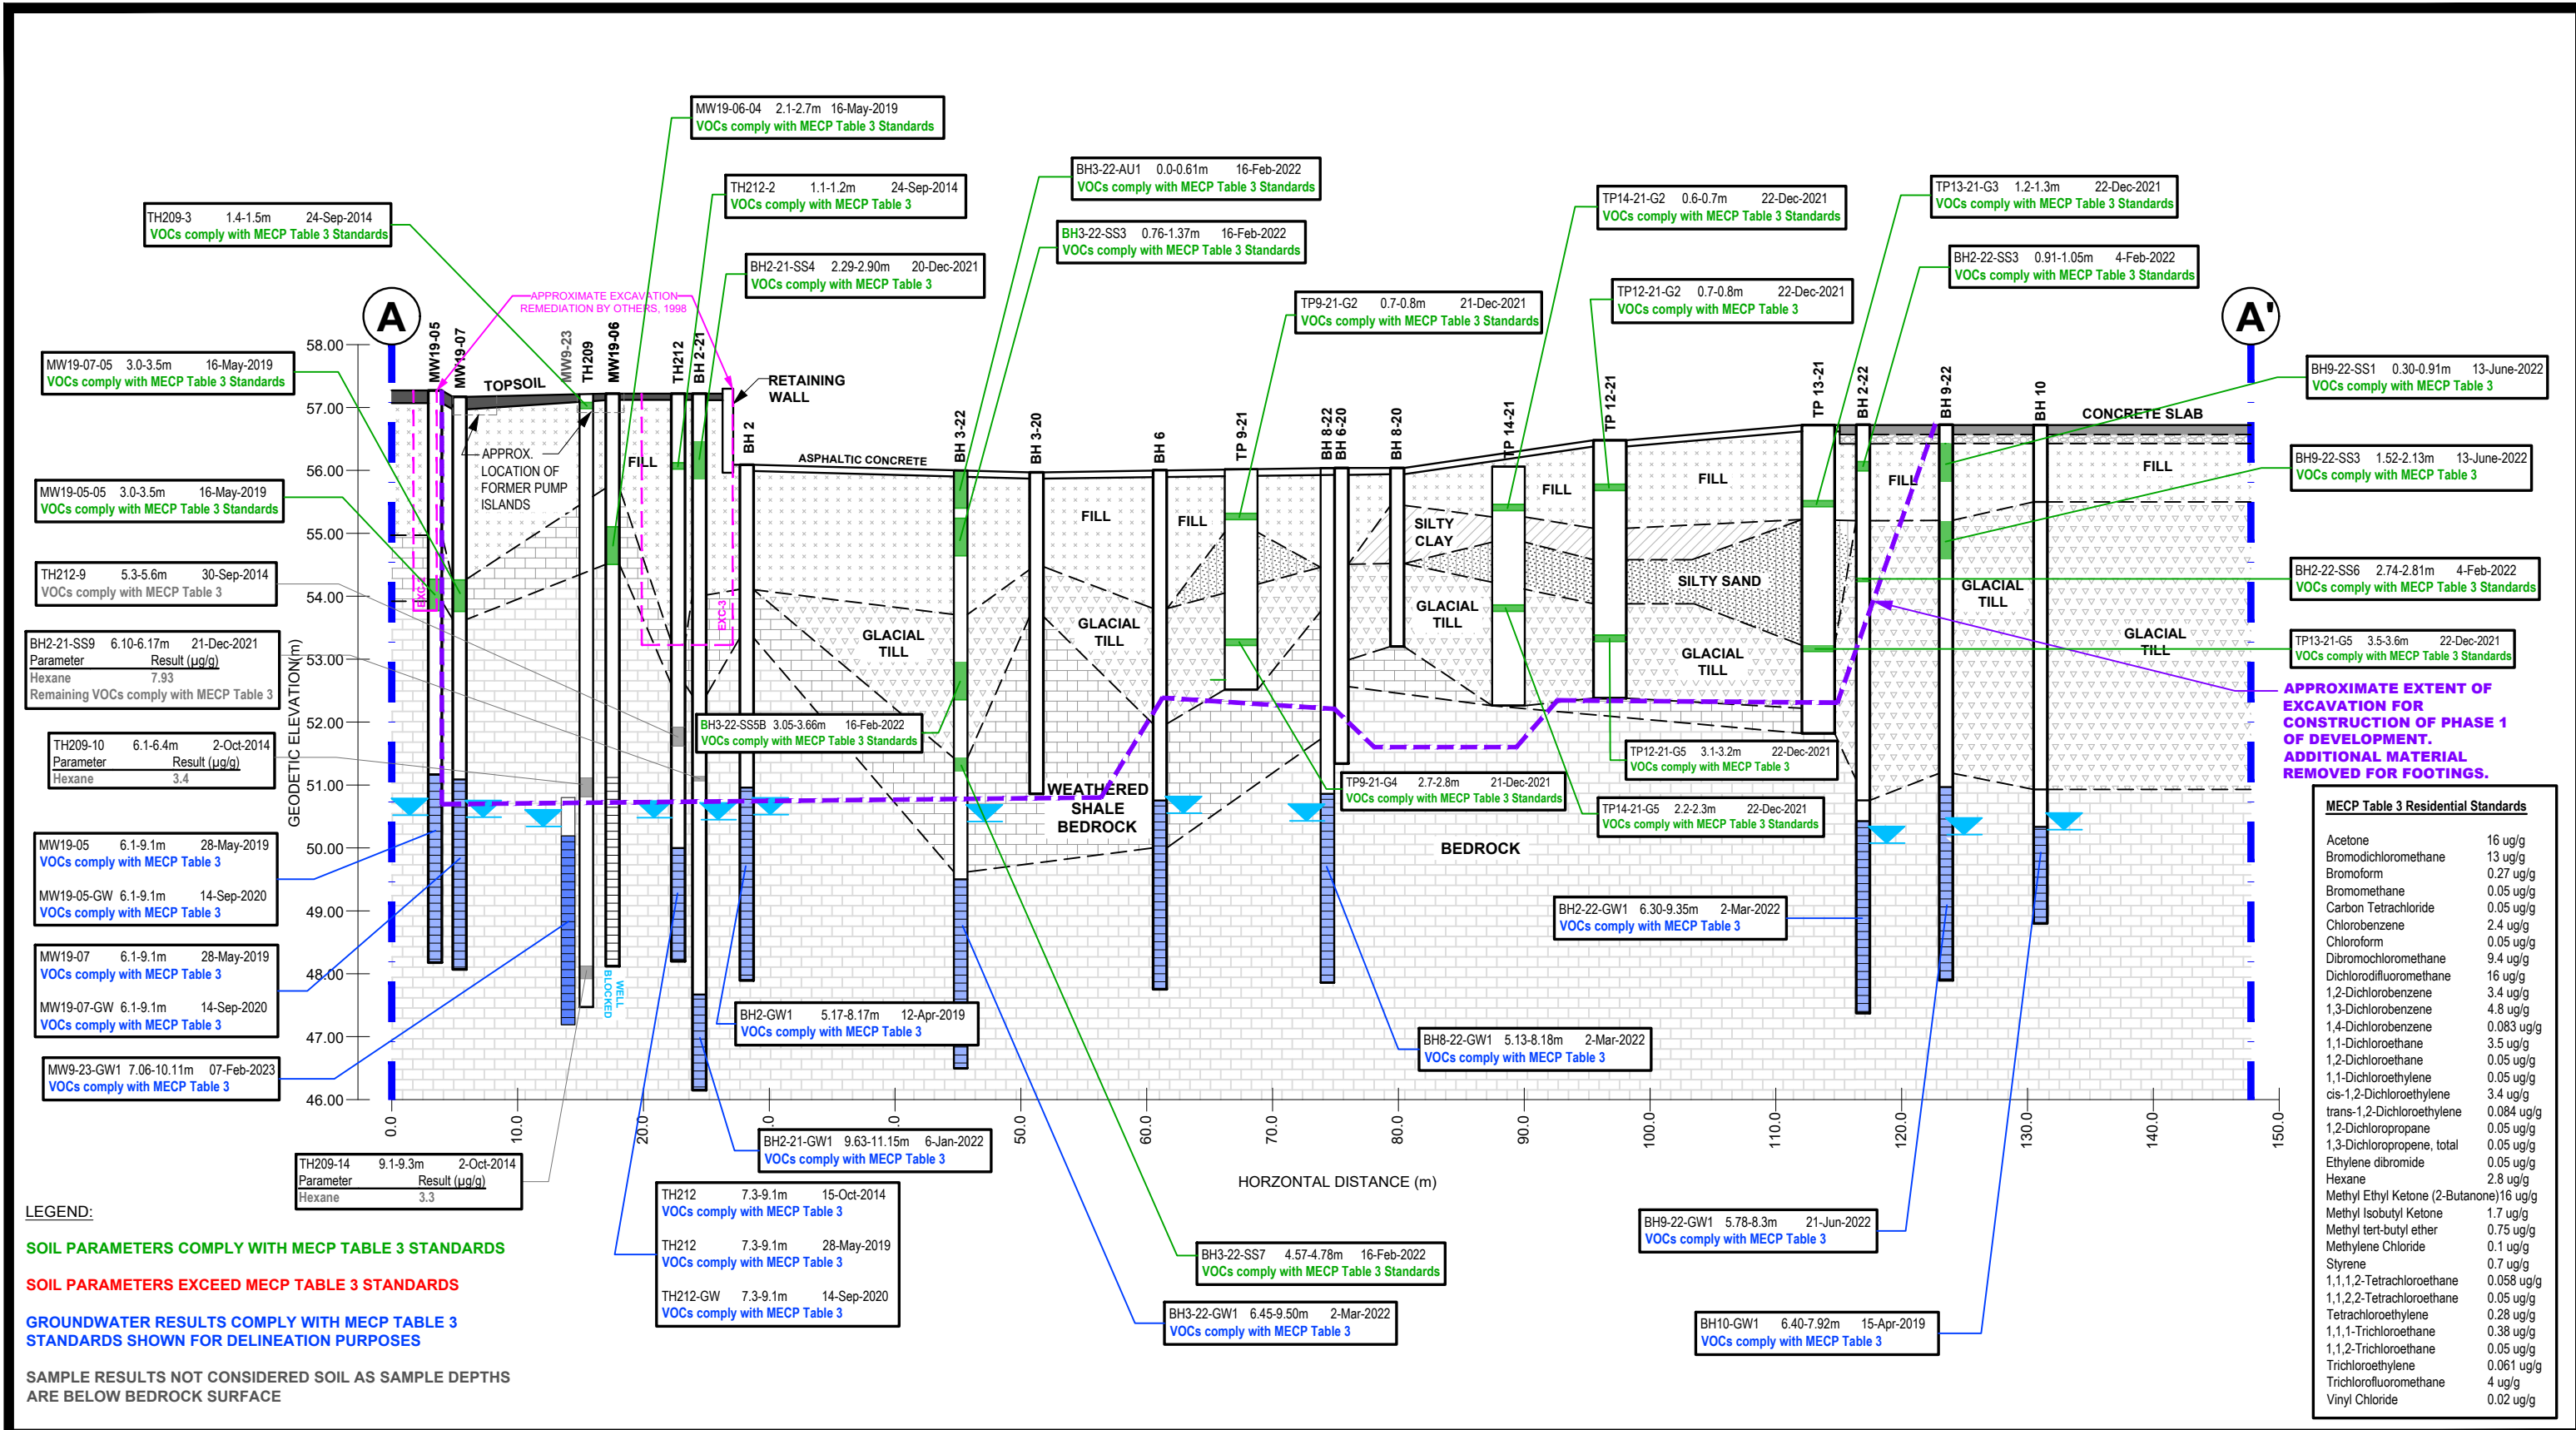
PE4546-4

SOIL PARAMETERS COMPLY WITH MECP TABLE 3 STANDARDS

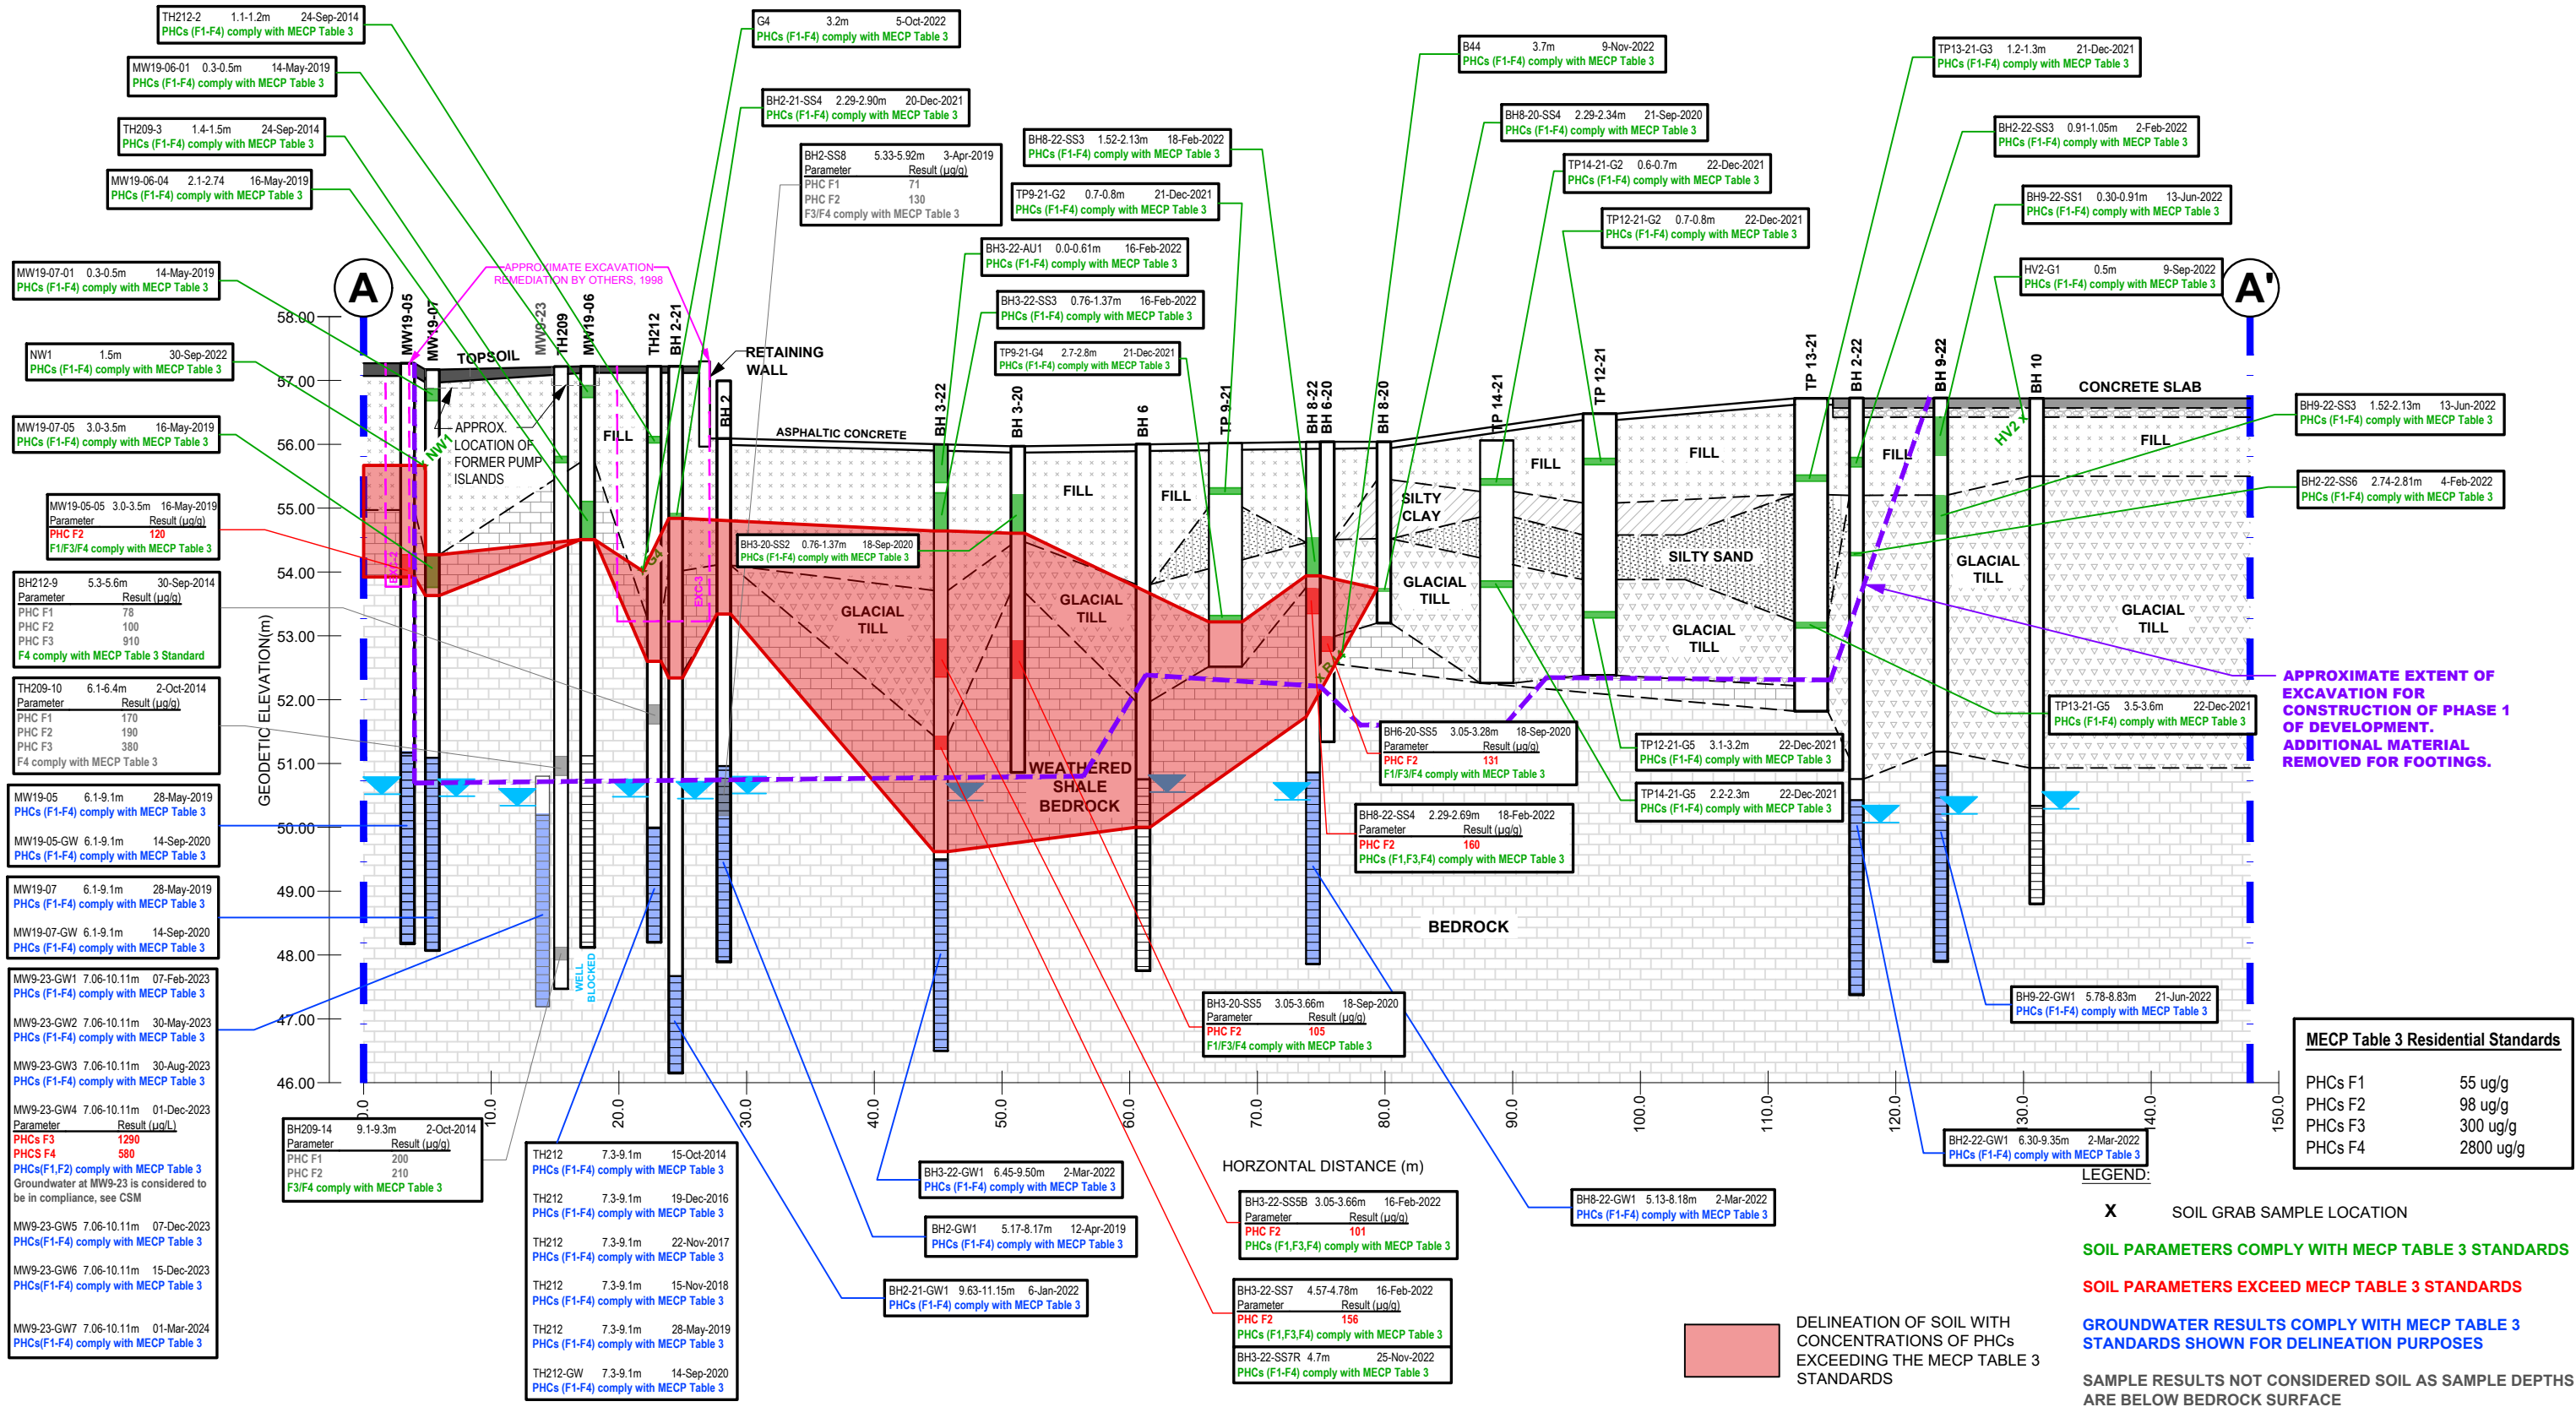
APPROXIMATE EXTENT OF EXCAVATION FOR CONSTRUCTION OF PHASE 1 OF DEVELOPMENT. ADDITIONAL MATERIAL REMOVED FOR FOOTINGS.

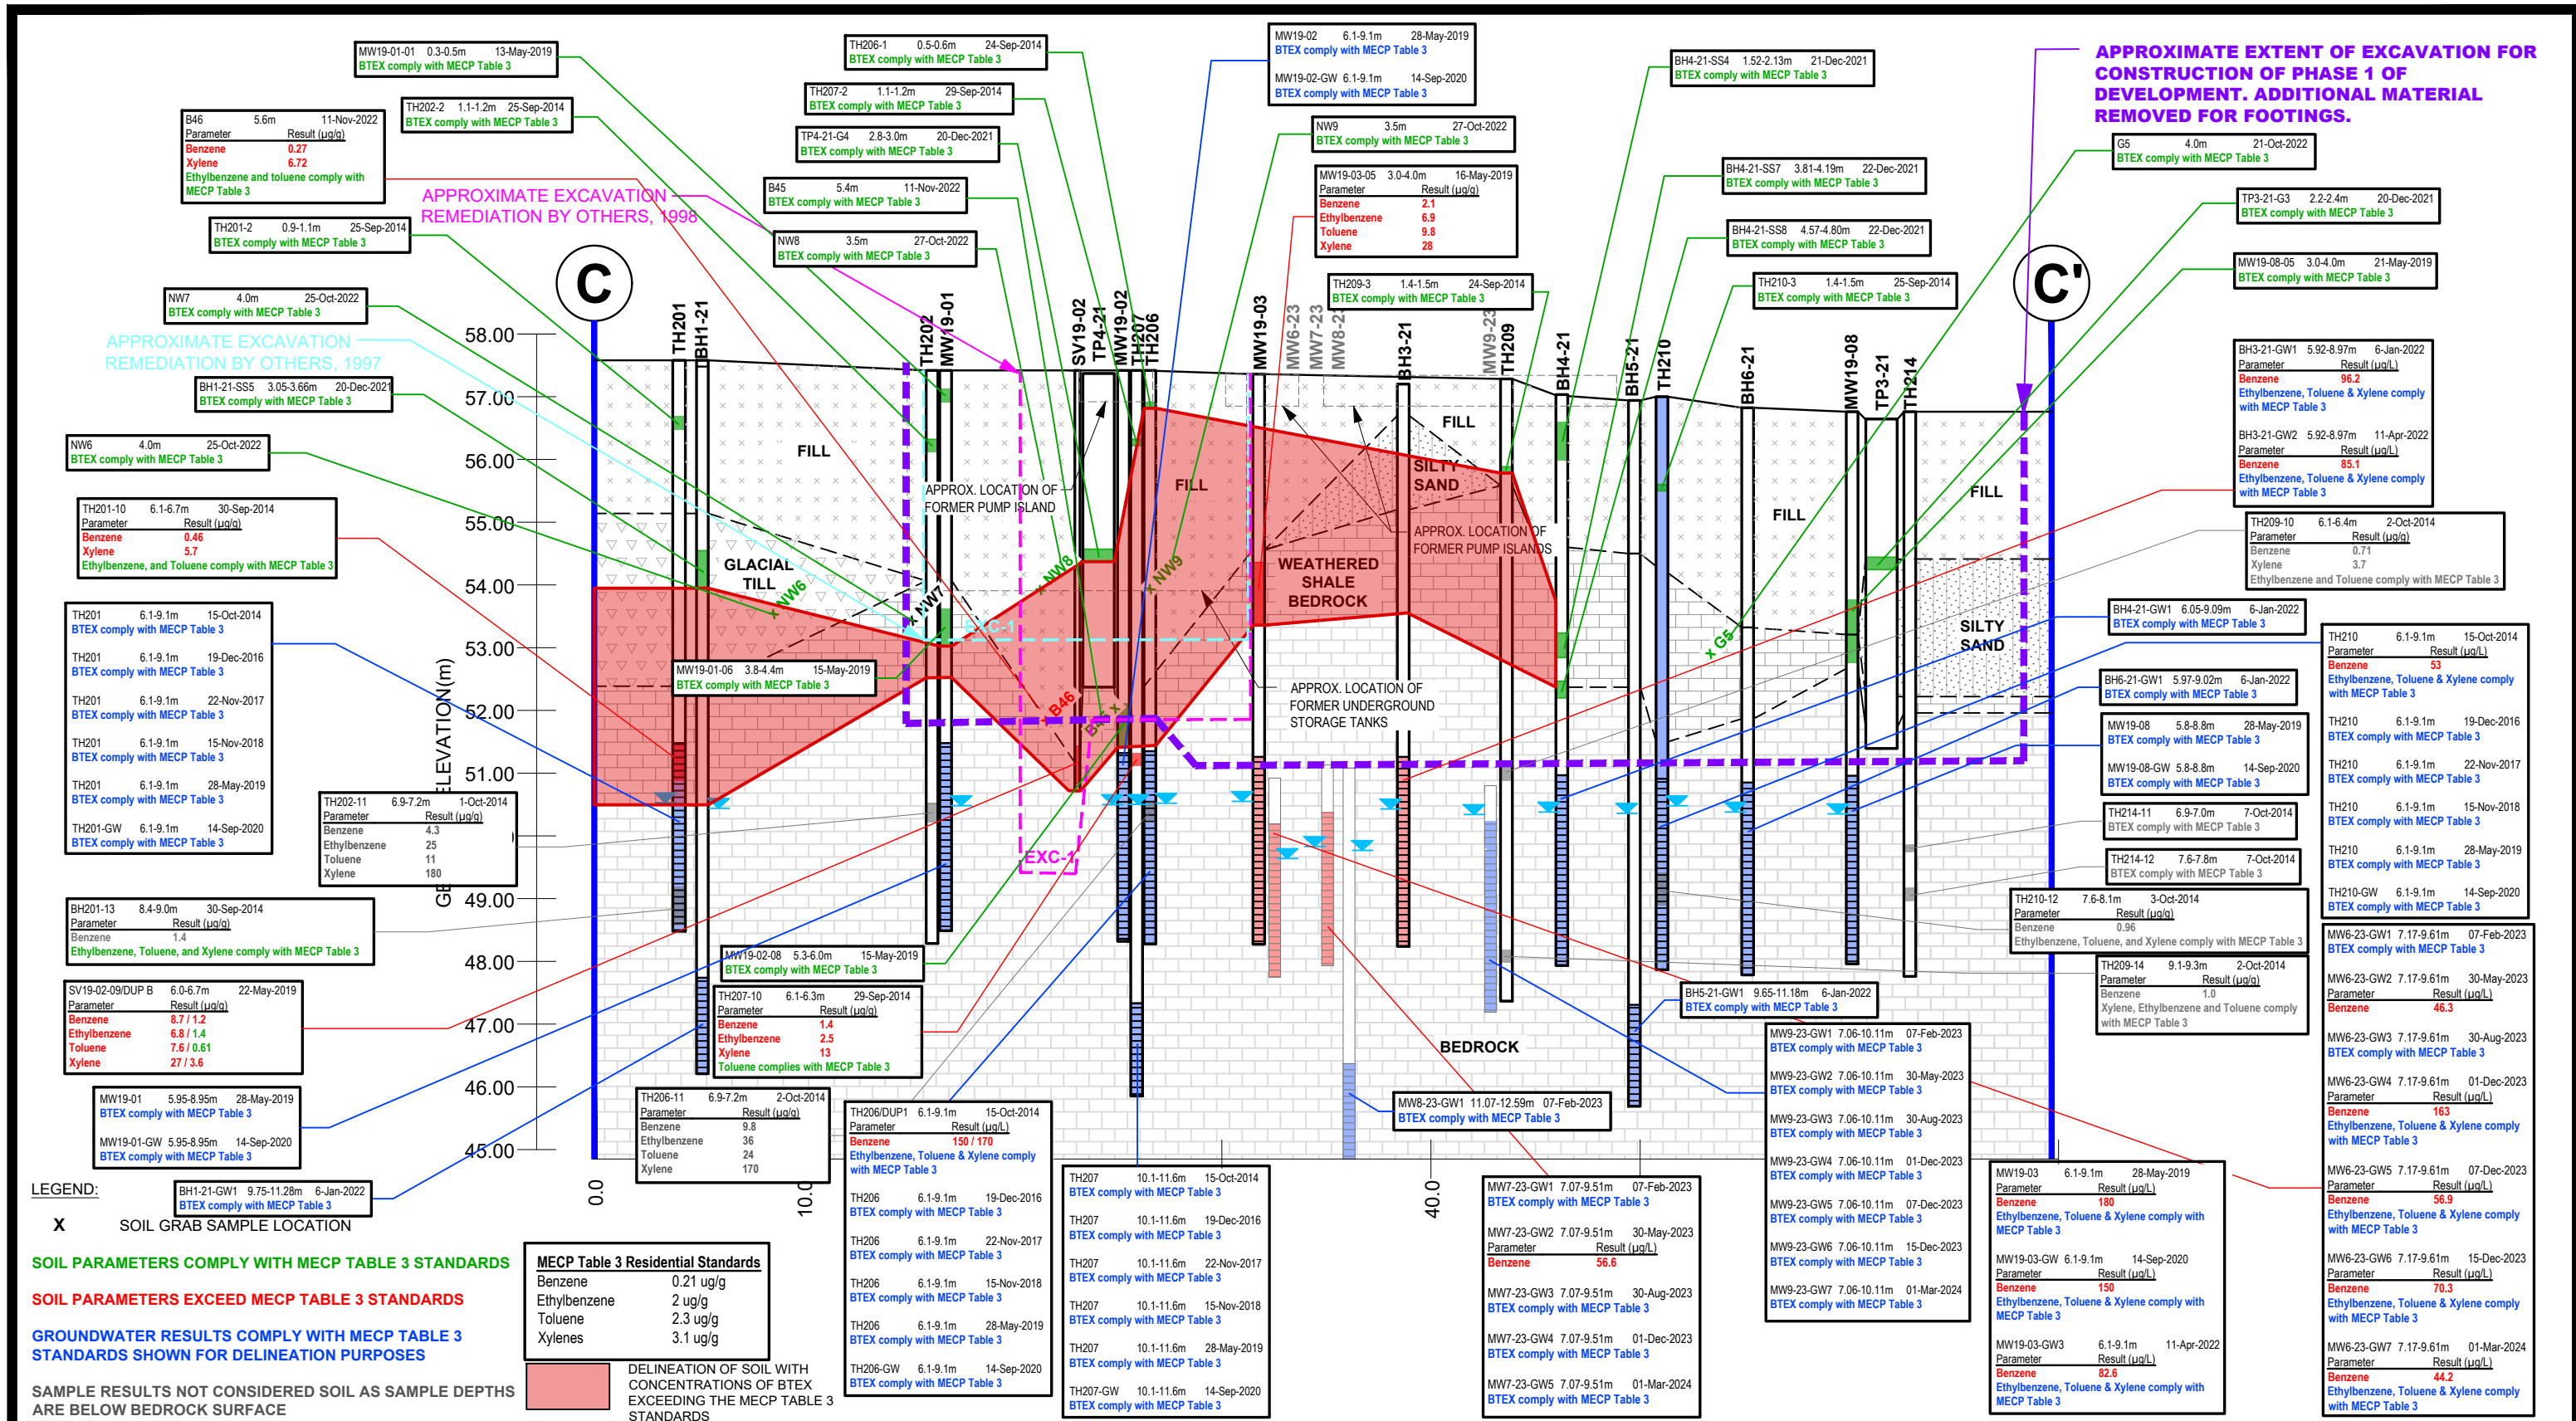
- X SOIL GRAB SAMPLE LOCATION
- SOIL PARAMETERS COMPLY WITH MECP TABLE 3 STANDARDS
- SOIL PARAMETERS EXCEED MECP TABLE 3 STANDARDS
- GROUNDWATER RESULTS COMPLY WITH MECP TABLE 3 STANDARDS SHOWN FOR DELINEATION PURPOSES
- SAMPLE RESULTS NOT CONSIDERED SOIL AS SAMPLE DEPTHS ARE BELOW BEDROCK SURFACE

Based on the depth of the samples below the reported sound bedrock surface, these samples are considered to be samples of shale rock that were augered through and not representative of soil quality. These samples are shown as grey on the above-mentioned drawings as they are not considered to be soil and not representative of exceedances of the soil standards. Groundwater samples have been collected in the vicinity of each of these locations and were in compliance with the applicable site condition standards as summarized below:

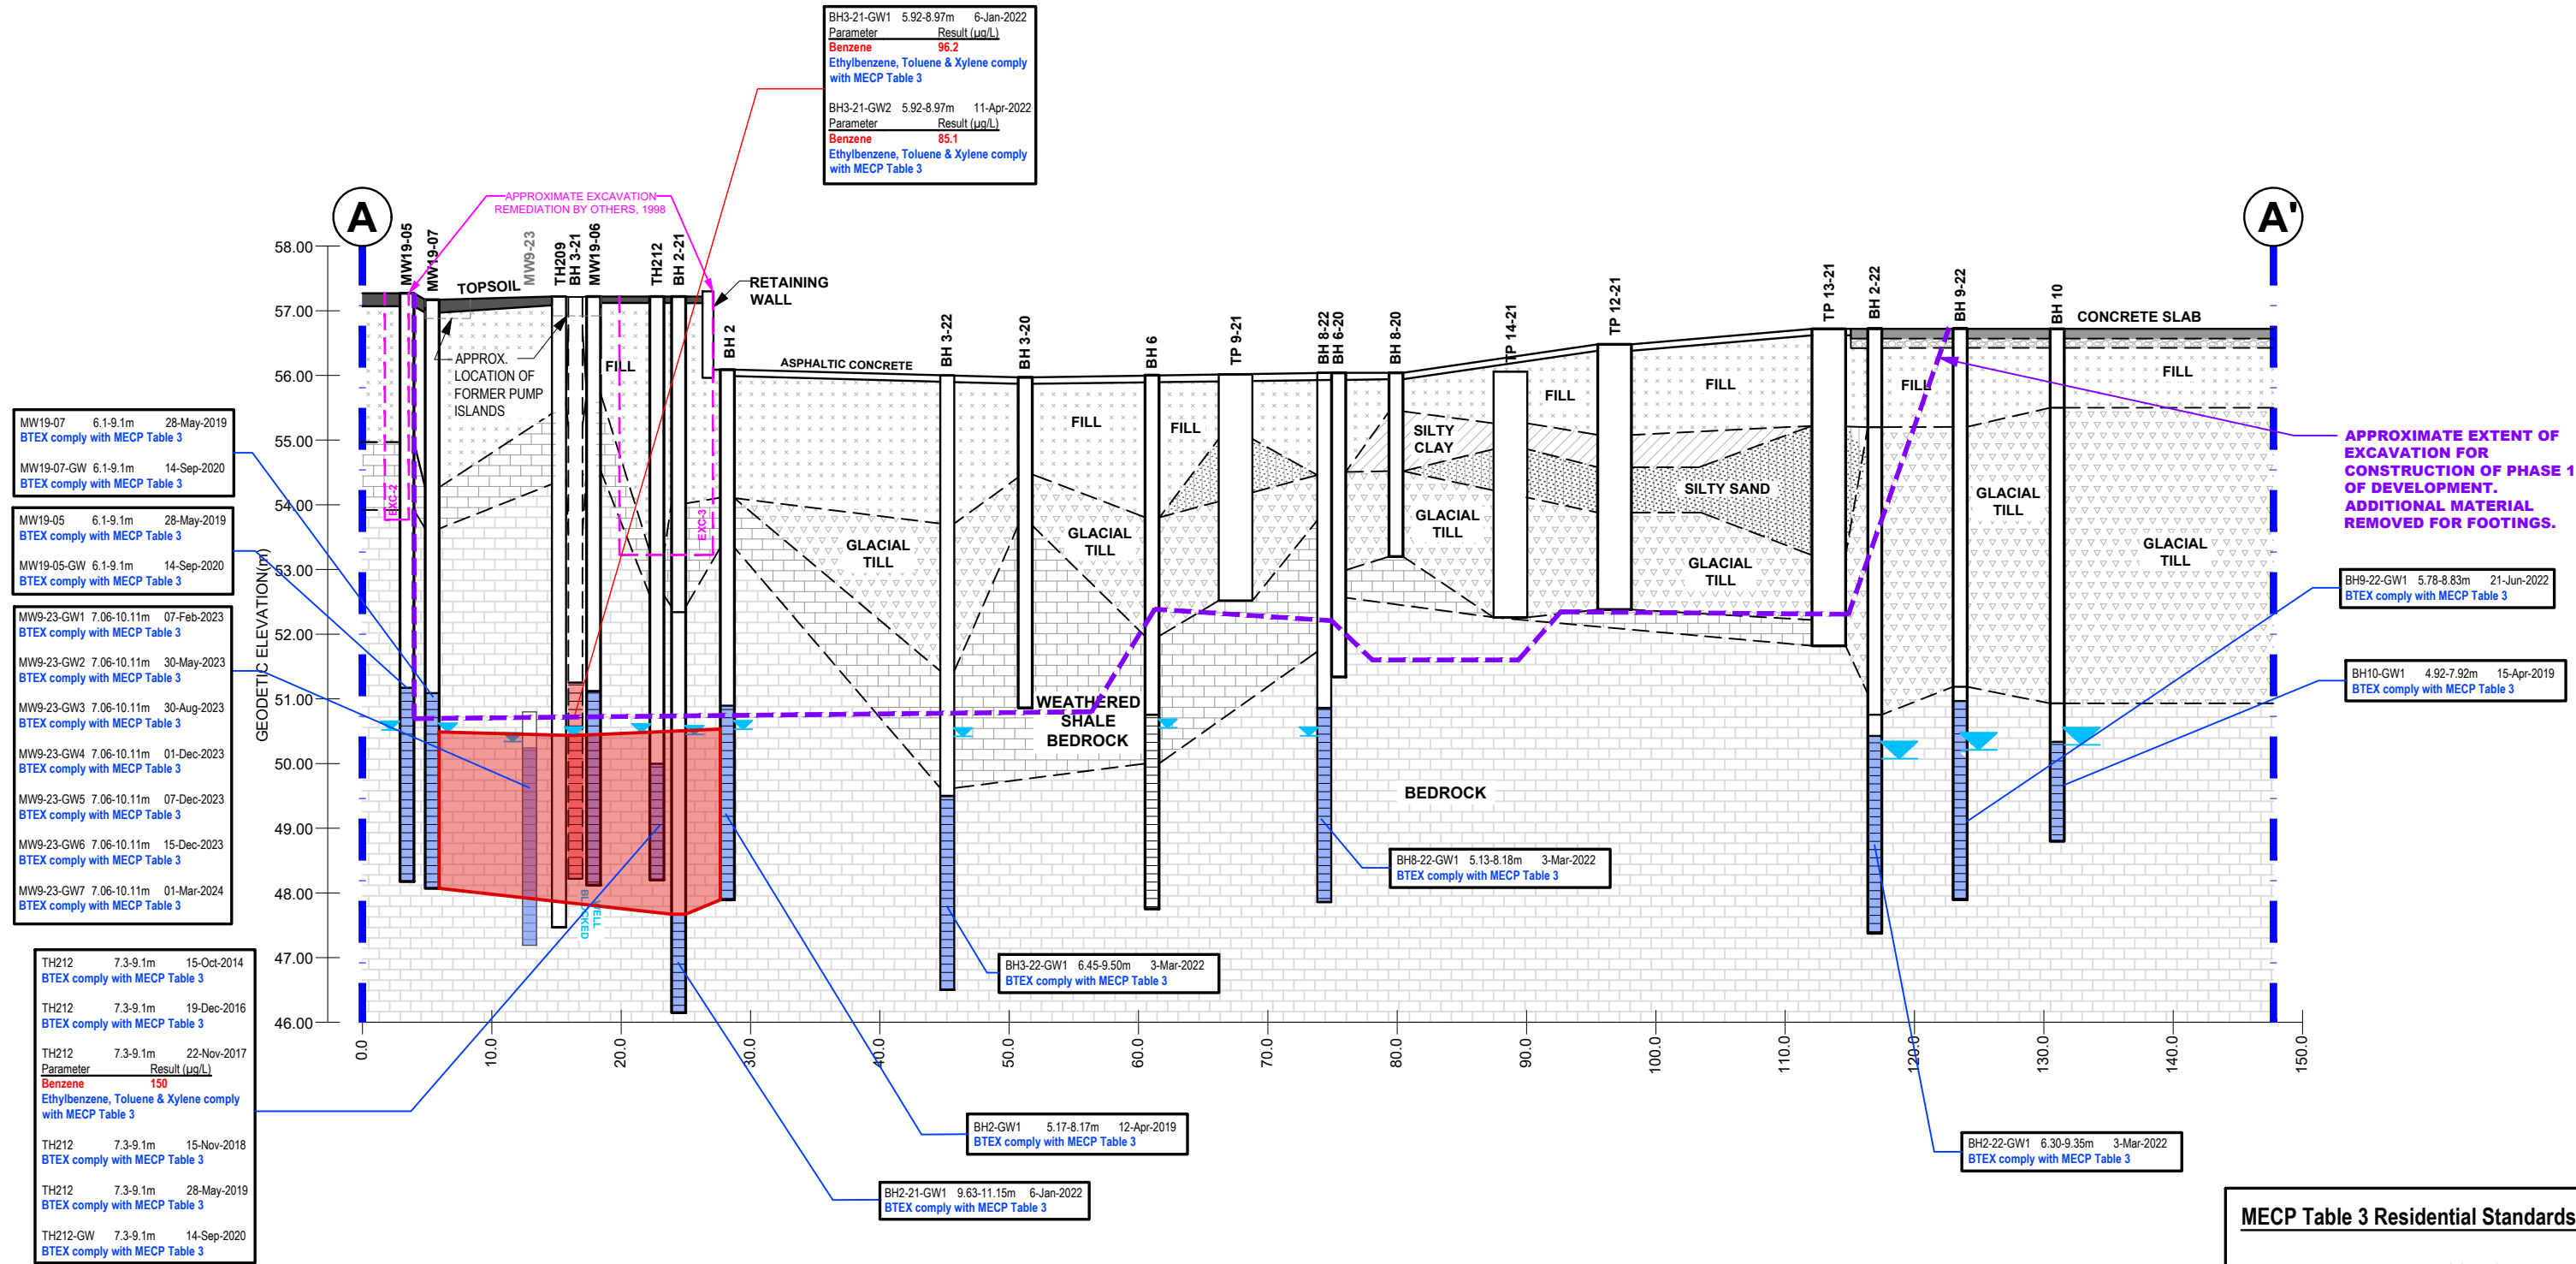
**GROUNDWATER PARAMETERS COMPLY WITH MECP TABLE 3 STANDARDS**

Based on the results of the Phase II ESA, groundwater exceeded the applicable site condition standards for benzene on the northern portion of the RSC Property.

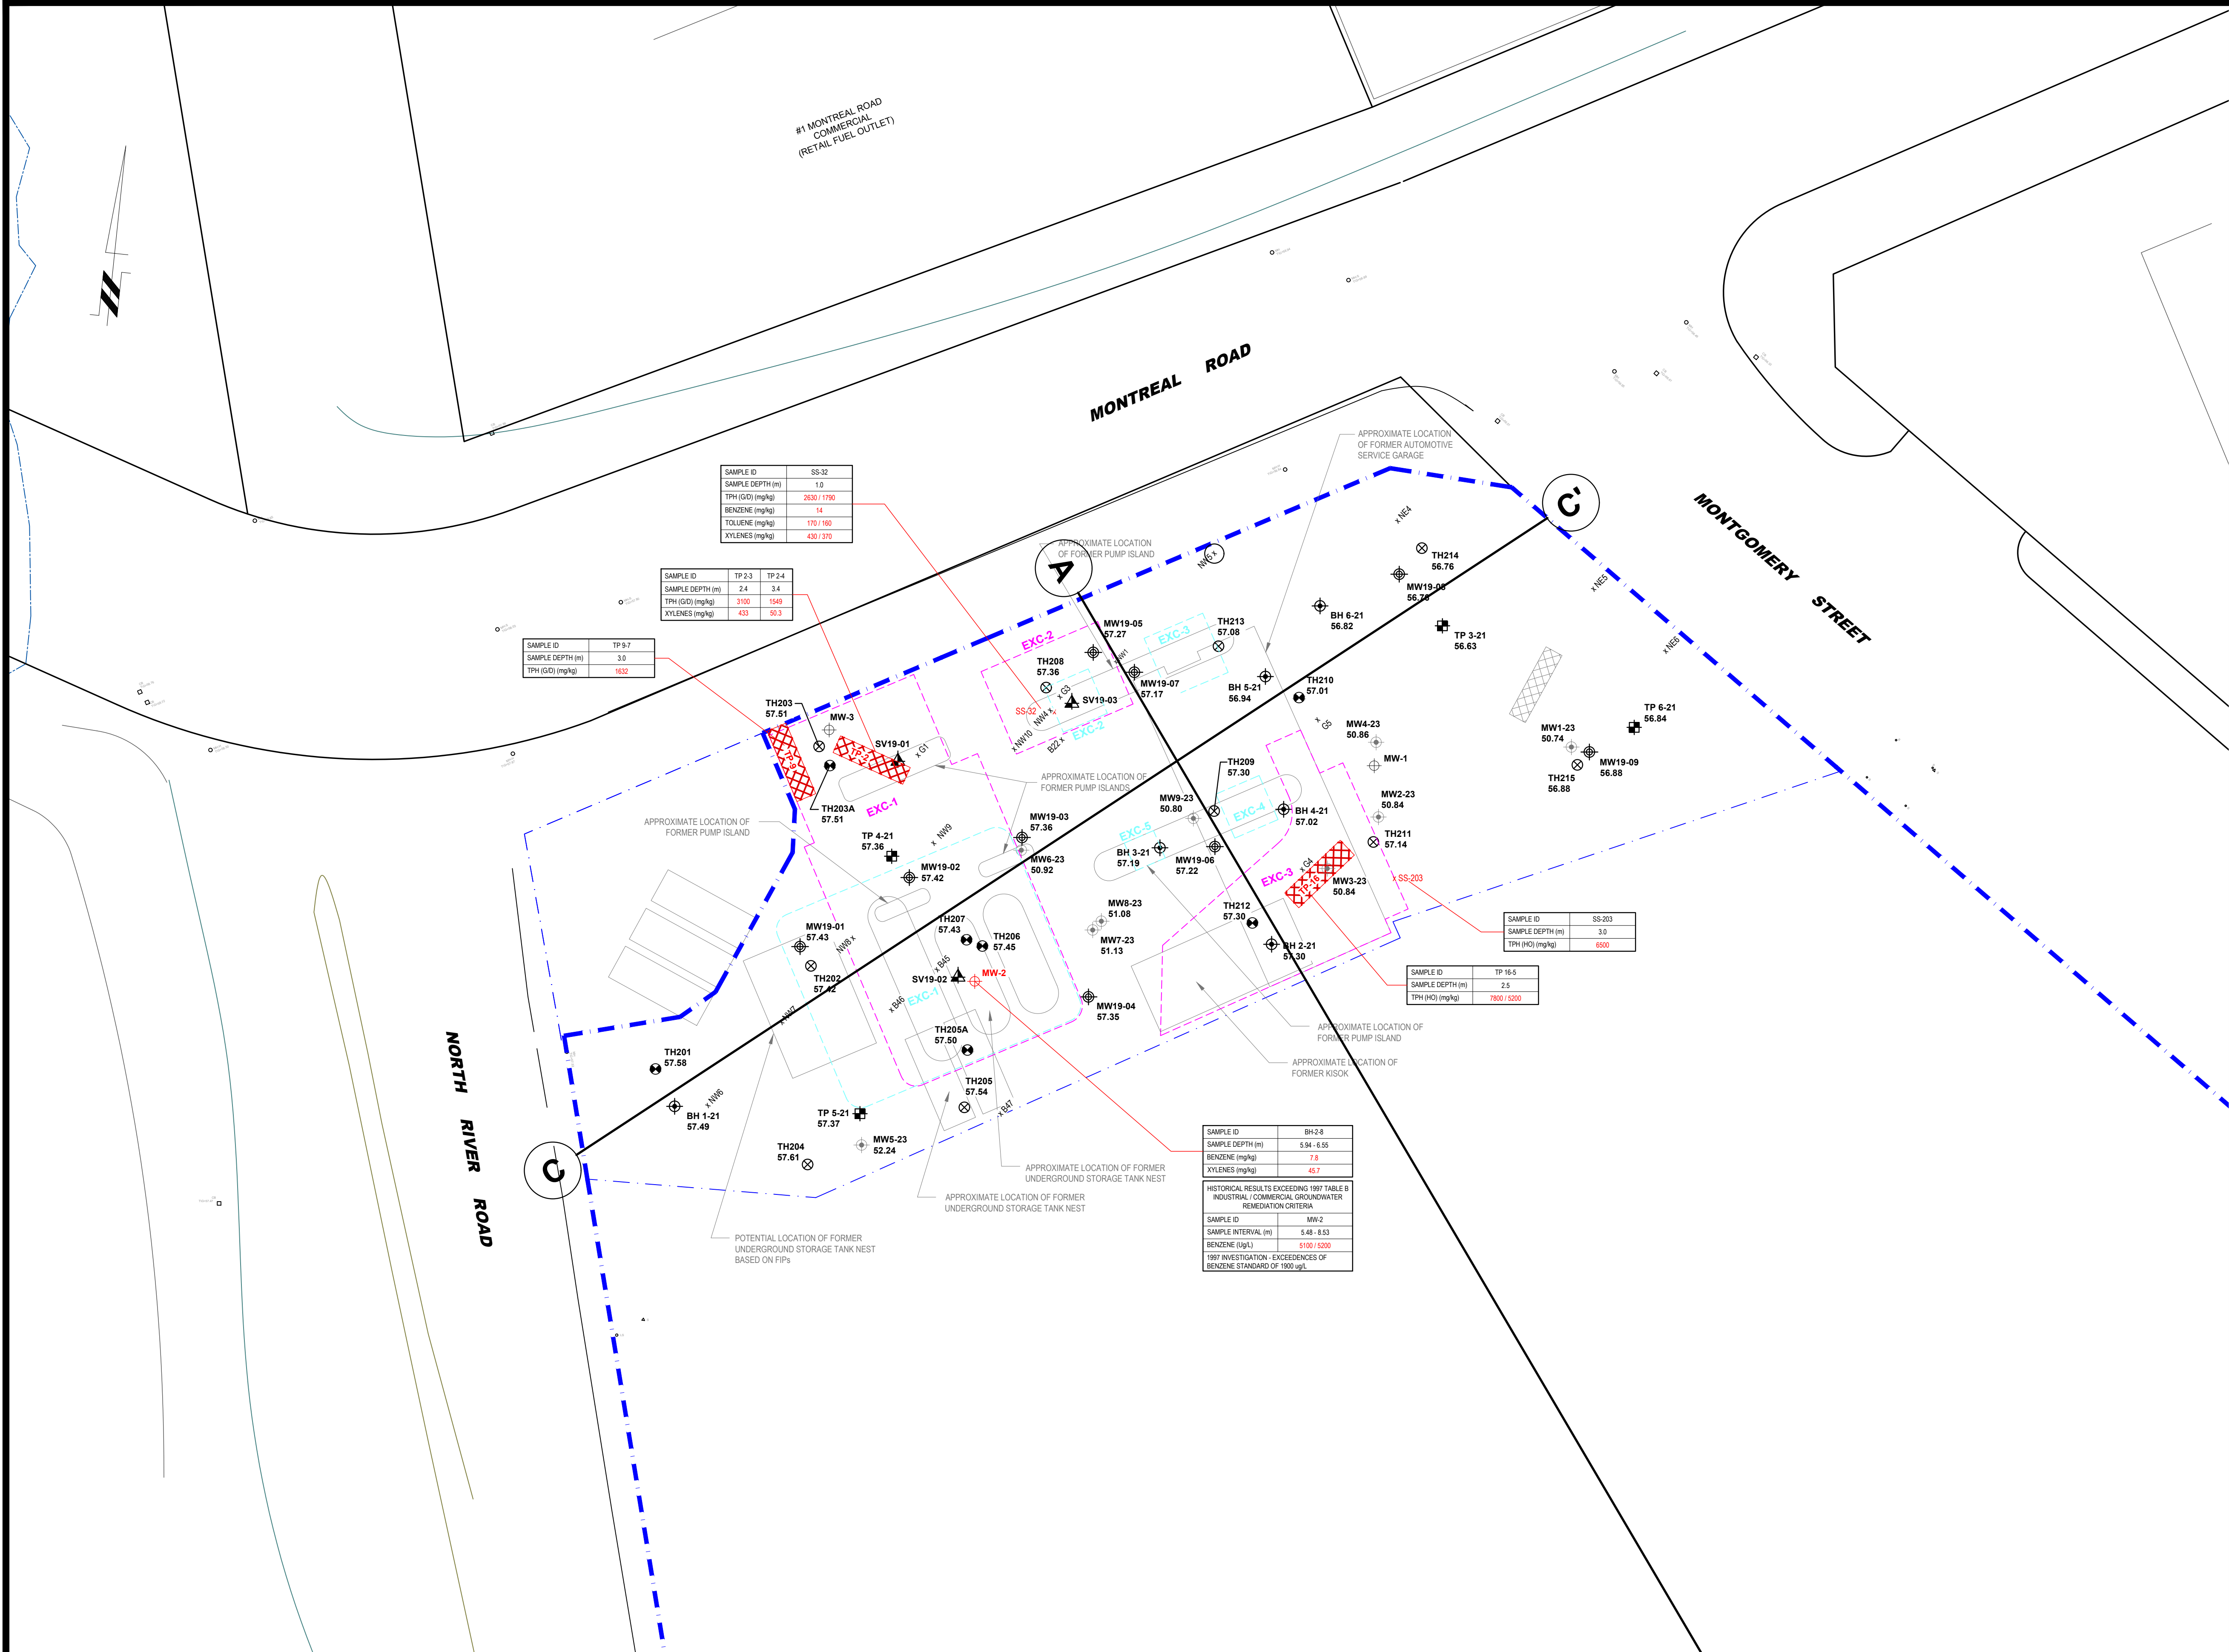
- LEGEND:
- BOREHOLE WITH MONITORING WELL LOCATION
  - POST REMEDIATION MONITORING WELL 2023
  - TEST PIT LOCATION, PATERSON GROUP 2021
  - BOREHOLE WITH MONITORING WELL LOCATION BY OTHERS (GOLDER)
  - SOIL VAPOUR PROBE LOCATION (GOLDER)
  - BOREHOLE WITH MONITORING WELL LOCATION BY OTHERS (EXP)
  - BOREHOLE LOCATION BY OTHERS (EXP)
  - MONITORING WELL LOCATION BY OTHERS (AQUA TERRE)
  - TEST PIT LOCATION BY OTHERS (AQUA TERRE)
  - GROUND SURFACE ELEVATION (m)
  - PHASE I, PHASE II AND RSC PROPERTY
  - APPROXIMATE EXCAVATION REMEDIATION BY OTHERS, 1997
  - APPROXIMATE EXCAVATION REMEDIATION BY OTHERS, 1998

| 1997 TABLE B GROUNDWATER REMEDIATION CRITERIA (COMMERCIAL / INDUSTRIAL) | |
| BENZENE | 1900 ug/L |
