August 11, 2025  
File: PE4546-LET.13

Subject: **Phase II - Environmental Site Assessment Update**  
**280 Montgomery Street**  
**300 Montgomery Street**  
**2 Montreal Road**  
**3 Selkirk Street**  
**Ottawa, Ontario**

Further to your request, Paterson Group (Paterson) carried out a Phase II - Environmental Site Assessment (ESA) Update for the aforementioned property. This report updates a Phase II-ESA prepared by Paterson Group entitled "Phase II-Environmental Assessment Update, 3 Selkirk Street, 2 Montreal Road, 280 Montgomery Street, and 300 Montgomery Street, Ottawa, Ontario" dated August 9, 2024. This report is only used to update the site conditions for the purposes of filing a Record of Site Condition (RSC) on the property.

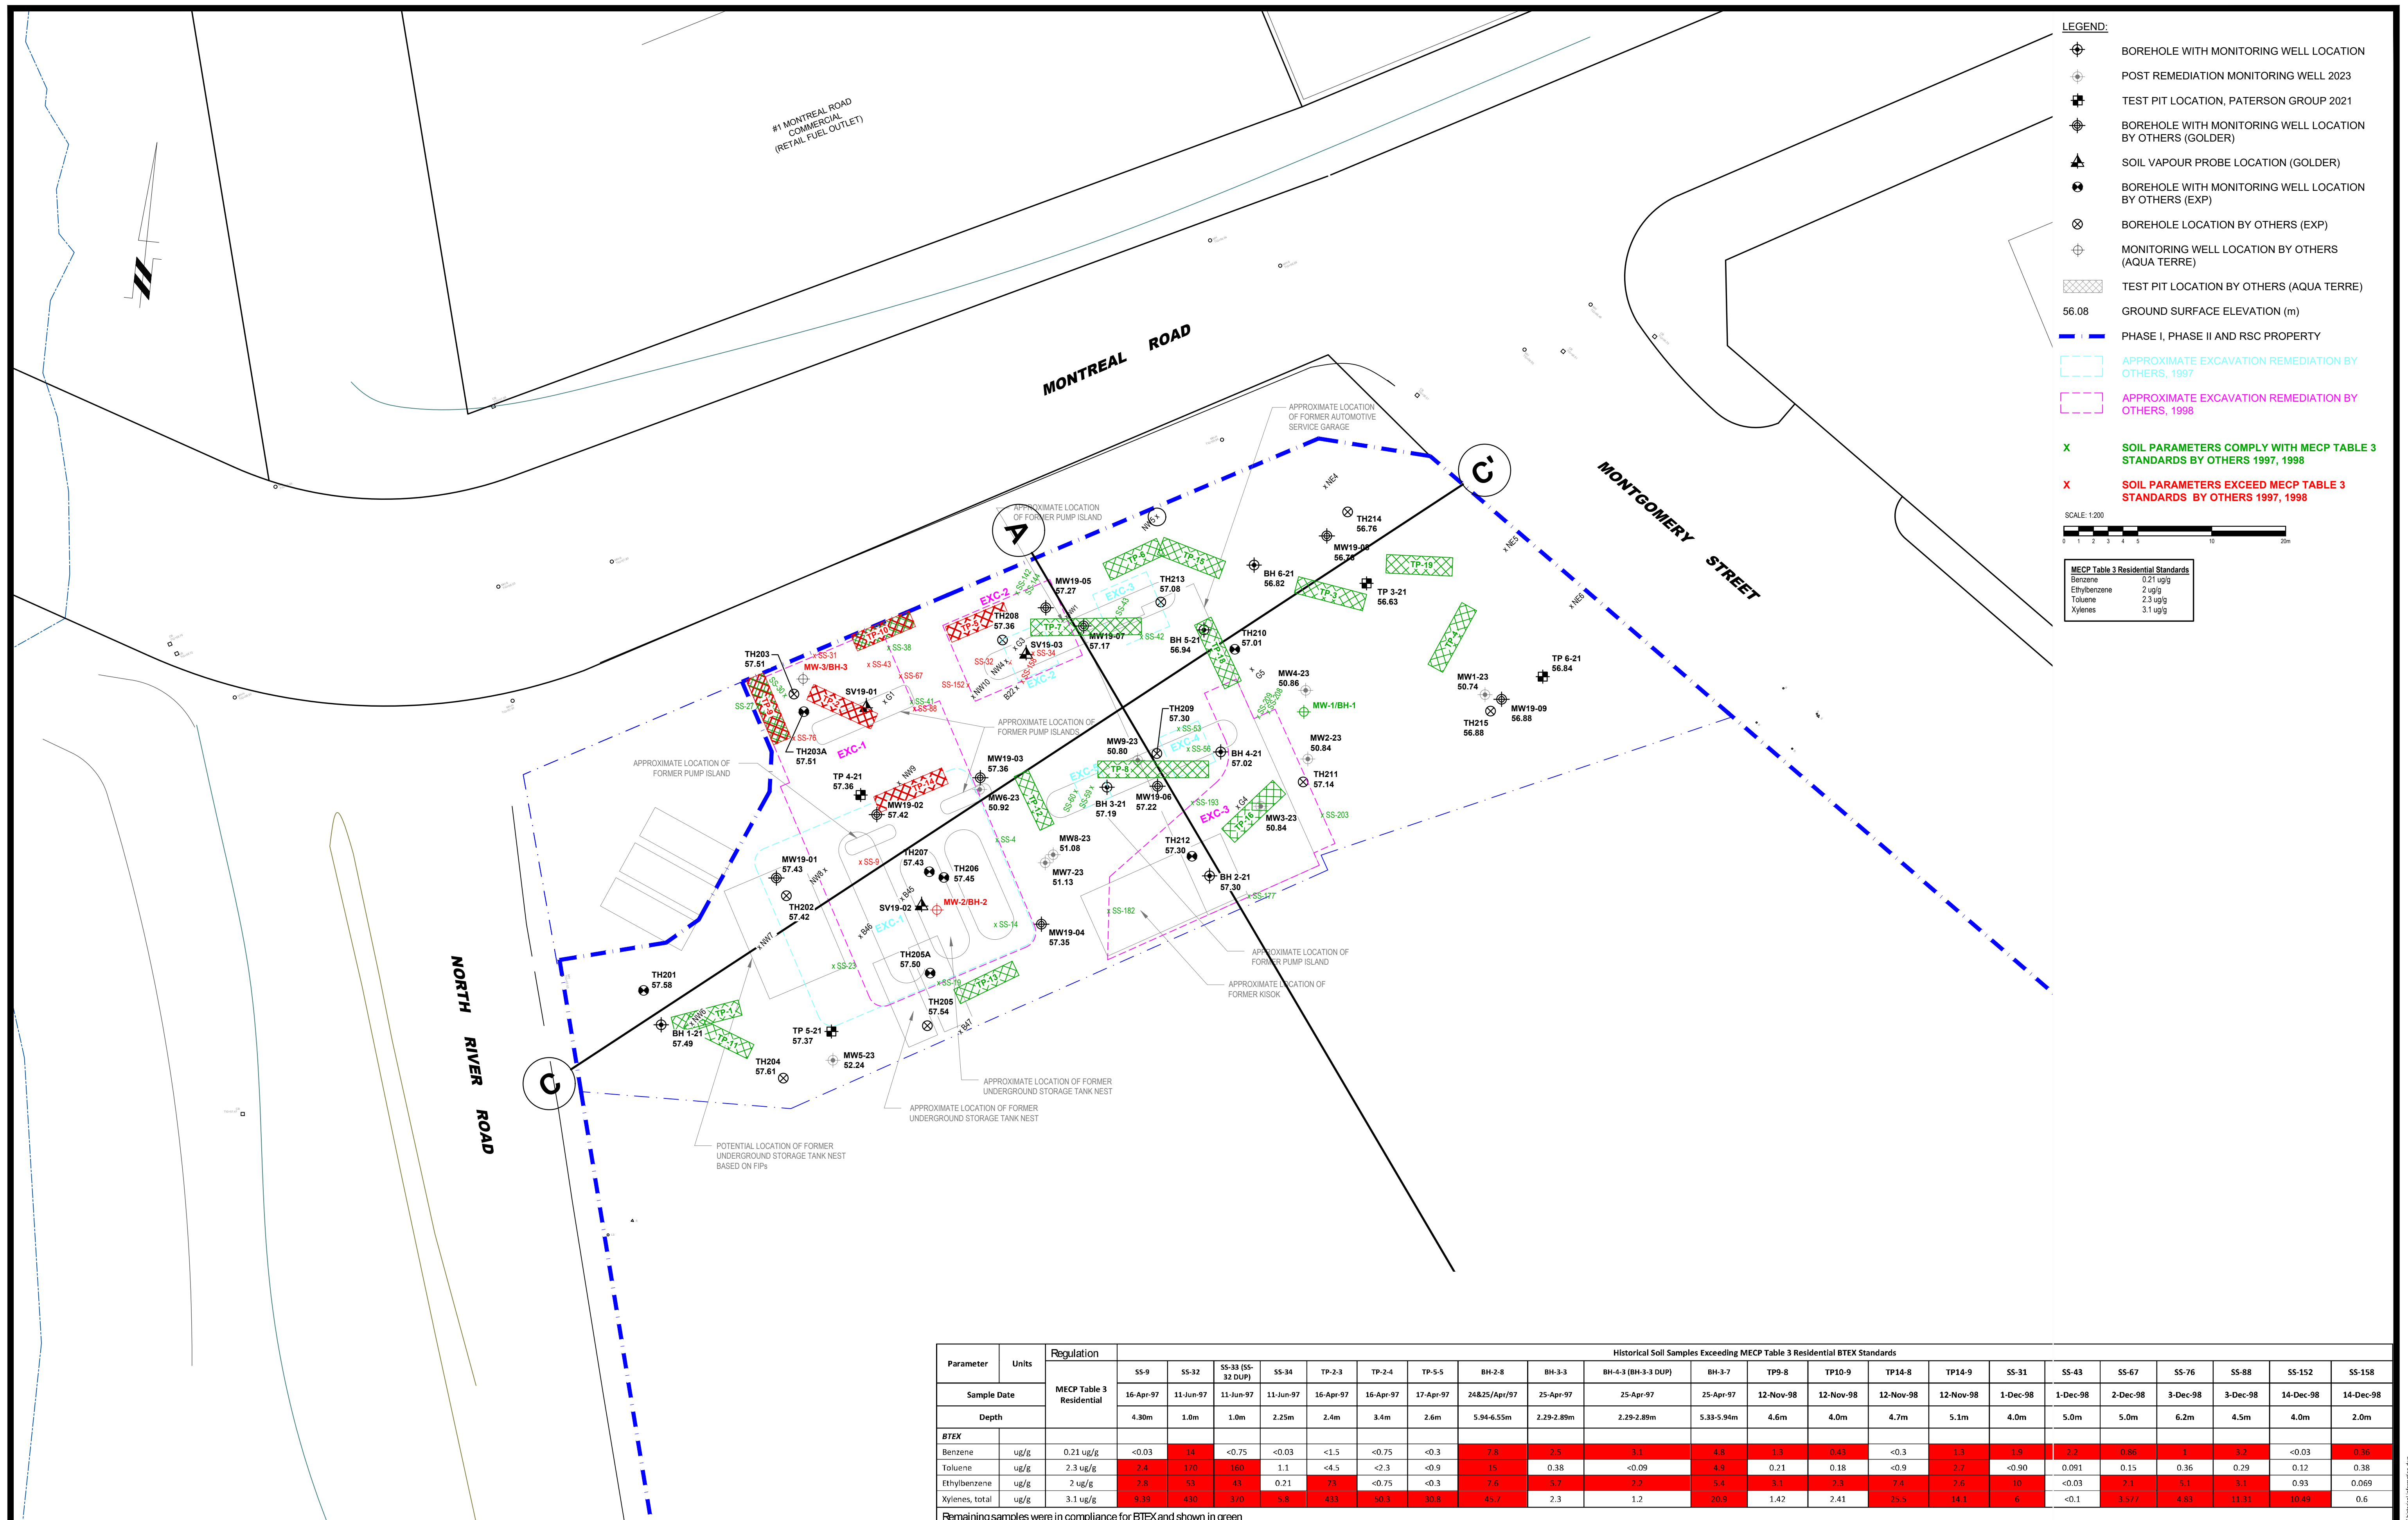
| Parameter | Units | Regulation | Historical Soil Samples Exceeding MECP Table 3 Residential BTEX Standards | | | | | | | | | | | | | | | | | | | | | |
| Remaining samples were in compliance for BTEX and shown in green | | | | | | | | | | | | | | | | | | | | | | | | |

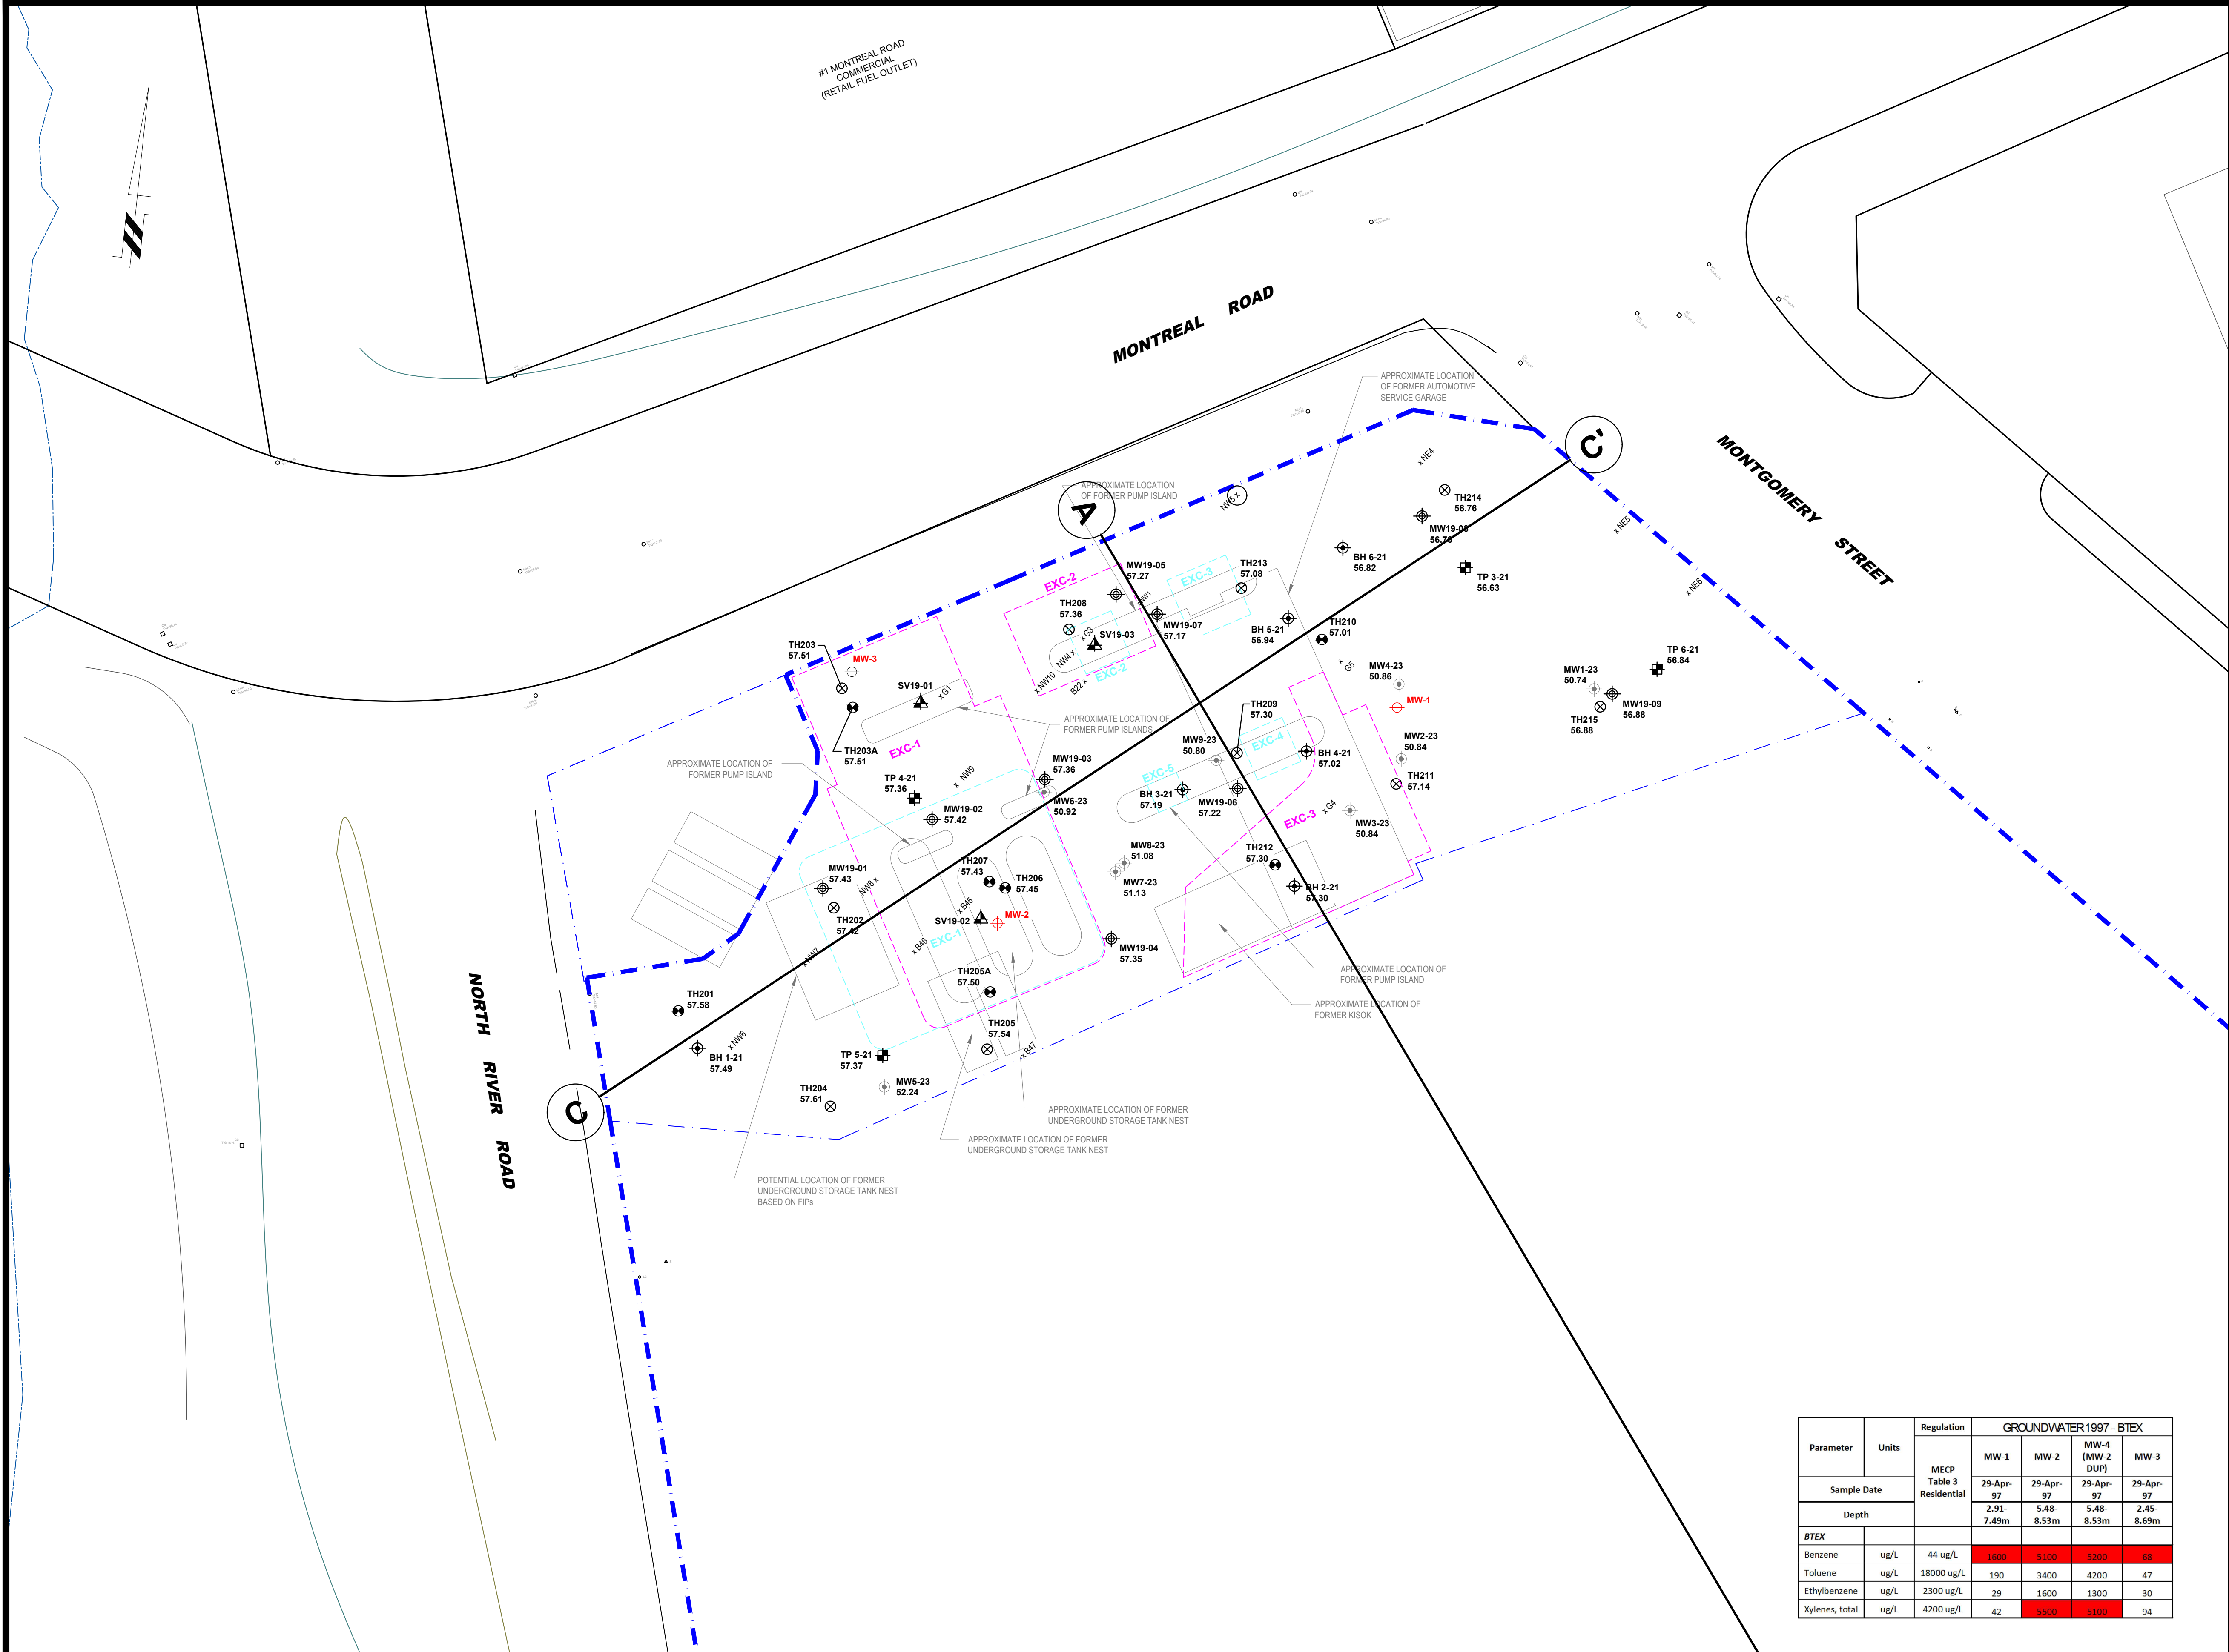
Drawing No.: **PE4546-20**

- BOREHOLE WITH MONITORING WELL LOCATION
- POST REMEDIATION MONITORING WELL 2023
- TEST PIT LOCATION, PATERSON GROUP 2021
- BOREHOLE WITH MONITORING WELL LOCATION BY OTHERS (GOLDER)
- SOIL VAPOUR PROBE LOCATION (GOLDER)
- BOREHOLE WITH MONITORING WELL LOCATION BY OTHERS (EXP)
- BOREHOLE LOCATION BY OTHERS (EXP)
- MONITORING WELL LOCATION BY OTHERS (AQUA TERRE)
- GROUND SURFACE ELEVATION (m)
- PHASE I, PHASE II AND RSC PROPERTY
- APPROXIMATE EXCAVATION REMEDIATION BY OTHERS, 1997
- APPROXIMATE EXCAVATION REMEDIATION BY OTHERS, 1998

| Parameter | Units | Regulation | GROUNDWATER 1997 - BTEX | | | |
|---|---|---|---|---|---|---|
| Ethylbenzene | ug/L | 2300 ug/L | 29 | 1600 | 1300 | 30 |
| Xylenes, total | ug/L | 4200 ug/L | 42 | 5500 | 5100 | 94 |

Analytical testing of BTEX in groundwater detected concentrations of benzene exceeding the applicable site condition standards on the northern portion of the RSC Property.

The source of the benzene concentration in groundwater is considered to be the former USTs and/or former pump island that were located on the northern portion of the RSC Property. Benzene is considered to have migrated from a pump island or UST leak into soil and then into the groundwater at the RSC Property.

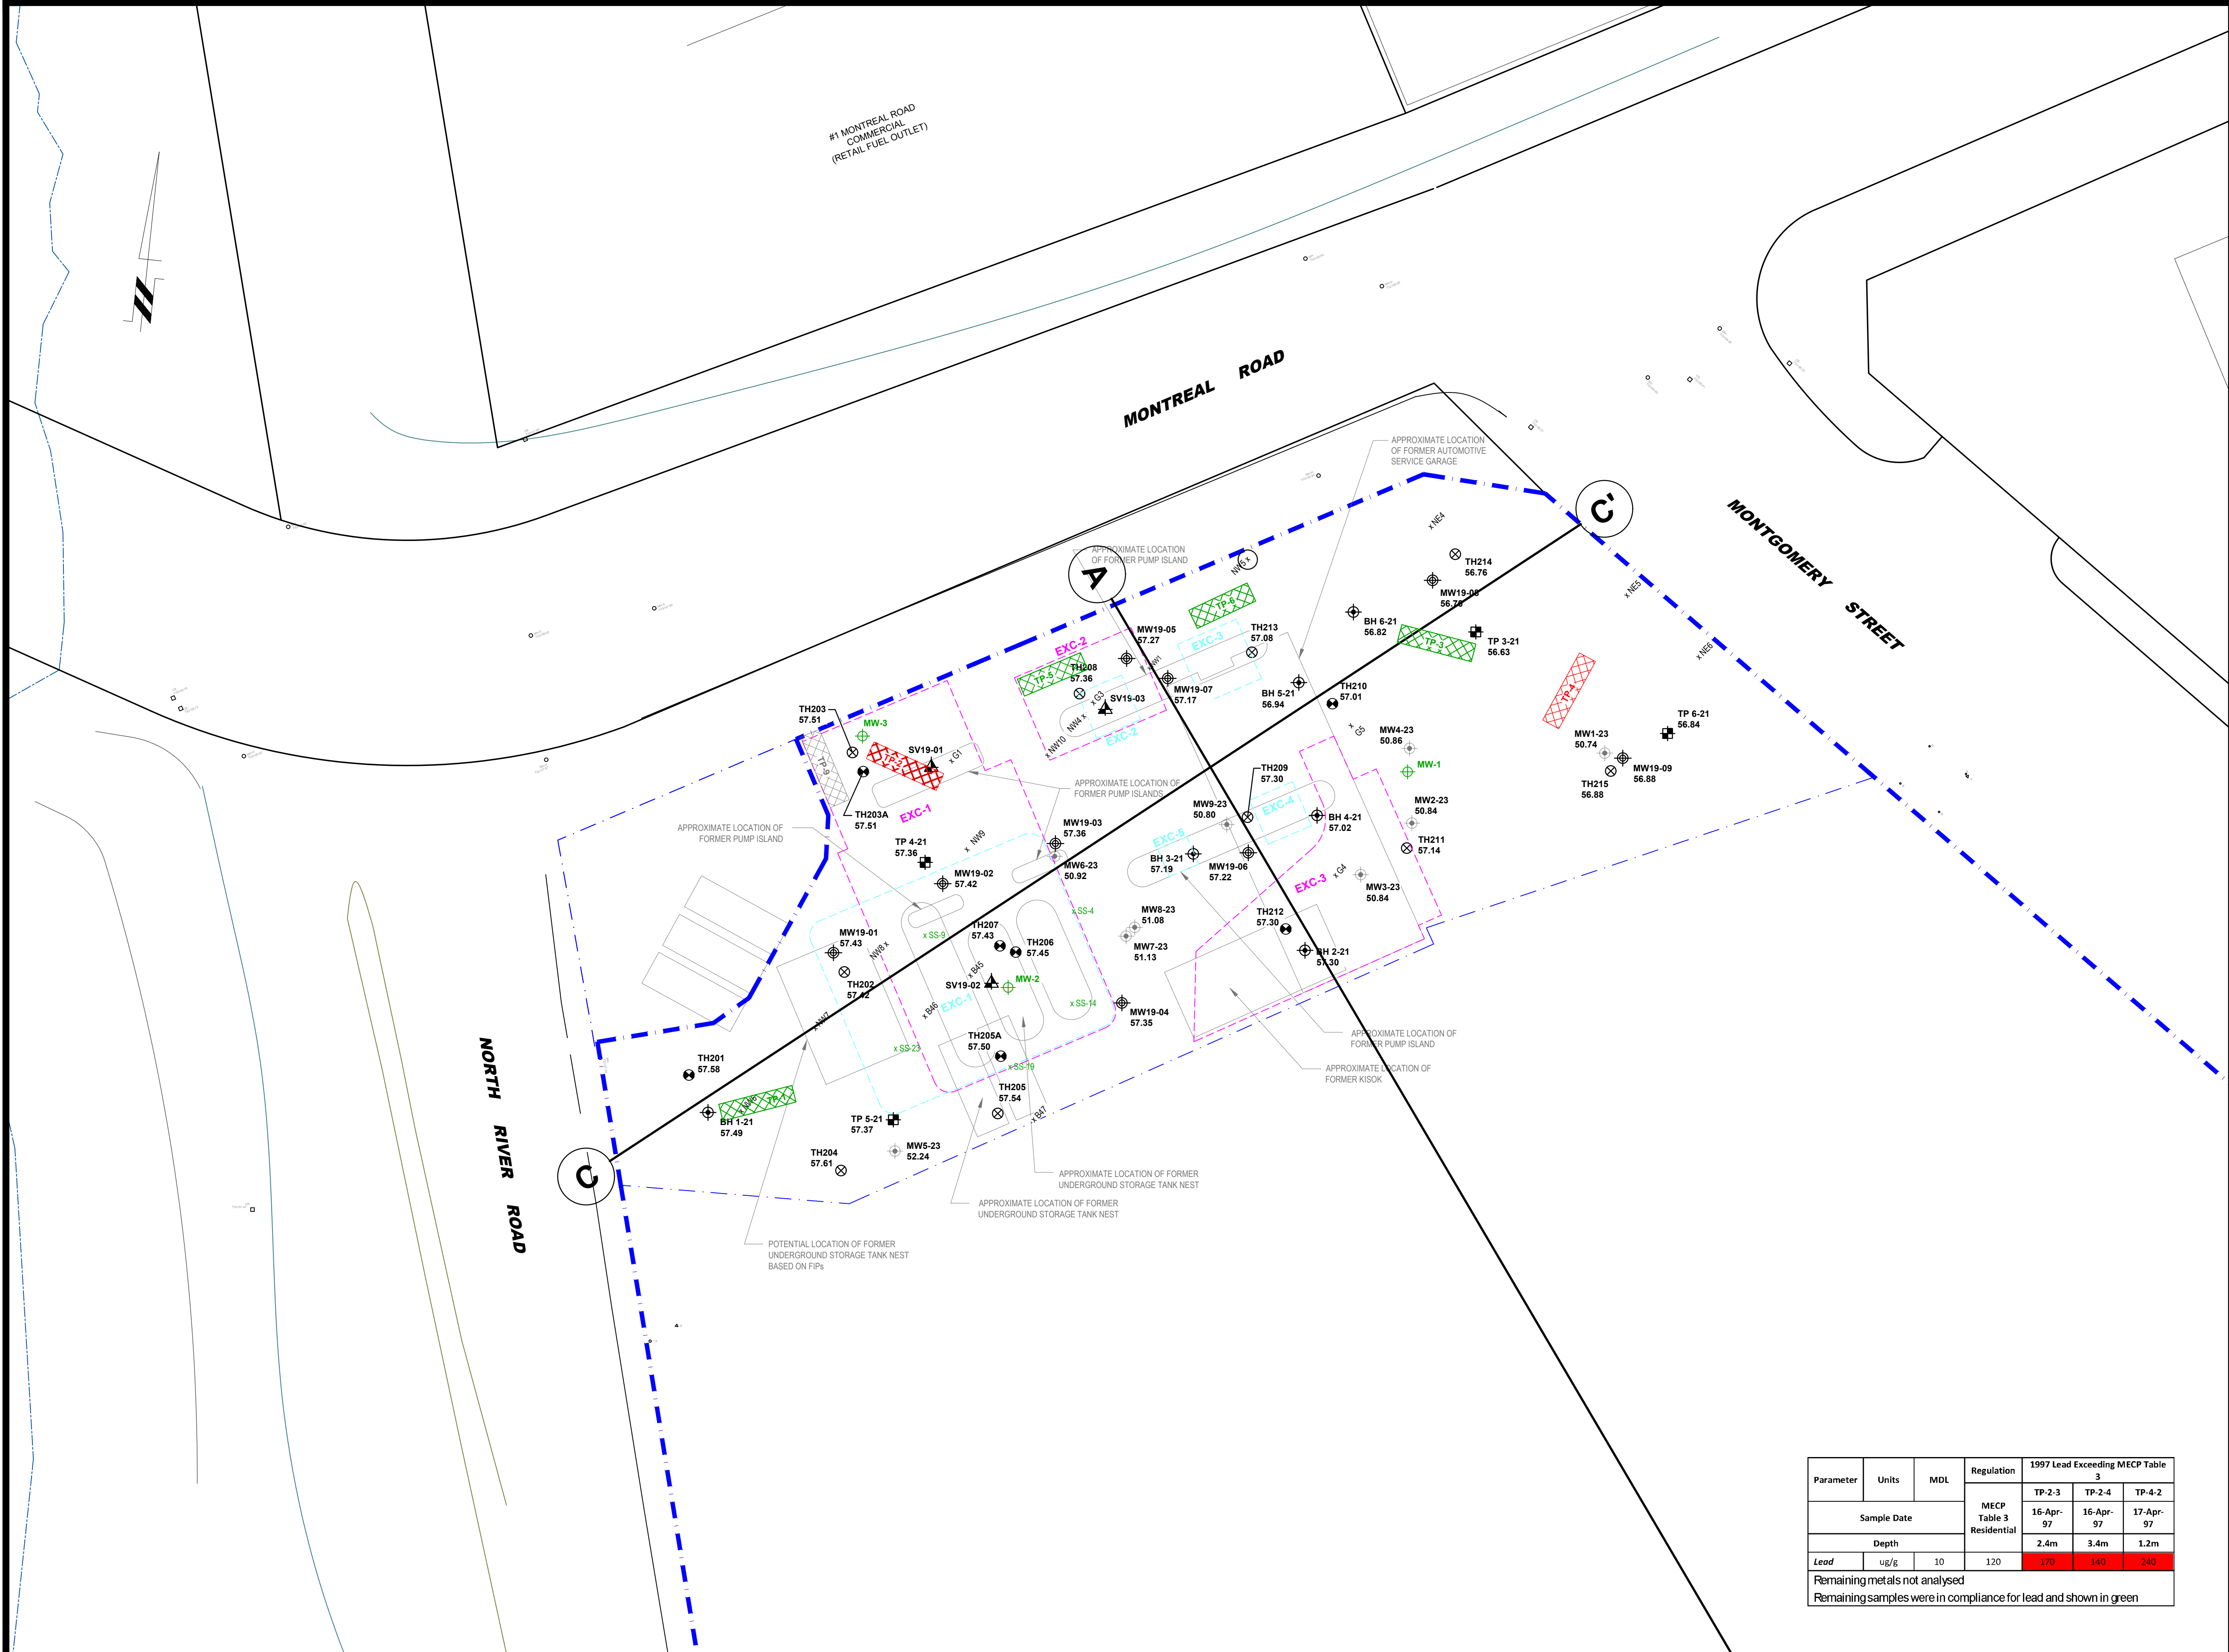
- LEGEND:**
- BOREHOLE WITH MONITORING WELL LOCATION
  - POST REMEDIATION MONITORING WELL 2023
  - TEST PIT LOCATION, PATERSON GROUP 2021
  - BOREHOLE WITH MONITORING WELL LOCATION BY OTHERS (GOLDER)
  - SOIL VAPOUR PROBE LOCATION (GOLDER)
  - BOREHOLE WITH MONITORING WELL LOCATION BY OTHERS (EXP)
  - BOREHOLE LOCATION BY OTHERS (EXP)
  - MONITORING WELL LOCATION BY OTHERS (AQUA TERRE)
  - TEST PIT LOCATION BY OTHERS (AQUA TERRE)
  - GROUND SURFACE ELEVATION (m)
  - PHASE I, PHASE II AND RSC PROPERTY
  - APPROXIMATE EXCAVATION REMEDIATION BY OTHERS, 1997
  - APPROXIMATE EXCAVATION REMEDIATION BY OTHERS, 1998
  - LEAD COMPLY WITH MECP TABLE 3 STANDARDS BY OTHERS 1997, 1998
  - LEAD EXCEED MECP TABLE 3 STANDARDS BY OTHERS 1997, 1998

| Parameter | Units | MDL | Regulation | 1997 Lead Exceeding MECP Table 3 | | |
|---|---|---|---|---|---|---|
| Remaining samples were in compliance for lead and shown in green | | | | | | |

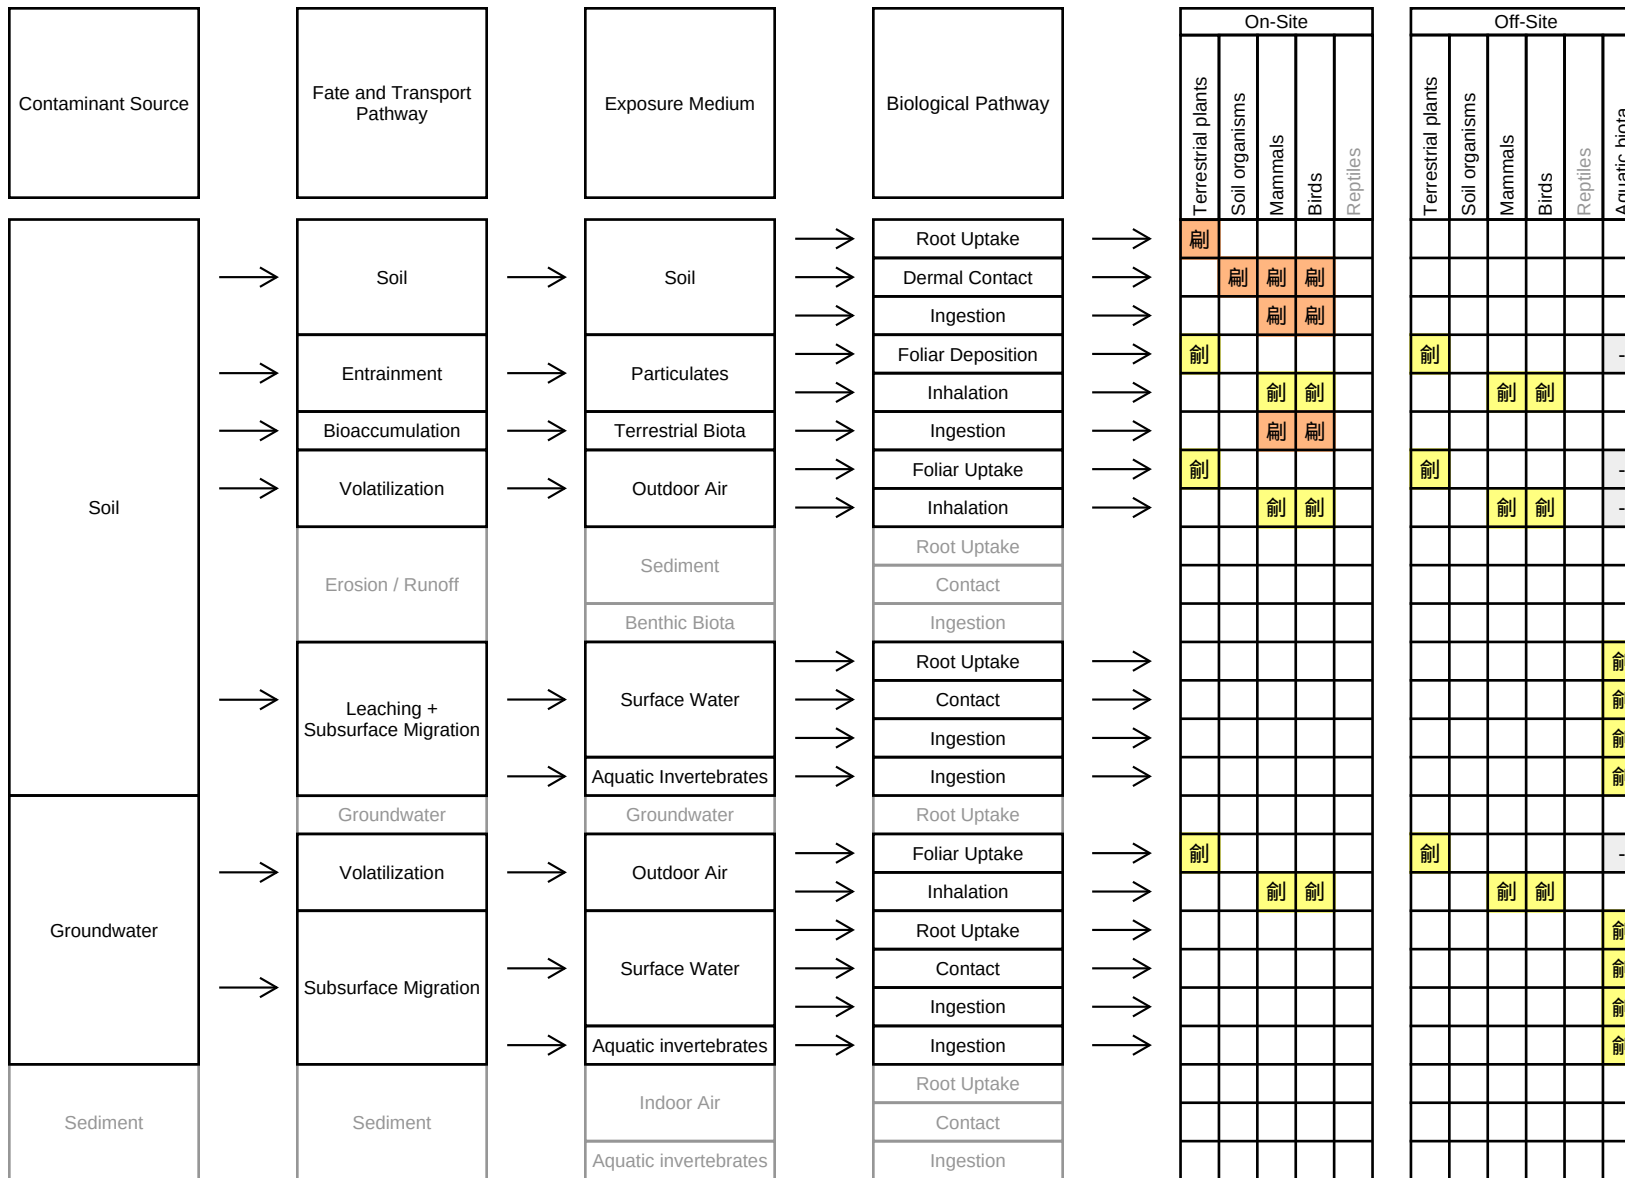
- Major exposure pathway
- Minor exposure pathway
- Negligible exposure pathway
- Incomplete exposure pathway

- Figure 4: Human Health Conceptual Exposure Model
- Figure 6: Ecological Conceptual Exposure Model
