**PATERSON  
GROUP**

August 11, 2025  
File: PE4546-LET.13

Subject: **Phase I - Environmental Site Assessment Update**  
**280 Montgomery Street**  
**300 Montgomery Street**  
**2 Montreal Road**  
**3 Selkirk Street**  
**Ottawa, Ontario**

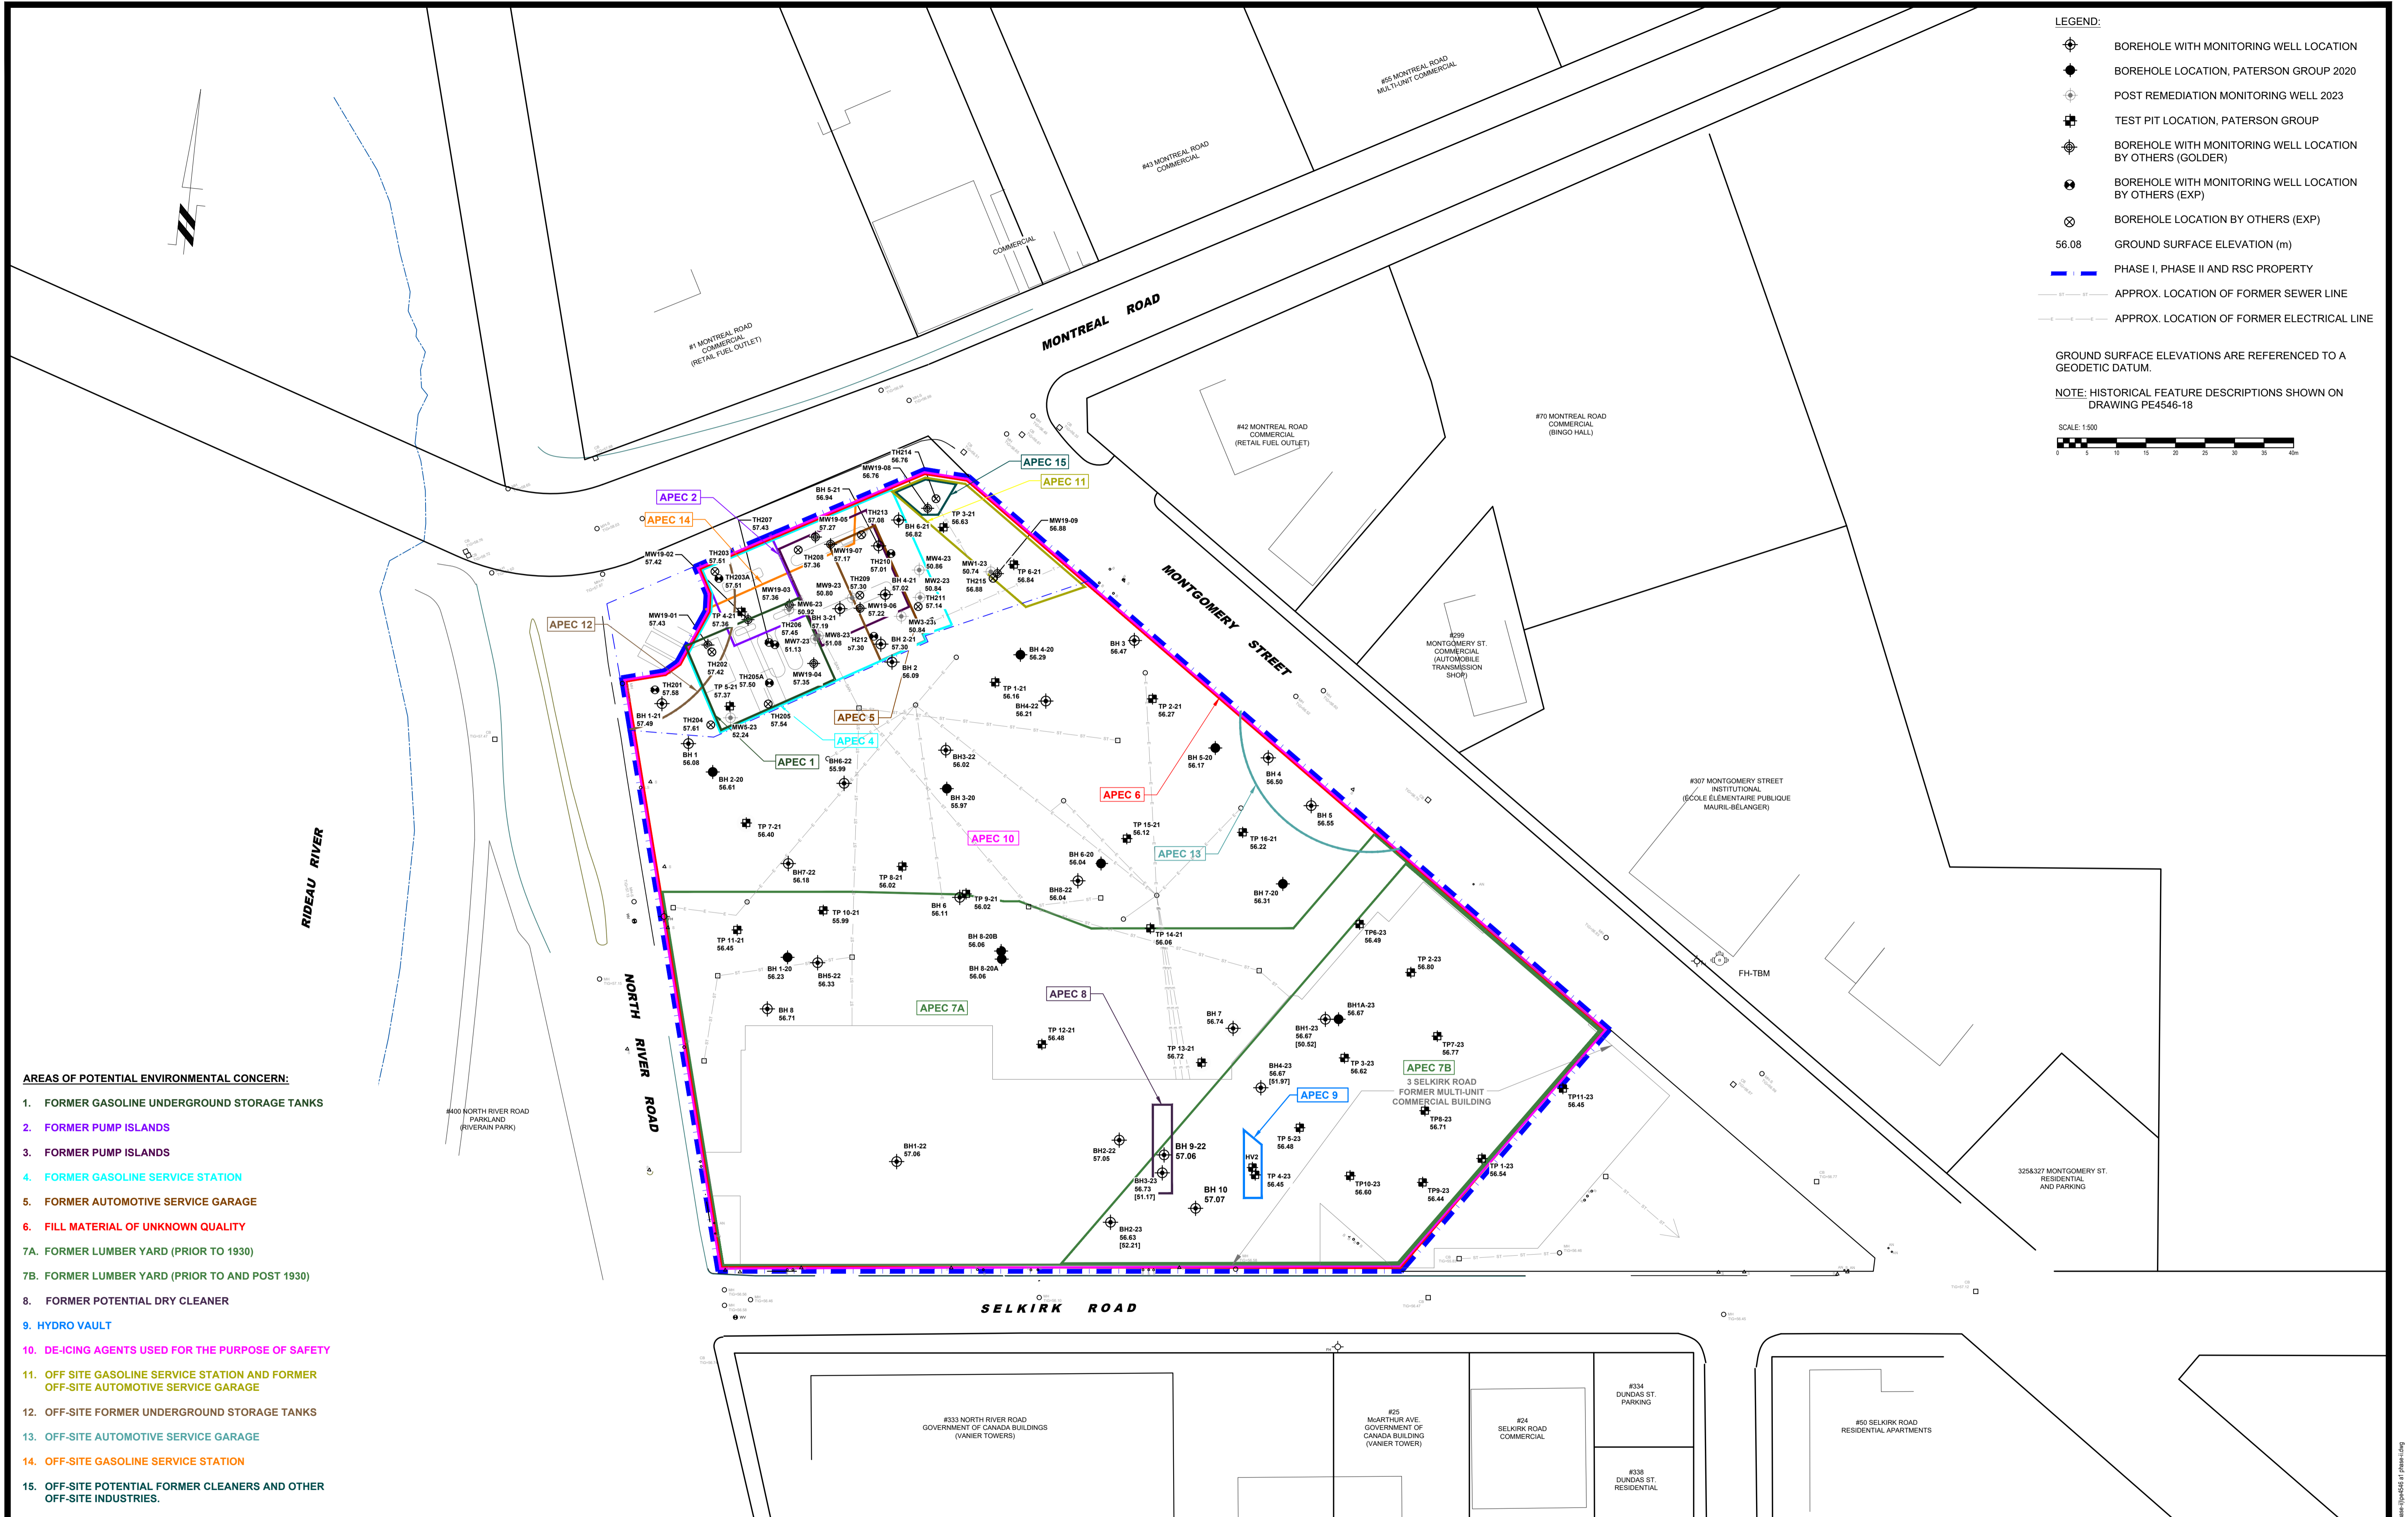
**SITE PLAN**

Based on the results of the Phase I ESA and Phase I ESA Updates completed for the RSC Property, Potentially Contaminating Activities (PCAs) were identified to represent Areas of Potential Environmental Concern (APECs) with respect to the RSC Property. The APECs on the RSC Property are summarized in the table below with their respective Contaminants of Potential Concern (CPC). Areas of Potential Environmental Concern are illustrated on Drawing PE4546 – 1 – Site Plan.

**APEC 1 – Former Gasoline Underground Storage Tanks (USTs)** - Former gasoline underground storage tanks (USTs) associated with the former use of the RSC Property as a retail fuel outlet were identified on the 1948 Fire insurance Plan and in previous environmental reports as being located on the north western portion of the RSC Property. The former gasoline USTs represent APEC 1 on the RSC Property.

**APEC 2, APEC 3 - Former Pump Islands** – Former pump islands associated with the former use of the RSC Property as a retail fuel outlet were identified on the northwestern portion of the RSC Property and the northcentral portion of the RSC Property. The locations of the former pump islands were identified in previous environmental reports. The reported locations of the former pump islands appear consistent with the images in the 1965 and 1991 areal photographs. The former pump island and associated piping are considered to represent APEC 2 and APEC 3 on the northwestern and north central portions of the RSC Property.

**APEC 5 – Former Automotive Service Garage** – A former automotive service garage was identified as located on the north central portion of the RSC Property. No features of the former garage associated with APEC 5 are known. FIPs were reviewed as part of the Phase I ESA and no information regarding the location of tanks or hoists associated with the garage could be identified from the FIPs. The former garage can be seen in the 1965

**APEC 6 – Fill Material of Unknown Quality** - Fill material was encountered across the RSC Property and including in areas of the former USTs and former pump islands. Three soil sample results for lead with concentrations of 170 mg/kg, 140 mg/kg and 240 mg/kg collected from TP2 and TP4 in 1997 exceed the current 2011 MECP Table 3 residential standard of 120 ug/g for lead but were in compliance with the MOE Table B commercial remedial criteria at the time. These sample results are considered to be included in the fill material of unknown quality APEC. The results for lead from TP2 and TP4 is shown on drawing PE4546- 8 – Soil (CrVI, metals including As, Sb and Se).

**APEC 8 – Former Potential Dry Cleaner** – A former cleaner was listed in the city directories for an address located in the former commercial building and shown on an old plan as located centrally in the former commercial building. It could not be confirmed if dry cleaning equipment was used. The former potential dry cleaner is considered to be a PCA representing APEC 8 on the RSC Property.
