Project: **RIVERAIN DISTRICT**

2 MONTREAL RD. & 3 SELKIRK ST,
 OTTAWA., ONTARIO

Drawing: **TREE CONSERVATION REPORT**

Project Number: 2052-01 Sheet Number: TCR 01

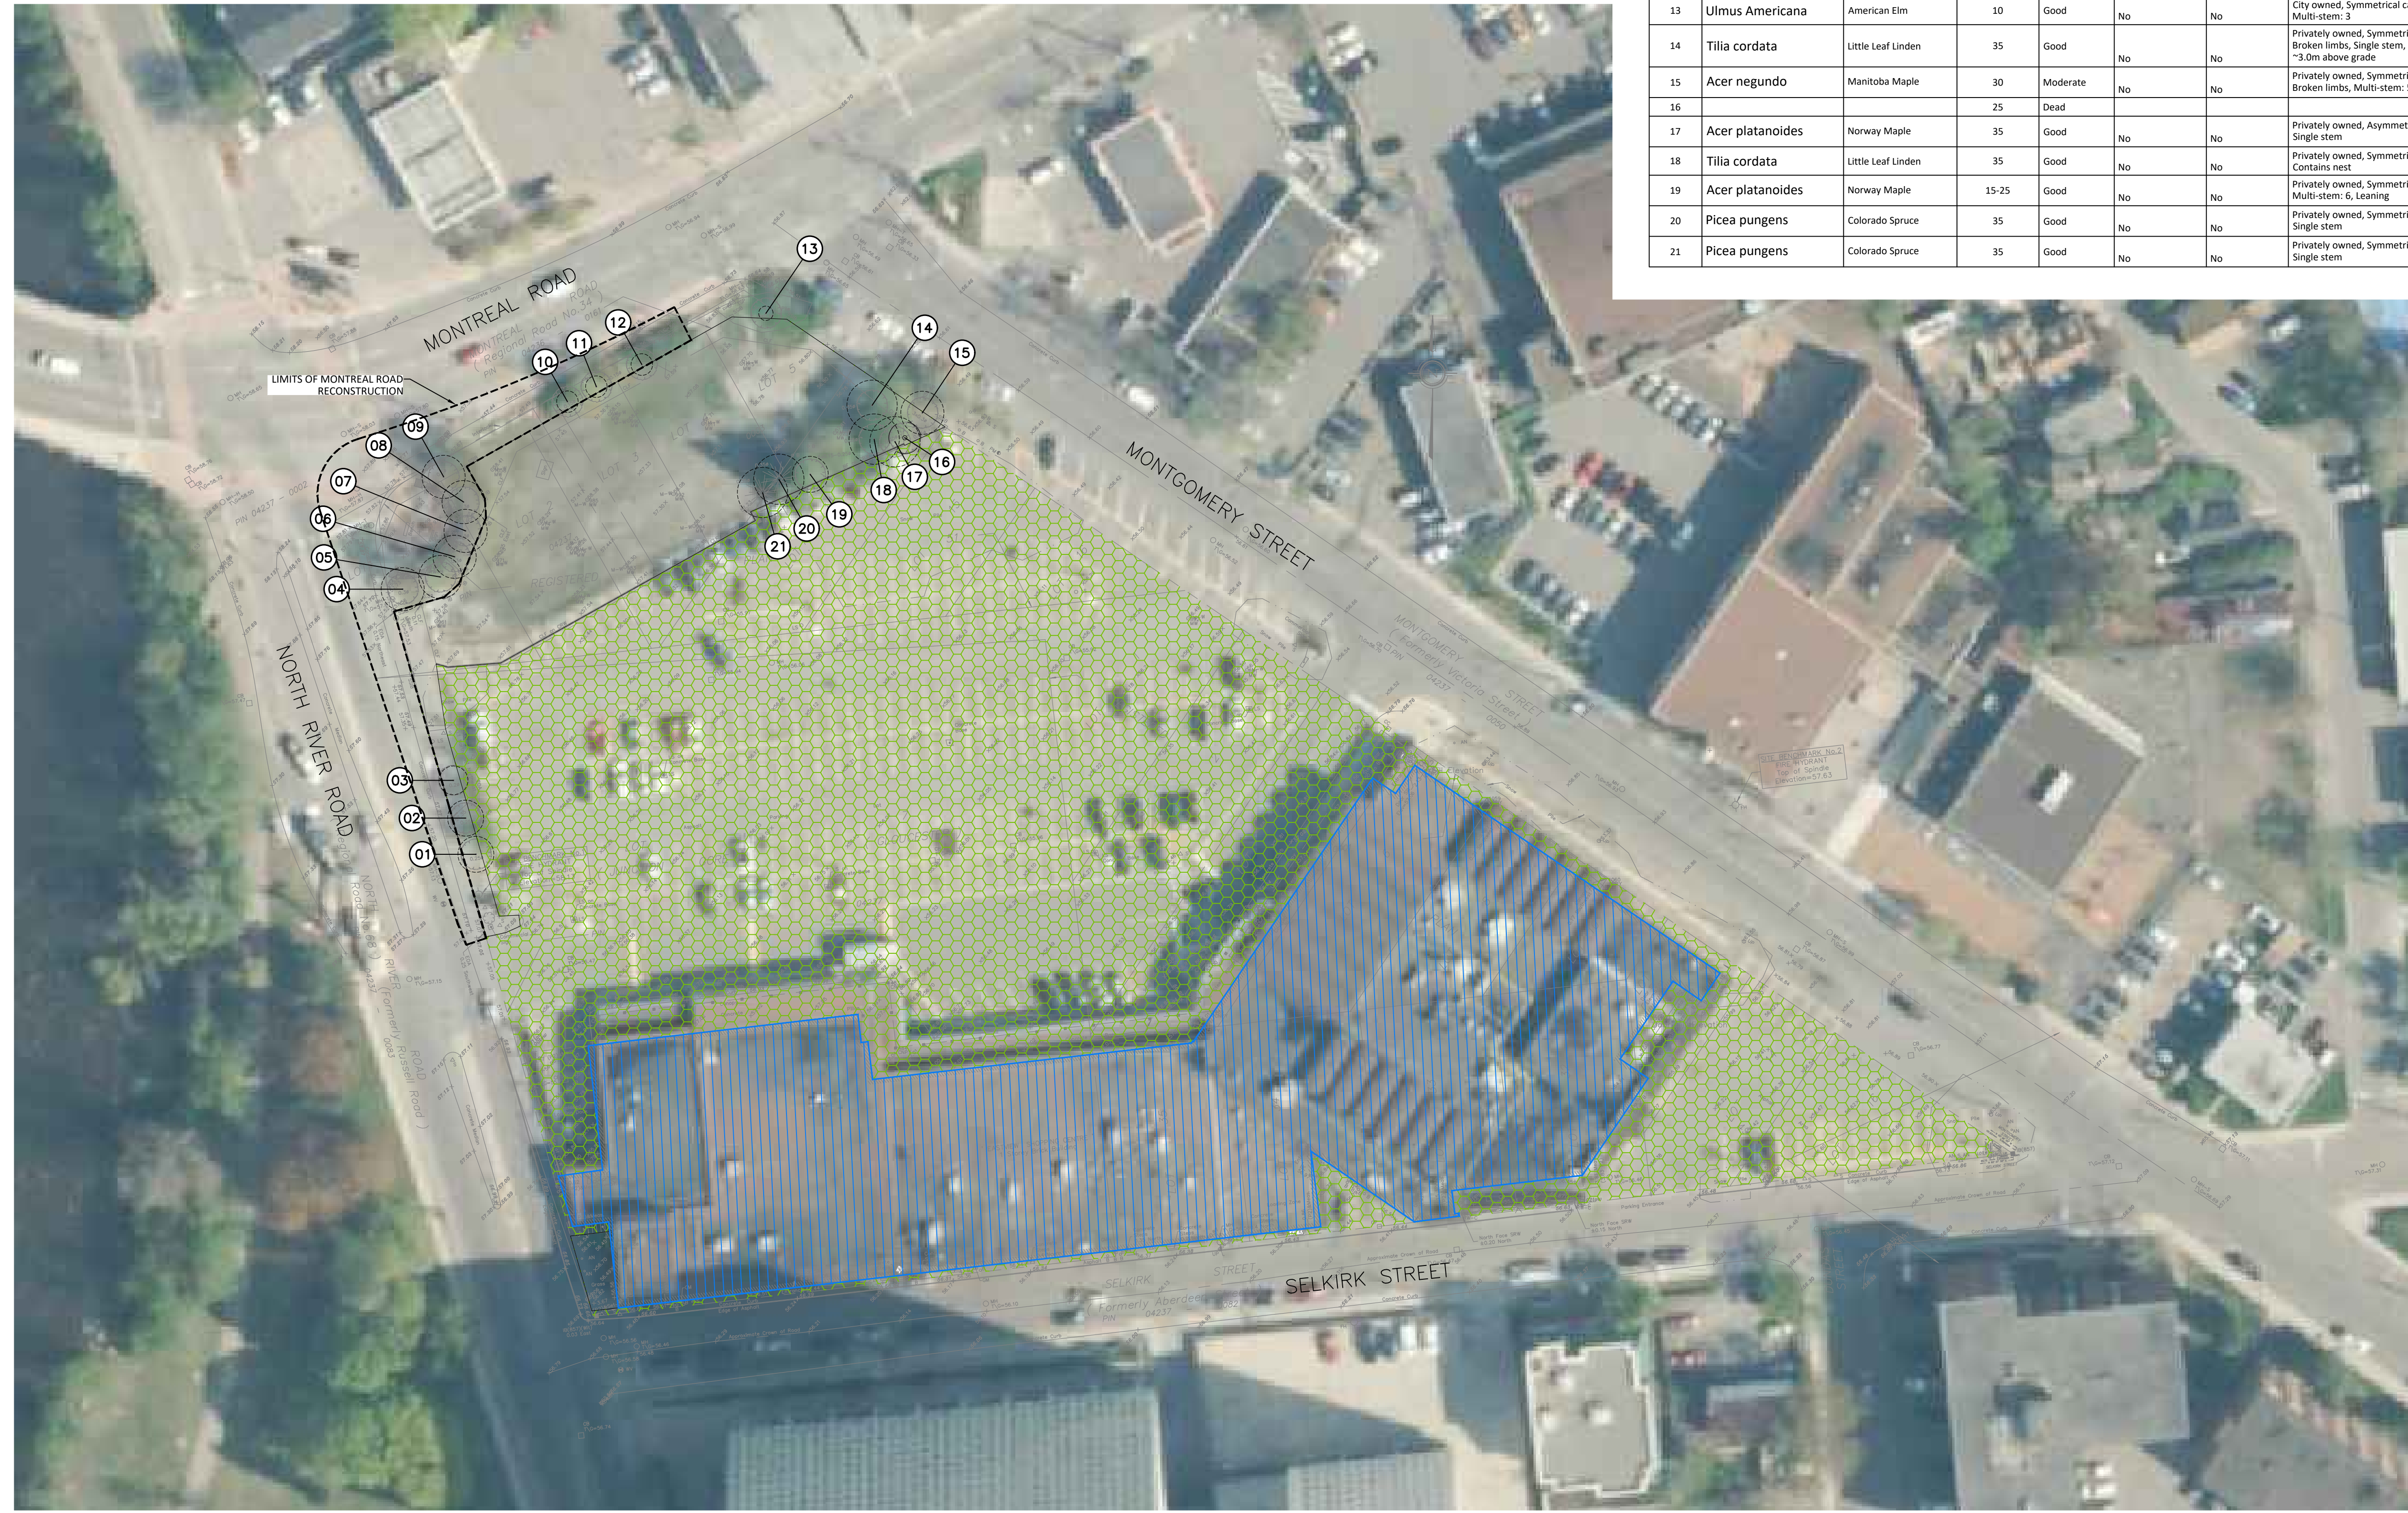
1 EXISTING VEGETATION

- THE EXISTING SITE CONTAINS MULTIPLE PARCELS OF LAND. THE LARGEST LAND PARCEL INCLUDES A SINGLE STORY COMMERCIAL/RETAIL BUILDING AND IS LARGELY OCCUPIED BY PARKING LOT. THE PROPERTY IS FAIRLY FLAT AND VOID OF TREES WITH THE EXCEPTION OF A FEW ALONG THE WESTERN EDGE BETWEEN THE PARKING AND SIDEWALK ADJACENT NORTH RIVER ROAD. THE SECOND SMALLER PARCEL TO THE NORTH IS COMPRISED OF TURF AND ASPHALT CONSISTENT WITH A DECOMMISSIONED LOT. THE PARCEL IS SEPARATED FROM THE PARKING LOT BY A LOW RETAINING WALL AND FENCING CHAIN LINK AND WOOD BOARD FENCING. A NUMBER OF TREE ARE ESTABLISHED NORTH OF THE RETAINING WALL.

- THE SITE IS 16930m² (1,693Ha).
 - APPROXIMATELY 9553m² IS OCCUPIED BY HARD SURFACES.
 - APPROXIMATELY 5577m² IS OCCUPIED BY BUILDING.
- GENERALLY, THE TREES ON THE PROPERTY ARE IN GOOD CONDITION. TREES OUTSIDE THE PROPERTY (CITY TREES) ARE GENERALLY IN GOOD CONDITION WITH THE EXCEPTION OF A COUPLE THAT ARE EITHER DEAD/POOR CONDITION.

- 21 TREES WERE INVENTORIED IN THE PROXIMITY OF THE PROJECT PROPERTY.
 - 10 TREES ARE ON CITY PROPERTY, WHILE 11 TREES ARE ON PRIVATE PROPERTY.
 - THE CITY TREES AT THE NORTHWEST CORNER OF THE PROPERTY ARE PART OF A PARKETTE/SEATING SPACE PER THE INTERSECTION OF NORTH RIVER ROAD AND MONTREAL ROAD. THESE LARGE TREES, WHICH ARE IN GOOD CONDITION, PROVIDE SHADE FOR THE SEATING AREA AND HAVE A HIGH VALUE FUNCTION. A COUPLE OF THE TREE'S CRITICAL ROOT ZONES CROSS THE PROPERTY LINE AND DO SO IN A MINOR CAPACITY.

TREE CONSERVATION - FIELD NOTES								
Tree #	Botanical Name	Common Name	Caliper (cm)	Condition	High Quality Tree	Rare Tree	Comments	To Be Preserved
1	Tilia cordata	Little Leaf Linden	25	Moderate	No	No	Privately owned, Symmetrical canopy, Die-back ~15%, Broken limbs, Single stem, Leaning, Included bark	Remove
2	Tilia cordata	Little Leaf Linden	25	Good	No	No	Privately owned, Symmetrical canopy, Single stem, Co-dominant leaders 2 @ ~2.0m above grade, Included bark	Remove
3	Tilia cordata	Little Leaf Linden	20	Poor	No	No	Privately owned, Die-back ~50%, Single stem, Co-dominant leaders 3 @ ~2.0m above grade, Bark rot @ limbs	Remove
4	Tilia cordata	Little Leaf Linden	30	Good	No	No	City owned, Symmetrical canopy, Single stem	Retain
5	Tilia cordata	Little Leaf Linden	30	Good	No	No	City owned, Symmetrical canopy, Single stem	Retain
6	Tilia cordata	Little Leaf Linden	30	Good	No	No	City owned, Symmetrical canopy, Single stem	Retain

7	Tilia cordata	Little Leaf Linden	30	Good	No	No	City owned, Symmetrical canopy, Single stem	Remove
8	Tilia cordata	Little Leaf Linden	30	Good	No	No	City owned, Symmetrical canopy, Single stem	Remove
9	Tilia cordata	Little Leaf Linden	30	Good	No	No	City owned, Symmetrical canopy, Single stem	Retain
10	Acer platanoides	Norway Maple	15	Good	No	No	City owned, Symmetrical canopy, Single stem, Co-dominant leaders 2 @ ~2.0m above grade, Single stem, Co-dominant leaders 2 @ ~2.0m above grade	Remove
11	Acer platanoides	Norway Maple	15	Good	No	No	City owned, Symmetrical canopy, Single stem, Co-dominant leaders 2 @ ~2.0m above grade, Establishing vines	Remove
12	Ulmus Americana	American Elm	15	Poor	No	No	City owned, Symmetrical canopy, Die-back ~90%, Single stem, Significant vines	Remove
13	Ulmus Americana	American Elm	10	Good	No	No	City owned, Symmetrical canopy, Minor pruning.	Remove
14	Tilia cordata	Little Leaf Linden	35	Good	No	No	Privately owned, Symmetrical canopy, Die-back ~5%, Broken limbs, Single stem, Co-dominant leaders 2 @ ~3.0m above grade	Remove

15	Acer negundo	Manitoba Maple	30	Moderate	No	No	Privately owned, Symmetrical canopy, Die-back ~5%, Broken limbs, Multi-stem: 5, Leaning	Remove
16			25	Dead				Remove
17	Acer platanoides	Norway Maple	35	Good	No	No	Privately owned, Asymmetrical canopy, Die-back ~5%, Single stem	Remove
18	Tilia cordata	Little Leaf Linden	35	Good	No	No	Privately owned, Symmetrical canopy, Single stem, Contains nest	Remove
19	Acer platanoides	Norway Maple	15-25	Good	No	No	Privately owned, Symmetrical canopy, Die-back ~5%, Multi-stem: 6, Leaning	Remove
20	Picea pungens	Colorado Spruce	35	Good	No	No	Privately owned, Symmetrical canopy, Die-back ~20%, Single stem	Remove
21	Picea pungens	Colorado Spruce	35	Good	No	No	Privately owned, Symmetrical canopy, Die-back ~5%, Single stem	Remove

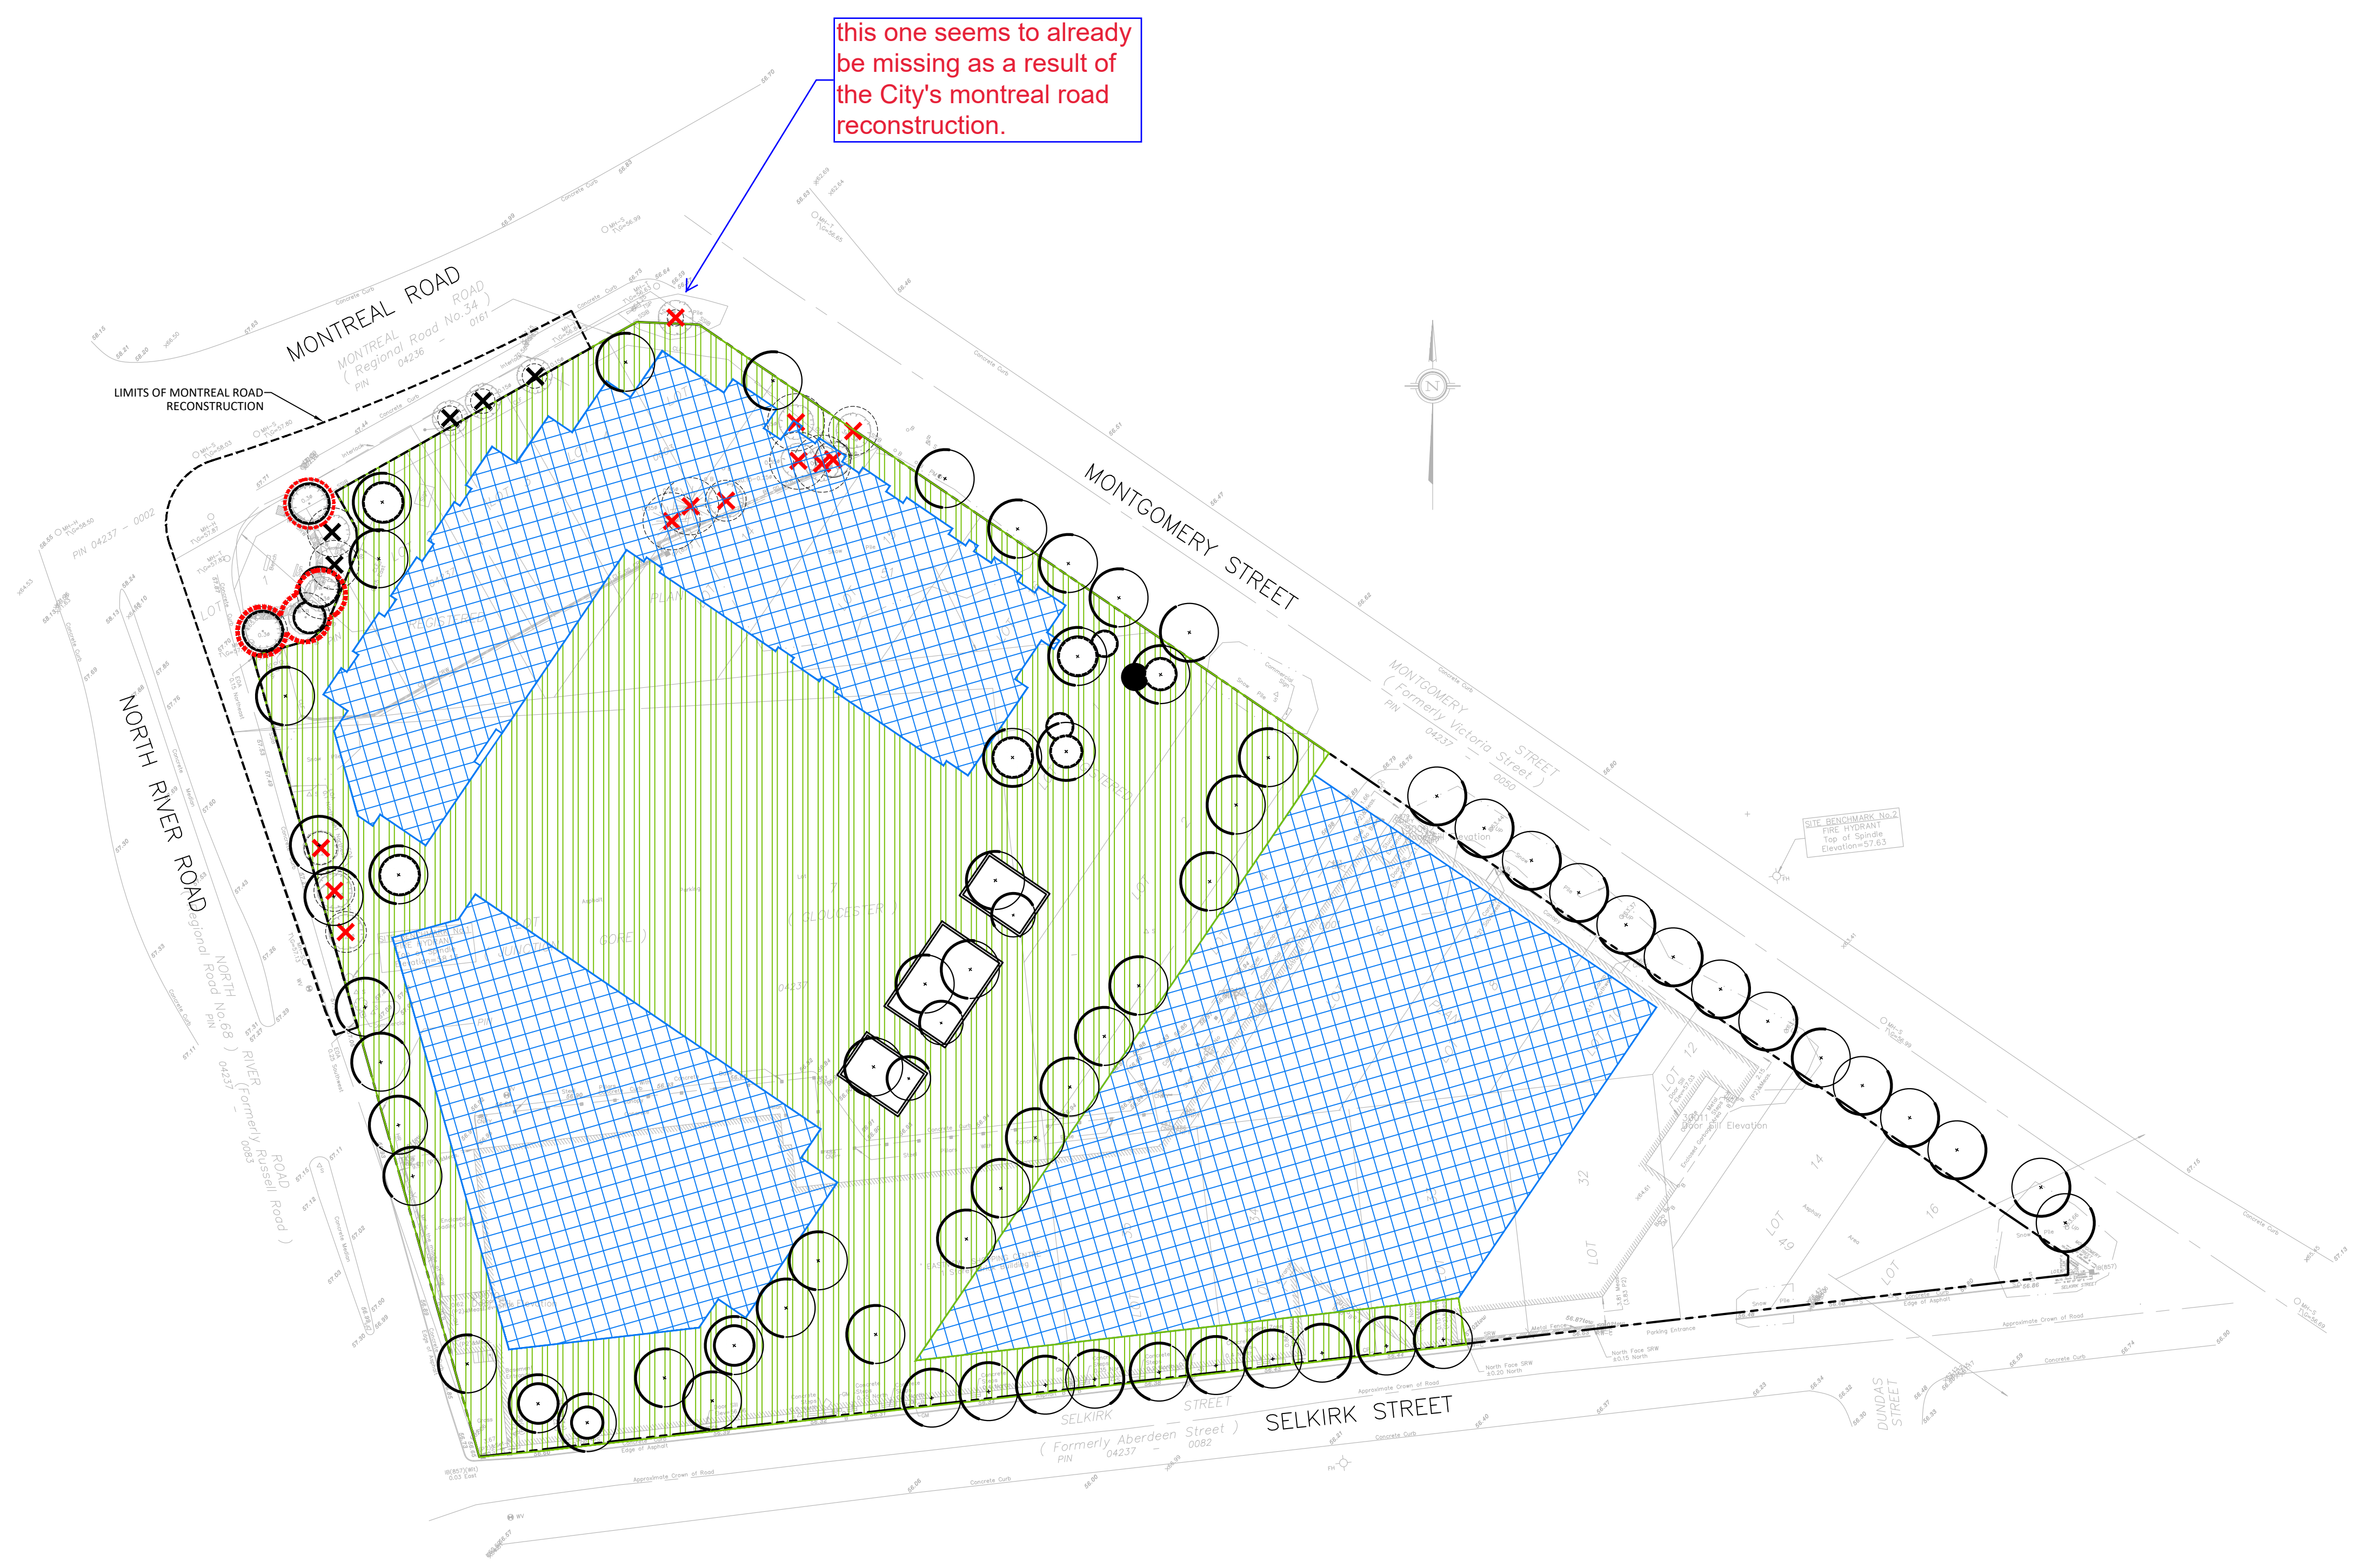
2 PROPOSED DEVELOPMENT & CONSERVED VEGETATION

- LEGEND
- CRITICAL ROOT ZONE (CRZ)
 - DEAD TREE
 - EXISTING TREE TO BE REMOVED (BY CITY OF OTTAWA QTY.5)
 - EXISTING TREE TO BE REMOVED (BY OWNER QTY.12)
 - TREE TO BE PROTECTED DURING CONSTRUCTION
 - PROPOSED DECIDUOUS TREES
 - PROPOSED BUILDING / STRUCTURE
 - PROPOSED HARD / IMPERMEABLE SURFACE
