Phase One Environmental Site Assessment

Parkdale 3 Lands
131 & 139 Parkdale Avenue
and 122 Forward Avenue
Ottawa, Ontario

Prepared for:
11034936 Canada Inc.

LOP26-035A

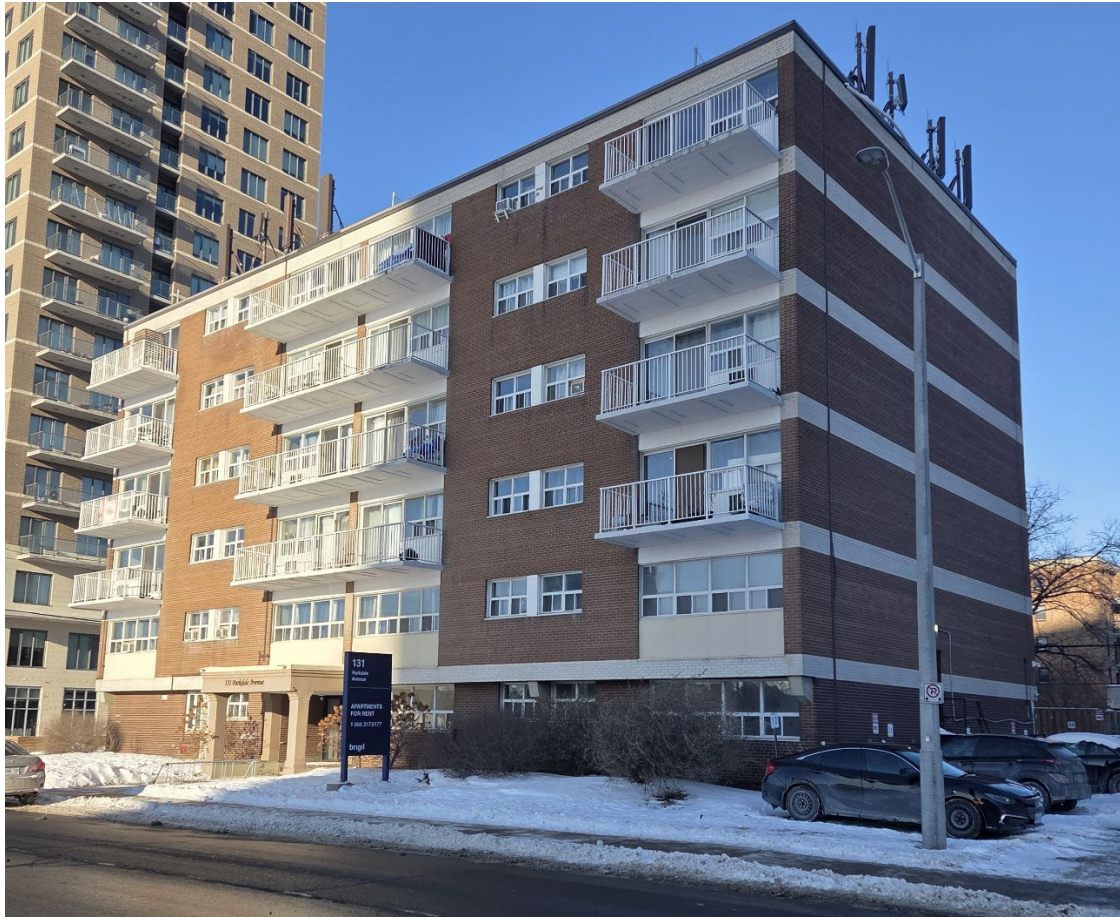
Photograph 1: View of the of the northwest portion of the Phase One Property looking northeast. View shows the residential apartment building at 131 Parkdale Avenue.

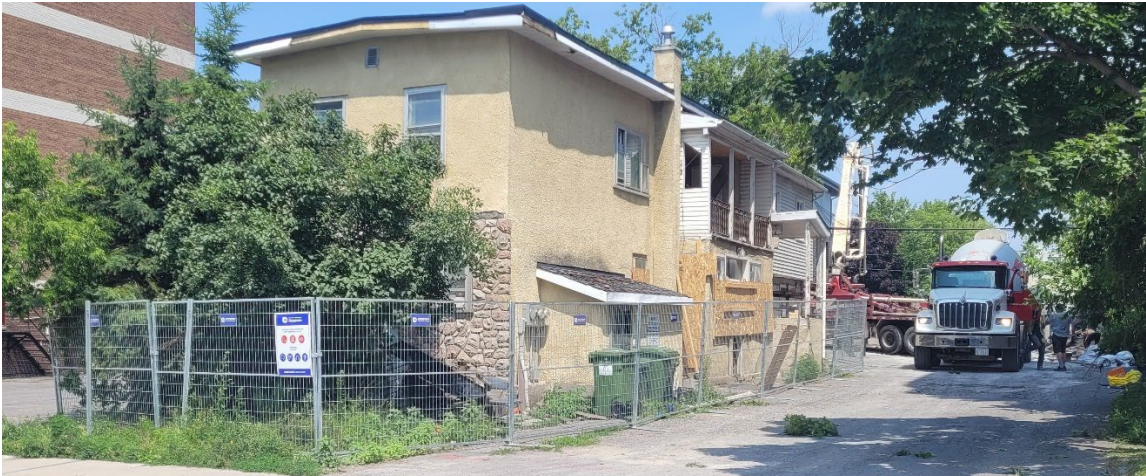
Photograph 2: View of the of the southwest portion of the Phase One Property looking northeast. View shows the vacant residential dwelling at 139 Parkdale Avenue.

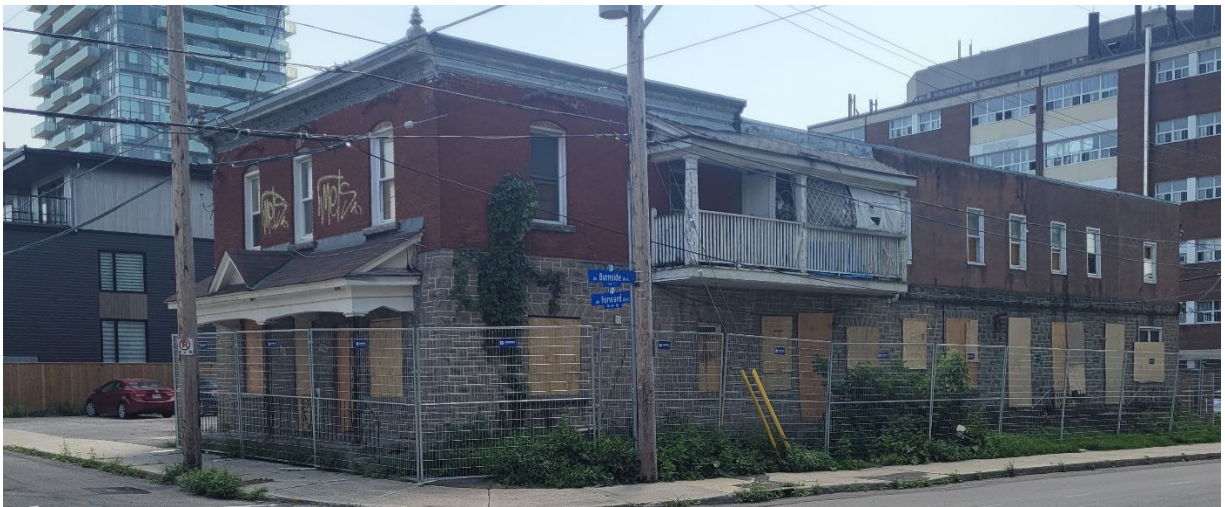
Photograph 3: View of the of the northeast portion of the Phase One Property looking southwest. View shows the vacant residential rooming house building at 122 Forward Avenue.

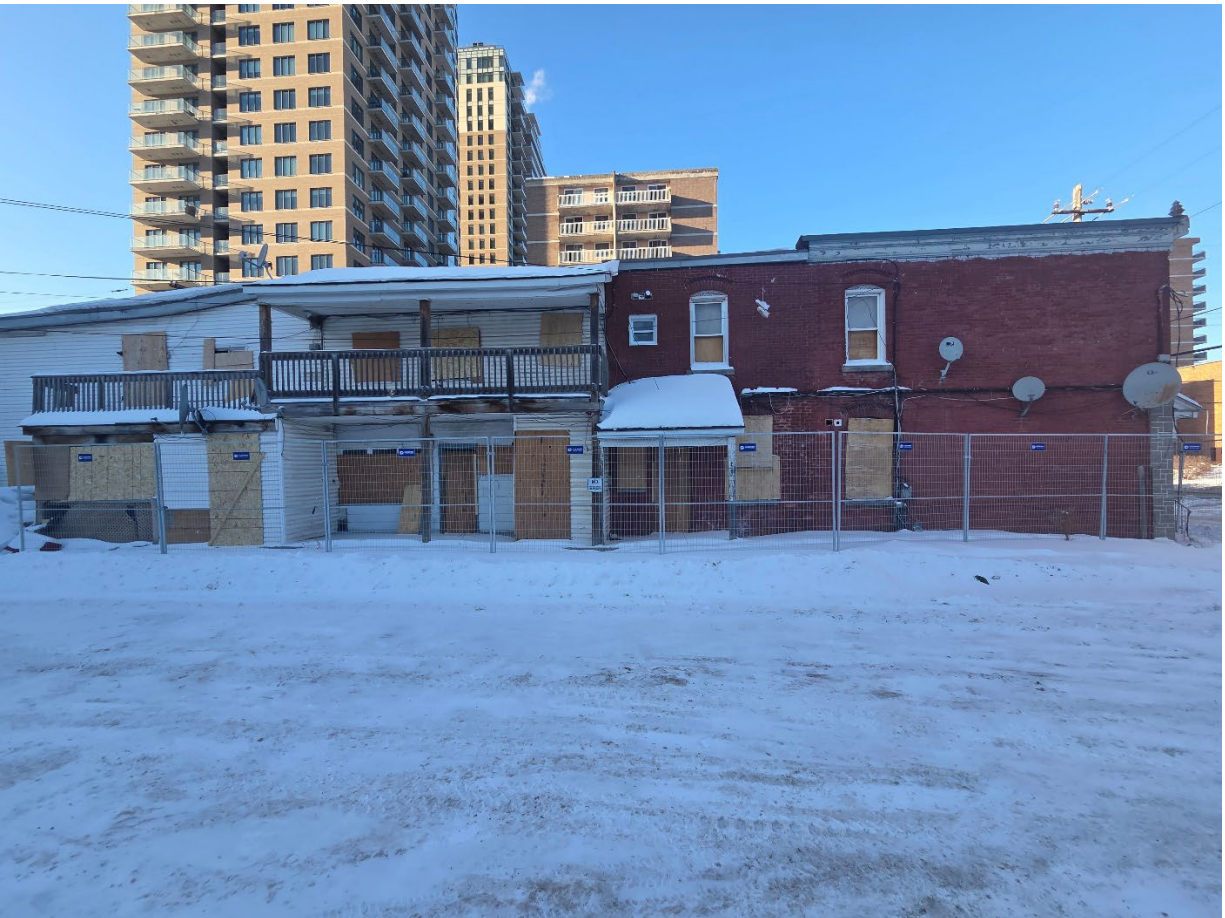
Photograph 4: View of the of the east portion of the Phase One Property looking north. View shows the vacant residential rooming house building at 122 Forward Avenue and adjacent parking area to the south.

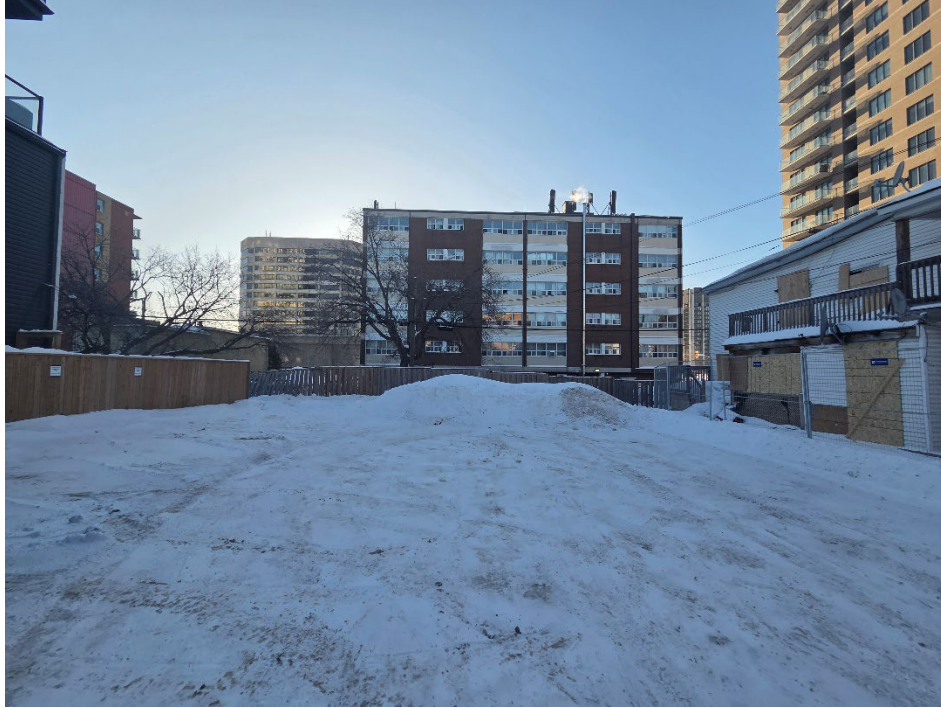
Photograph 5: View of the of the east portion of the Phase One Property looking west. View shows the parking area on the southeast portion of the Property and the apartment building further west, on the northwest portion of the Property.

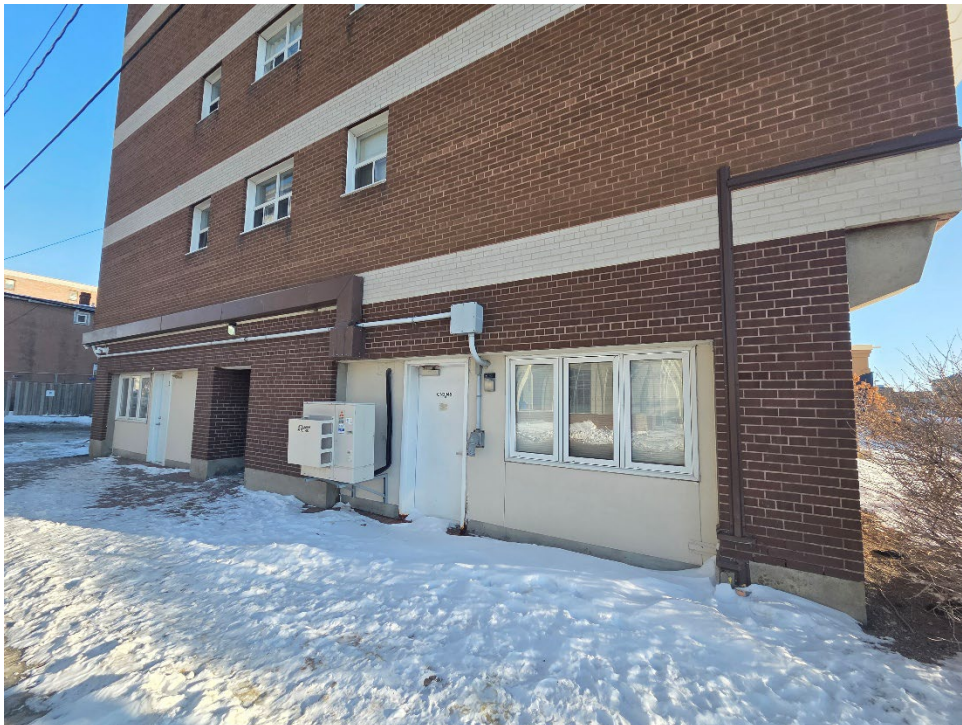
Photograph 8: View of north side of the residential apartment building at 131 Parkdale; view is looking southeast.
