# PATERSON GROUP

December 19, 2025  
File: PE4690-LET.08

Subject: **Phase I - Environmental Site Assessment Update  
Part of 4055 Russell Road  
Ottawa, Ontario**

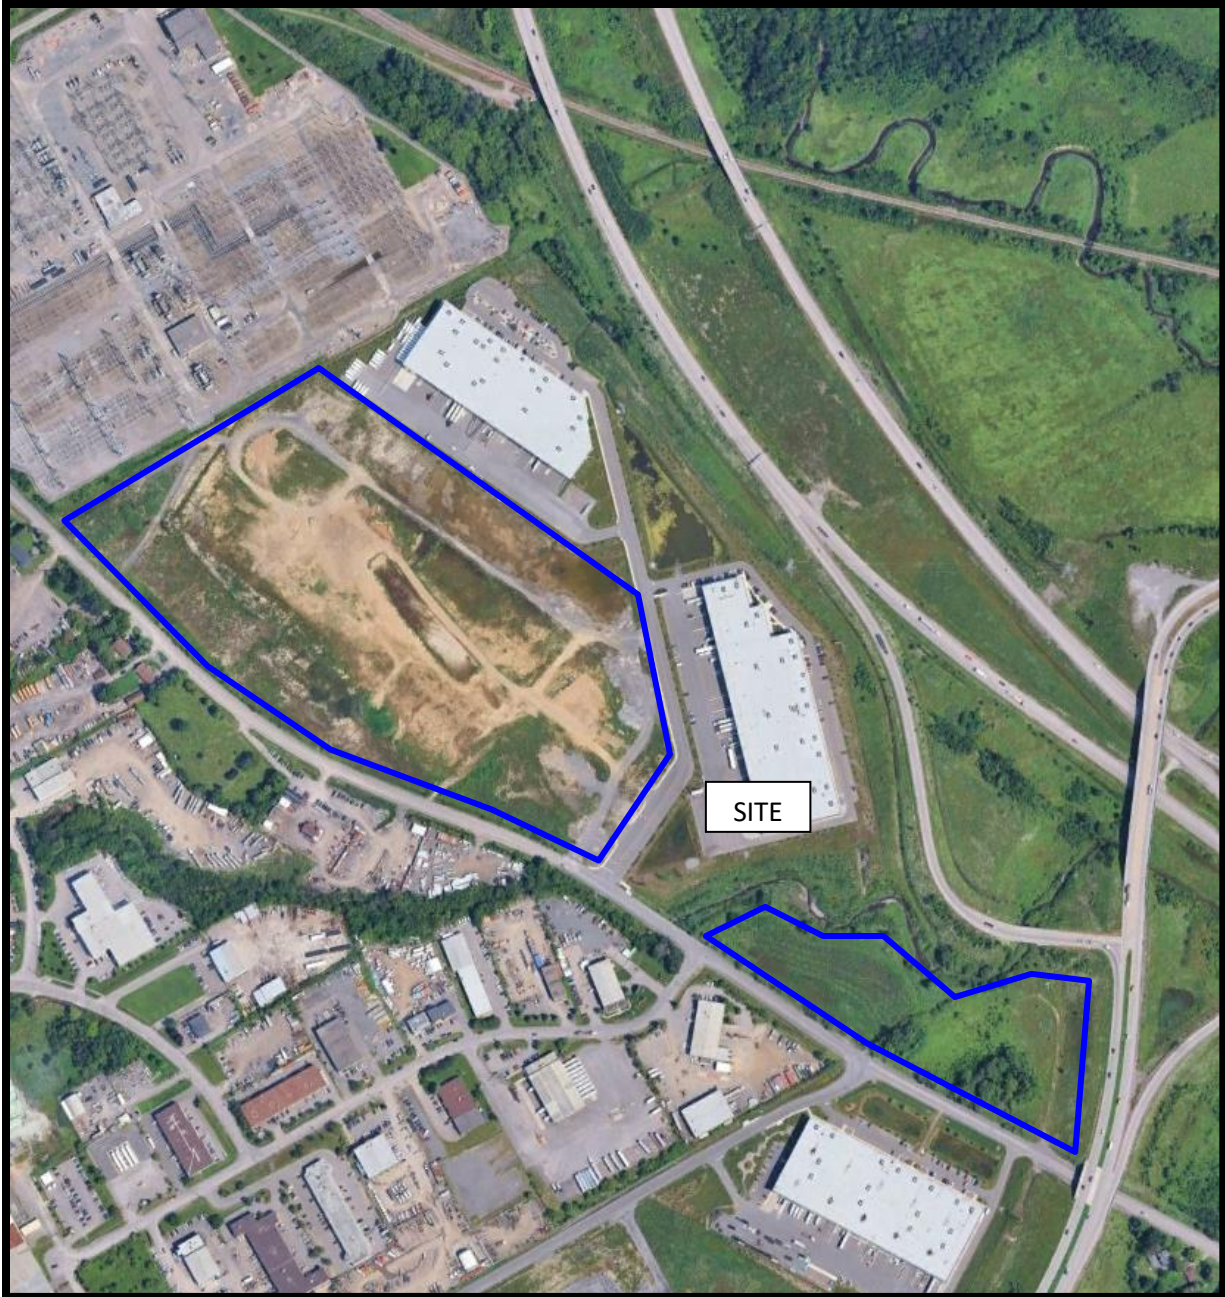
AERIAL PHOTOGRAPH  
2024

In the 2024 aerial photograph, no significant changes were apparent with respect to the Phase I Property since the time of the previous 2019 aerial photograph, though much of the land has been stripped in preparation for future development. The neighbouring lands to the north and east have since been developed with commercial warehouse buildings.

The Phase I Property and the surrounding lands appear in this photograph as they exist today. A copy of the 2024 aerial photograph has been appended to this letter.
