Phase I - Environmental Site Assessment

4055 & 4120 Russell Road
Ottawa, Ontario

Avenue 31 Capital Inc.

Report: PE4690-1

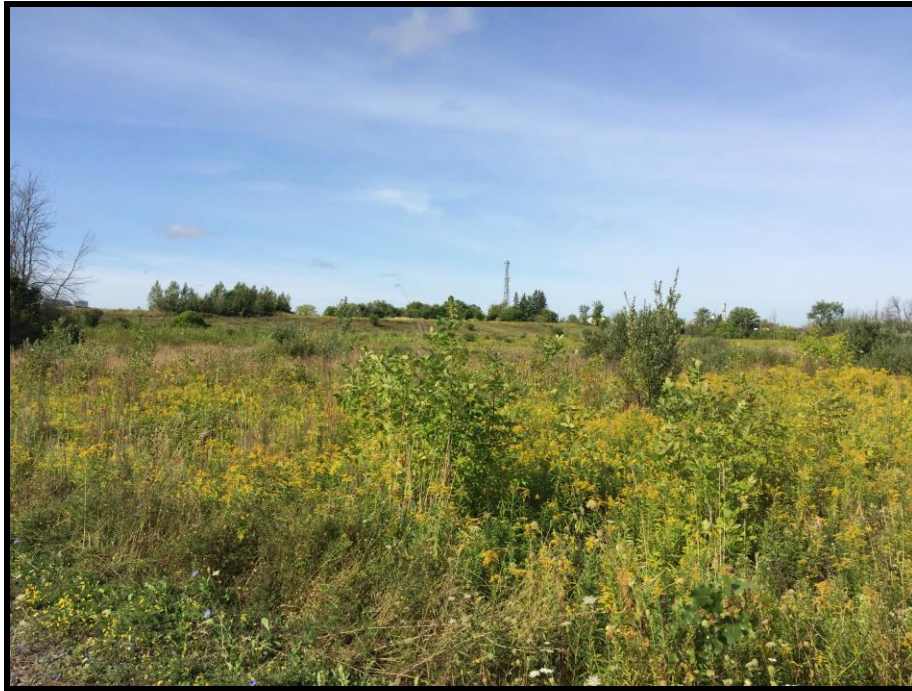
Photograph 1: View of the southeast portion of 4120 Russell Road, facing northwest from Russell Road.

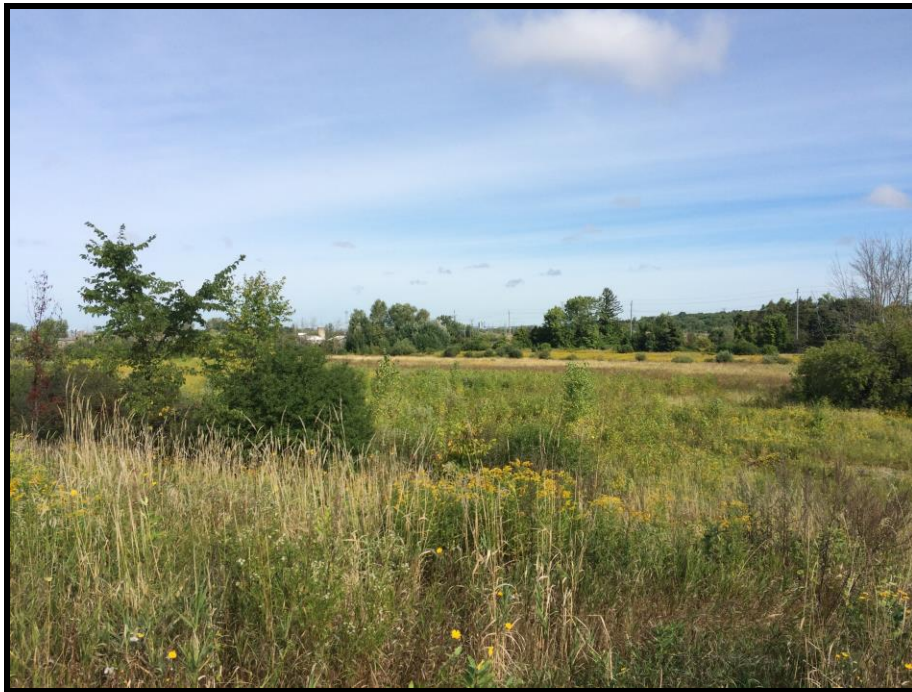
Photograph 2: View of the south portion of 4120 Russell Road, facing northeast from Hunt Club Road.

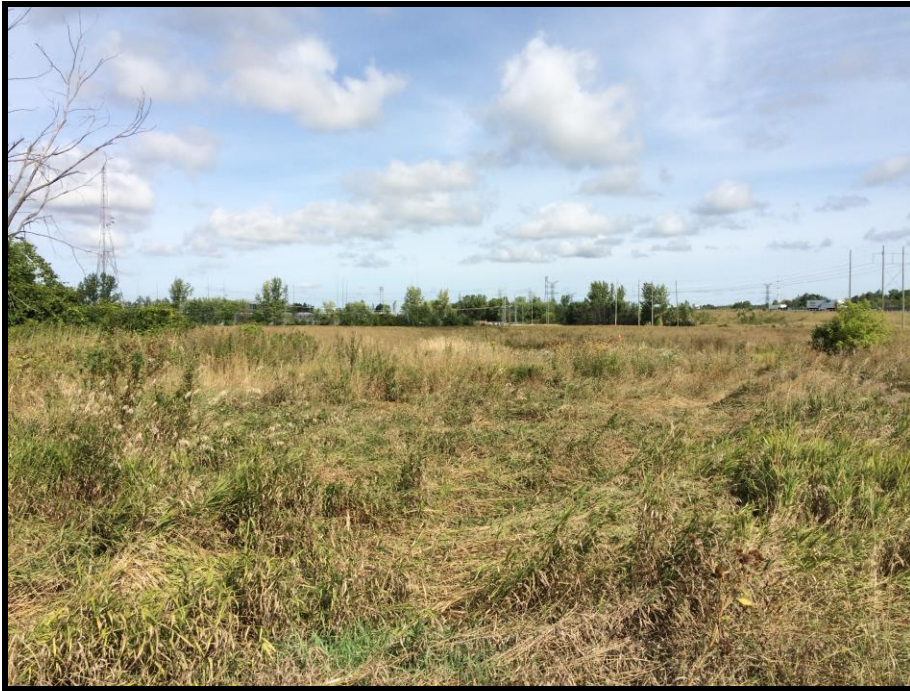
Photograph 3: View of the central portion of 4055 Russell Road, facing north.

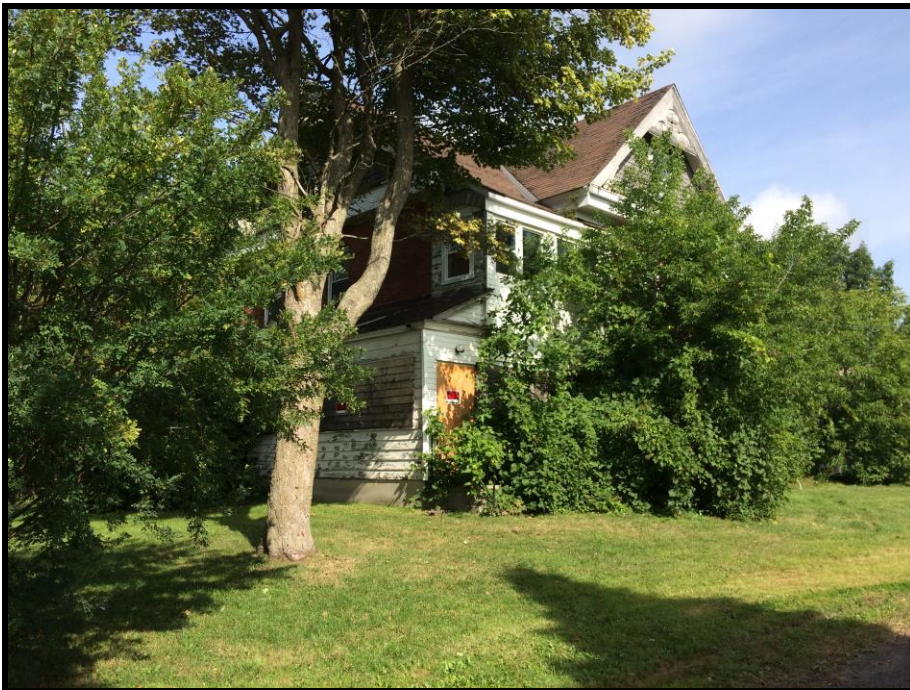
The abandoned farmhouse, situated on 4055 Russell Road, is a three (3) storey residence with one (1) basement level, reportedly constructed in 1918. The building is constructed with a wood frame and a rubble stone foundation and is finished on the exterior with brick, wood siding, and a sloped shingled roof. The associated storage sheds and barns consist of one (1) storey, slab-on-grade style structures, constructed with a wood frame and finished on the exterior with wood or aluminum siding and a sloped metal roof. Three (3) grain silos are also present on the subject site, which are constructed with concrete blocks and a domed metal roof.

Photograph 4: View of the abandoned farmhouse, situated on 4055 Russell Road.

Multiple asbestos containing building materials were determined to be present within the abandoned farmhouse situated on 4055 Russell Road. These materials include the drywall joint compound, cement wall board, vinyl sheet flooring, mastic adhesive, duct heat guard, window glazing, and roofing sealant. These materials were observed to be in poor condition at the time of the site inspection. An asbestos management and abatement program should be conducted prior to the demolition or renovation of the subject building.

Large growth patches of white coloured mould were observed within the basement of the abandoned farmhouse at 4055 Russell Road. Extensive water damage was observed within certain portions of the building which may have fostered an environment which promoted mould growth. It is recommended that an appropriate filter/mask be worn when entering the building.

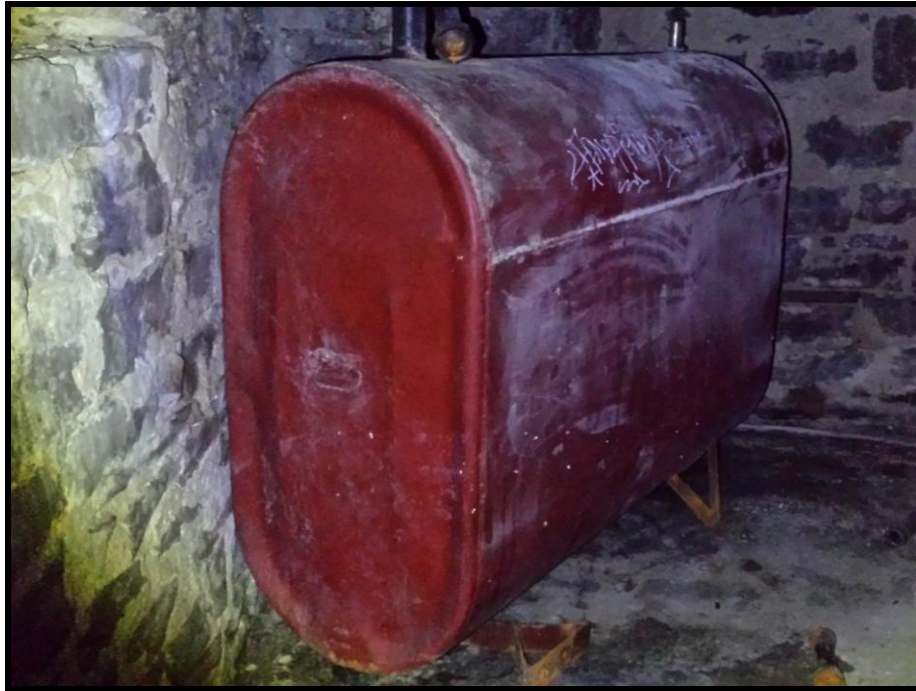
The abandoned farmhouse contained one (1) aboveground oil tank (935 L capacity) in the basement, which connected to an oil-fired furnace. The tank was noted to be in good condition at the time of the site inspection as no signs of leaks or staining were observed on the tank or the underlying floor. According to the property manager, the tank was emptied of fuel in 2009 and has not been in used since that time.

Photograph 5: View of an empty oil tank, located in the basement of the abandoned farmhouse on 4055 Russell Road.

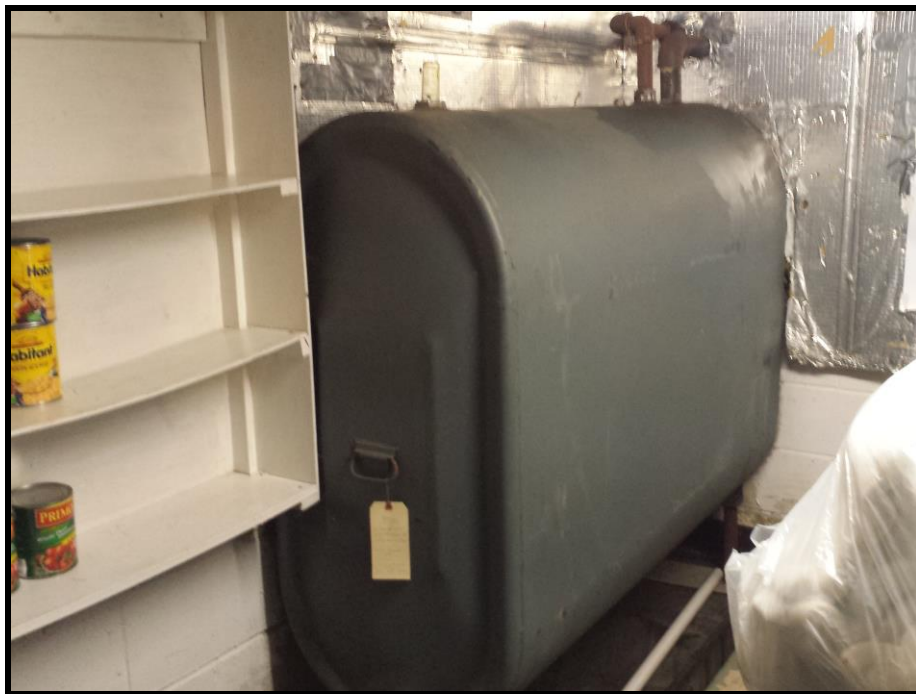
The residence at 3995 Russell Road contained one (1) aboveground oil tank in the basement, which connected to an oil-fired furnace. The tank, manufactured in 2002, is a single walled steel tank with a capacity for 935 L. The tank was noted to be situated within a plastic containment unit. Both the tank and the containment unit were noted to be in good condition at the time of the site inspection as no signs.

Photograph 6: View of an oil tank, located in the basement of the occupied residence situated on 4055 Russell Road (addressed 3995 Russell Road).

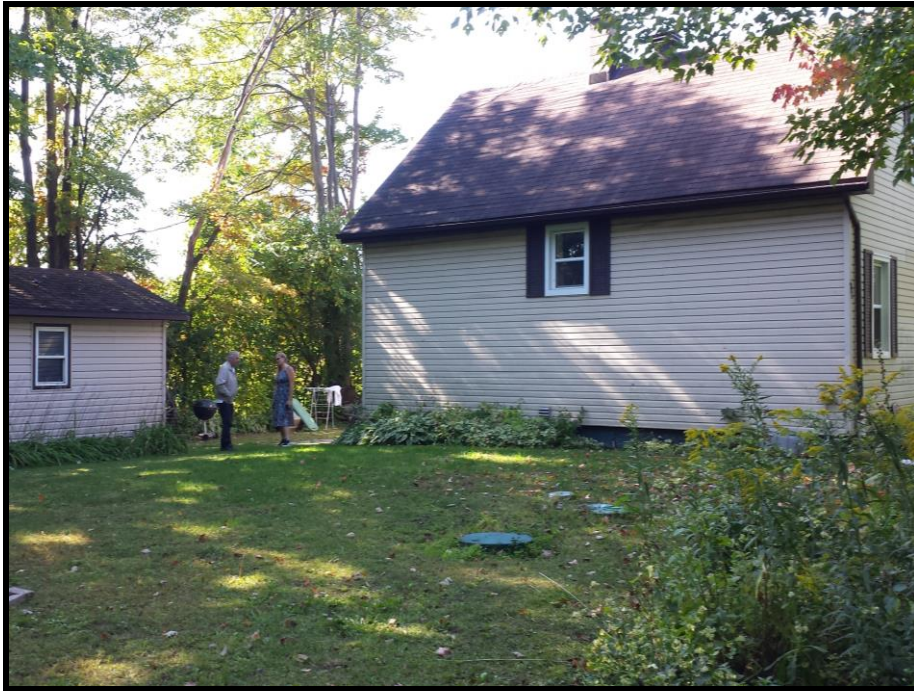
Domestic wastewater, consisting of wash water and sewage, from the occupied residential dwelling on the property addressed 3995 Russell Road, is currently discharged into an underground holding tank on the east side of the residence. Roof drainage is currently discharged into the subject properties via infiltration. No ponded water was observed on either subject property at the time of the site inspection. No concerns with respect to wastewater drainage was identified during the site inspection.

Photograph 7: View of the private septic tank cap, located on the exterior the occupied residence situated on 4055 Russell Road (addressed 3995 Russell Road).
