# PHASE TWO ENVIRONMENTAL SITE ASSESSMENT

261 Buena Vista Road, Ottawa, Ontario

CO680.02

**ELMWOOD SCHOOL**

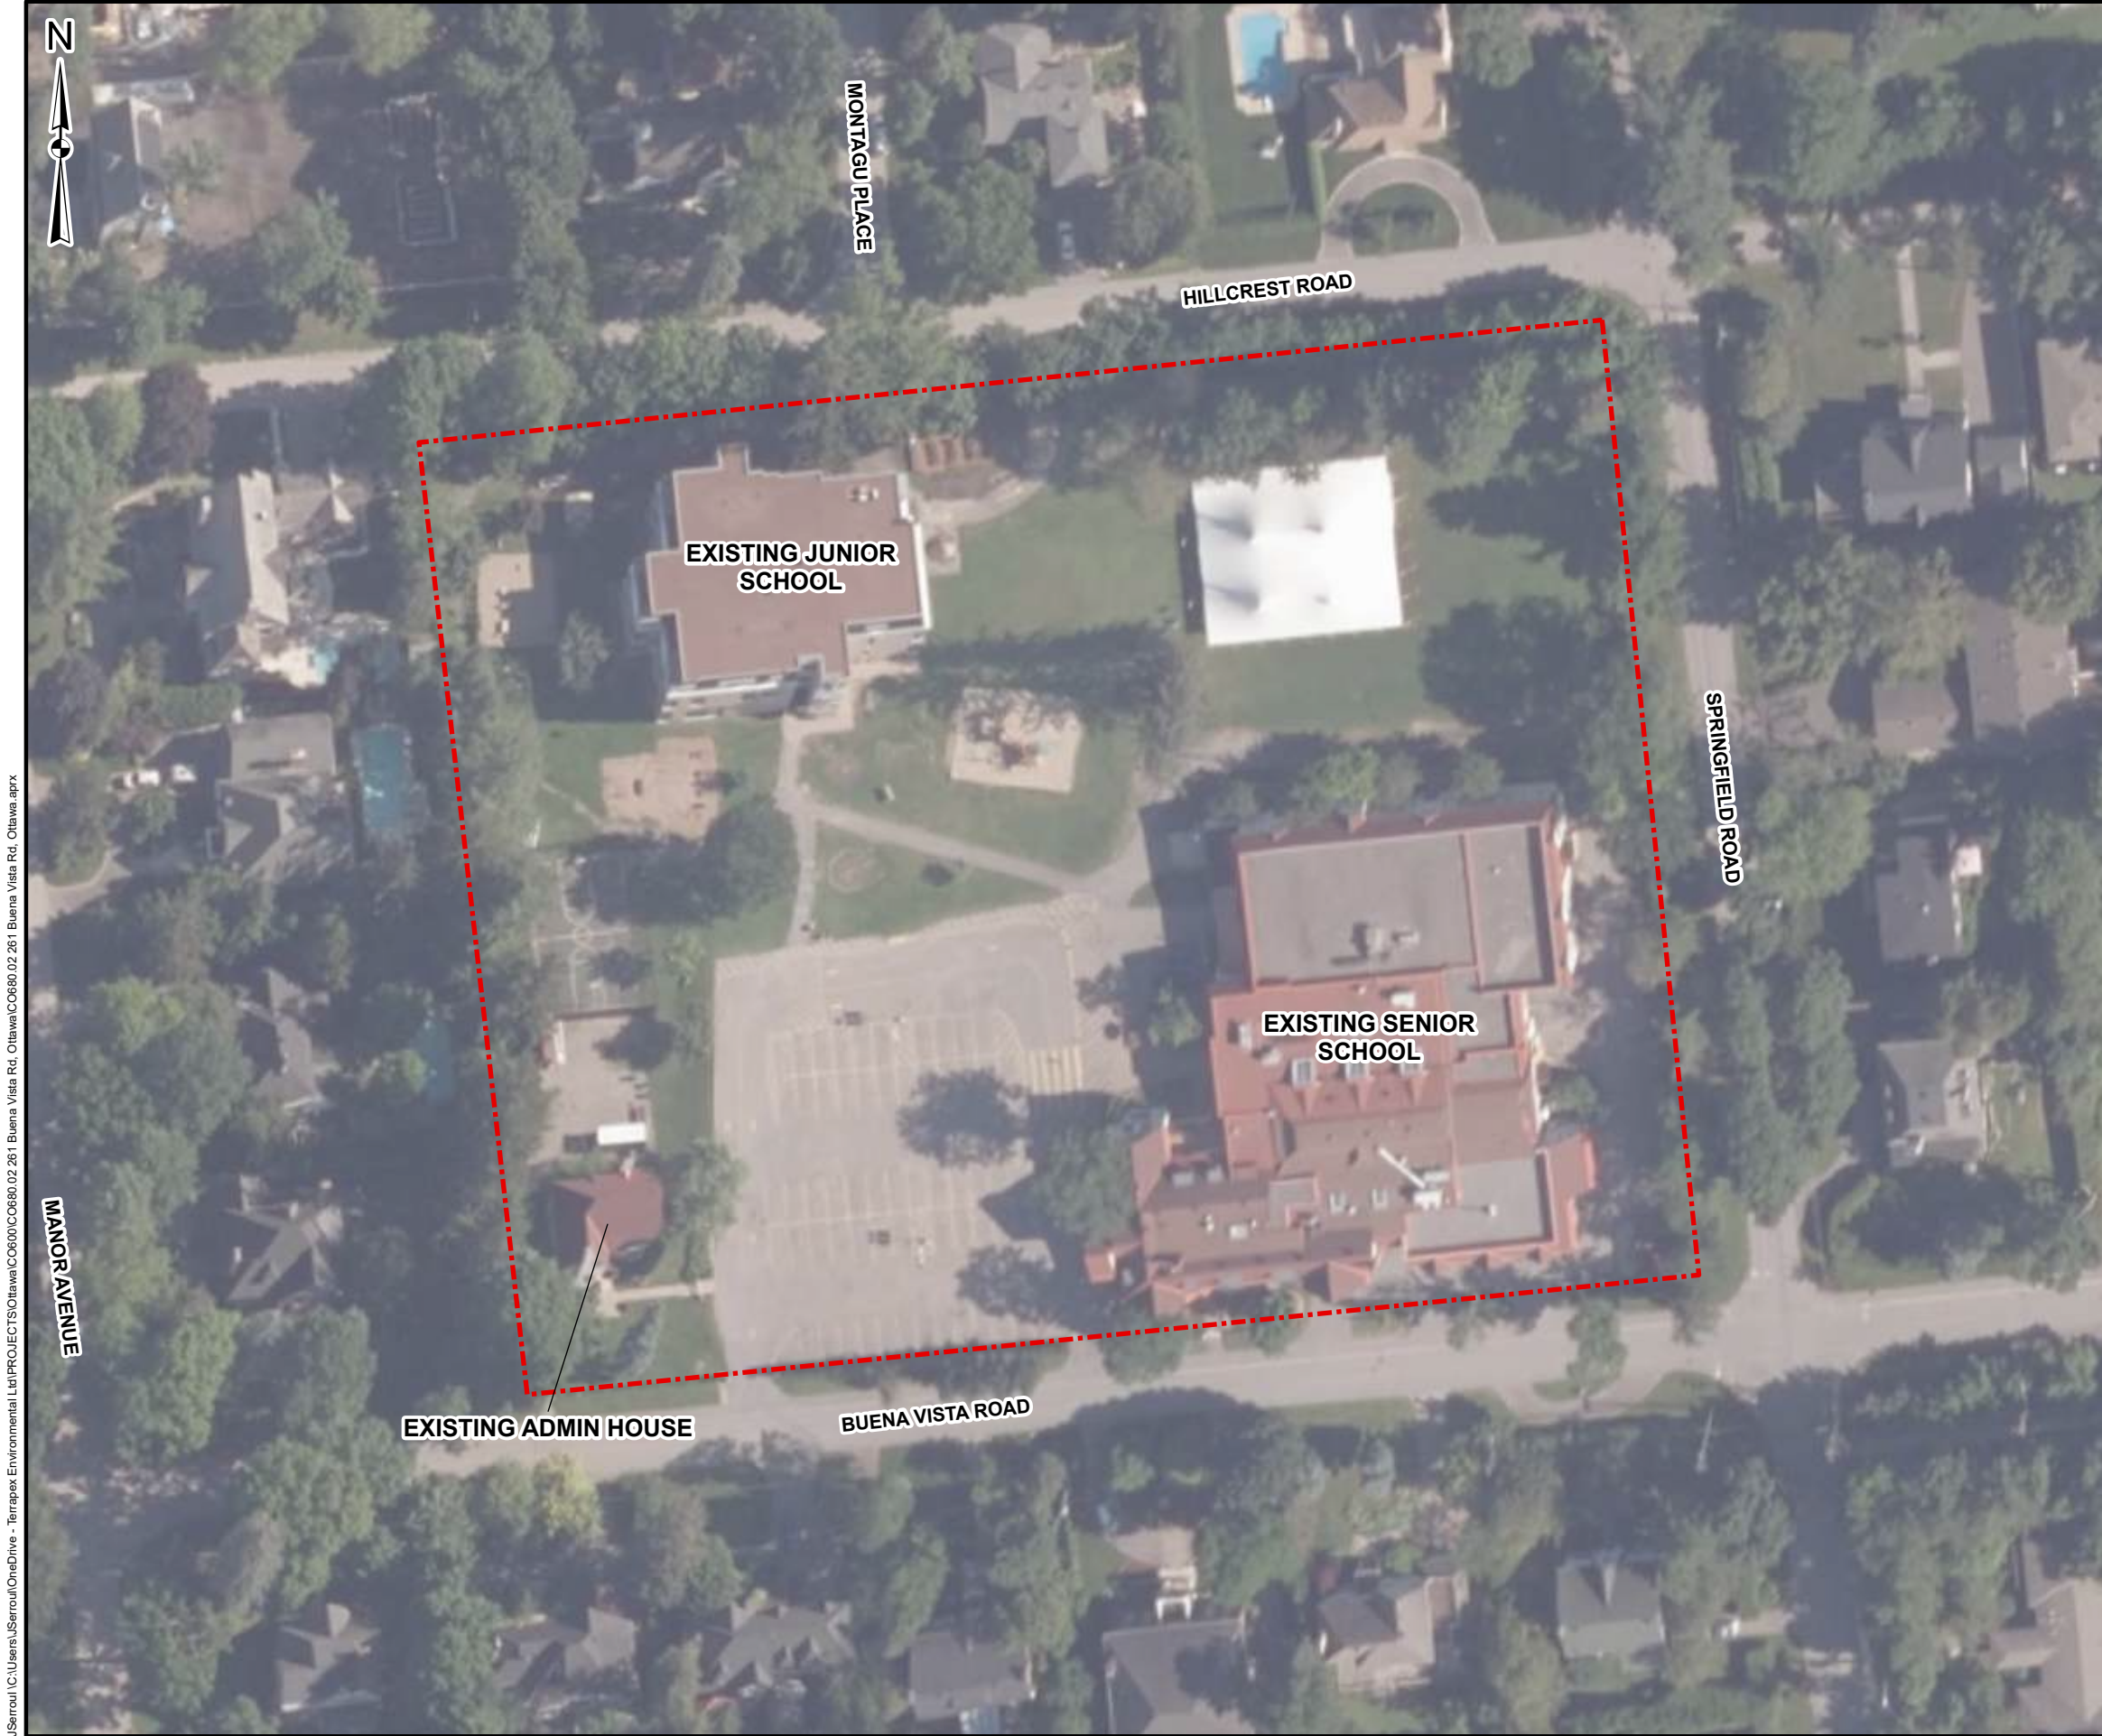
| 00 | FEBRUARY 2026 | <b>2</b> |

The Site is located in a neighbourhood comprised of residential land use as shown on Figure 1 (Site Location Plan) and Figure 2 (Site Features).

Information regarding the location, identification, and geometry of the Phase Two Property is provided in the table below. Refer to Figure 1 for the location of the Site, and to Figure 2 for the general layout and features of the Site at the time of the site reconnaissance.

| Requisite Feature | Figure |
|---|---|
| i. Show any existing buildings and structures, | Figure 1: Site Location<br>Figure 2: Site Features |

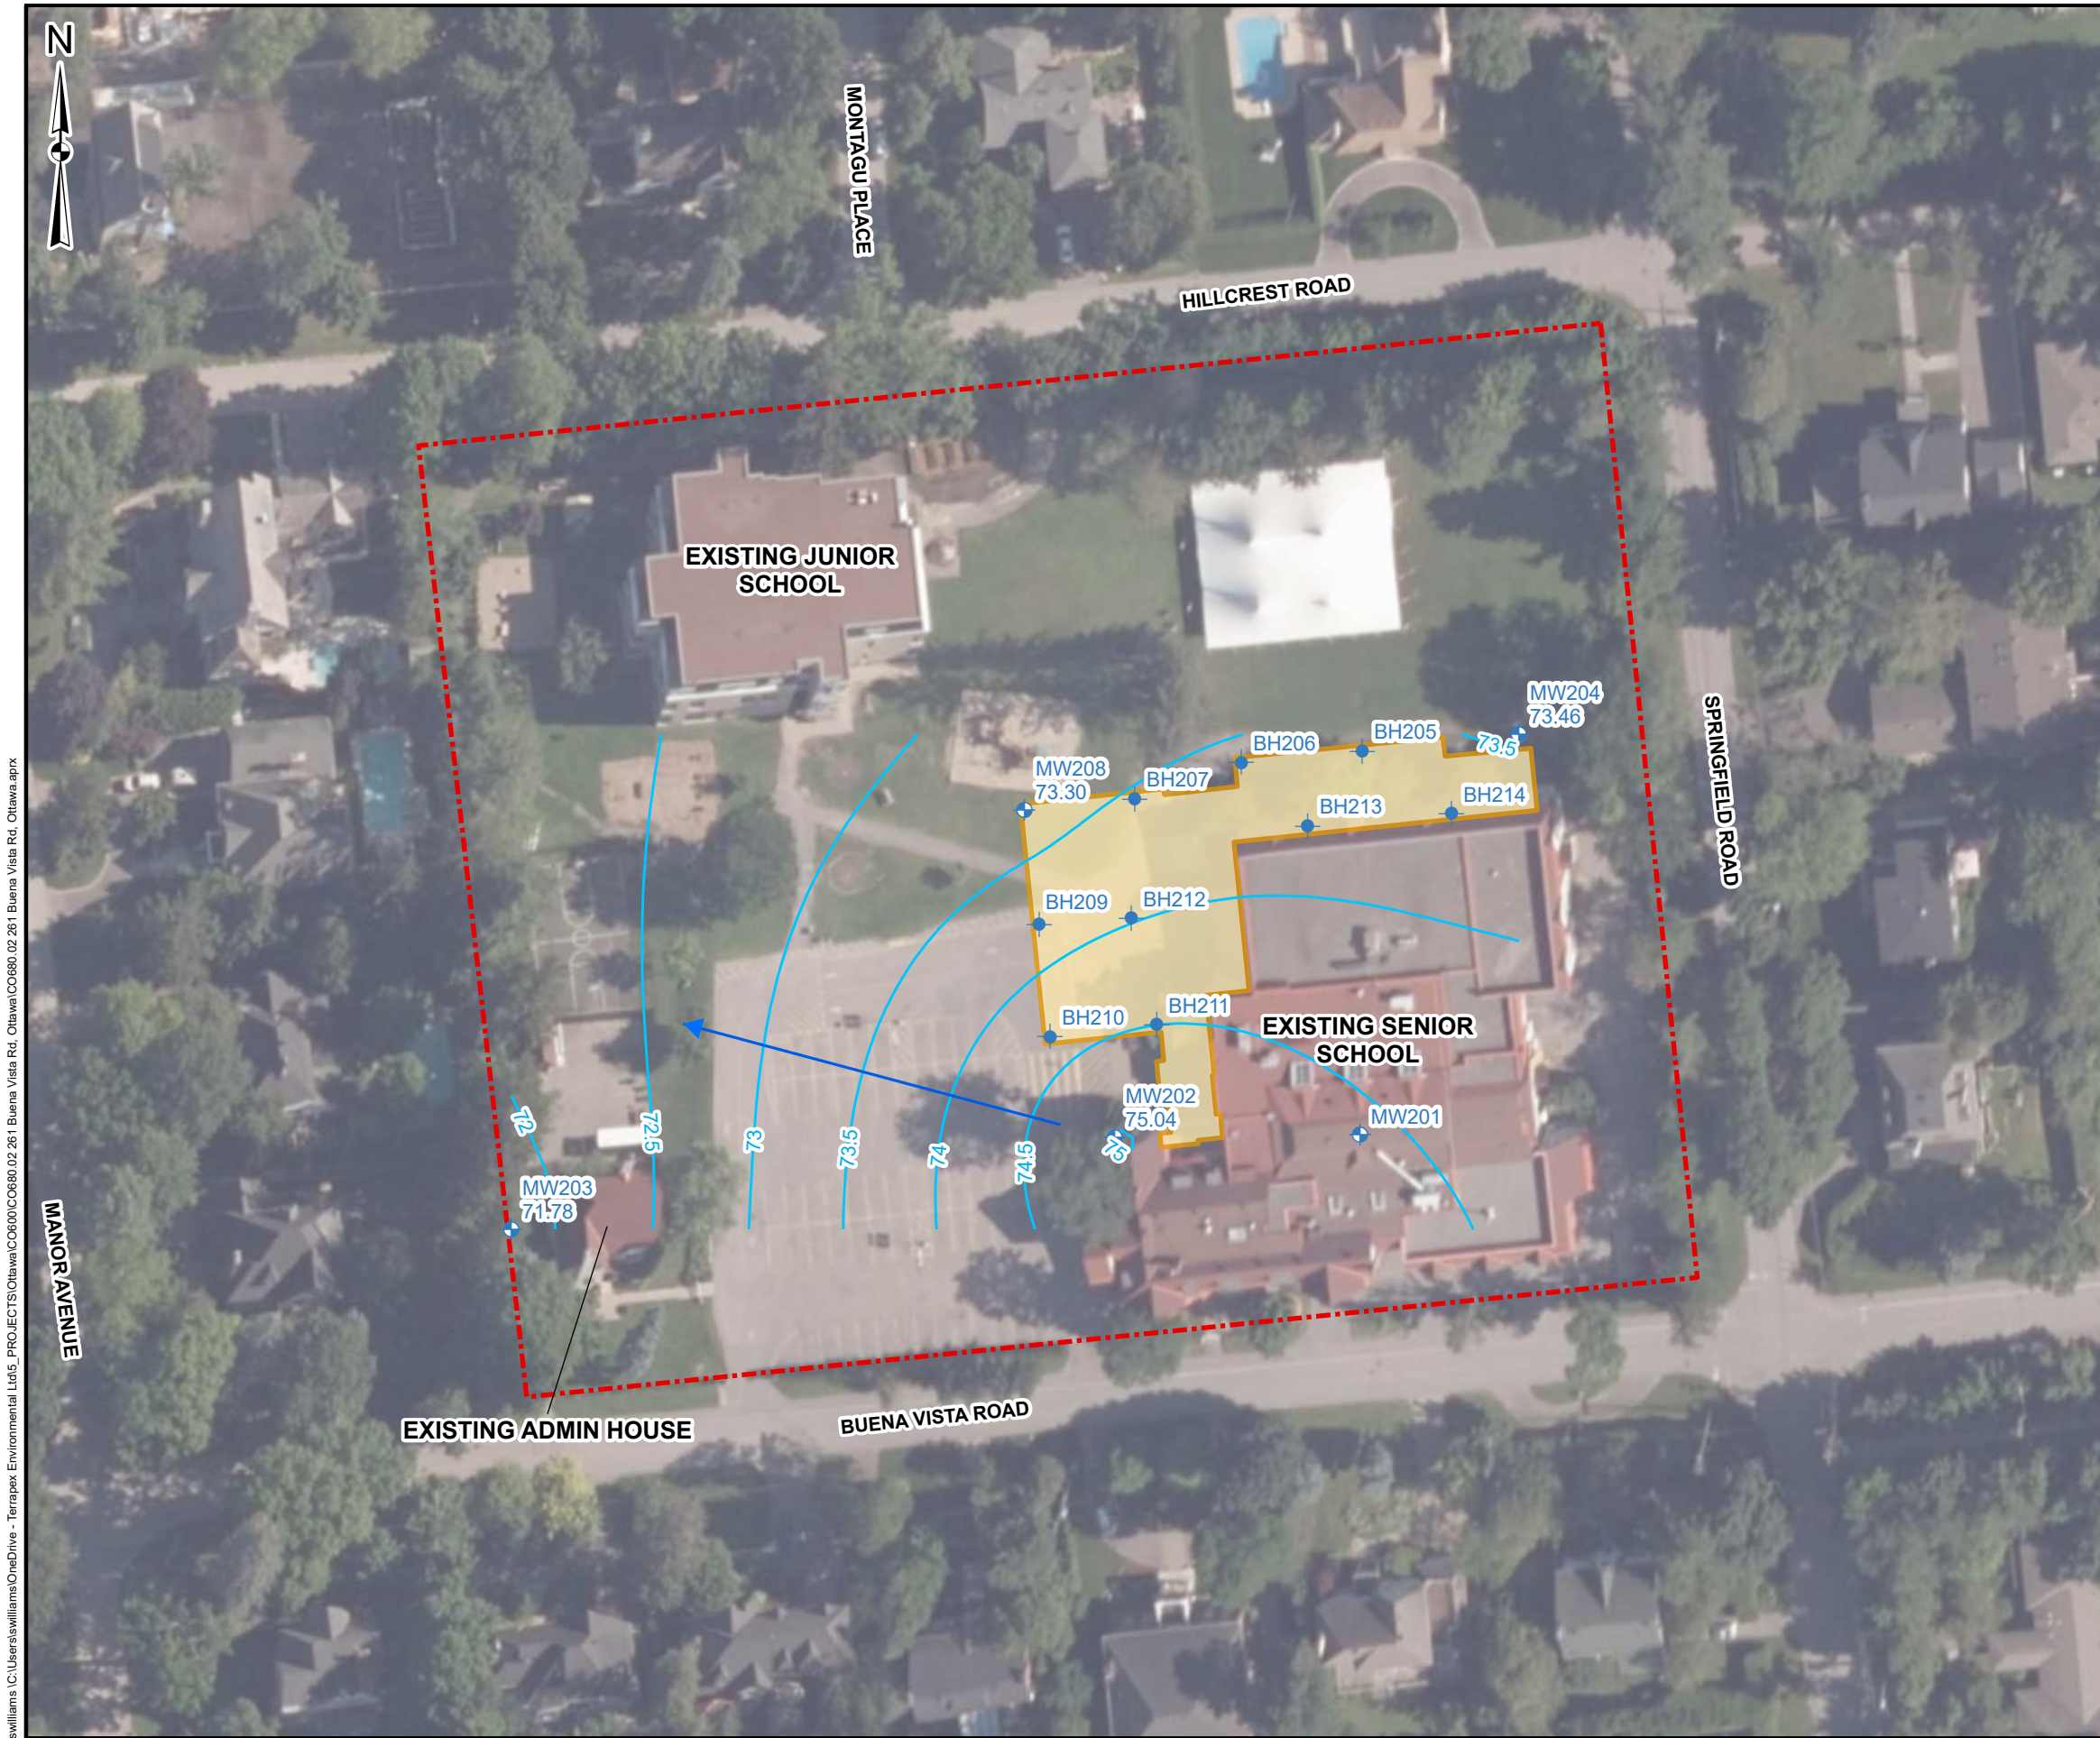
| 00 | APRIL 2026 | <b>6</b> |

- SITE BOUNDARY
- PROPOSED ADDITION
- BOREHOLE
- MONITORING WELL
- GROUNDWATER FLOW DIRECTION
- GROUNDWATER CONTOUR
- 74.51    STATIC WATER LEVEL (27 Mar. 2026) (m ASL)
