**Phase One Environmental Site Assessment**  
**1770 Heatherington Road, Ottawa, Ontario**  
*City of Ottawa*

**Project Name:**  
Phase One Environmental Site Assessment  
1770 Heatherington Road, Ottawa, Ontario

**Project Number:**  
OTT-00018293-J8

**Date Submitted:**  
April

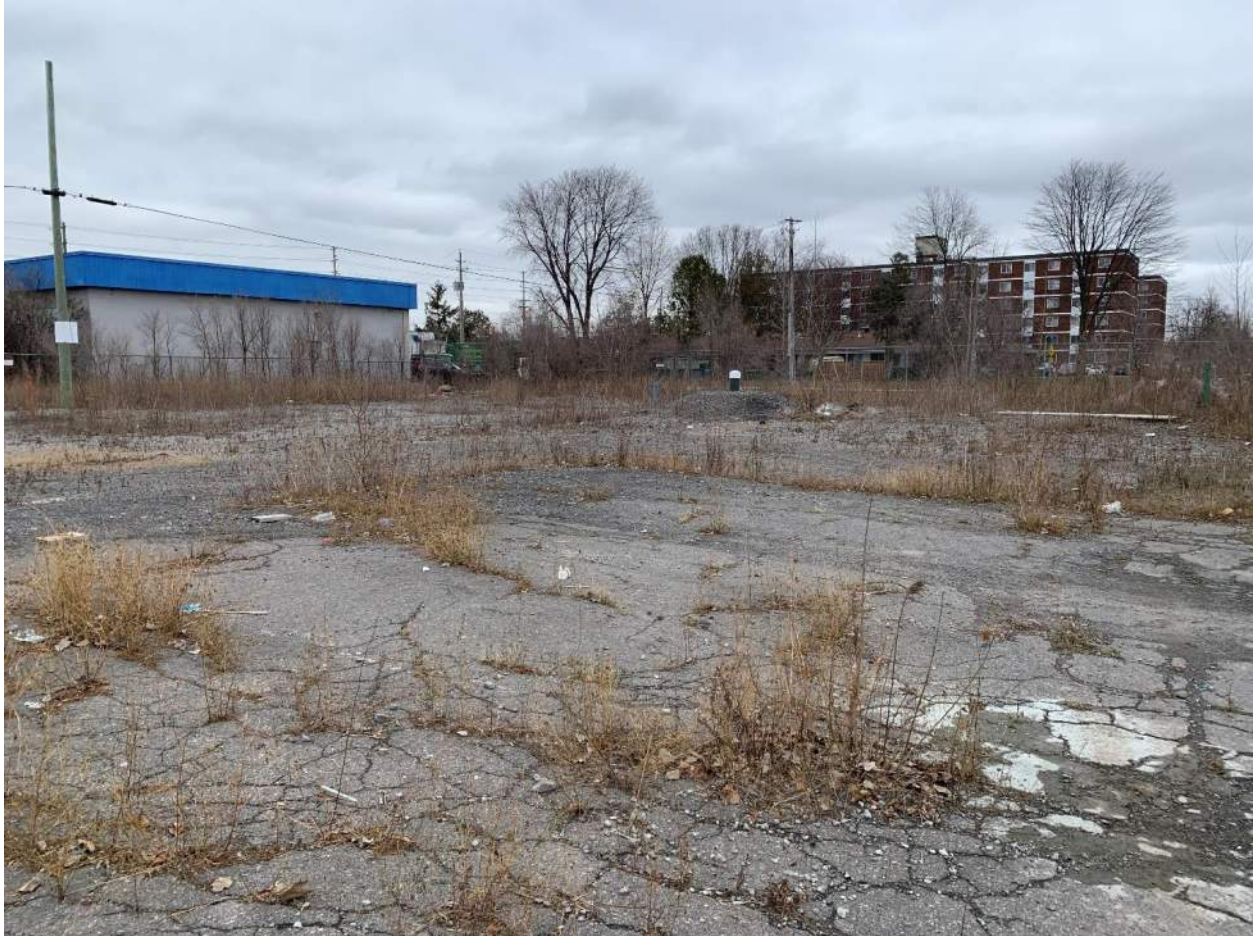
**Photograph No. 1**

View of site facing northeast

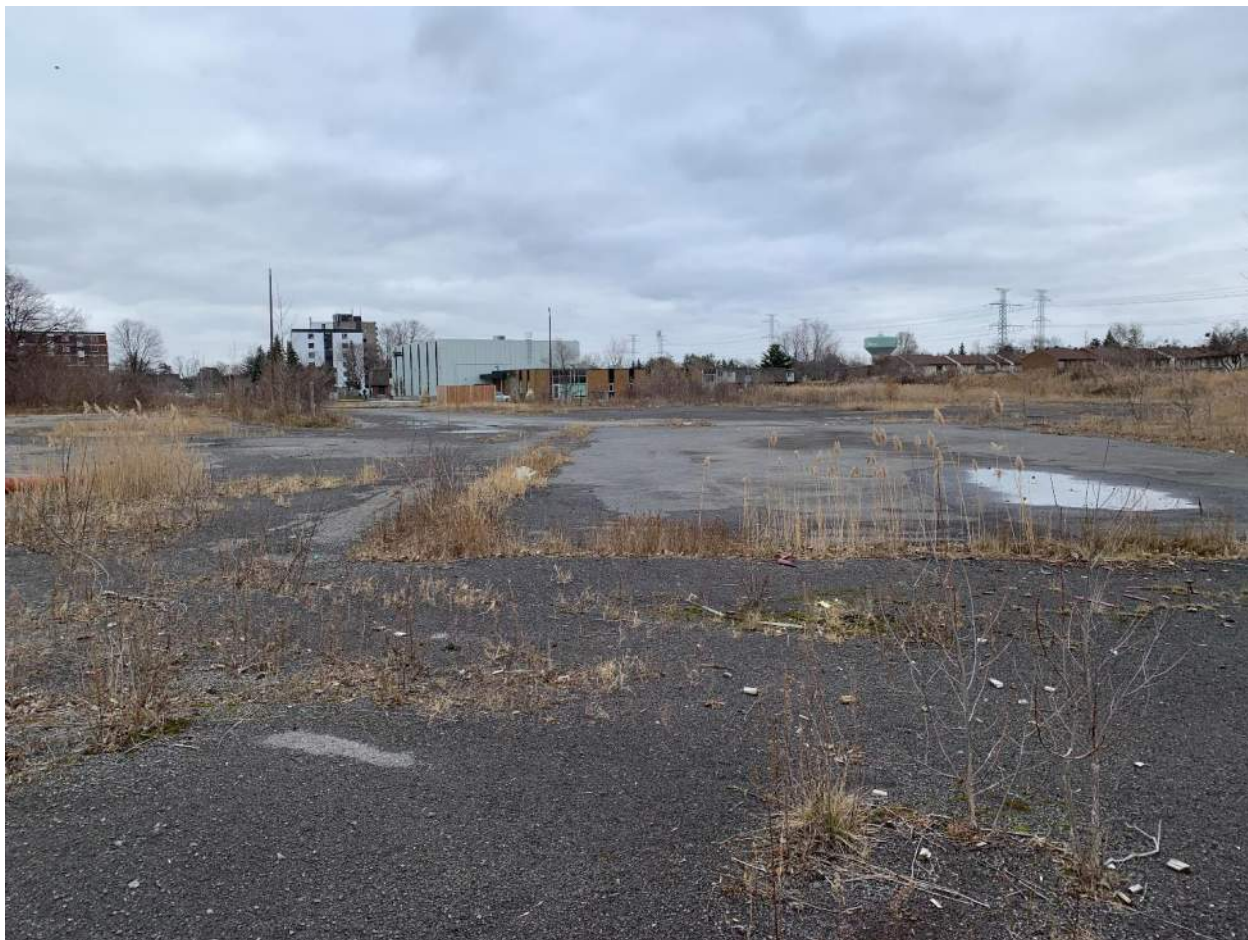
**Photograph No. 2**

View of site facing east

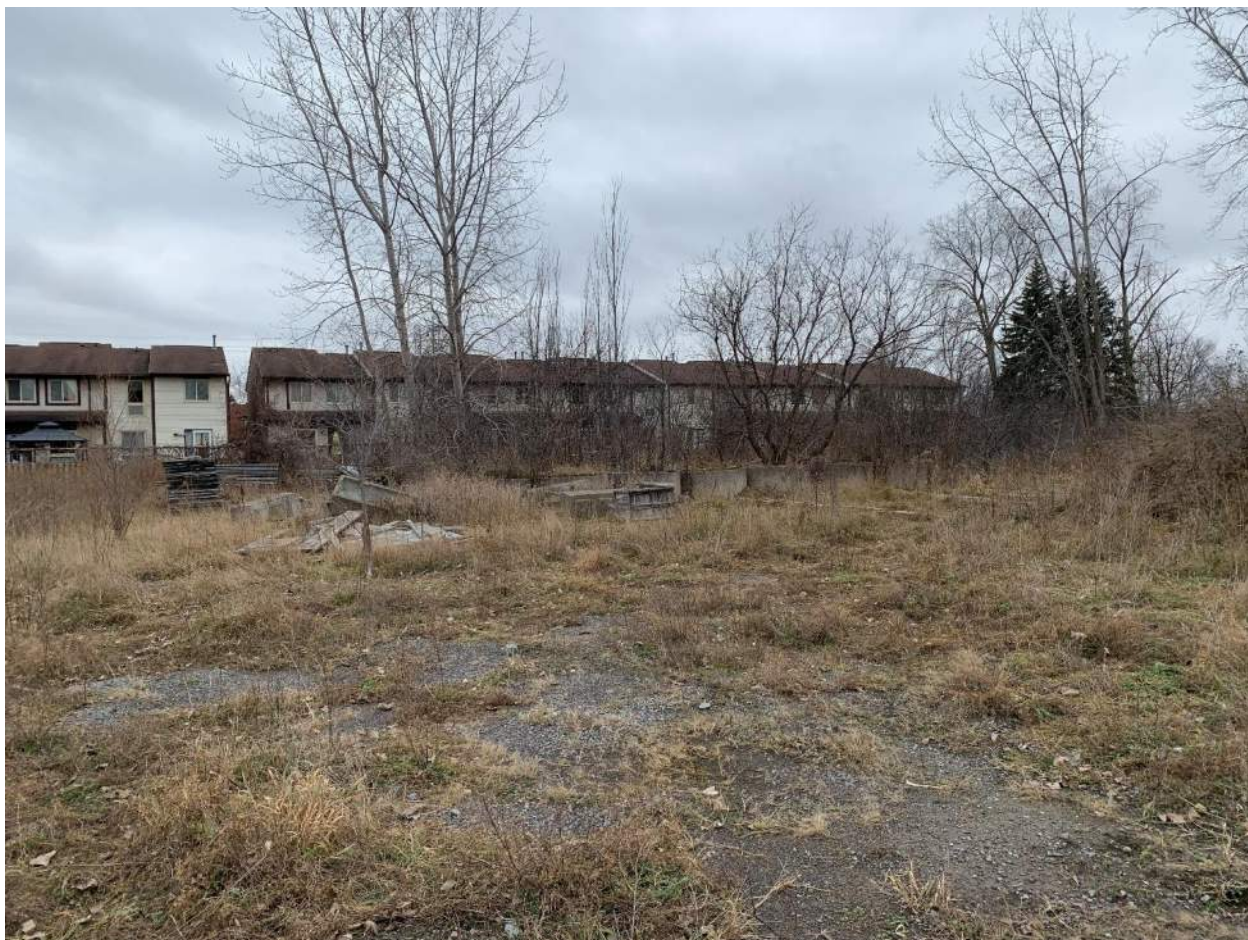
**Photograph No. 3**

View of site facing southwest

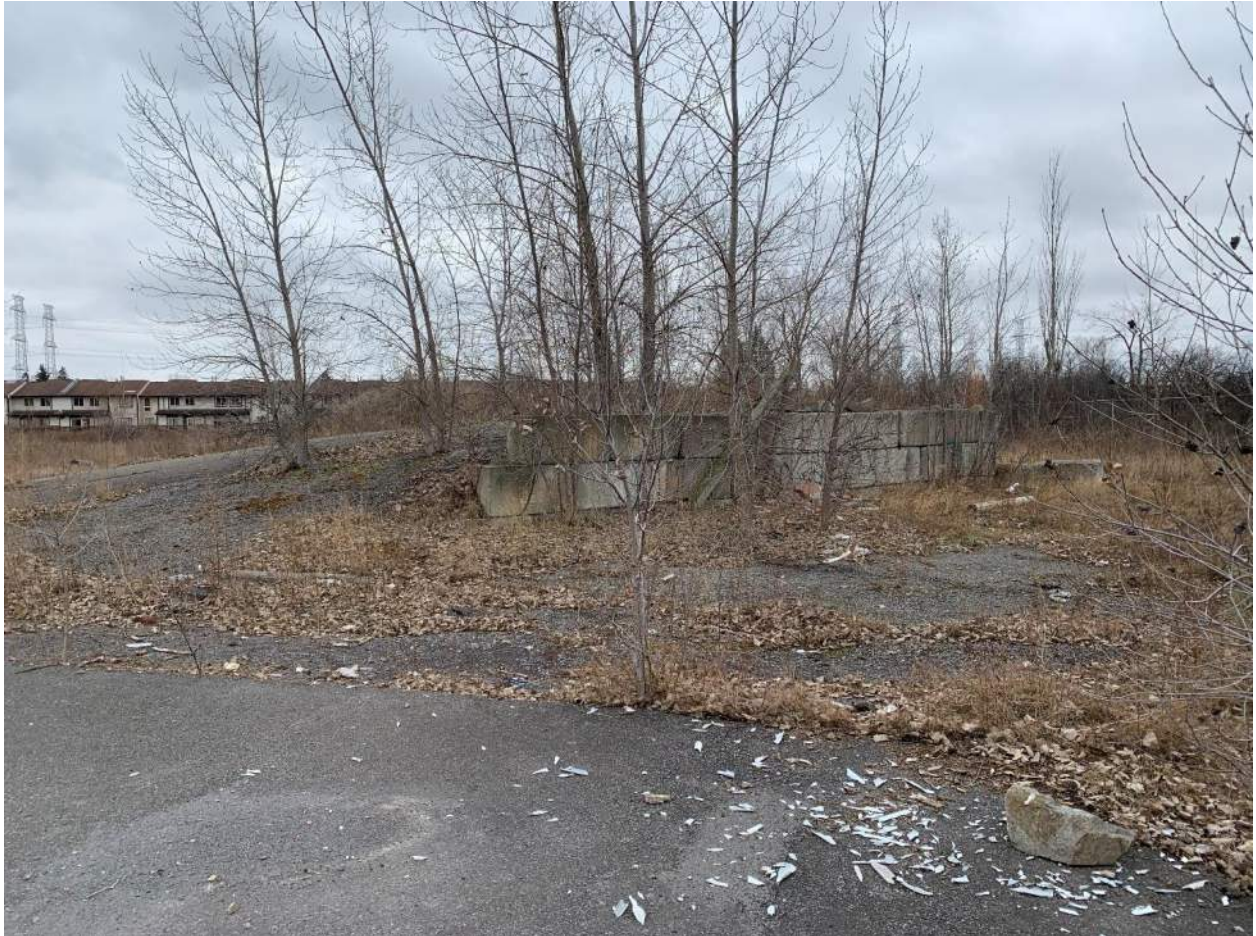
**Photograph No. 4**

View of site facing southeast
