**RE: Environmental Impact Statement and Tree Conservation Report Update
319 Huntmar Drive
Southeast Portion of Taggart's Palladium Drive Kanata West Development**

26-6019A
HUNTMAR DRIVE
CITY OF OTTAWA

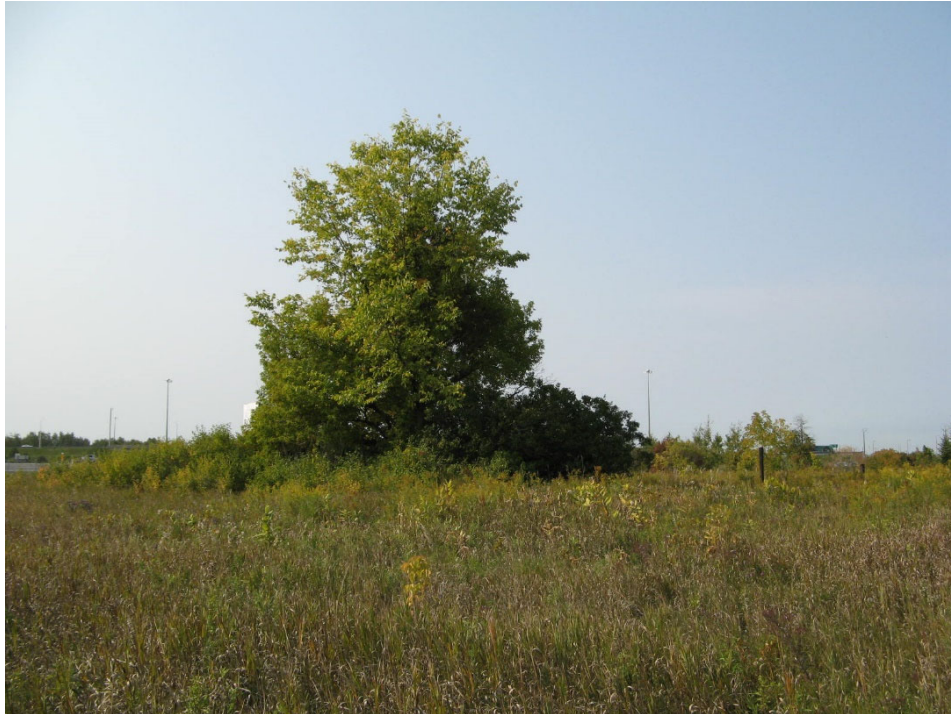
Photo 2 – Meadow habitat in the west portion of the site. View looking east to south end of intermittent deciduous hedgerow in the central-west portion of the site.

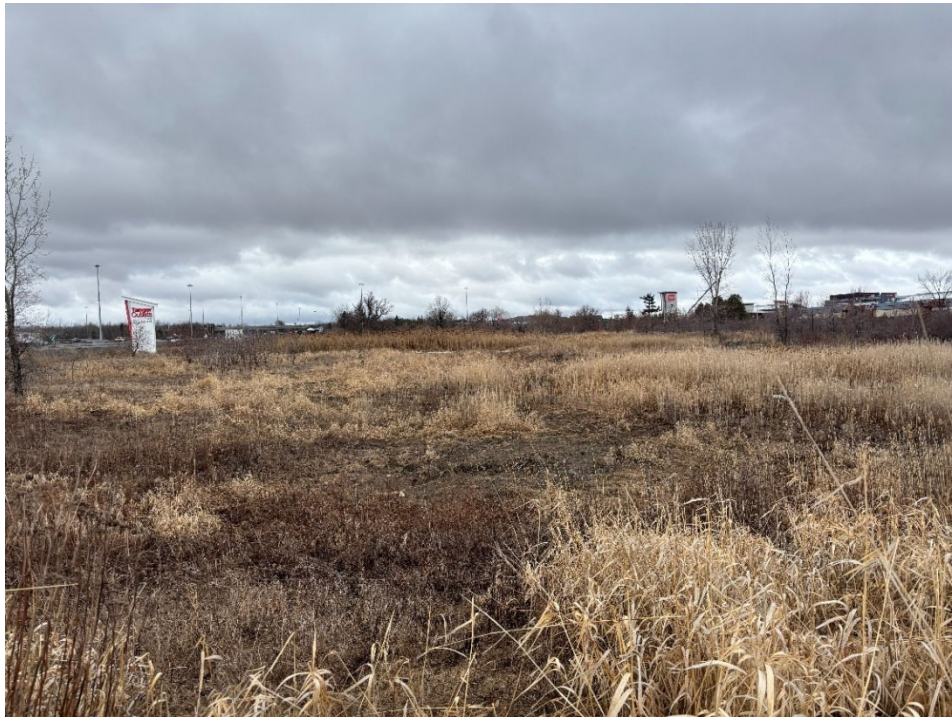
Photo 4 – Meadow habitat in the east portion of the site. View looking west near Huntmar Drive. Photo taken April 1, 2026.

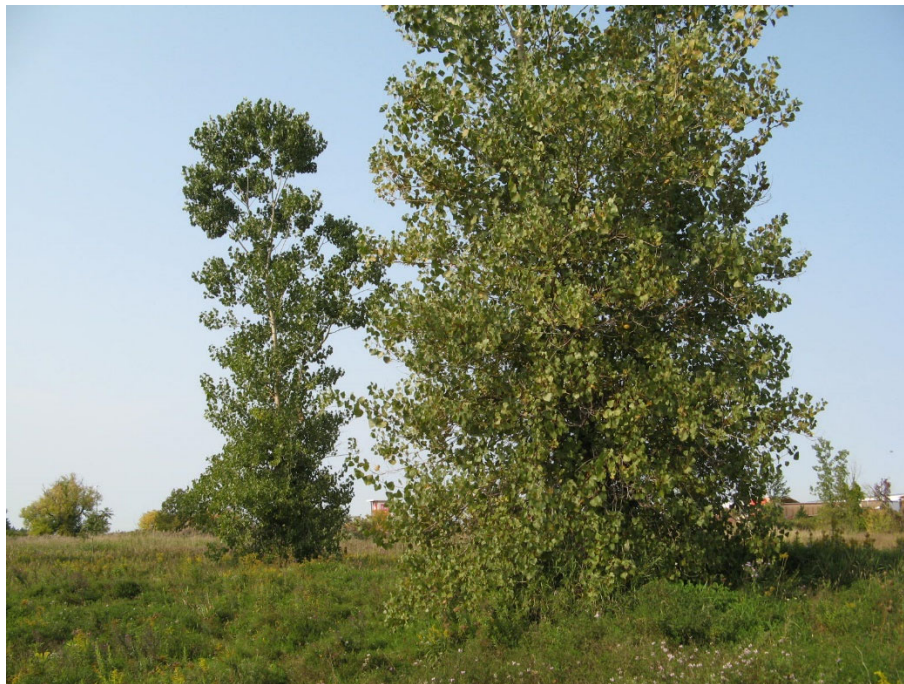
A few trembling aspens up to 38cm diameter at breast height (dbh) are in the meadow habitat in the southeast portion of the site (Photo 6). Fungal growth was extensive on the poplar trunks. Staghorn sumac shrubs are among the poplar trees. Trembling aspen and Manitoba maple stems up to 25cm dbh are also along portions of the north site boundary (Photo 7). Regenerating white cedar and Manitoba maple stems up to 10cm dbh are scattered in the west meadow habitat, along with serviceberry, red raspberry, and staghorn sumac shrubs.

Photo 6 – Scattered trembling aspen in the southeast portion of the meadow habitat. View looking northwest.

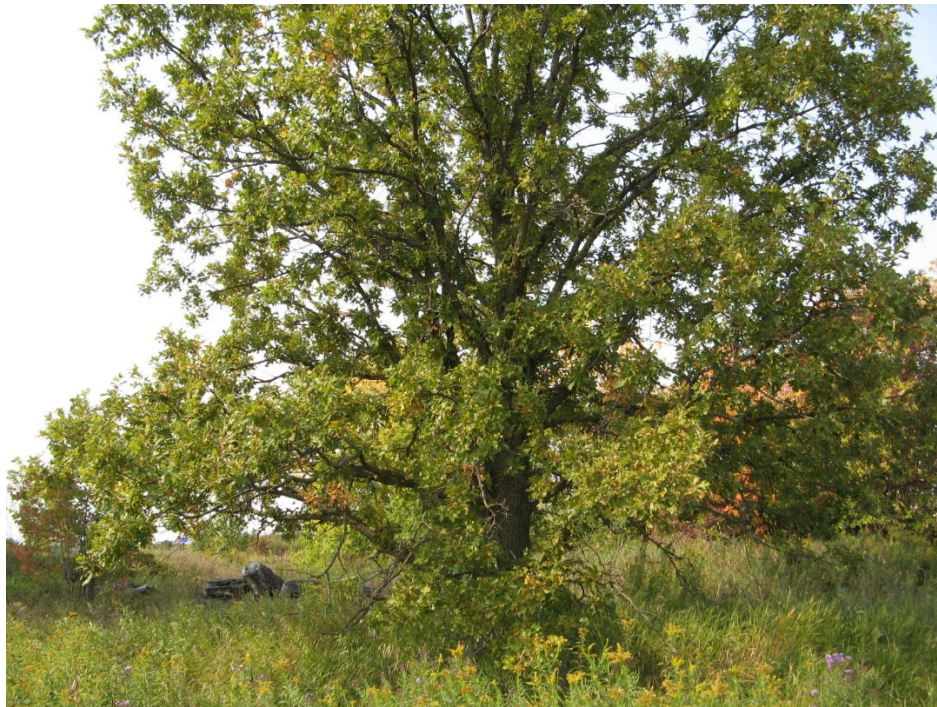
*Photo 8 –Mature bur oak in the intermittent deciduous hedgerow in the central -west portion of the
current site. View looking west.*

No tree retention was identified on or adjacent to the current site in the 2015 Tree Conservation Report. Other than the mature bur oak in the central-west portion of the site, no prime candidate trees for retention (due to species and/or condition) were observed on the current site. There are no co-owned trees or adjacent trees with critical root zones extending onto the site due to adjacent roadways and generally open Feedmill Creek corridor to the north.

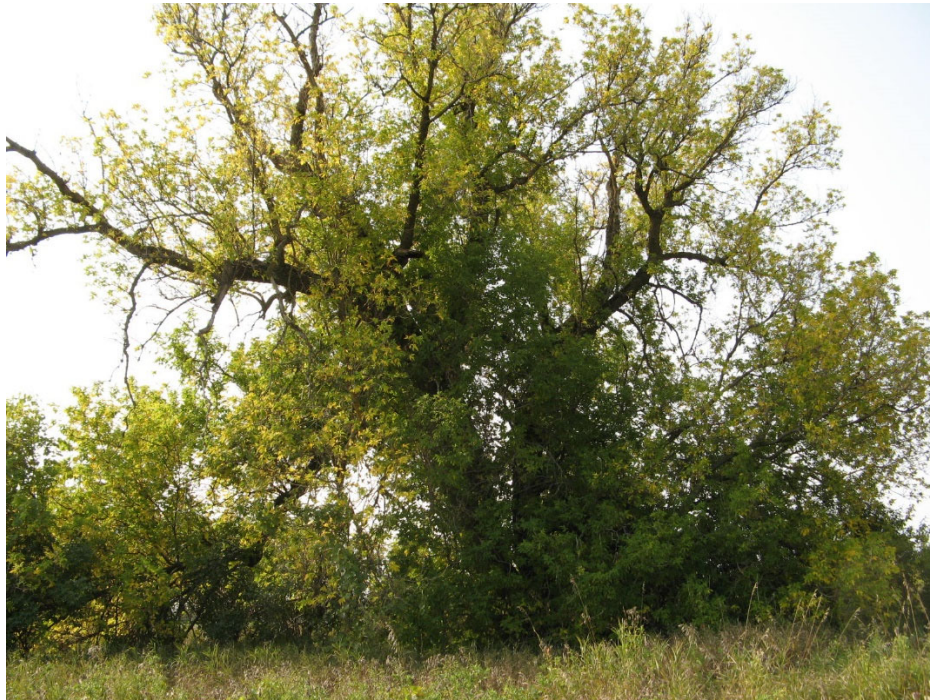
Photo 9 –Mature Manitoba maple in the intermittent deciduous hedgerow. View looking southwest.

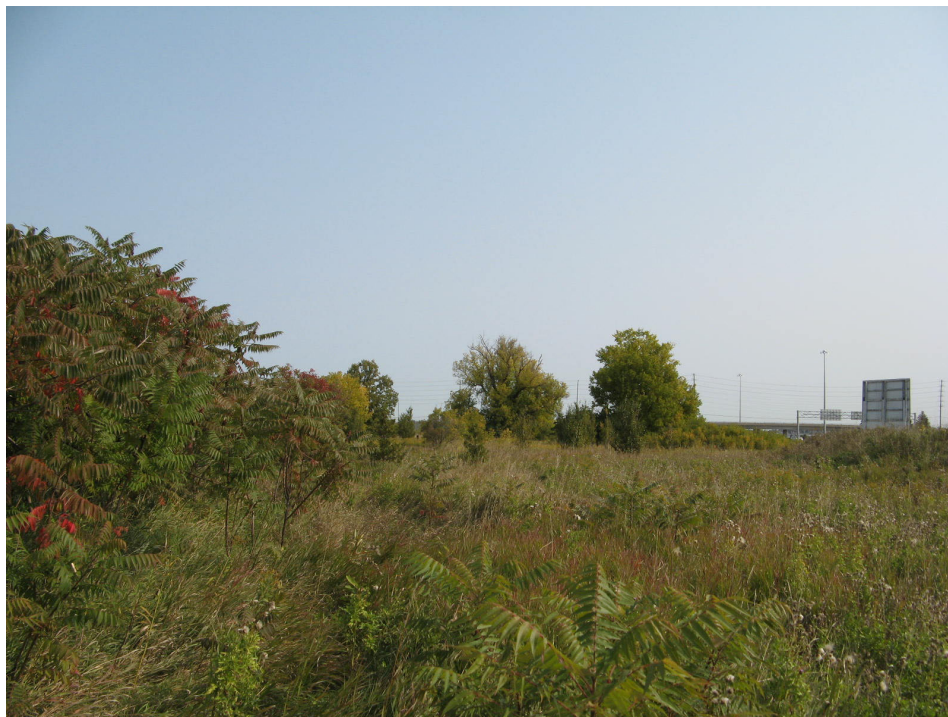
Where the shrub coverage is greater than 25 percent, the vegetation community is identified on Map 1 as cultural thicket. In addition to the well-represented red raspberry and staghorn sumac, common buckthorn, tartarian honeysuckle, red-osier dogwood, and nannyberry shrubs are also present in the thicket habitat, along with regenerating Manitoba maple, white birch, and trembling aspen stems (Photos 10 and 11).

*Photo 10 –Cultural thicket (left) and meadow (right) habitat in the central -west portion of the site.
View looking east.*

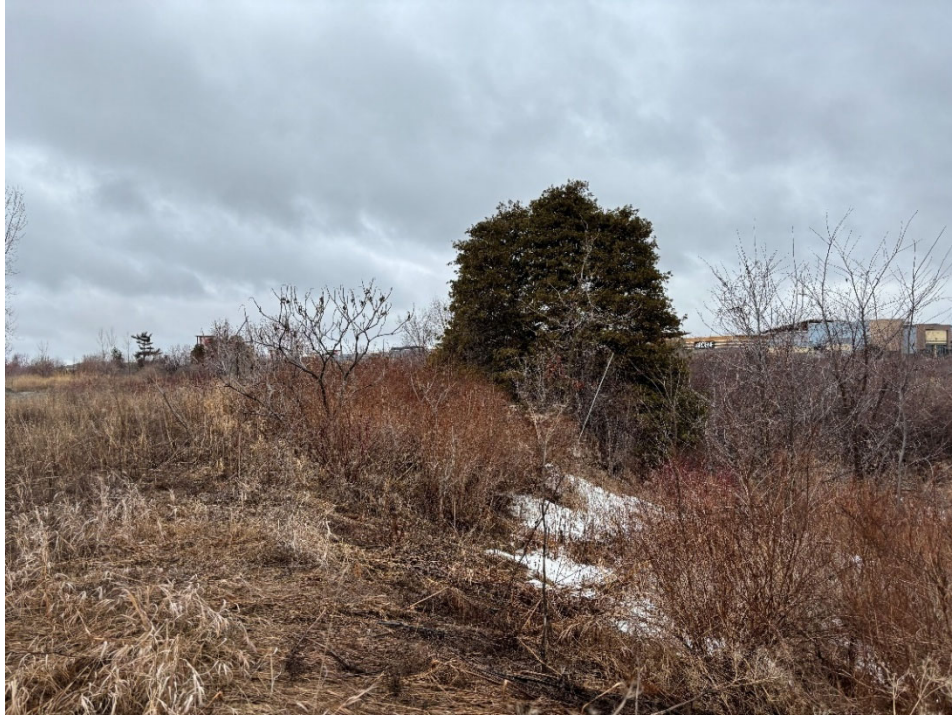
*Photo 13 –Feedmill Creek corridor to the north of the current site. View looking southwest.
Photo taken April 1, 2026.*

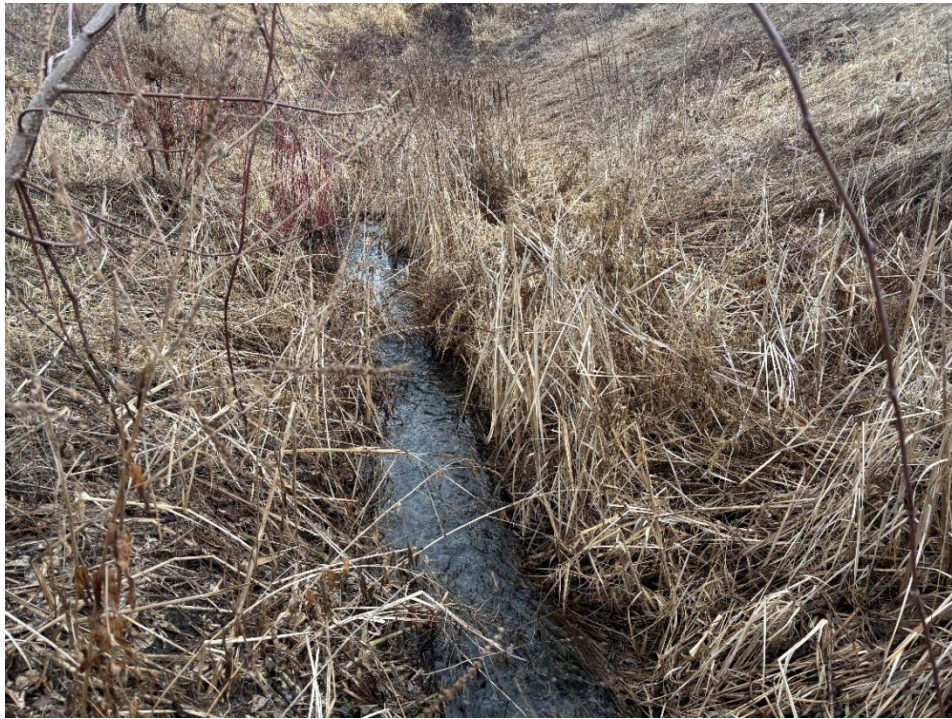
*Photo 14 – Ditch along eastern property line. View looking northwest from south of existing access
from Huntmar Drive. Photo taken April 1, 2026.*

Direct fish habitat is also considered to be present in the lower reach of the ditch (immediately adjacent to Feedmill Creek), along the eastern property line, which conveys water from a stormwater pond on the south side of Highway 417, as illustrated on Map 3. This ditch contained clear, flowing water at the time of the April 1, 2026 site visit, and two barriers were observed in the ditch at the locations shown on Map 3, which would prevent any fish movement further upstream and therefore the majority of this ditch is considered to be indirect fish habitat. In order to protect the potential downstream fish habitat utilization within this ditch and Feedmill Creek, all development will be located at least 10 metres from the ditch, with the exception of the extension of an existing culvert under the access road from Huntmar Drive in order to provide for a new access road, as well as some site grading.

1. A 10 metre wide buffer area from the highwater mark of the existing ditch, shall be maintained in a natural vegetated state and be re-vegetated with native species.
2. Prior to any works related to the construction of a new stormwater outlet to the Creek or the extension of the existing culvert under the access road from Huntmar Drive, a Request for Review form will need to be submitted to the Department of Fisheries and Oceans (DFO) for review and any recommendations from DFO are to be properly implemented.
3. Permits from the Mississippi Valley Conservation Authority for the works within their regulated areas, will also need to be obtained.
