# **Phase I Environmental Site Assessment**

319 Huntmar Drive  
Ottawa, Ontario

Prepared for: Ironclad Developments Inc.

**Report: PE7242-1**  
**Date: December 2, 2025**

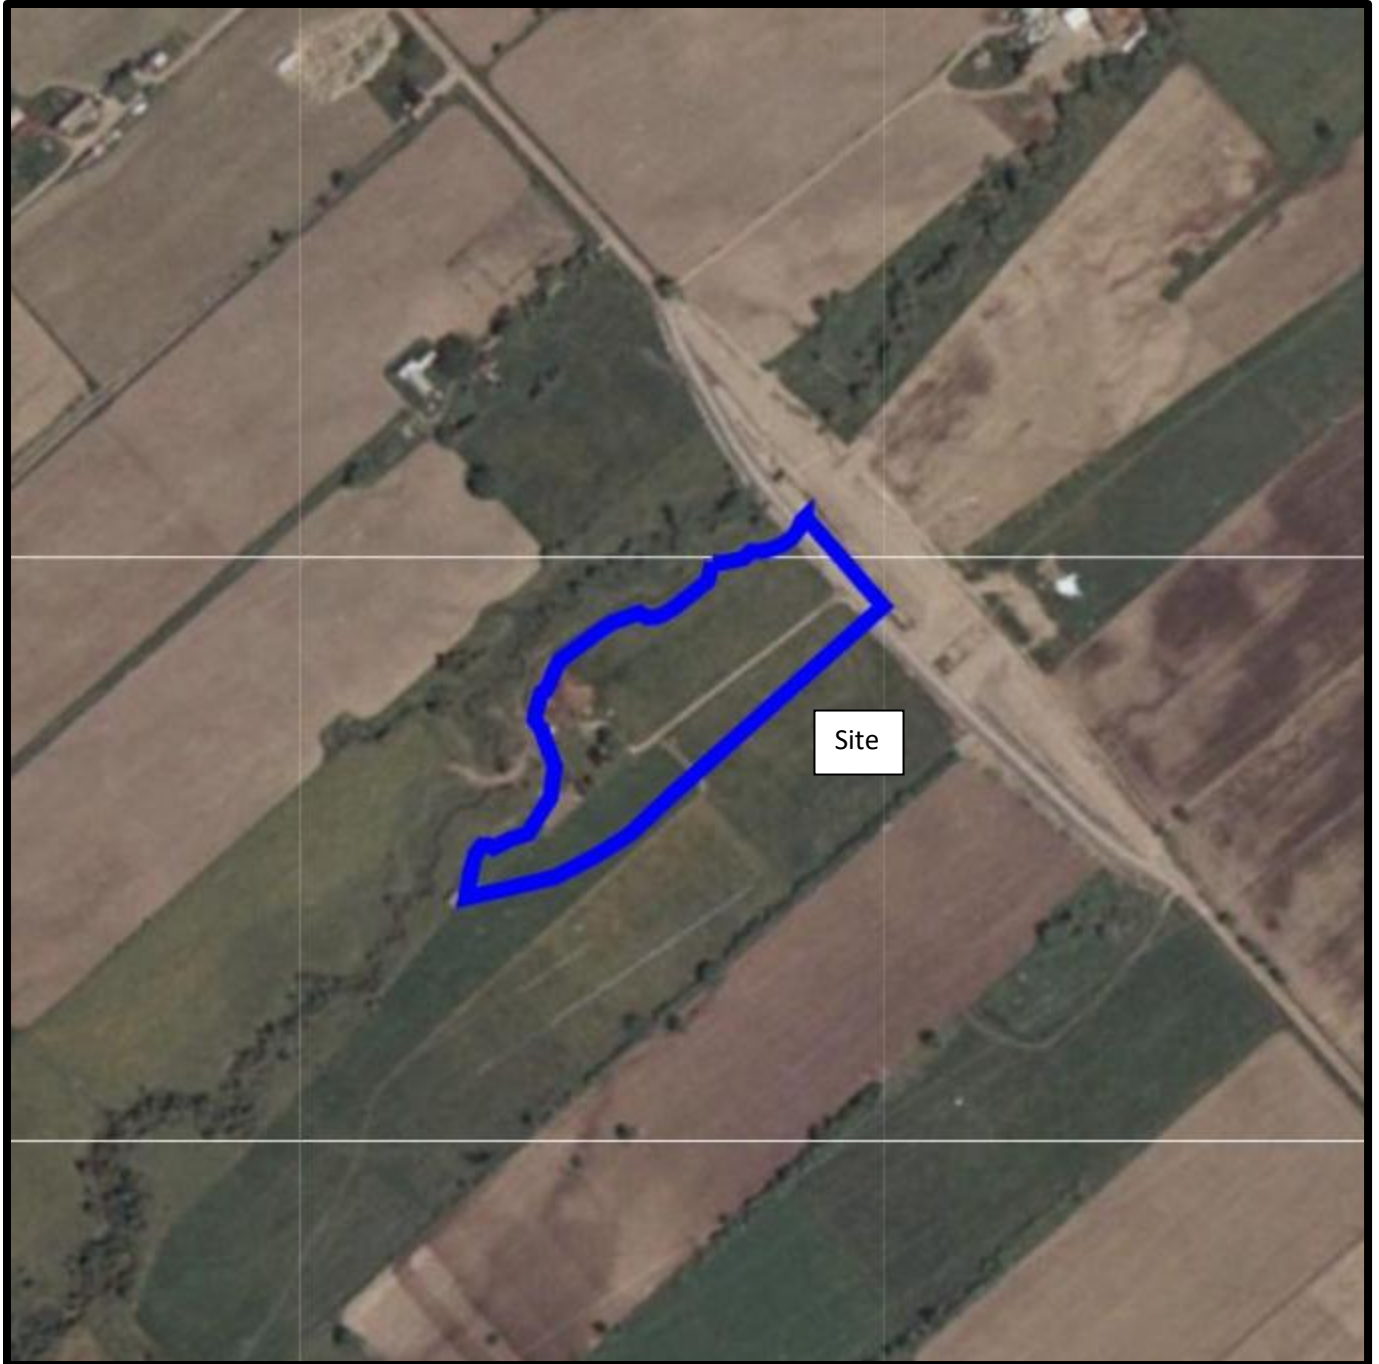
AERIAL PHOTOGRAPH  
1976

| 1976 | (GeoOttawa) No significant changes are apparent with regard to the Phase I Property. A slight temporary deviation in Huntmar Drive was observed, likely associated with the construction of Highway 417 and the Huntmar Drive overpass. |

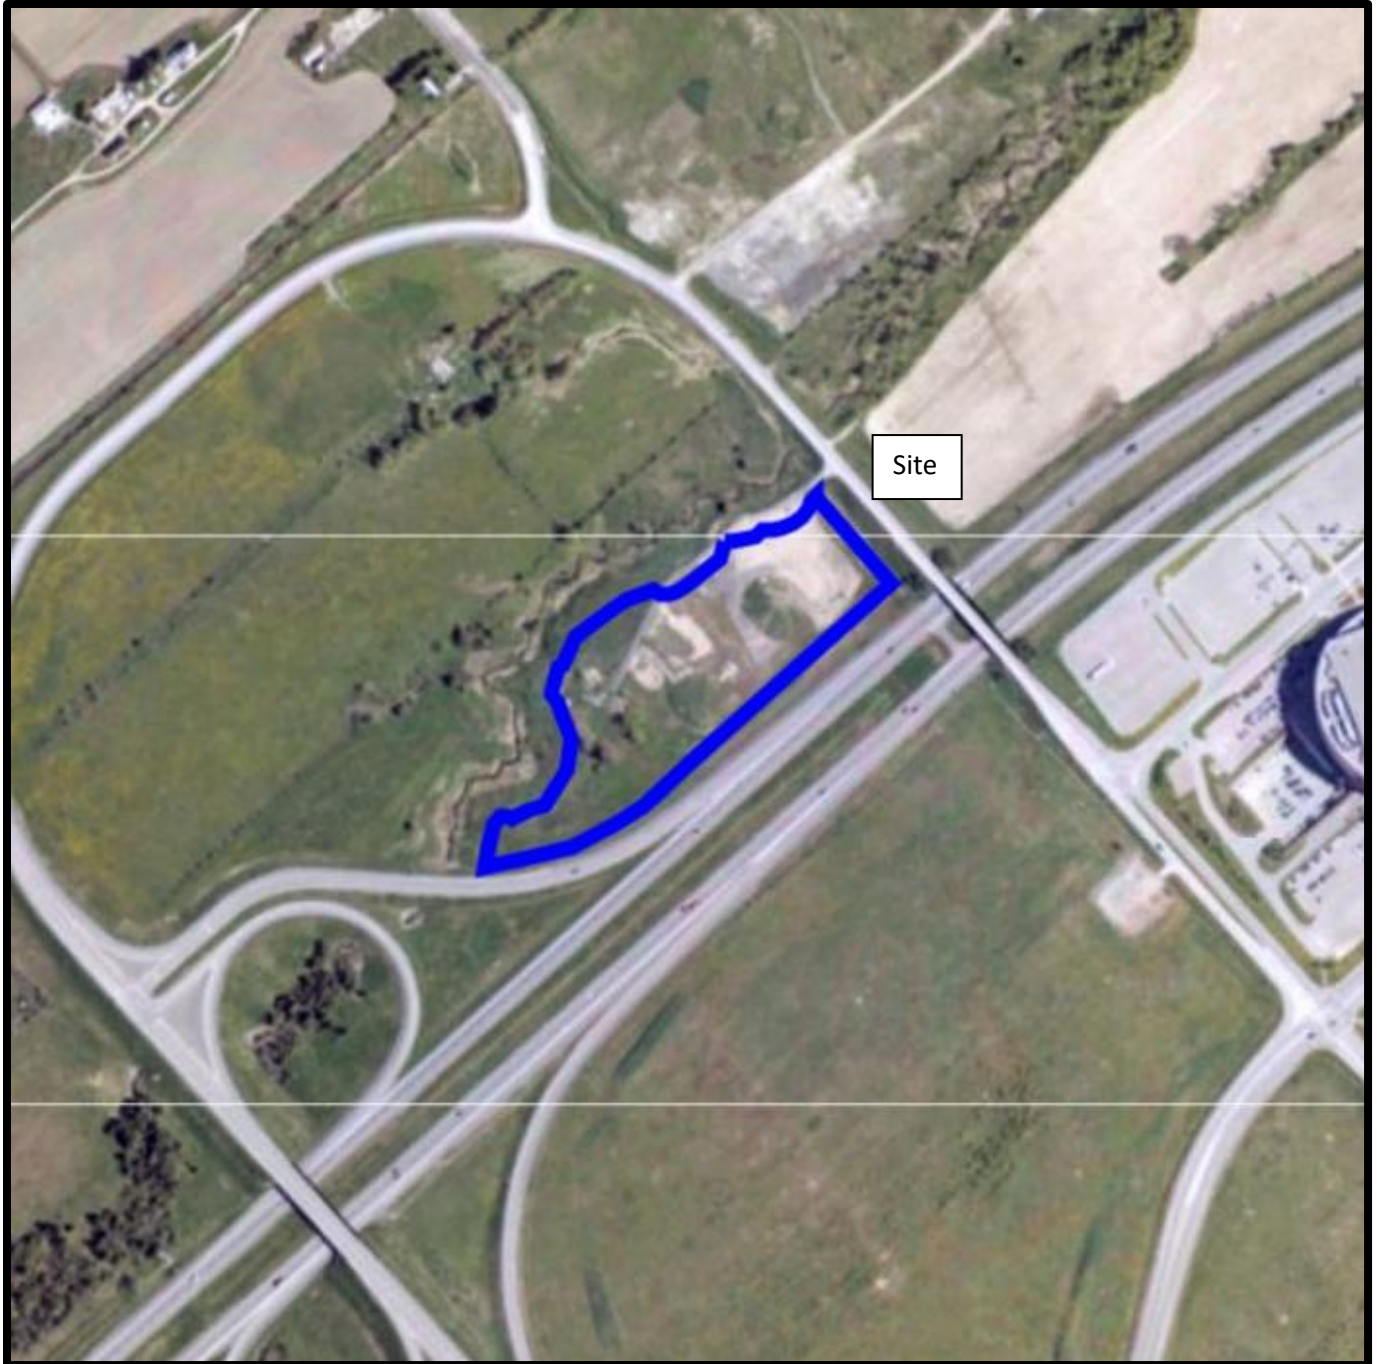
AERIAL PHOTOGRAPH  
2002

| 2002 | (GeoOttawa) The farmstead buildings on the Phase I Property appears to have been demolished, leaving only foundations visible. The property further to the east of the Phase I Property, appears to be developed with a large commercial building. A highway |

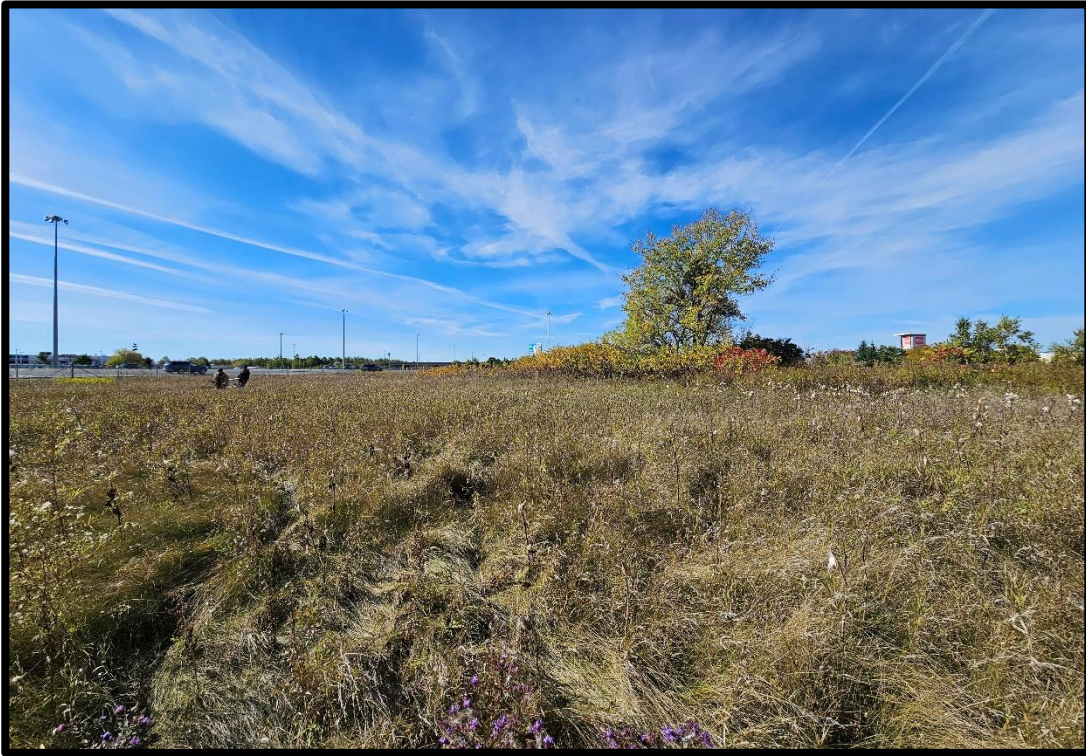
Photograph 1: View of the southwestern portion on the Phase I Property, facing south.

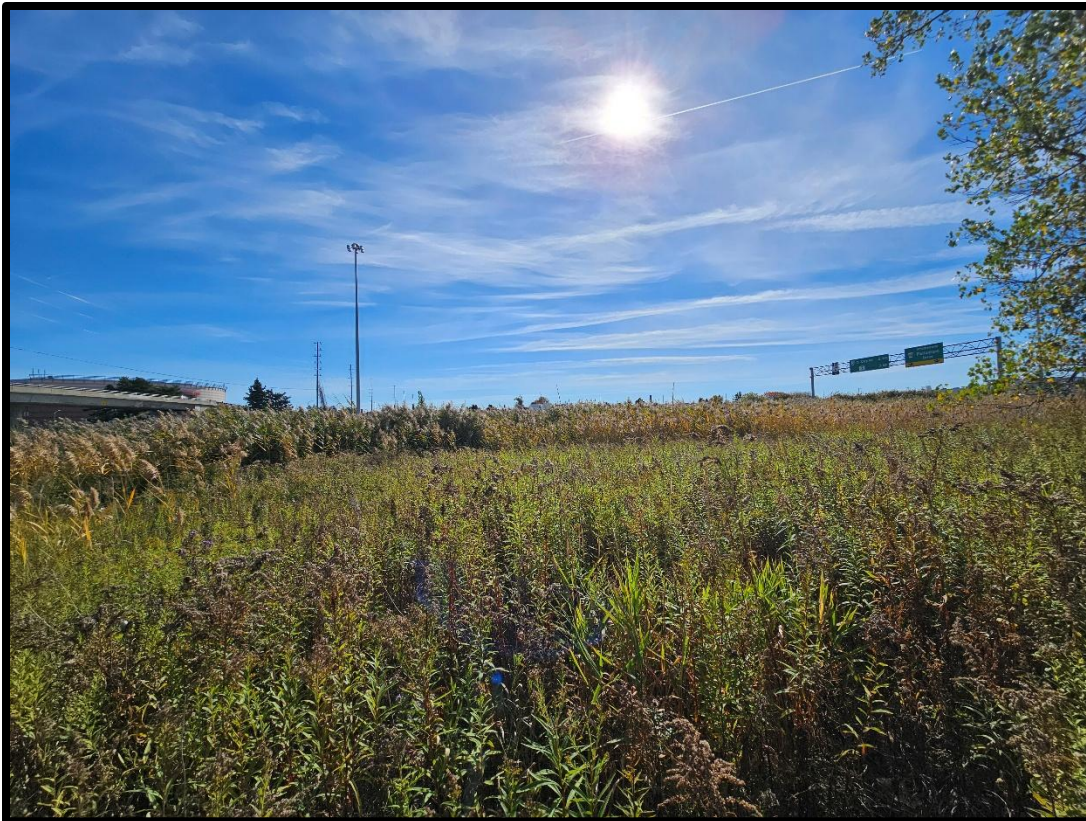
Photograph 2: View of the northeastern portion of the Phase I Property, facing south.

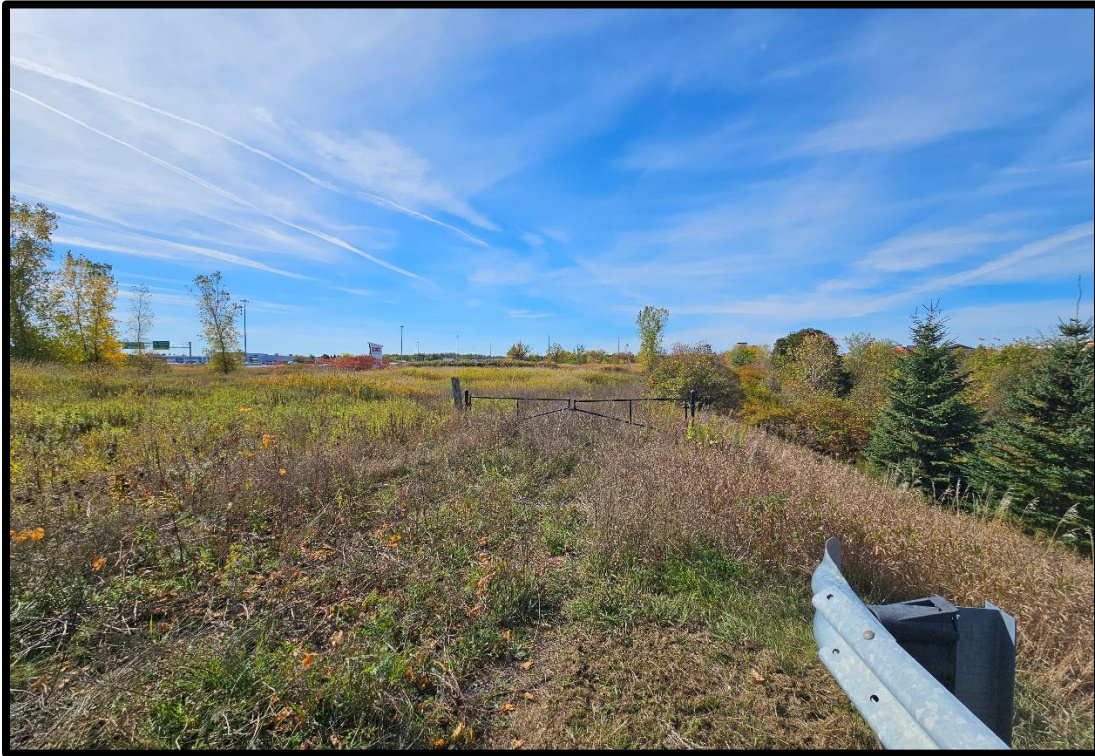
Photograph 3: View of the northern portion of the Phase I Property, facing west.

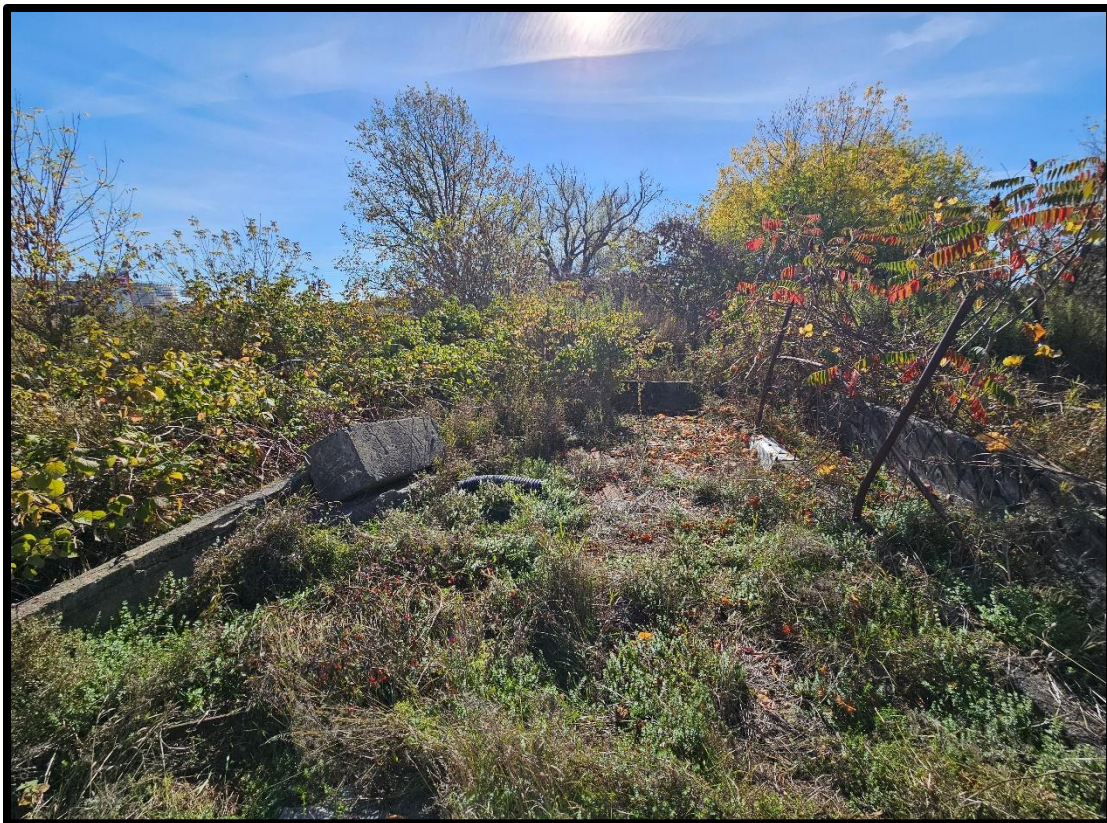
Old foundations from the former on-site farm buildings were observed on the Phase I Property during the site visit. No other building or structures are present on the Phase I Property.

The Phase I Property consists of grassed and treed vacant land, with remnants of old foundations observed in the northwestern portion and a Tanger Outlet sign located near the central-southern portion of the site.

Photograph 4: View of the old foundation on the Phase I Property.

The former farm building foundations may be managed at the time of site redevelopment, however they do not present an immediate environmental concern.

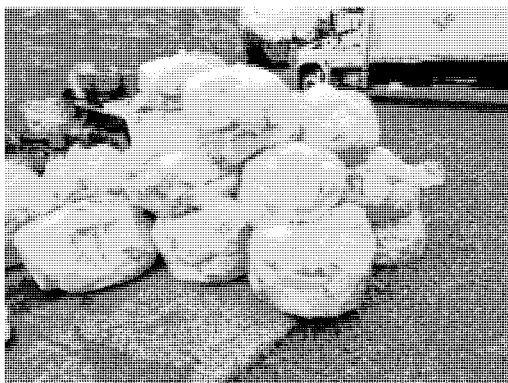
An example of packing paper collected at just one compactor over a 24-hour period

**SHRINK WRAP AND PACKING PAPER:** With the number of clothing retailers at Tanger, there is a significant volume of plastic wrap/bags and packing paper generated daily. While there are recycling totes provided for mixed paper and shrink wrap, they can usually only hold a couple of bags on average. We would suggest contacting GFL to see if they can provide you with a more suitable alternative to enable you to capture a higher percentage of these materials.
