**Phase One Environmental Site Assessment**  
**Alexander Community Centre and Alexander Park**  
**960 Silver Street, Ottawa, Ontario**

Phase One Environmental Site Assessment

OTT-23011957-Q0

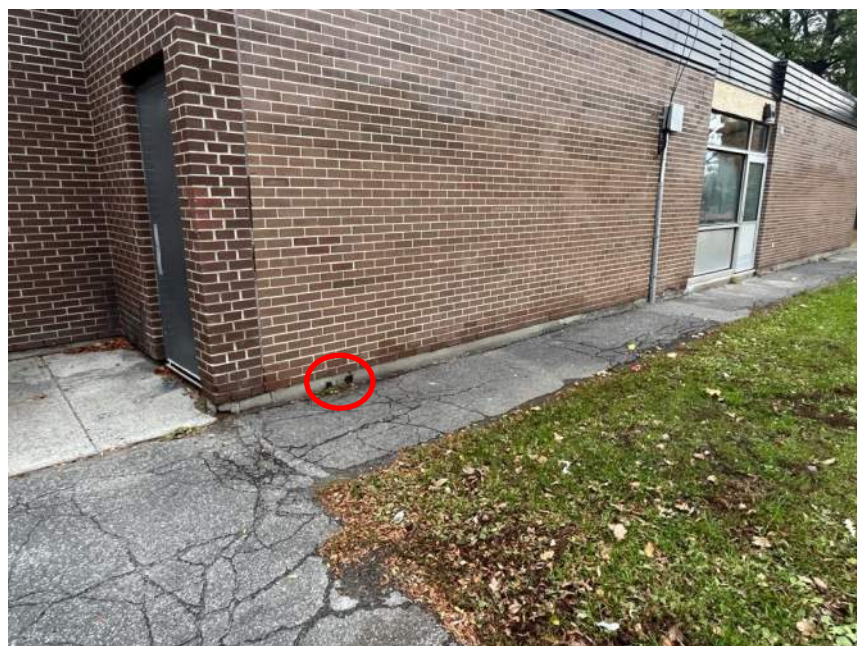
**Photograph No. 4**

The location of the former vent/fill pipes was observed on the north wall of the building during the site visit (**PCA 5**). The transformer on the east side of the site building is a PCA (**PCA 23**). As these PCAs are located on the Phase One property, they are considered to contribute to an APEC.

View of the north building wall and suspected vent/fill pipes.

EXP did not observe any evidence of above storage tanks (ASTs) during the site reconnaissance. Historic building drawings show that two ASTs (**PCA 5**) were located in the northeast corner of the basement. These were used to store furnace oil for boilers used to heat the building. Holes from the vent/fill pipes were observed in the parking at the base of the north wall of the community building.

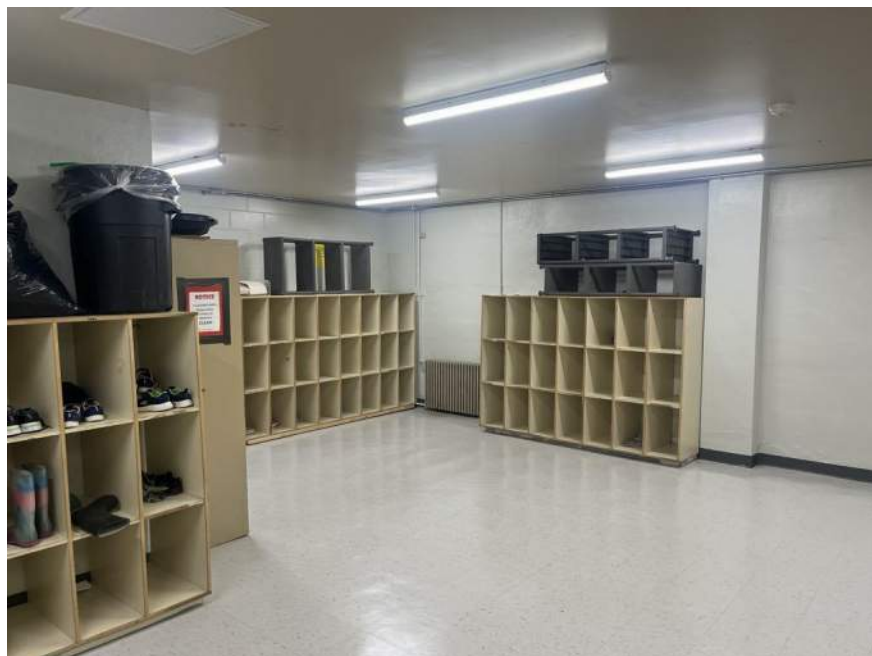
**Photograph No. 7**

The building is heated and cooled by roof-top natural gas fired furnaces/air conditioning units. There were also hot water radiators observed in the basement of the building.

View of the basement of the site building.

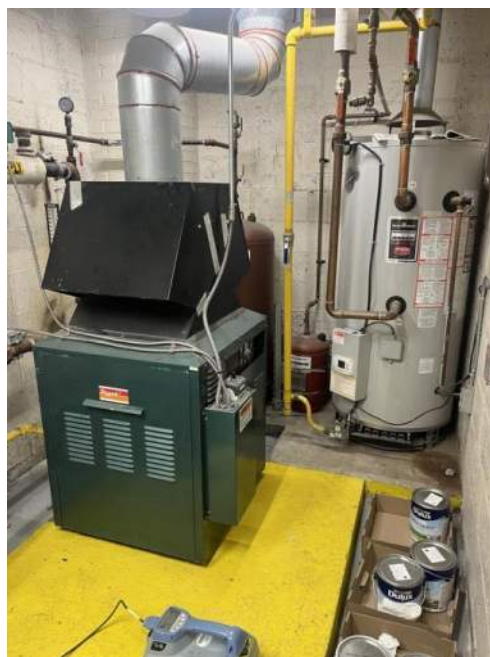
**Photograph No. 8**

View of the natural gas fired boiler in the basement mechanical room.

The City also provided several historic drawings showing the site building layout. An as-built drawing 573/M-1 from 1965 shows two 250 gallon above ground storage tanks (ASTs) located in the northeast corner of the basement (**PCA 5: PCA #28 – Gasoline and associated products storage in fixed tanks**). Drawing M-1 from 1984 showed renovations to the community centre, including the removal of the ASTs, and the replacement of the oil fired boiler with a natural gas fired boiler.
