PROJECT:  
**41 EDGEWATER**

LOCATION:  
**41 EDGEWATER ST  
 OTTAWA, ON**

## TREE CONSERVATION REPORT

# TCR1

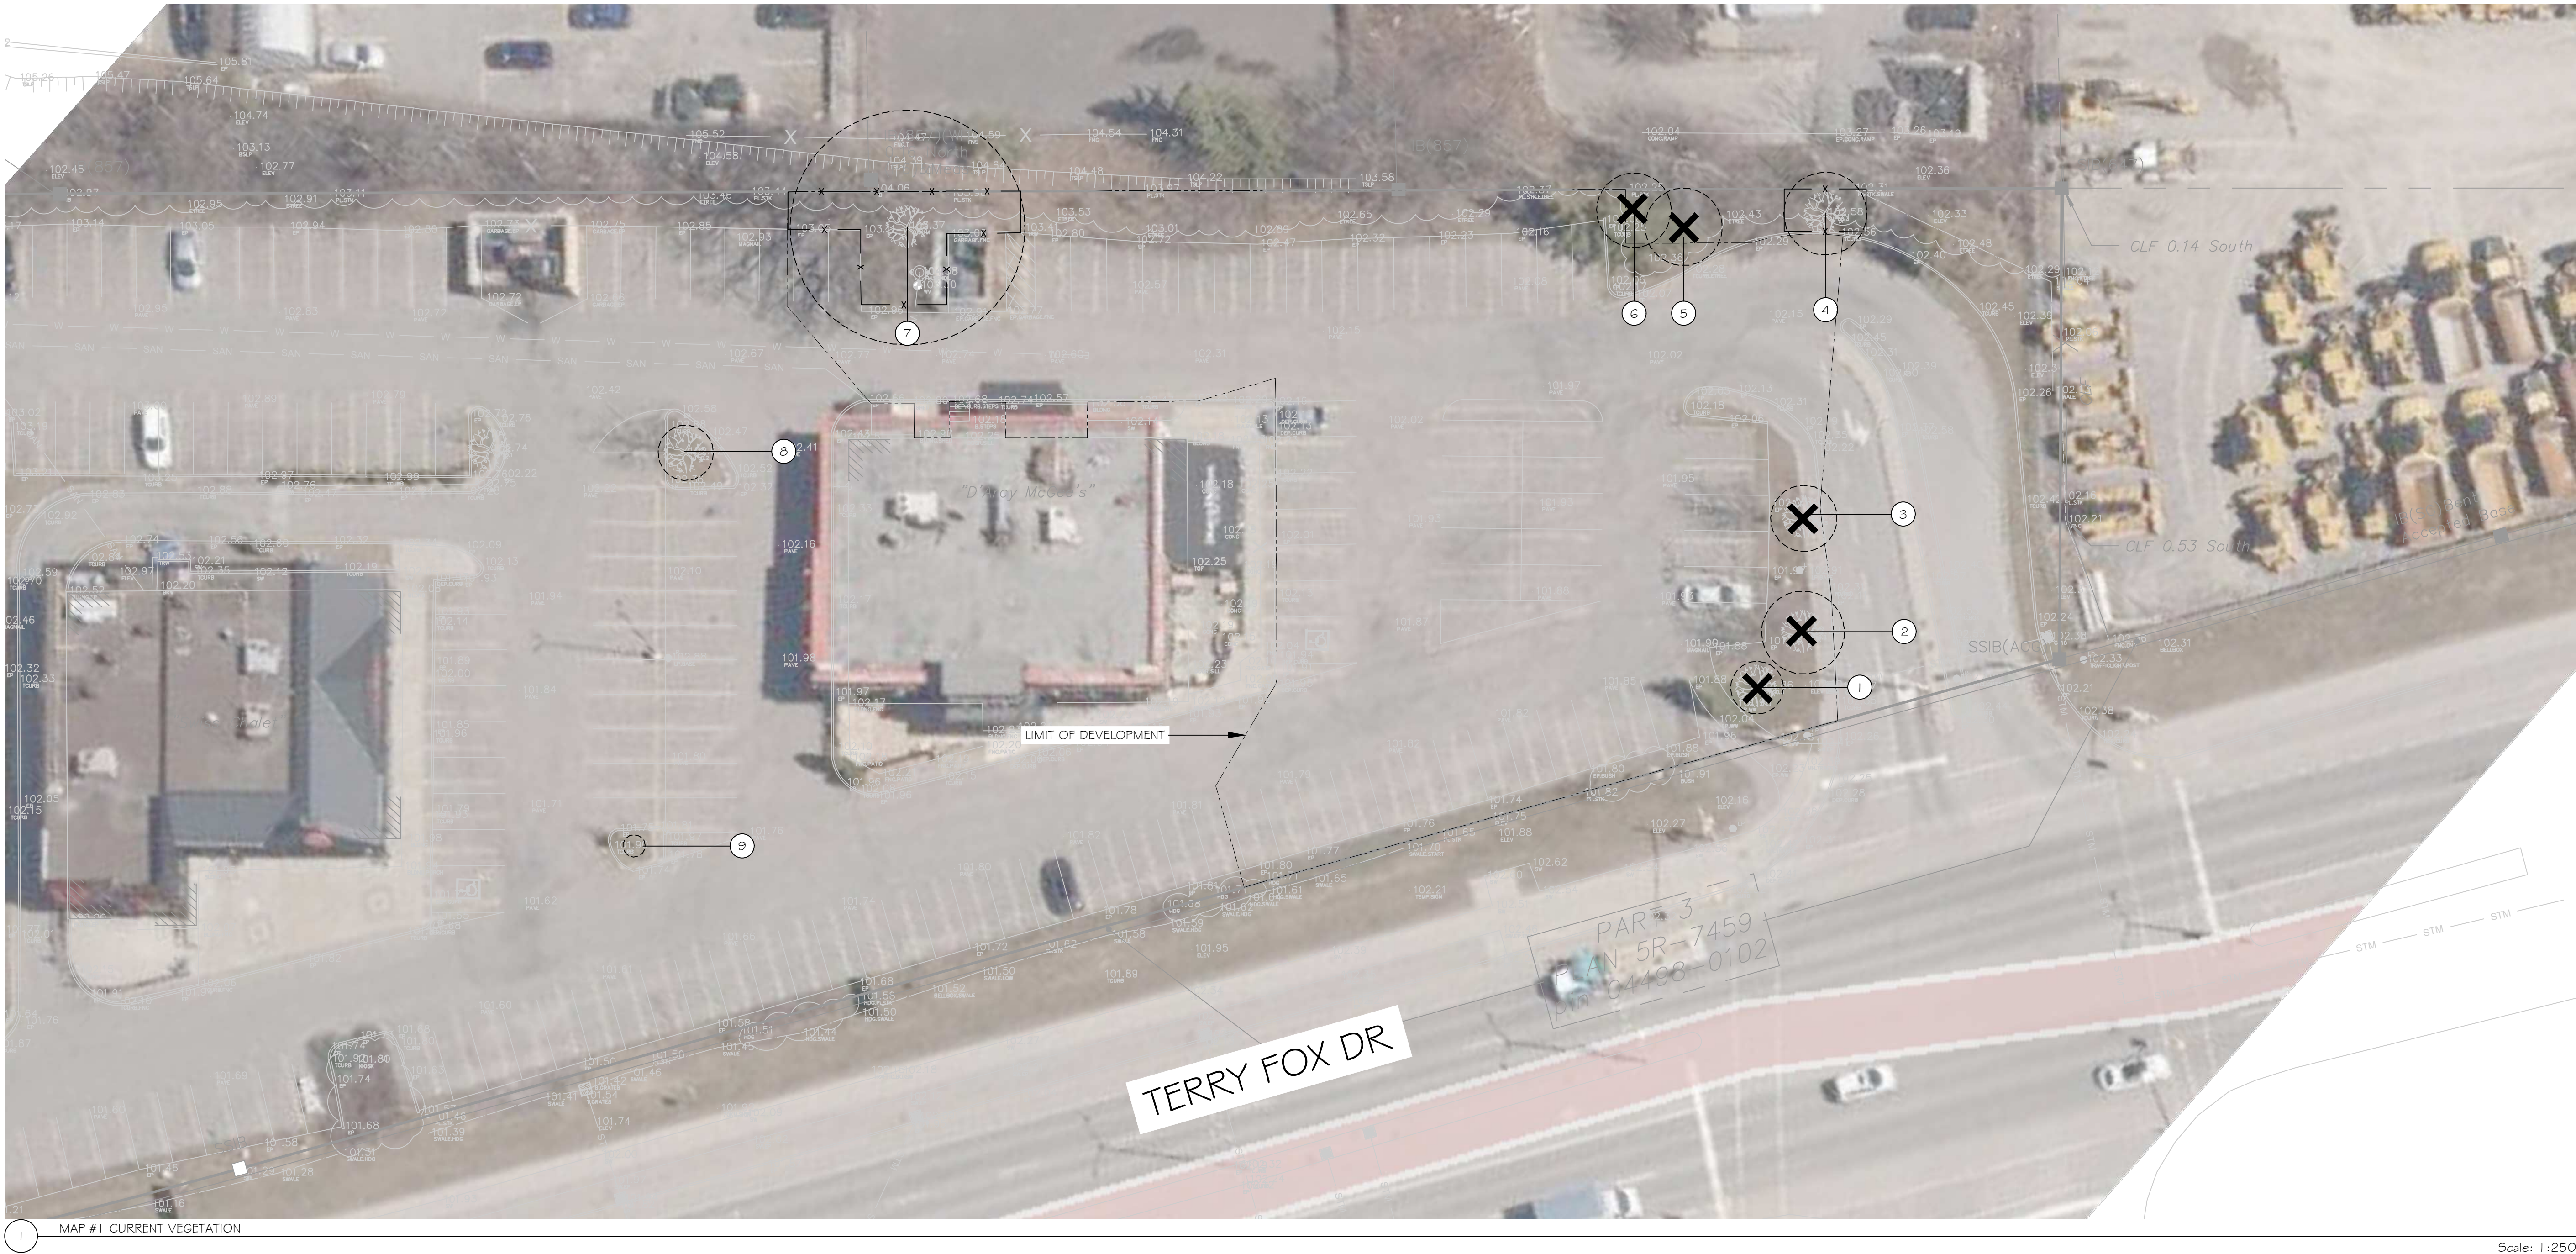
| Tree # | Botanical Name | Common Name | DBH (cm) | Ownership | Condition | Comments | Arborist Recommendation | Removal Reason |
|---|---|---|---|---|---|---|---|---|
| 1 | Picea species | Spruce | 19 | Private | Dead | Standing dead | Remove | Dead |
| 2 | Acer saccharum | Sugar Maple | 30 | Private | Poor | Symmetrical tree with frost cracks and decay of bark on trunk and limbs. Broken branches. Showing signs of stress. | Remove | Construction |
| 3 | Acer saccharum | Sugar Maple | 24 | Private | Poor | Symmetrical tree with frost cracks and decay of bark on trunk and limbs. Broken branches. Showing signs of stress. | Remove | Construction |
| 4 | Acer saccharum | Sugar Maple | 30 | Private | Poor | Symmetrical tree with frost cracks and decay of bark on trunk and limbs. Broken branches. | Retain | |
| 5 | Picea pungens | Colorado Spruce | 28 | Private | Moderate | Minor canopy dieback, yellowing needles | Remove | Construction |
| 6 | Picea glauca | White Spruce | 27 | Private | Poor | ~40% canopy dieback, | Remove | Construction |
| 7 | Quercus macrocarpa | Burr Oak | 85 | Private | Good | Slightly asymmetrical and some minor broken limbs | Retain | |
| 8 | Acer saccharum | Sugar Maple | 20 | Private | Good | | Retain | |
| 9 | Syringa reticulata | Japanese Tree Lilac | 8 | Private | Poor | Major lean. Damage to bark of trunk and limbs | Retain | |

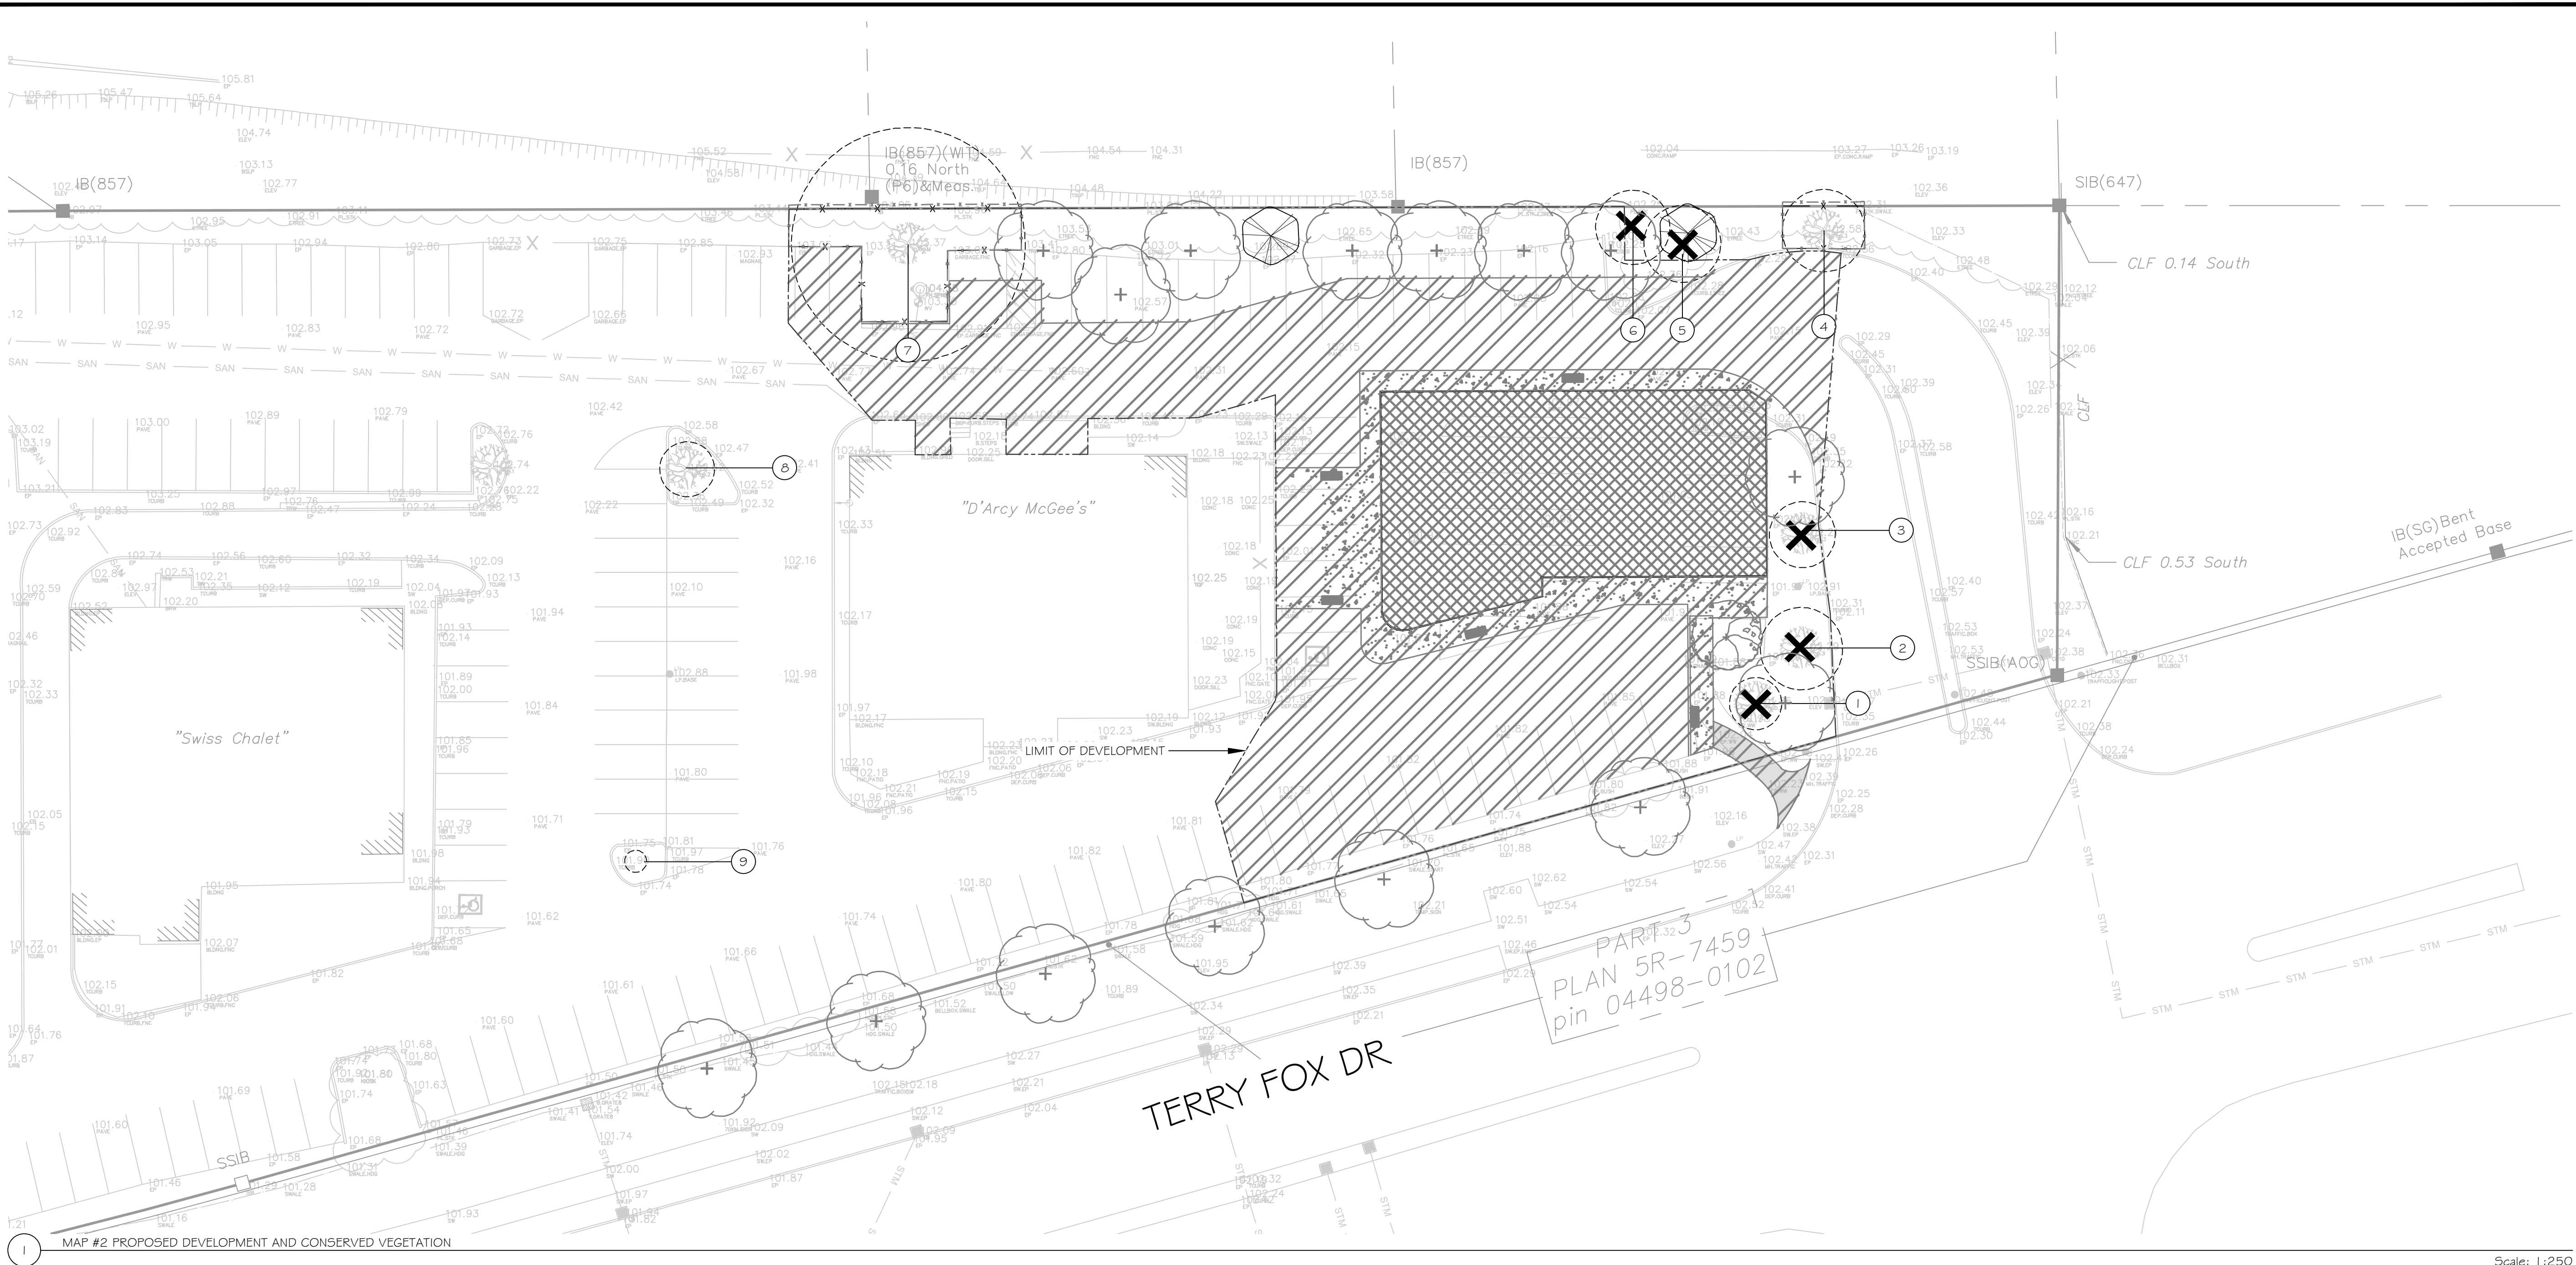
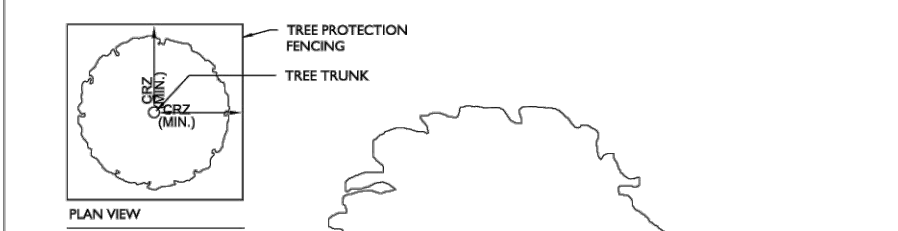
| | TREE PROTECTION FENCING | REV: JAN 2026 |

- NOTES:
1. TREE PROTECTION FENCING TO BE INSTALLED PER F-801 AND PER THE TREE CONSERVATION REPORT (TCR), THE TREE INFORMATION REPORT (TIR) OR AS INDICATED IN THE CONTRACT DRAWINGS.
  2. TREE PROTECTION FENCING MUST BE AT LEAST 1.2M IN HEIGHT AND BE CONSTRUCTED OF RIGID OR FRAMED MATERIALS SUCH AS:
    - A. POLYCARBONATE
    - B. ALUMINUM
    - C. MODULAR STEEL PANELS
  3. INSTALLATION OF ALL FENCING TYPES A, B OR C, MUST MINIMIZE DAMAGE TO EXISTING ROOTS.
  4. CRITICAL ROOT ZONE (CRZ) TO BE MEASURED FROM OUTSIDE OF THE TREE MAE. DIAMETER AT GROUND HEIGHT (DGH) TO BE MEASURED AT HEIGHT OF 1.3M FROM GROUND.
