**Environmental Impact Study for  
1867 Alta Vista Drive, Ottawa, Ontario**

**Final Report**

**KILGOUR & ASSOCIATES LTD.**  
[www.kilgourassociates.com](http://www.kilgourassociates.com)

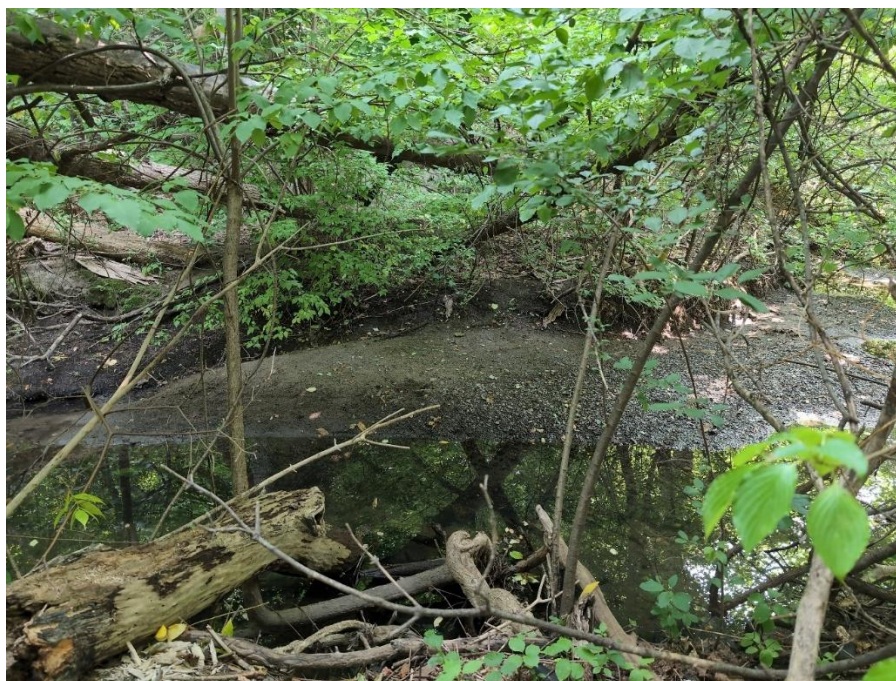
**Figure 3 Watercourse east of the Site (August 7, 2025)**

section of the entire watercourse. The channel originates from a stormwater outlet located southeast of the Site and north of Smyth Road, where it is likely fed by stormwater runoff from surrounding developed lands. North of the Site, the watercourse enters approximately 185 m of culvert beneath Alta Vista Drive before re-emerging north of Hospital Link Road. This long, culverted section likely represents a significant fish barrier; only very small numbers of highly tolerant fish species could, on limited occasions, have any potential for access to the feature. As such, the potential for the feature to provide direct fish habitat is considered to be negligible.

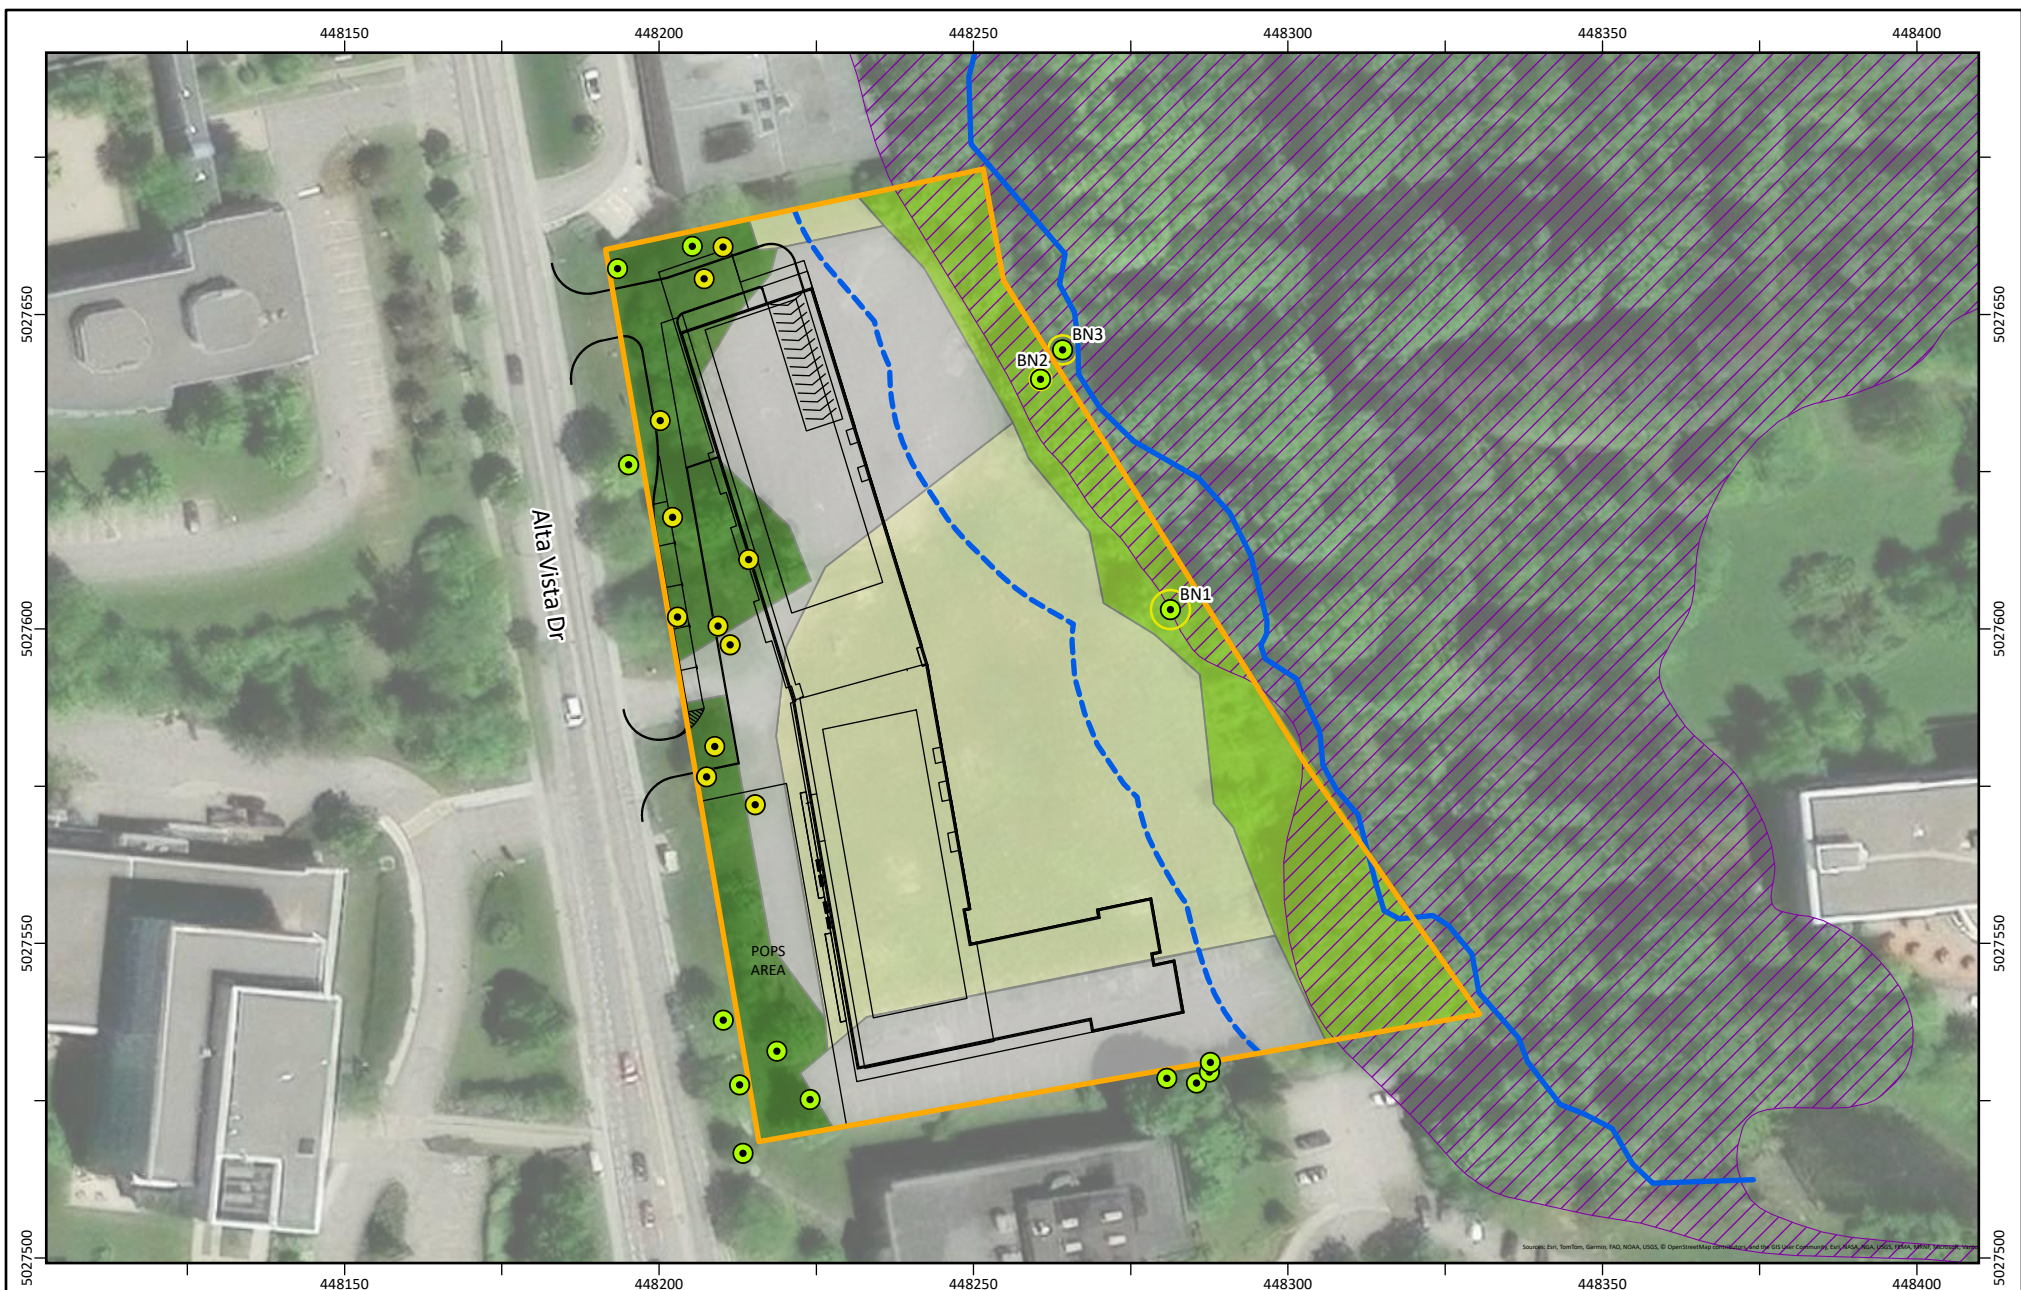
**Figure 4. Proposed development plan and tree fate**

- Site Boundary
- Proposed Development
- Trees**
- Existing Retained
- Existing Removed

- CRZ
- Watercourse
- 30 m Watercourse Setback
- UNA #161

- ELC**
- FODM11
- WODM5-3
- CUM1-1
- CVI\_1

The list of individual trees on and adjacent to the Site boundaries and their anticipated fates, are listed in Appendix A.
