# **Tree Conservation Report for 1867 Alta Vista Drive, Ottawa, Ontario**

**December 15, 2025**

**Final Report**

Mr. Evan Johnson  
Soul Alta Vista GP Inc.

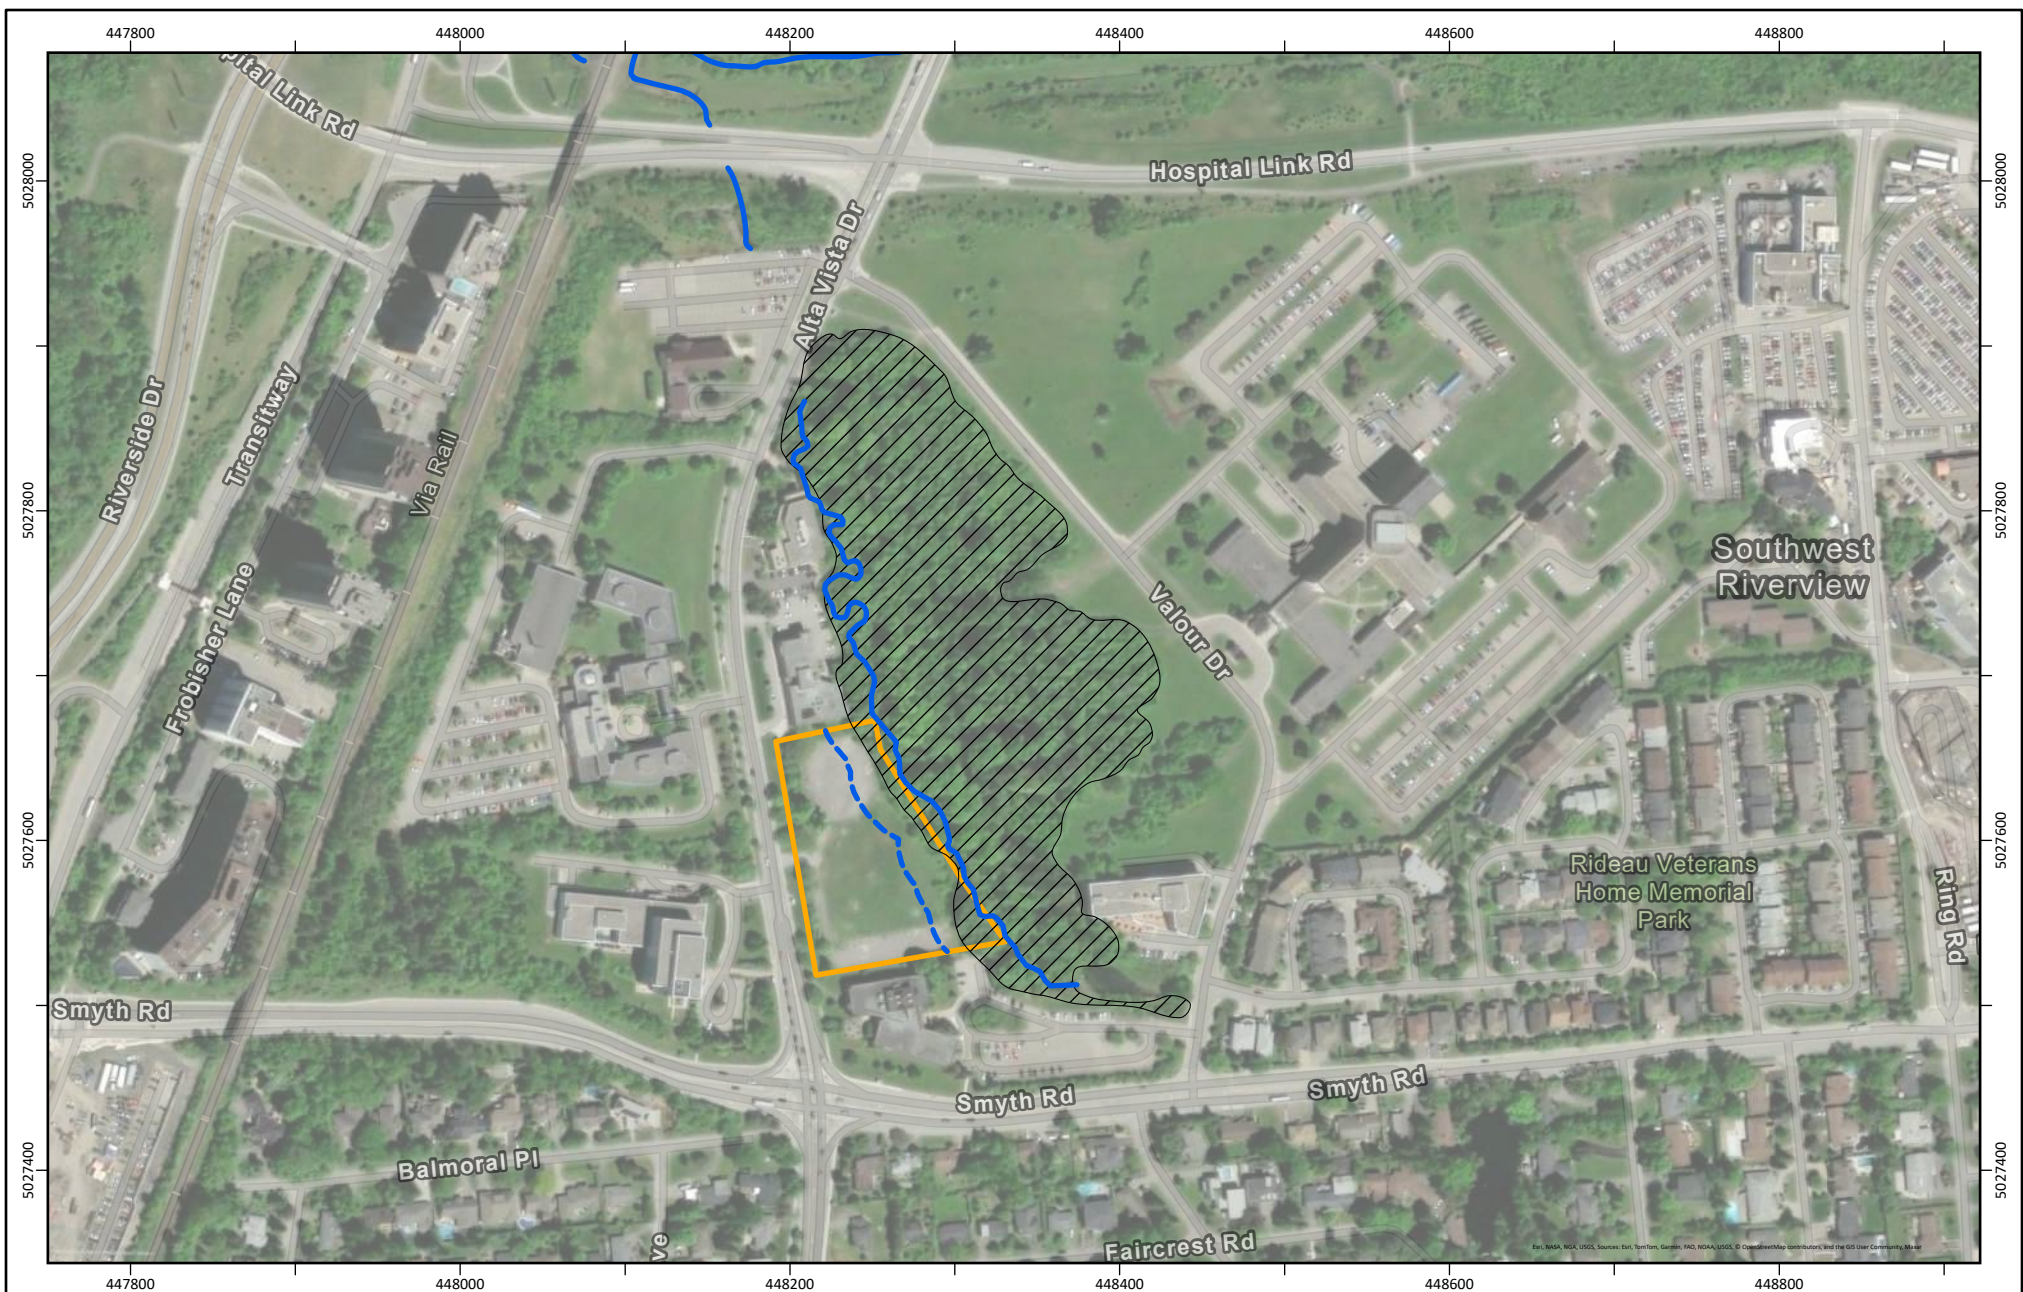
**Figure 1. Site context**

The Site is approximately 1.21 hectares (ha) in size and is located at 1867 Alta Vista Drive, Ottawa, Ontario (Lat: 45.399788°N and Long: -75.661239°W; Figure 1). The Site is currently a vacant urban lot that previously contained a commercial building. Based on aerial imagery, the building was removed between September 2016 and June 2017 (City of Ottawa, 2025). The Site is partly paved and supports regenerating vegetation where the previous building stood. Trees are situated along the Site boundaries, including planted trees along the north, west, and south sides of the Site and natural woodland along the east side of the Site. Immediately east of the Site and extending onto the east portion of the Site is Urban Natural Area (UNA) #161 (Hospital Woods West). The Site is located approximately 550 m east of the Rideau River. The zoning of the Site is IP12 (Subzone – Hospital Lands).

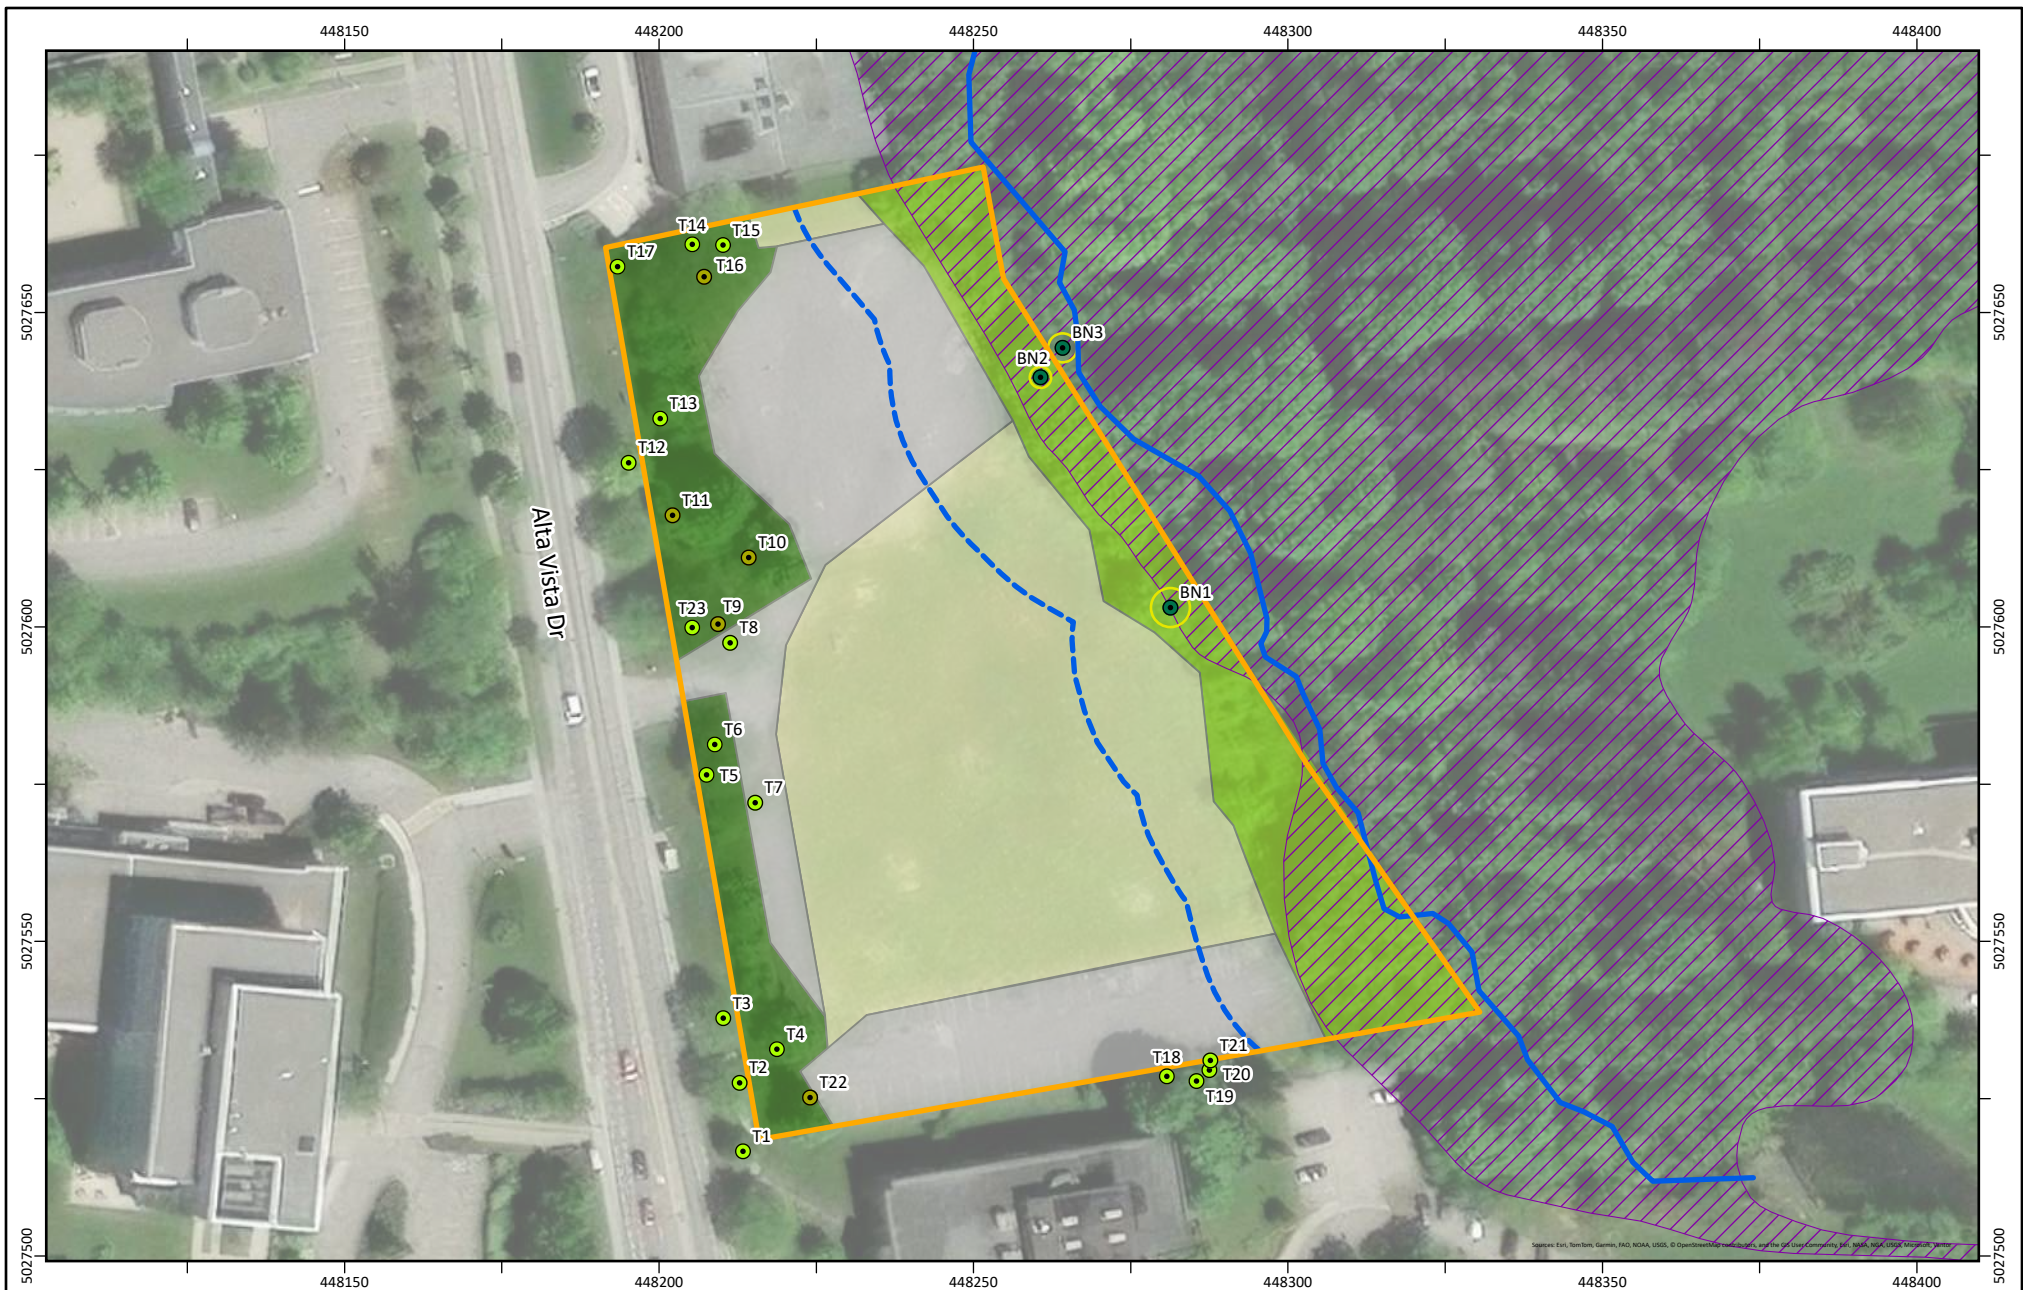
**Figure 2. Existing conditions and trees on the Site**

No trees with DBH measurements of 10 cm or greater were identified within the central meadow area onsite (CUM1-1). Within or adjacent to the FODM11 (regenerating hedgerow) onsite, 19 individual trees were identified, with DBH measurements ranging from 12 cm to 63 cm. These trees represented three distinct species: Honey Locust (*Gleditsia triacanthos*), Sugar Maple (*Acer saccharum*), and Manitoba Maple (*Acer negundo*). Five notable trees (i.e., with DBH measurements greater than 50 cm), all of which were Sugar Maple or Honey Locust, were observed on the Site.

City-owned boulevard trees were observed immediately west of the Site along Alta Vista Drive, and four trees were observed adjacent to the south property boundary. The trees to the south included Blue Spruce (*Picea pungens*) and Sugar Maple and had DBH measurements ranging from 16 cm to 50 cm. Two trees were observed adjacent to the north property boundary, both of which were Red Pine (*Pinus resinosa*) and had DBH measurements of 14 and 34 cm.

Within the WODM5-3 community, widespread tree species include Manitoba Maple, Basswood (*Tilia americana*), Eastern Cottonwood (*Populus deltoides*), and American Elm (*Ulmus americana*), with occasional Green Ash (*Fraxinus pennsylvanica*) and Apple (*Malus* sp.) trees. Average DBH measurements for trees within the woodland were approximately 25 cm.

Three Butternut trees (*Juglans cinerea*; Endangered under the ESA and SARA) were observed in the woodland (WODM5-3) on the east side of the Site. BN1 (DBH 31 cm) and BN2 (DBH 17 cm) are situated within the Site boundaries, with BN3 (DBH 23 cm) is situated offsite but with its CRZ extending onto the Site. All three trees were assessed as Category 1 based on the Butternut Health Assessment undertaken concurrently with this tree inventory (Appendix B). One additional Butternut had been observed approximately 16 m north of the Site during previous field studies in 2022. That tree was noted as dead in 2022 and it was confirmed to have fallen as of August 2025 and is not considered further in this report.

A watercourse runs parallel to the east property line and slightly intersects the property boundary in the southeastern corner of the Site (Figure 2). Field investigations in 2022 and 2025 characterized the stream as approximately 2-4 m wide, flowing from south to north, with a soft bottom interspersed with rocks (Figure 3). The feature has a 2-3% grade along its length, providing steady “run” conditions. Although fish studies were not undertaken, the observed depth (approximately 10 cm at the time of survey in August 2025) and general stream conditions suggest that the watercourse could provide habitat for some fish species. However, it is important to note that the section of the watercourse adjacent to the Site is the only open

The Site overall is relatively flat but slopes eastward within the deciduous woodland toward the watercourse (Figure 2). The watercourse has partly vegetated banks of approximately 2-3 m in height. The City of Ottawa previously suggested that the small ravine may meet the criteria for significant valleyland; however, after inspection it does not meet the necessary criteria; a thorough review of criteria is provided in the supporting Environmental Impact Study (Kilgour & Associates Ltd., 2025). As such, the Site does not contain any significant steep slopes or large banks.

The woodland on the east edge of the Site is part of UNA #161 (Hospital Woods West). UNA #161 encompasses approximately 4.7 ha, covering lands primarily east of the Site (Figure 2). UNA #161 was originally characterized as a mature, low upland deciduous forest on the western half (on/near the Site) and a young deciduous swamp forest with dense, non-native shrubbery on the eastern half (Muncaster Environmental Planning Inc. & Brunton Consulting Services, 2005). Significant features noted include: 1) exceptional abundance of mature Butternut (identified as possibly the largest population of Butternut in the City of Ottawa urban area); 2) significant wildlife corridor function for migratory passerine birds; 3) and

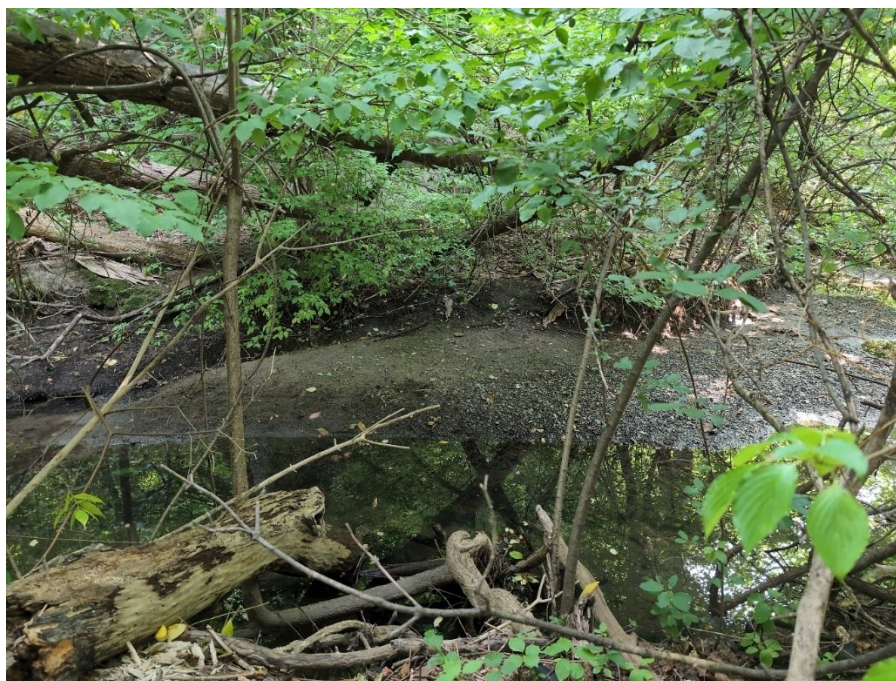
**Figure 3 Watercourse east of the Site (August 7, 2025)**

section of the entire watercourse. The channel originates from a stormwater outlet located southeast of the Site and north of Smyth Road, where it is likely fed by stormwater runoff from surrounding developed lands. North of the Site, the watercourse enters approximately 185 m of culvert beneath Alta Vista Drive before re-emerging north of Hospital Link Road. This long, culverted section likely represents a significant fish barrier; only very small numbers of highly tolerant fish species could, on limited occasions, have any potential for access to the feature. As such, the potential for the feature to provide direct fish habitat is considered to be negligible.

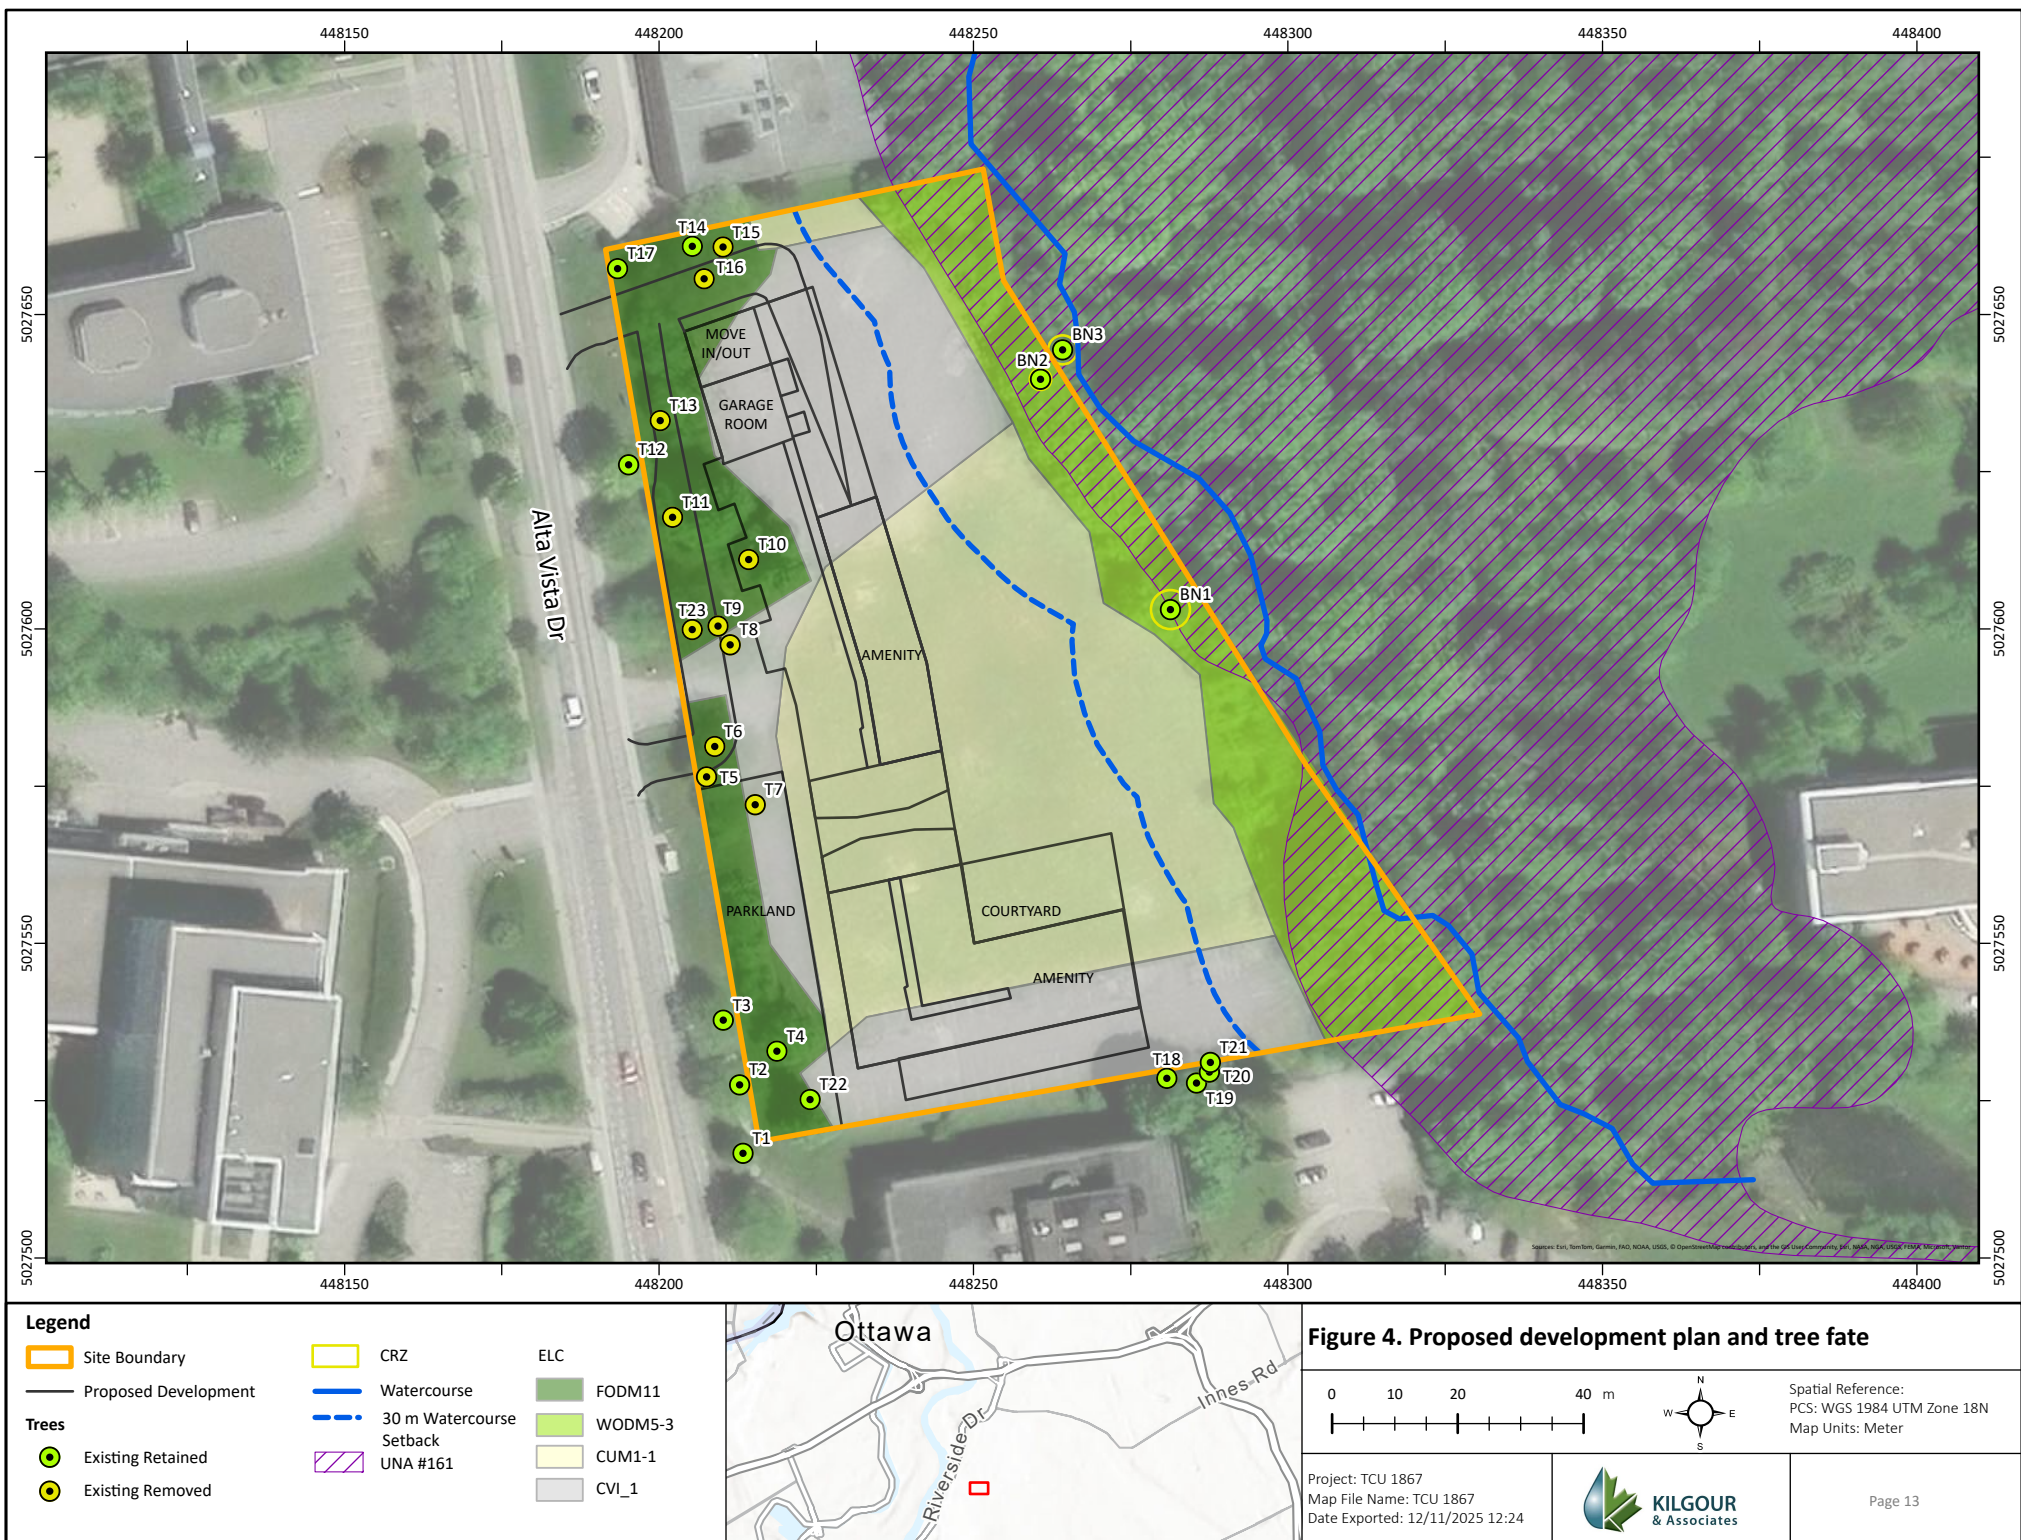
The proposed residential development would comprise a 9-storey residential building, with a total of 329 residential units (Figure 4). The proposed development includes two levels of underground parking, accessed by a ramp on the north side of the building. The ground level includes amenity spaces, a patio on the south side of the building, and a courtyard on the east side of the building, toward the woodland and watercourse. The southwest corner of the Site, adjacent to Alta Vista Drive is designated as Parkland. Road access will include entry points along Alta Vista Drive. The development incorporates a setback of 30 m from the watercourse east of the Site, providing a buffer for the watercourse and Significant Woodland areas. Trees will be planted along the east side of the proposed building. Where possible, existing onsite trees to the north, south, and west sides of the Site will be retained.

All trees subject to removal are fully located on the subject property.

It is expected that all trees within the development footprint will need to be cleared for the proposed project. Vegetation removal on the Site should be limited to that which is necessary to accommodate construction. All retainable trees on the Site and outside of the development footprint, including those off-site but adjacent to the property boundary and development footprint, should follow the general protection measures recommended during site preparation and construction (City of Ottawa, 2015):

- Erect a fence beyond the critical root zone (CRZ; i.e., 10x the diameter at breast height) of trees to be retained. The fence should be highly visible (orange construction fence) and paired with erosion control fencing. Pruning of branches is recommended in areas of potential conflict with construction equipment;
- Do not place any material or equipment within the CRZ of trees.
- Do not attach any signs, notices, or posters to any trees.
- Do not raise or lower the existing grade within the CRZ of trees without approval.
- Tunnel or bore when digging within the CRZ of a tree.
- Do not damage the root system, trunk, or branches of any remaining trees.
