# PATERSON GROUP

February 9, 2024  
File: PE6427-LET.01

Subject: **Phase I Environmental Site Assessment Update**  
**Vacant Commercial Property**  
**101 Nipissing Court**  
**Ottawa, Ontario**

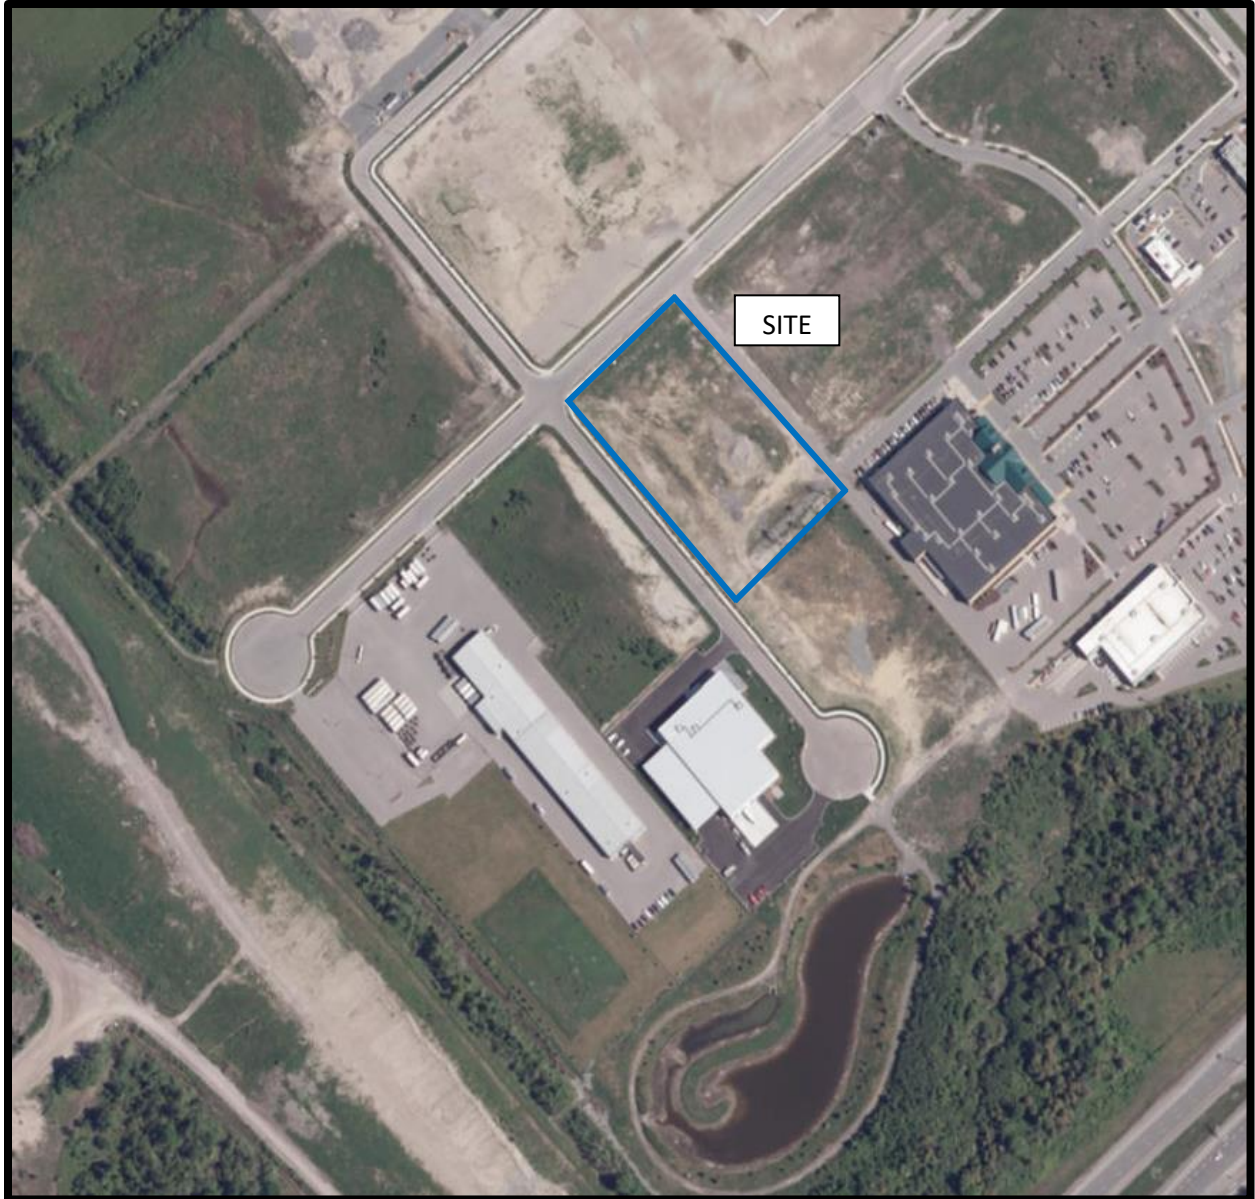
AERIAL PHOTOGRAPH  
2022

The most recent aerial photograph reviewed as part of the previous 2021 Phase I ESA Update was taken in 2019. An Aerial photograph from 2022, accessed via City of Ottawa website entitled “*GeoOttawa*”, was reviewed as part of the current Phase I ESA Update.

The construction of Nipissing Court can be seen adjoining the south side of the Upper Canada Street and Campeau Drive intersection along with a cul-de sac at the far south end of the road. A recently constructed commercial office/warehouse building, addressed 200 Nipissing Court (Team Harding, an HVAC contractor) can be observed on the neighbouring property located approximately 50 m to the southwest. Further construction of Upper Canada Street along with the stripping of vegetation and topsoil for future development on the neighbouring property addressed 8700, 8750 Campeau Drive and

1445, 1485 Upper Canada Street can be observed to the north. No other significant or apparent changes were identified on the subject or neighbouring properties.

No environmental concerns with respect to the subject site were identified by the air photo review.
