## **Phase I-Environmental Site Assessment**

3252 Navan Road  
Ottawa, Ontario

**December 9, 2019**  
Report: PE4588-1

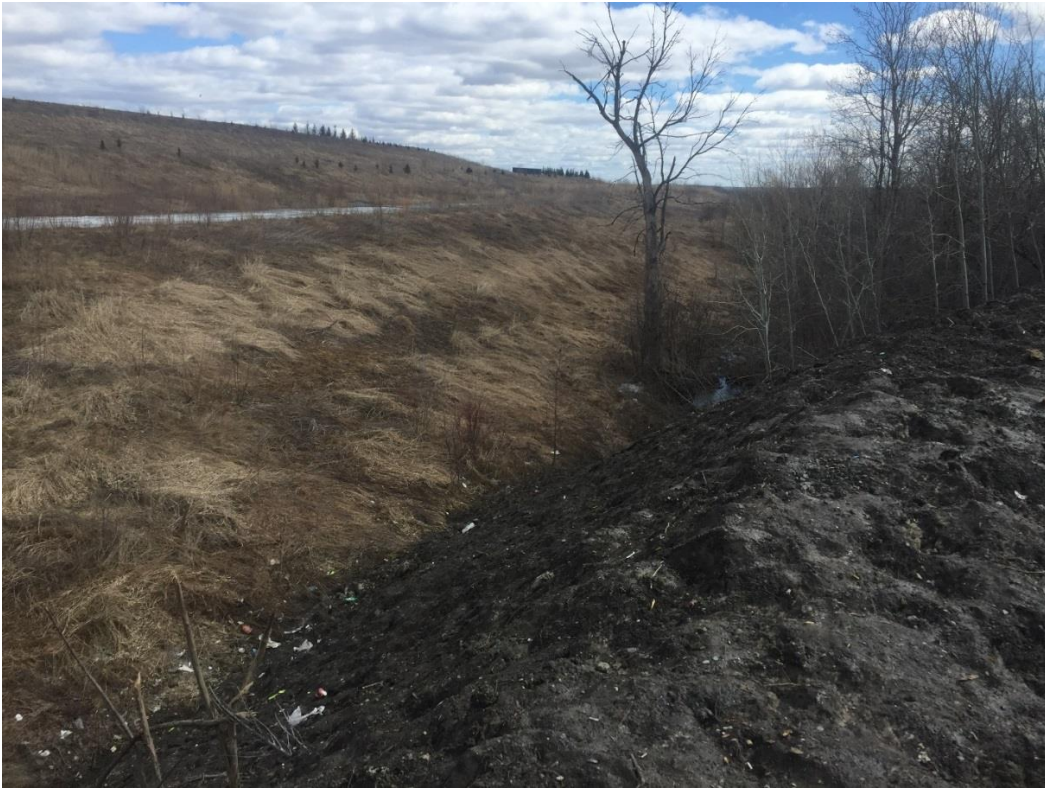
Photograph 3: Central portion of the site, facing southeast; treed land on-site and landfill off-site

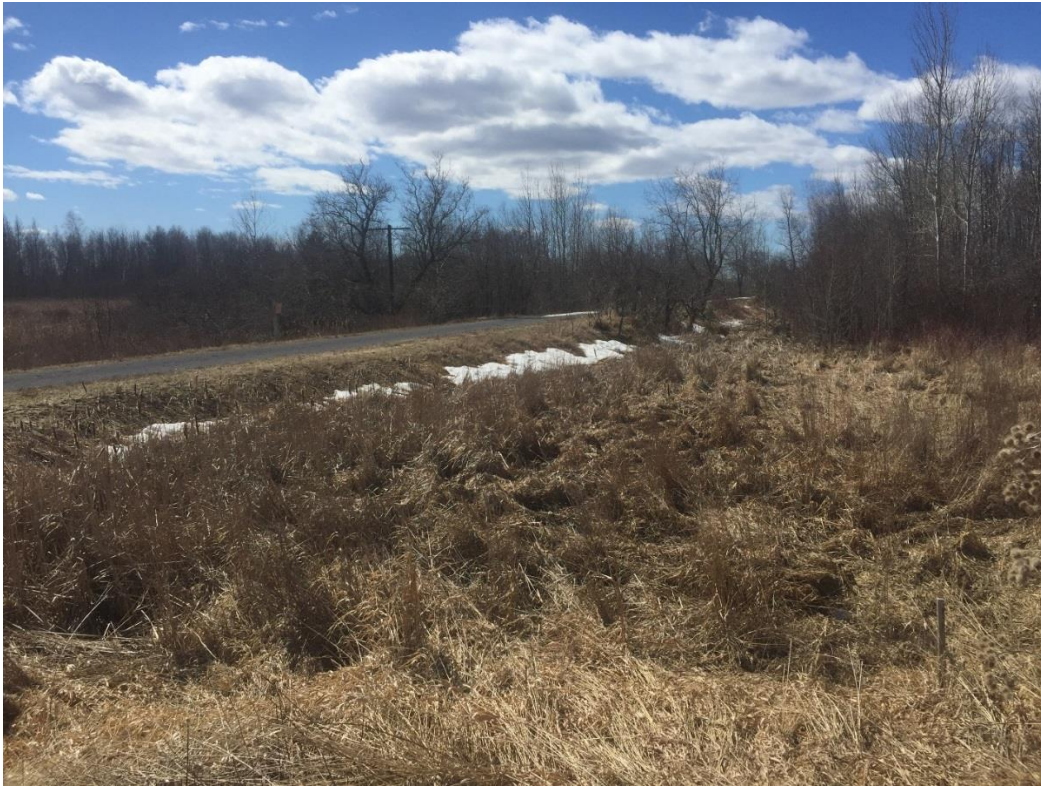
Photograph 5: A photo – Southern portion of the site, facing southwest; former railway

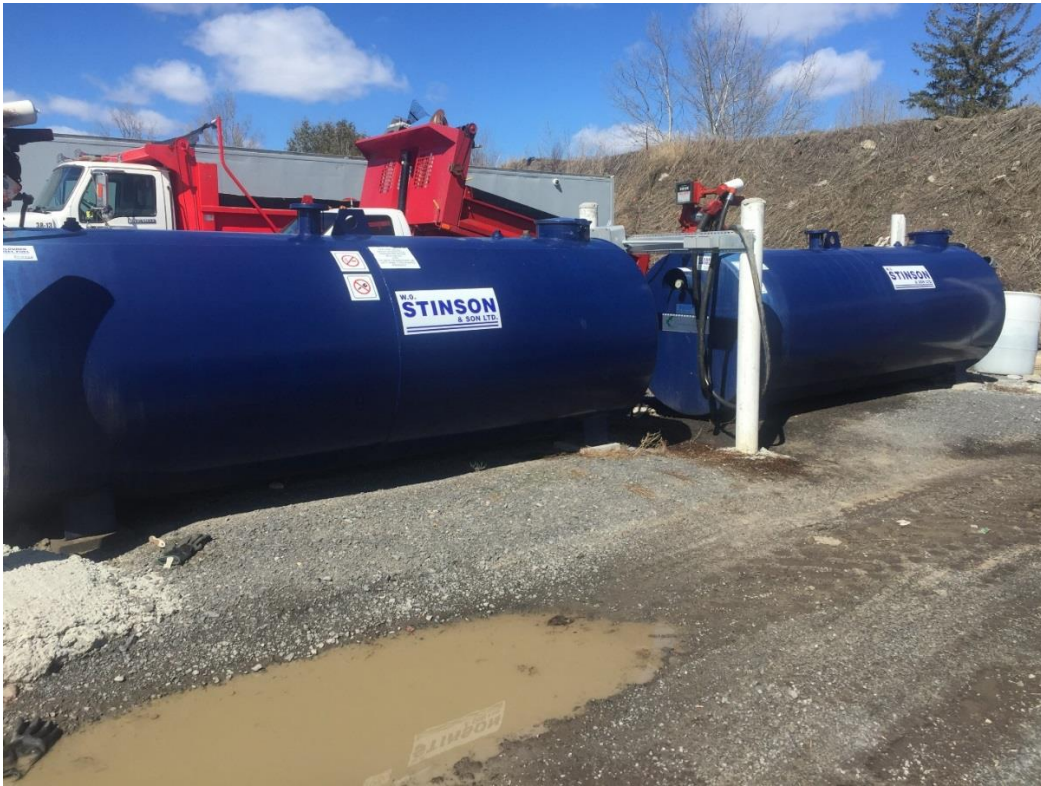
Two double-walled vacuum-monitored above ground storage tanks (AST) were noted in the northern portion of the subject site. Both are tagged as having a volume of 4540 litres and dated 2011. Online mapping, however, shows the tanks to be in place after August 2016.

Photograph 6: Two above ground diesel storage tanks

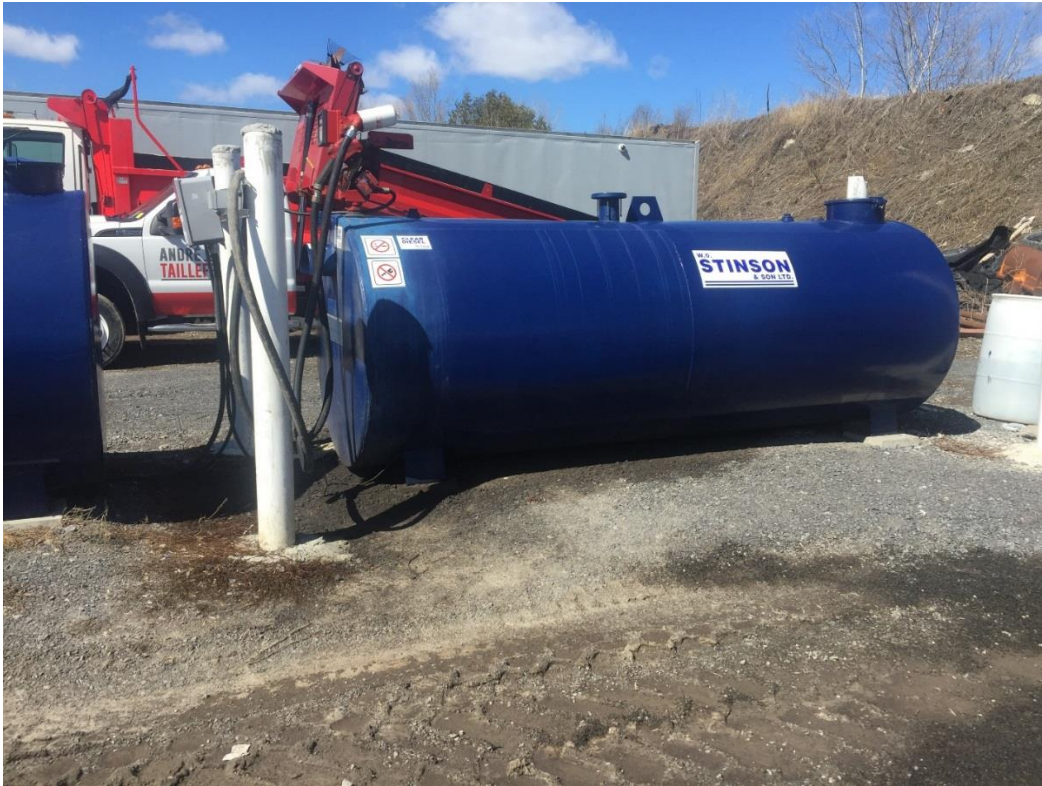
The tanks stood on concrete pads surrounded by gravel beneath and beside the structures. Some staining was noted on the gravel. Photographs of the condition of the tanks are presented in the appendix.

Photograph 7: Staining below the AST

Following the historical review, a site visit was conducted. Based on the findings of the site visit, on-site PCAs include fuel stored in 2 aboveground storage tanks. This PCA has resulted in an area of potential environmental concern (APEC) on the Phase I Property. At the time of the site visit, the current uses of the adjacent and neighbouring properties within the Phase I ESA Study Area were observed from publicly accessible areas. No additional off-site PCAs were identified within the Phase I Study Area at the time of the site visit.
