Kollaard Associates

**HYDROGEOLOGICAL INVESTIGATION
AND TERRAIN EVALUATION
PROPOSED RESIDENTIAL SUBDIVISION
3200 REIDS LANE
OSGOODE WARD, CITY OF OTTAWA
ONTARIO**

FILE # 210064

REVISION 3 March 17, 2025

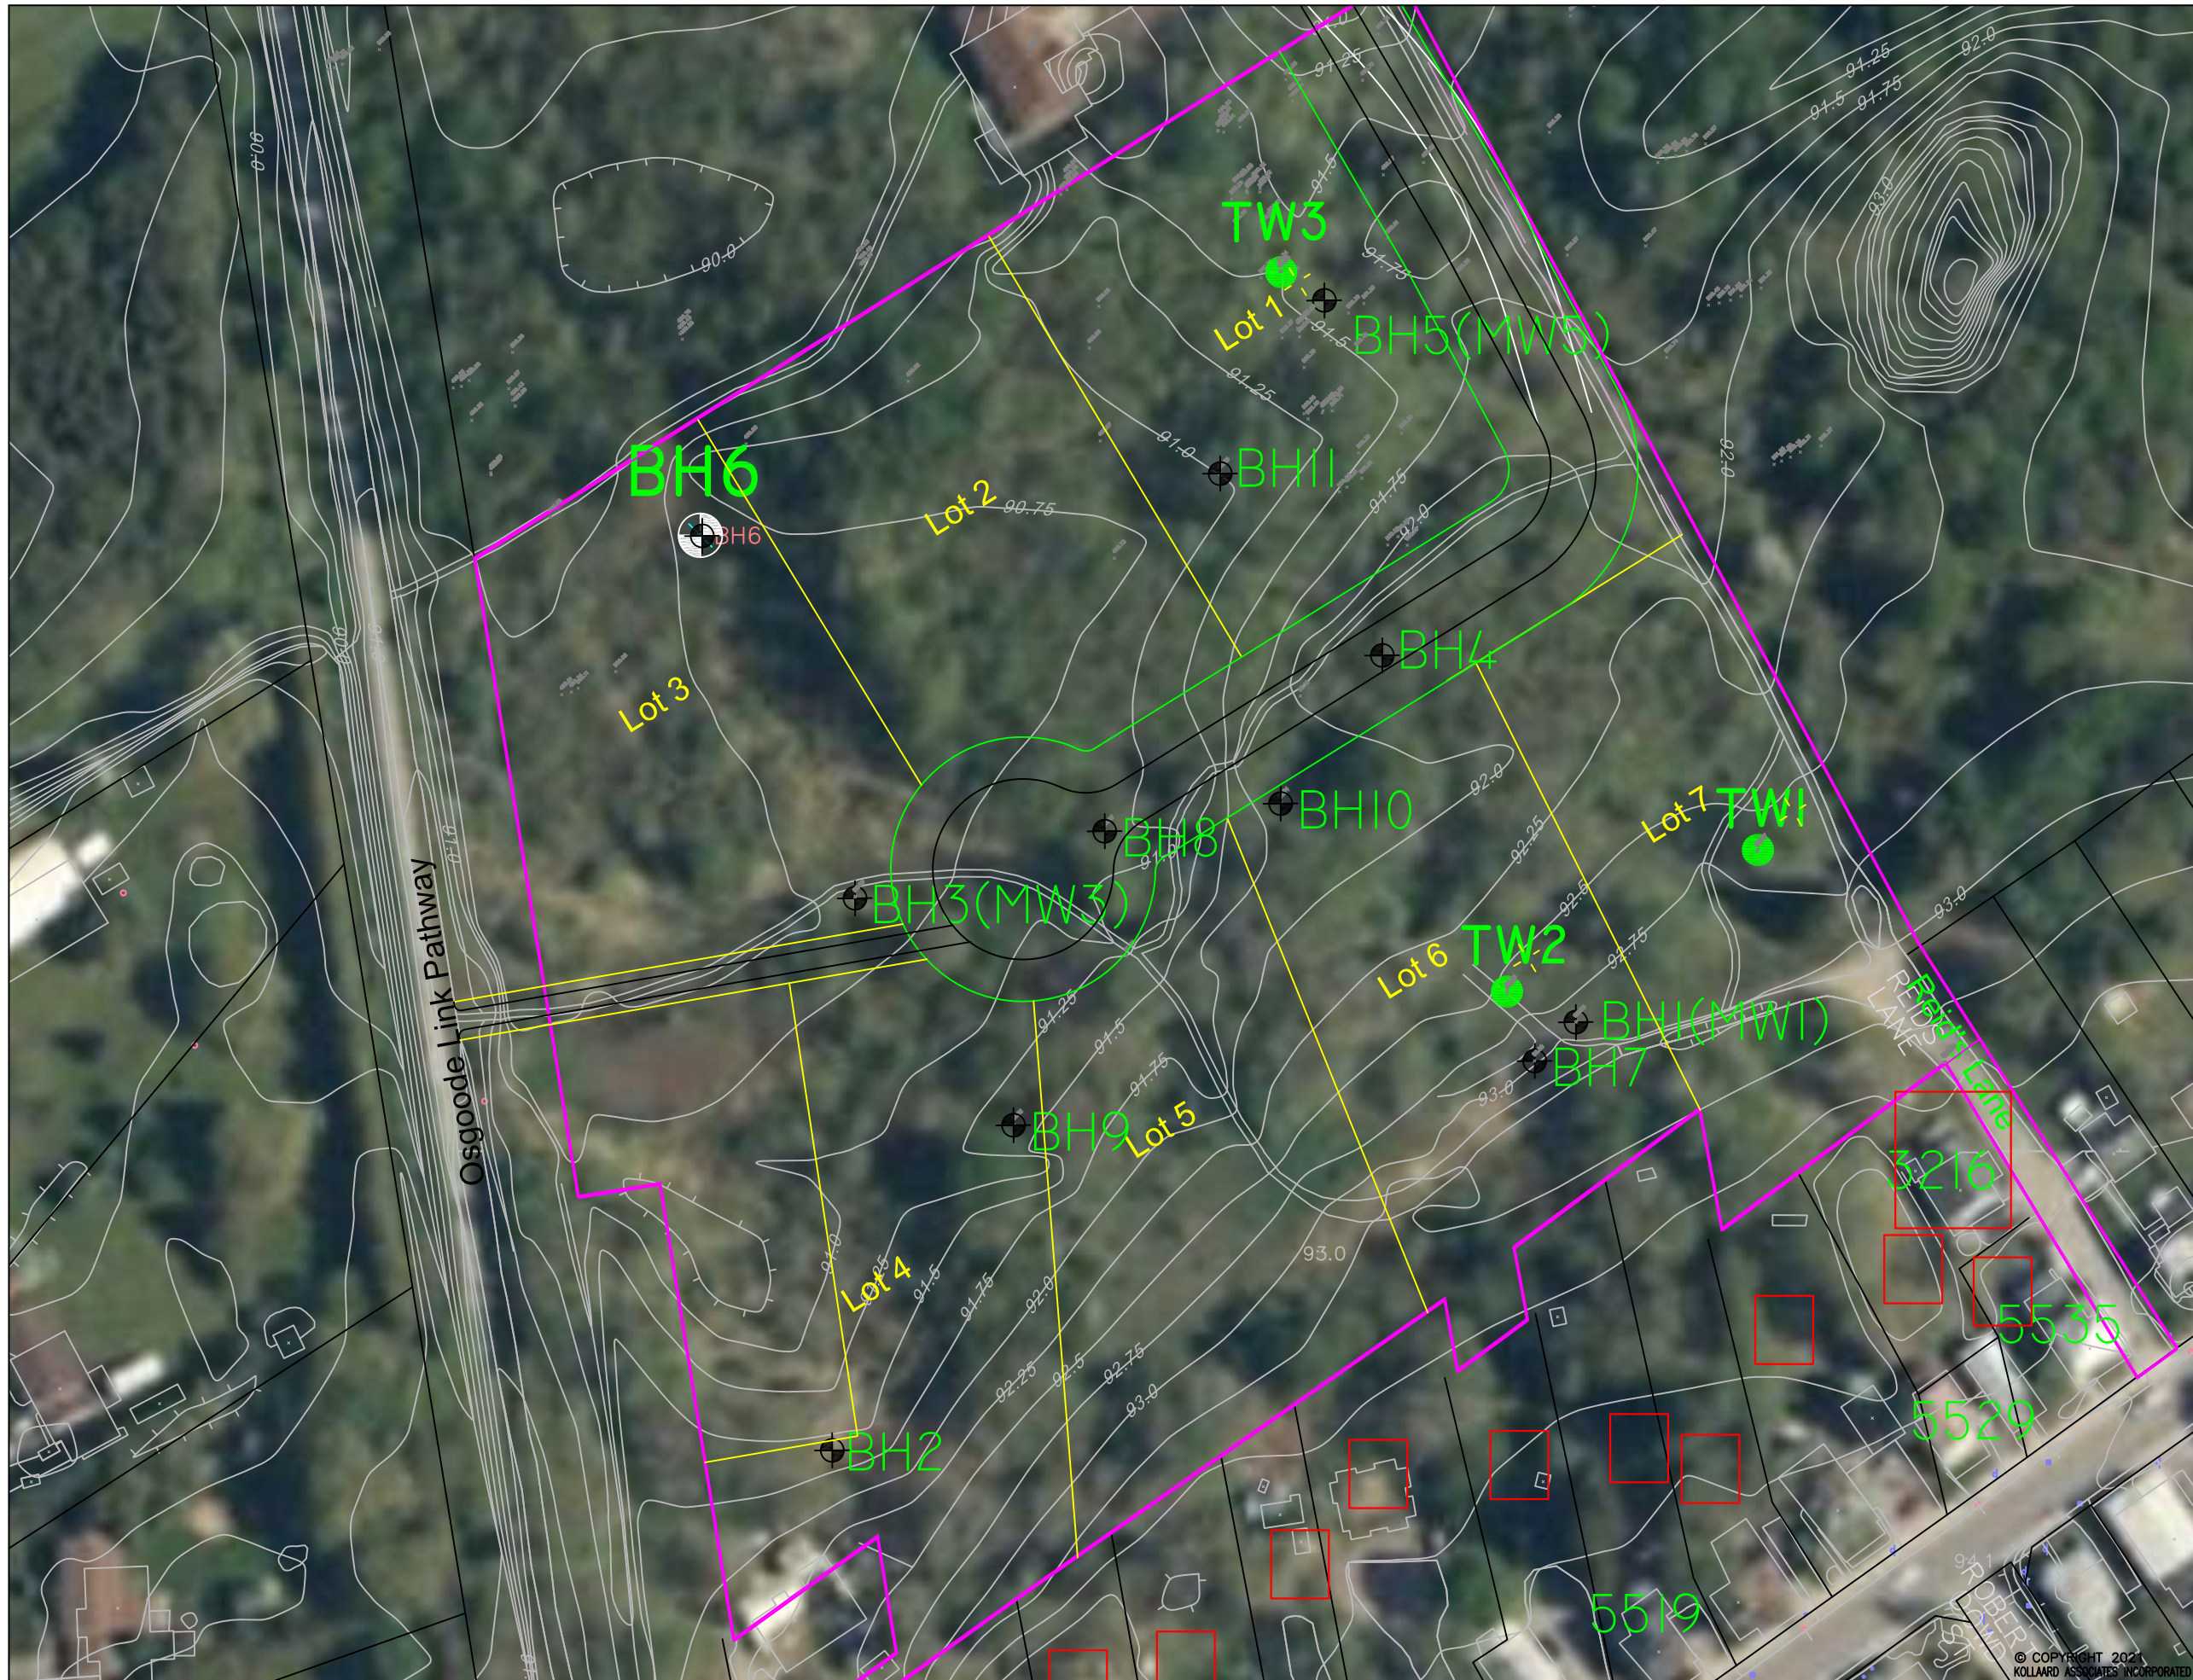
FIGURE 2

In order to evaluate the background water quality conditions in the receiving aquifer, three shallow monitoring wells were installed at the site and tested for nitrogen species. The construction details are provided in Section 2.1, the Records of Boreholes are appended to the report and groundwater levels are reported in Section 3.1. Background nitrogen concentrations from the shallow groundwater receiving effluent were reported (Section 3.1.1) and the original laboratory testing results are in Attachment D. The Site Plan, Figure 2, shows the locations of the monitoring wells.
