# **Phase I – Environmental Site Assessment**

Tunney's Pasture (Block 10)

Ottawa, Ontario

**Report: PE6040-1**

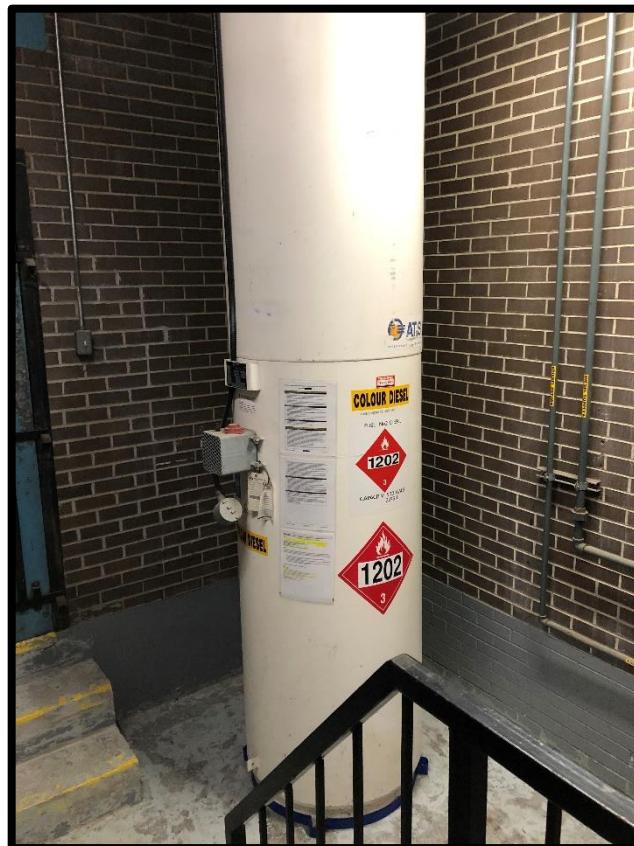
An in-use, double-walled, vacuum sealed, coloured diesel aboveground storage tank (AST) was observed within the southeast corner of the basement of the Brooke Claxton building on the Phase I Property. The tank was installed in 2008 and has a capacity of 2,275 L. The AST is situated on the concrete floor and is used to run an emergency generator. Approximately once a year the tank is refilled and approximately once a month the generator is turned on to ensure it is still in working order. The AST was noted to be in good condition at the time of the site inspection, with no signs of spills or staining observed in the vicinity of the tank. The presence of this tank is considered to represent an environmental concern to the Phase I Property (APEC 1).

**Photograph 6:** View of the 2,275 L AST in the basement of the Brooke Claxton building.
