# **Phase I – Environmental Site Assessment**

Tunney's Pasture (Block 8)

Prepared for IBI Group

**Report: PE6038-1**

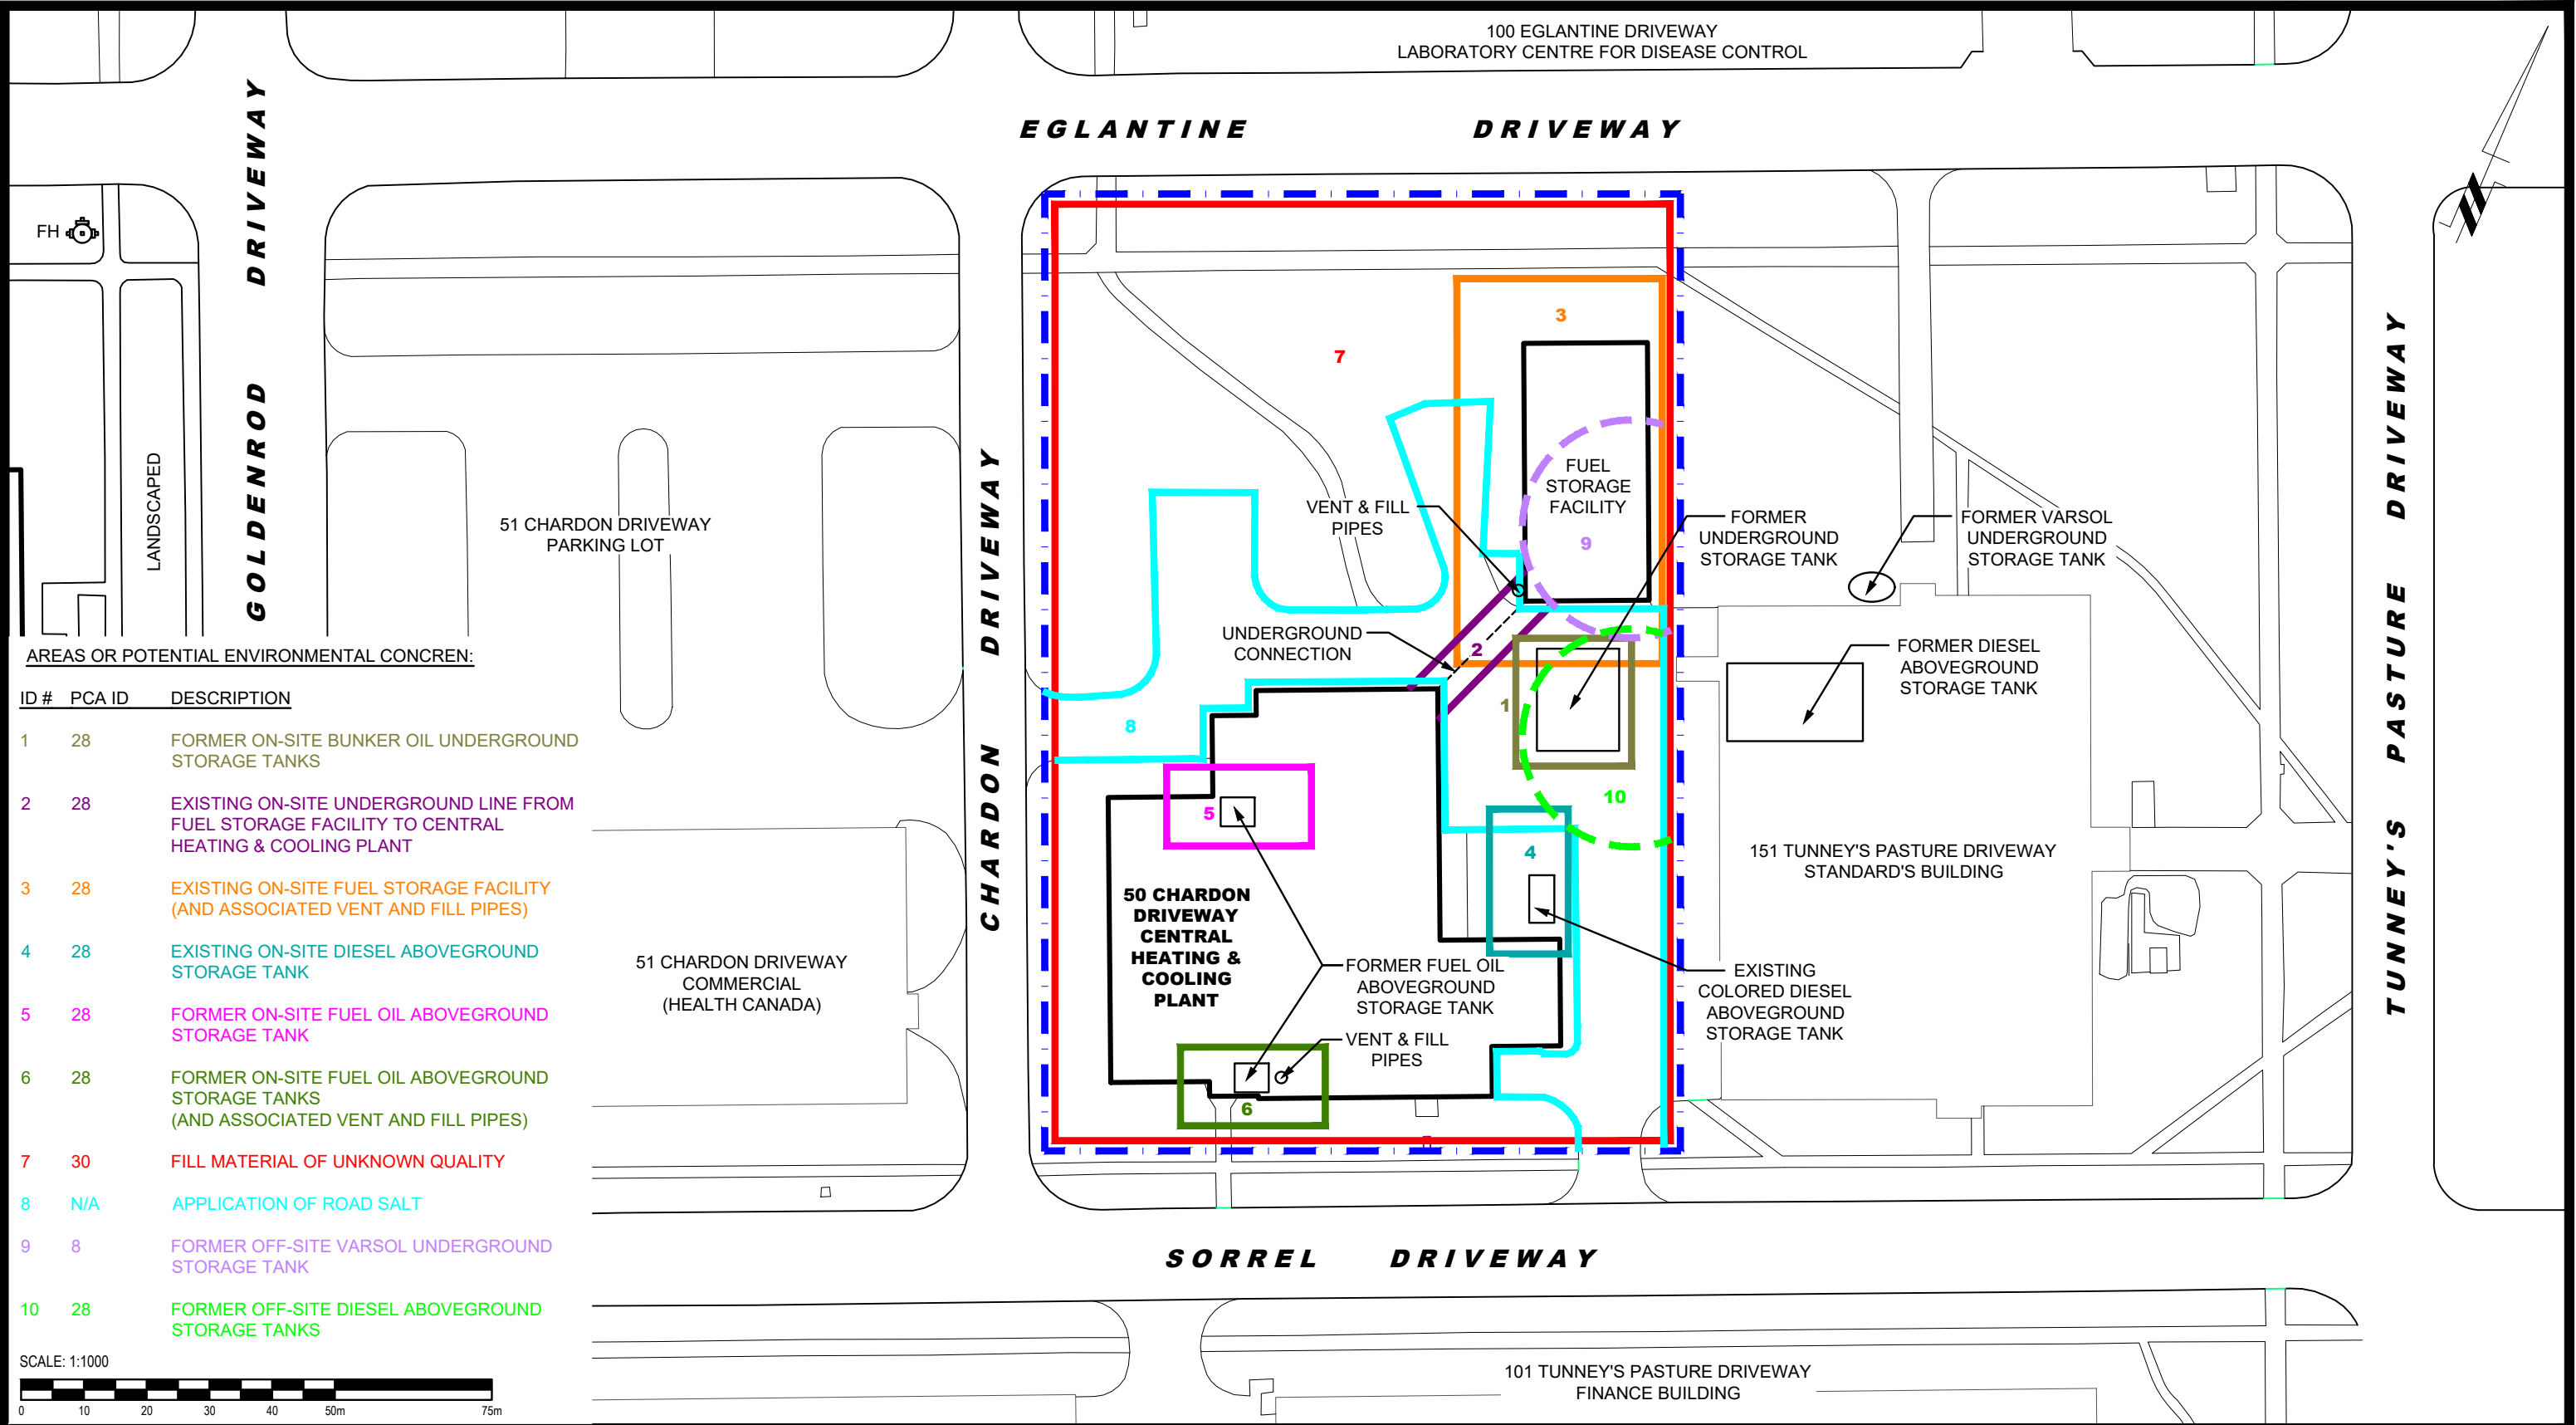
Dwg. No.: PE6038-1

AREAS OR POTENTIAL ENVIRONMENTAL CONCERN:

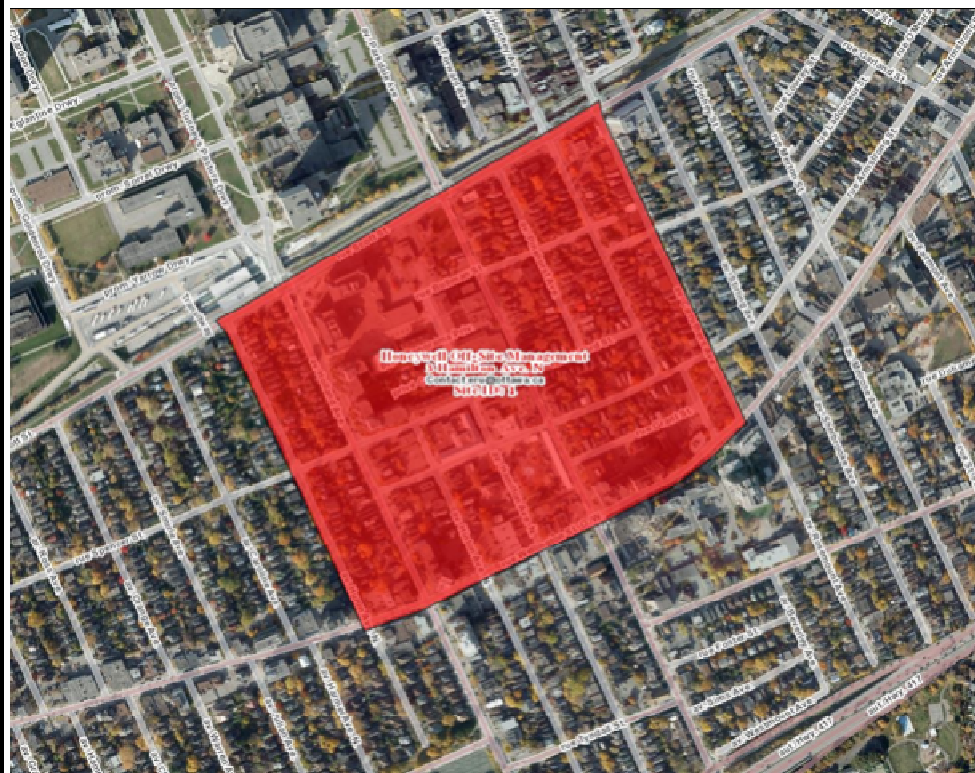
### 3 HAMILTON AVENUE N – HONEYWELL SITE

Outlined in bright purple on HLUI Map

There is known groundwater contamination in this area associated with a former Honeywell manufacturing facility located at 3 Hamilton Avenue N. Concentrations of volatile organic compounds (VOCs) have been found in groundwater at various on- and off-Site locations which exceed the provincial standards. Special consideration should be given for projects involving management of groundwater (i.e. contact w/ groundwater, pumping and/or dewatering).
