# **Phase I – Environmental Site Assessment**

Tunney's Pasture (Block 10)

Prepared for IBI Group

**Report: PE6040-1**

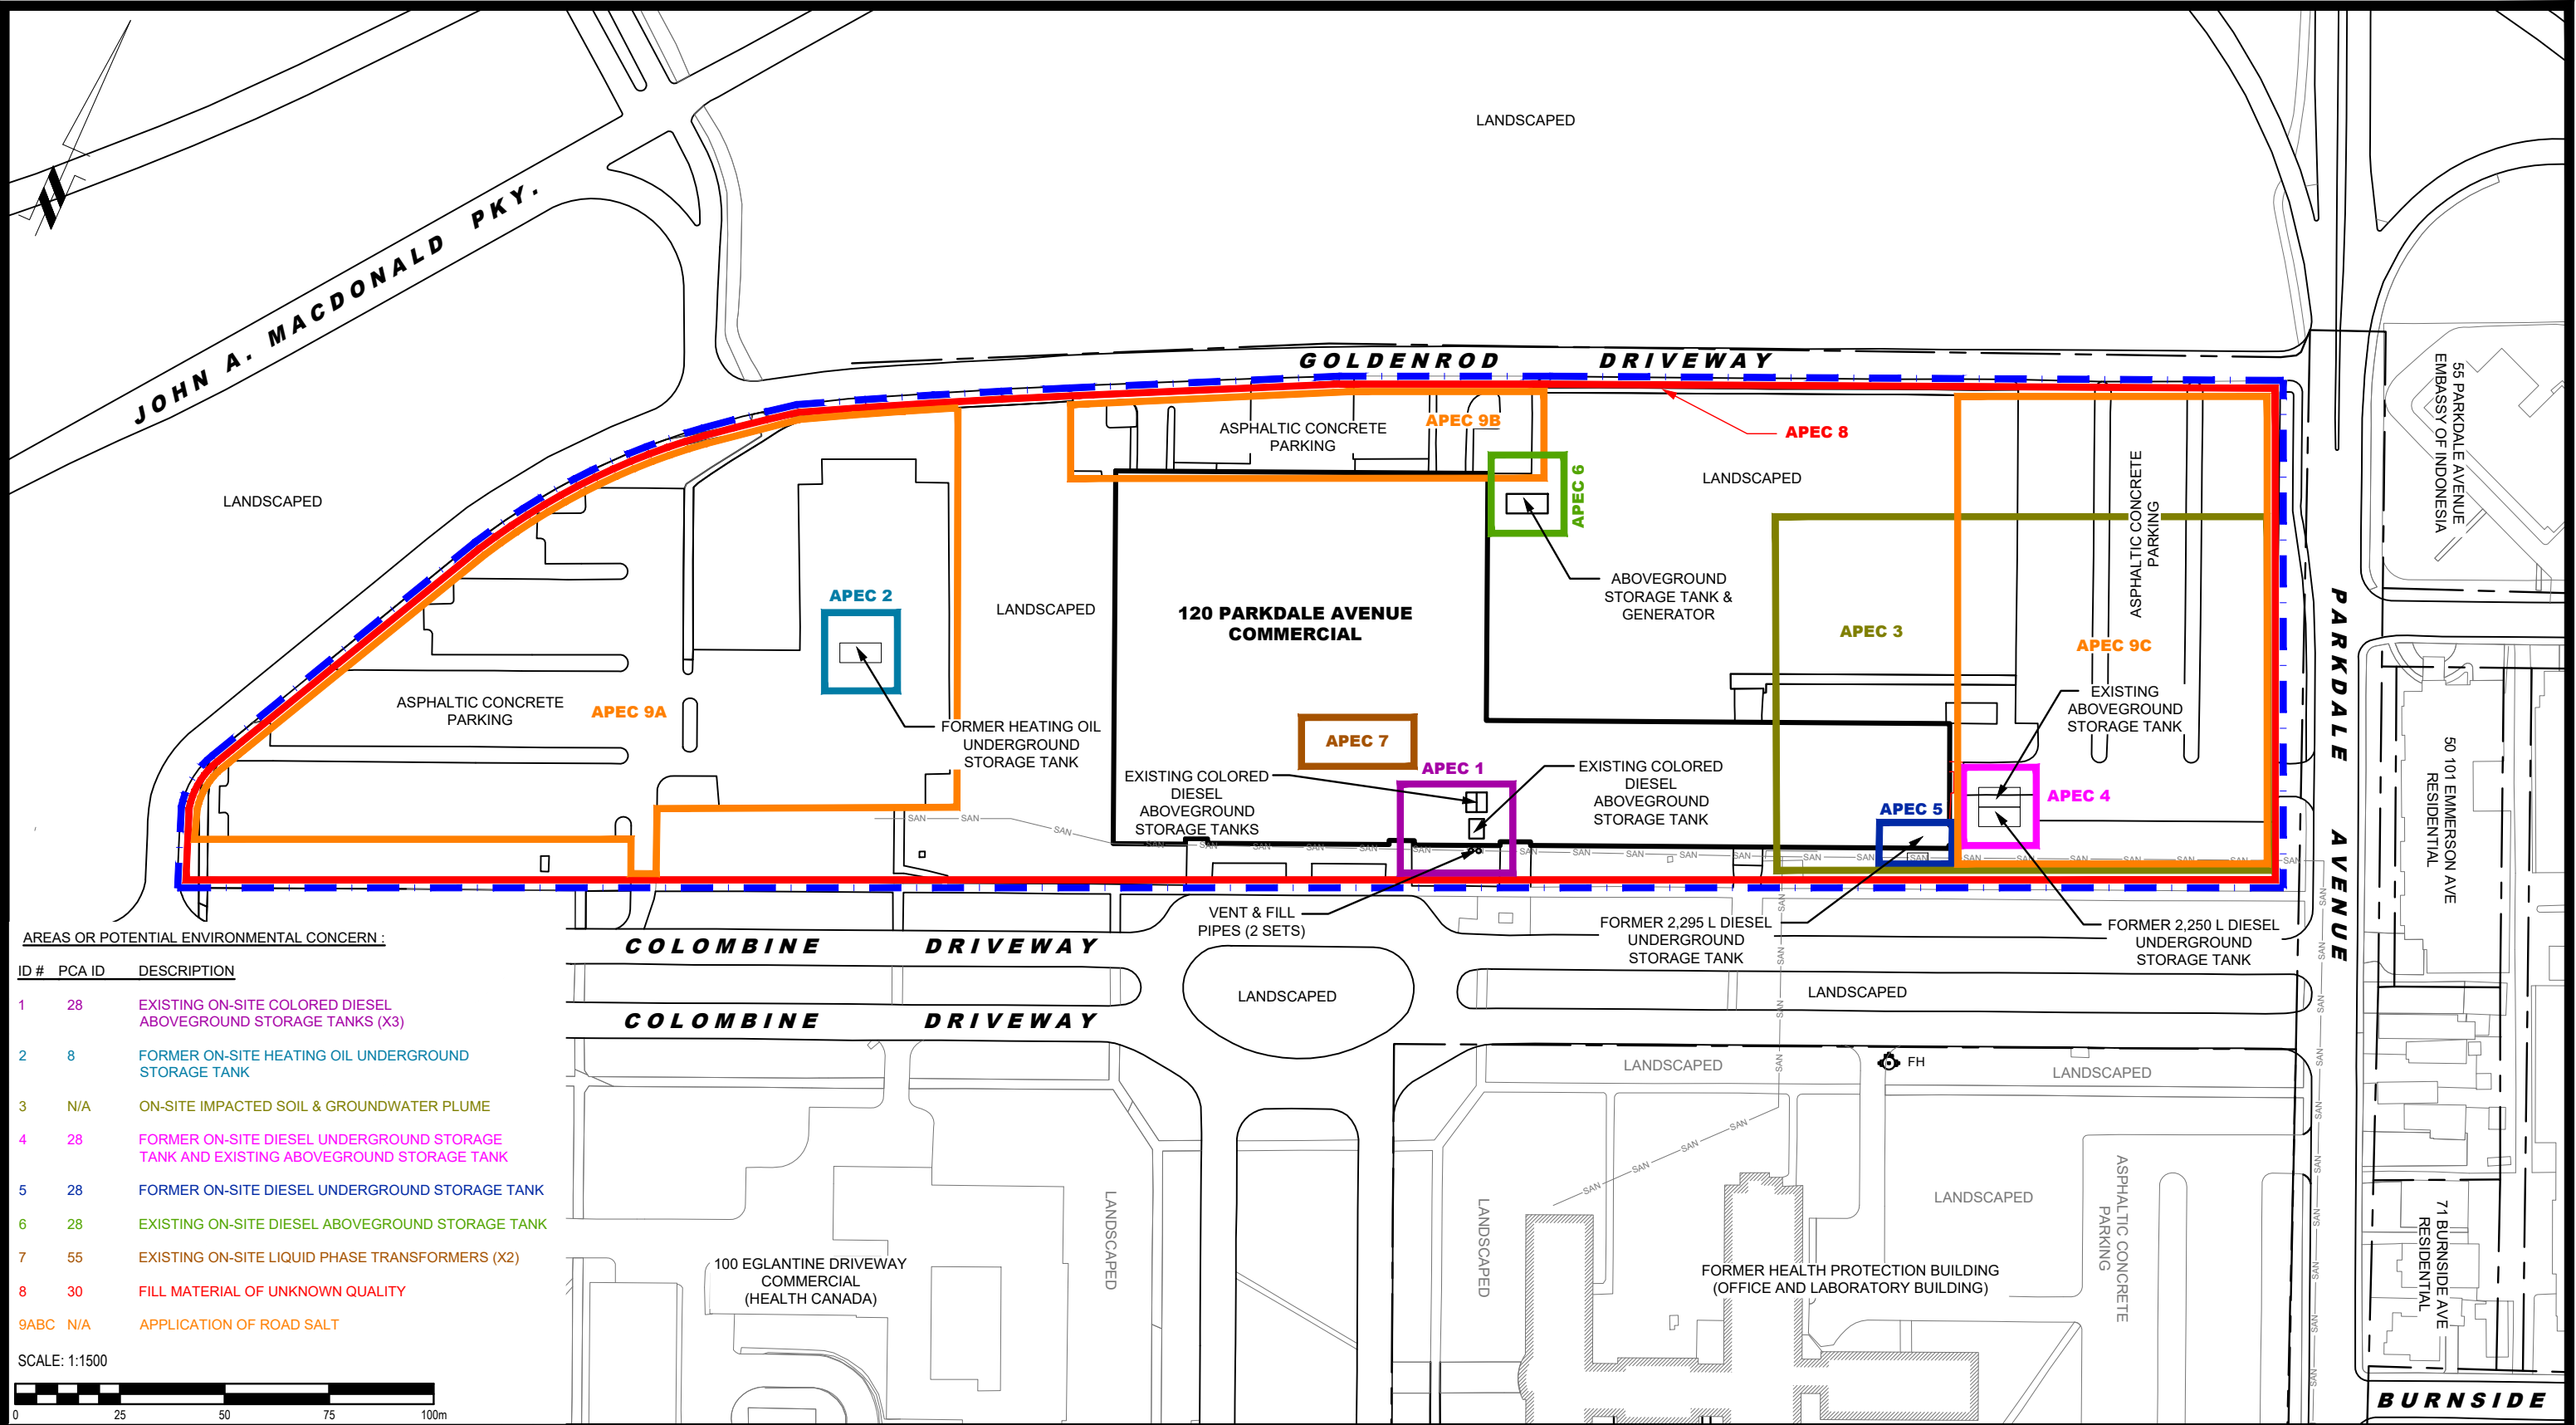
PHASE I - ENVIRONMENTAL SITE ASSESSMENT STUDY AREA

AREAS OR POTENTIAL ENVIRONMENTAL CONCERN :

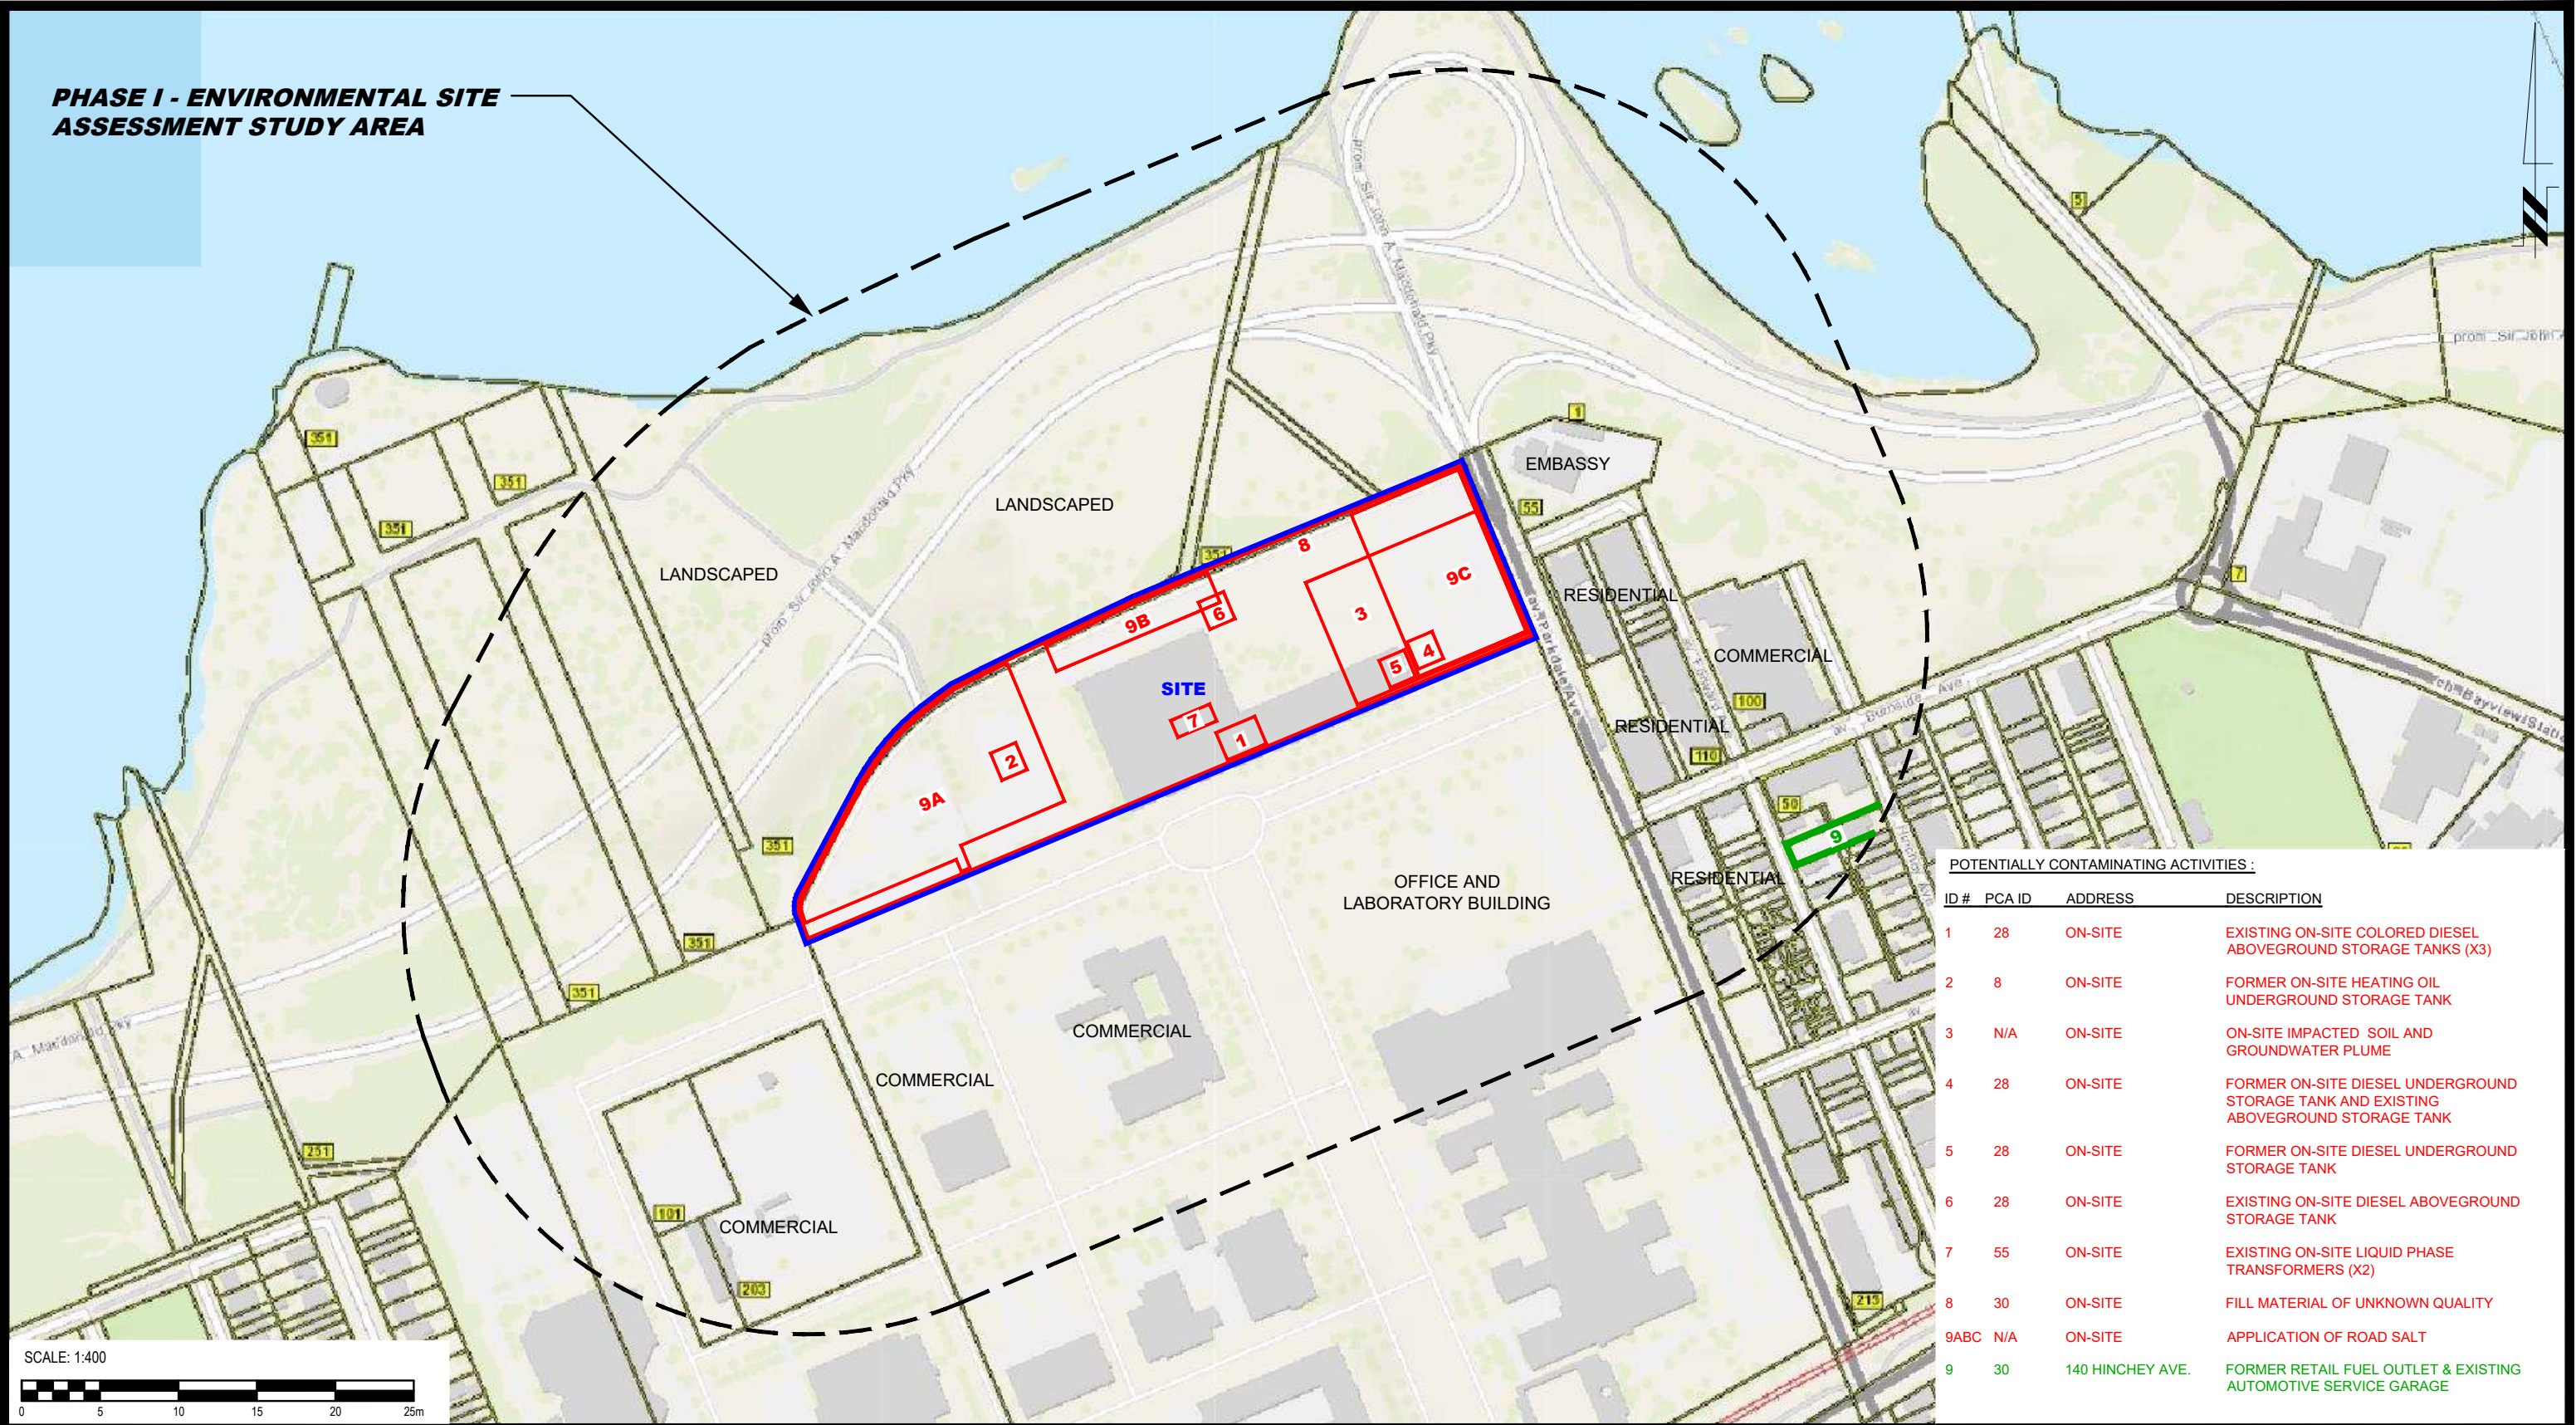
POTENTIALLY CONTAMINATING ACTIVITIES :
