# **Stittsville South W4 Future Neighbourhood Area – Eder Block: Environmental Impact Study for the Draft Plan of Subdivision**

**2025-05-30**

## **Final Report**

Project Number: CAIV 1300.4

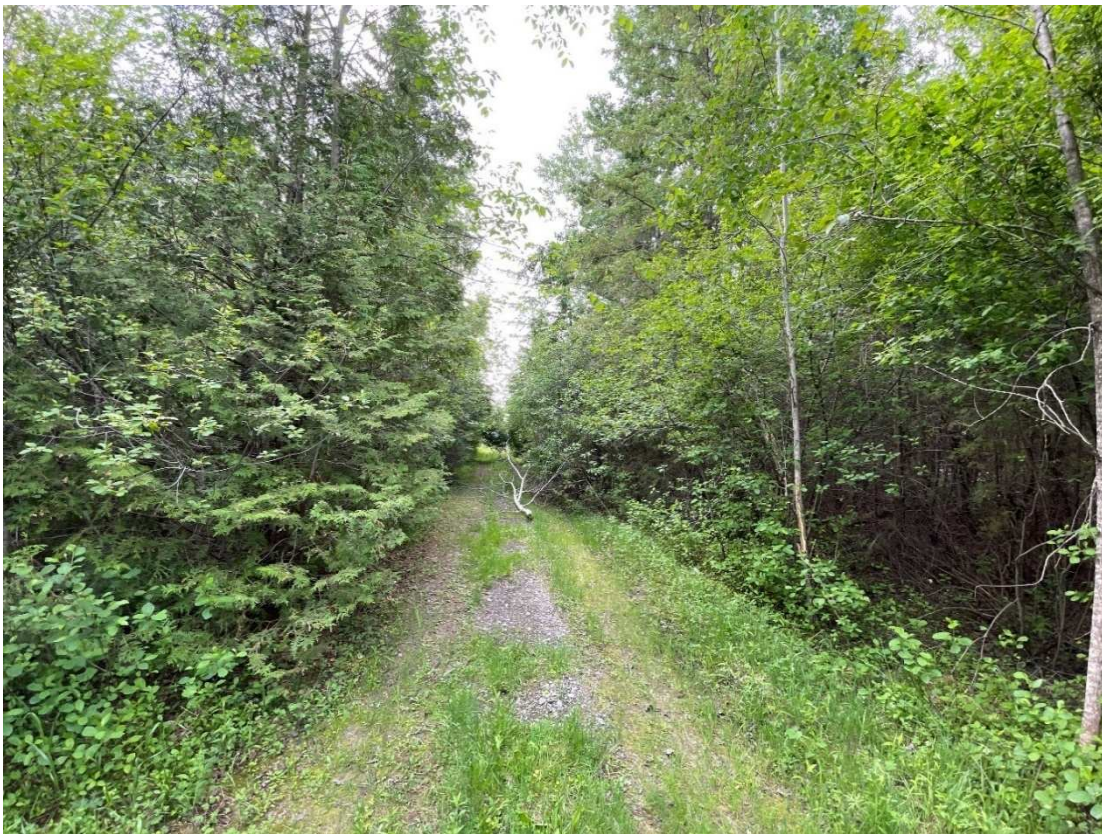
**Figure 4. Dry - Fresh White Cedar – Hardwood Mixed Forest Type (FOMM4-3)**

A broad swath of the western portion of the Site is characterized as a Dry - Fresh White Cedar – Hardwood Mixed Forest Type (FOMM4-3) community (Figure 4). It is dominated by Eastern White Cedar (*Thuja occidentalis*; 10-20 cm DBH), Trembling Aspen (*Populus tremuloides*; 10-20 cm DBH), Green Ash (*Fraxinus pennsylvanica*; 10-15 cm DBH), Large tooth Aspen (*Populus grandidentata*; ~15 cm DBH), White Spruce (*Picea glauca*; 30 cm DBH), White Pine (*Pinus strobus*; 25 cm DBH), Larch/Tamarack (*Larix laricina*; 15-20 cm DBH), American Beech (*Fagus grandifolia*; 10-15 cm DBH), and American Elm (*Ulmus americana*). Butternut\* (*Juglans cinerea*; 20-50 cm DBH) were observed scattered throughout this community.

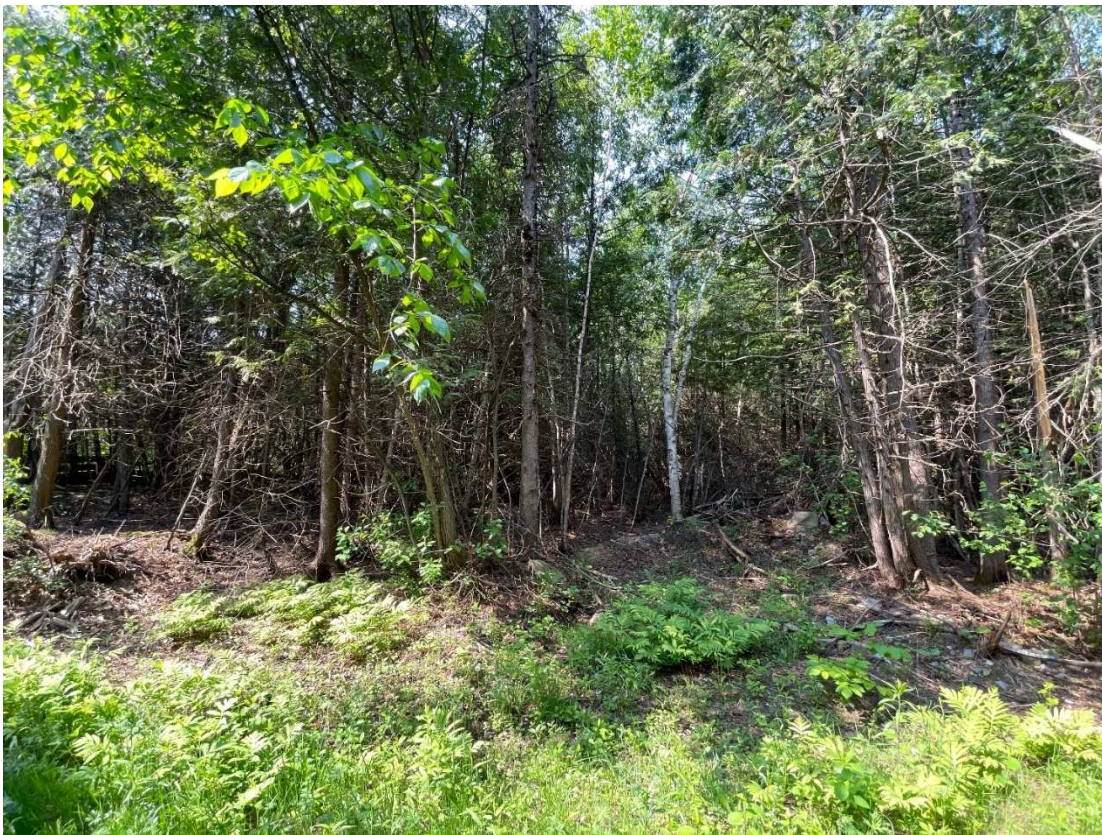
**Figure 5. Fresh - Moist White Cedar - Hardwood Mixed Forest Type (FOMM7-2)**

The western-most extent of the Site is characterized as a Fresh - Moist White Cedar - Hardwood Mixed Forest Type (FOMM7-2) community (Figure 5). It is dominated by Eastern White Cedar (*Thuja occidentalis*; 5-15 cm DBH), White Birch (*Betula papyrifera*; 10-20 cm DBH), Trembling Aspen (*Populus tremuloides*; 10-35 cm DBH), White Ash (*Fraxinus americana*; 5-8 cm DBH), White Spruce (*Picea glauca*; ~10 cm DBH), and Balsam Fir (*Abies Balsamea*) tree species.

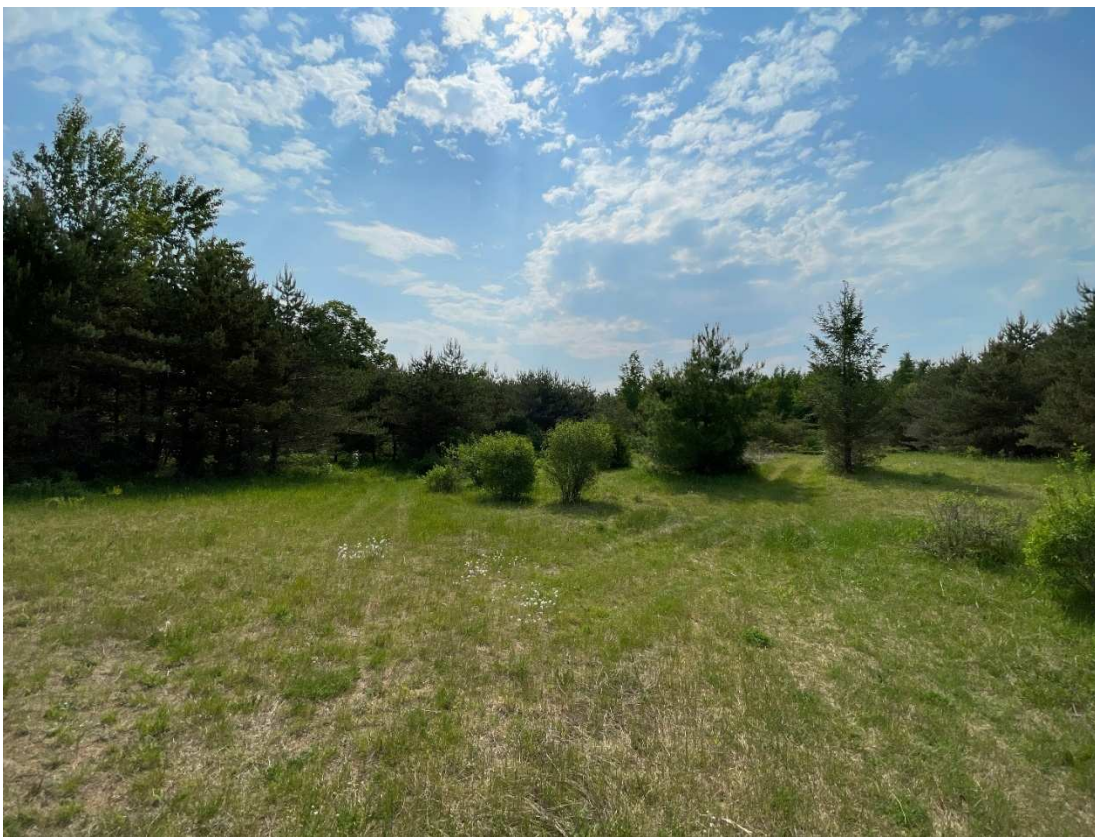
**Figure 6. Dry – Moist Old Field Meadow Type (CUM1-1)**

A Dry – Moist Old Field Meadow Type (CUM1-1; Figure 6) is located centrally on the Site. This area is characteristic of previous disturbance with scattered tree species including Large tooth Aspen (*Populus grandidentata*; ~5 cm DBH), Trembling Aspen (*Populus tremuloides*; 10-25 cm DBH), Eastern White Cedar (*Thuja occidentalis*; ~10 cm DBH), Scots Pine (*Pinus sylvestris*; 5-10 cm DBH), American Beech (*Fagus grandifolia*; ~10 cm DBH), Apple Spp. (*Malus*; 8-10 cm DBH), White Spruce (*Picea glauca*; 20-25 cm DBH), Larch/Tamarack (*Larix laricina*; ~5-10 cm DBH), Green Ash (*Fraxinus pennsylvanica*; <5 cm DBH). Dominant shrub and groundcover species included Common Juniper (*Juniperus communis*), Trembling Aspen (*Populus tremuloides*) saplings, Orchard Grass (*Dactylis glomerata*), Wild Strawberry (*Fragaria vesca*), Canada Goldenrod (*Solidago canadensis*), Poison Ivy (*Toxicodendron radicans*), Red Raspberry (*Rubus idaeus*), Alder Buckthorn (*Rhamnus frangula*), and Common Blackberry (*Rubus allegheniensis*).

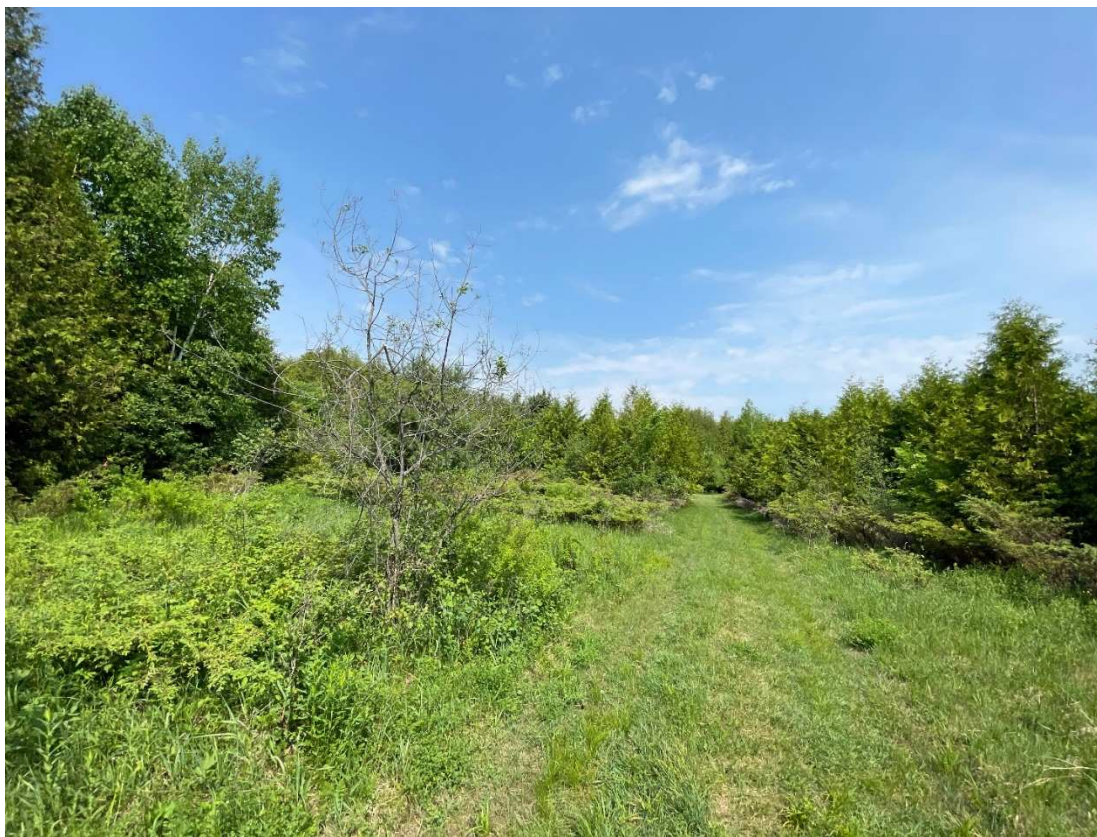
**Figure 7. Dry – Fresh Mixed Meadow Ecosite (MEMM3)**

A Dry – Fresh Mixed Meadow Ecosite (MEMM3) is located in the northwest corner of the Site (Figure 7). This area is mainly characterized by Eastern White Cedar (*Thuja occidentalis*), Scots Pine (*Pinus sylvestris*; ~10-20 DBH), Larch/Tamarack (*Larix laricina*; ~10 DBH), and scattered Butternut\* (*Juglans cinerea*; ~10-20 DBH) trees. Dominant shrub and groundcover species included Common Juniper (*Juniperus communis*), Orchard grass (*Dactylis glomerata*), Wild strawberry (*Fragaria vesca*), Canada Goldenrod (*Solidago canadensis*), Alder Buckthorn (*Rhamnus frangula*), and Common Blackberry (*Rubus allegheniensis*).

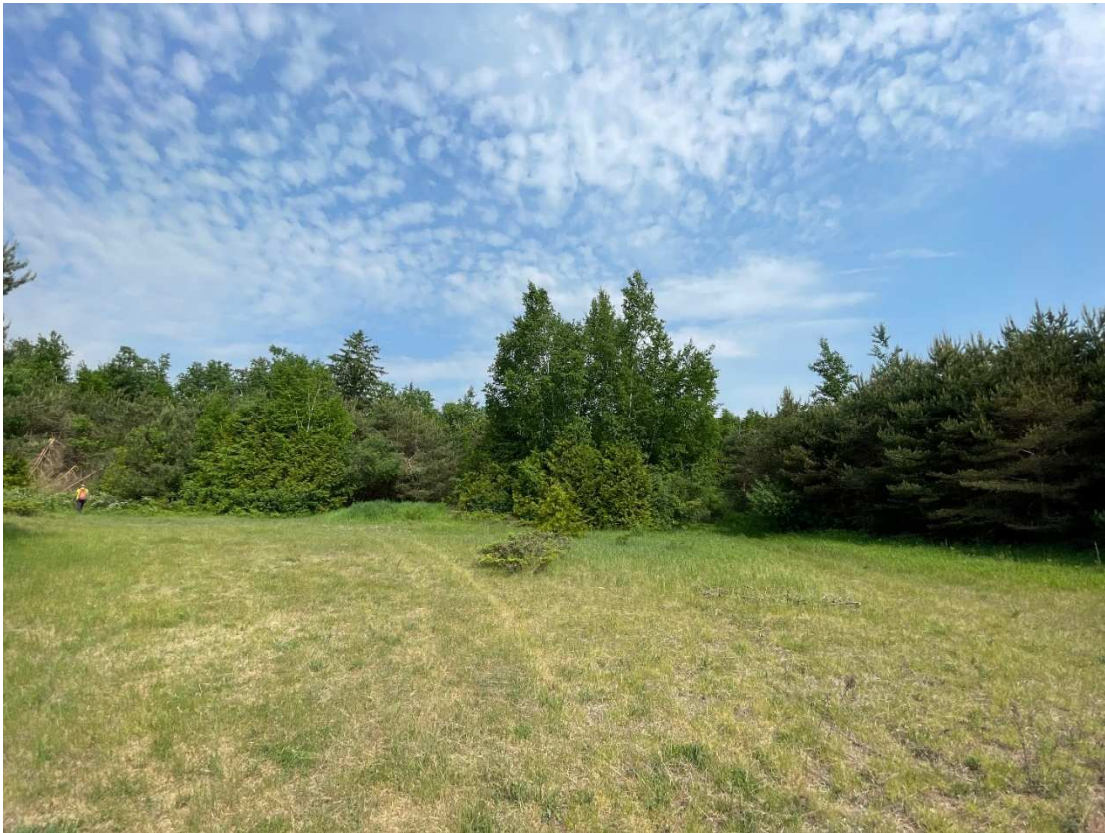
**Figure 8. Dry – Fresh Scots Pine Naturalized Coniferous Plantation Type (FOCM6-3)**

A Fresh Scots Pine Naturalized Coniferous Plantation Type (FOCM6-3) is located in the northwest corner of the Site (Figure 8). It is mainly dominated by Scots Pine (*Pinus sylvestris*; ~10-20 cm DBH), Jack Pine (*Pinus banksiana*; ~15 cm DBH), Eastern White Cedar (*Thuja occidentalis*), White Pine (*Pinus strobus*; ~20 cm DBH), White Birch (*Betula papyrifera*; 10-20 cm DBH), Butternut\* (*Juglans cinerea*), American Beech (*Fagus grandifolia*), and Green Ash (*Fraxinus pennsylvanica*; 10-15 cm DBH).

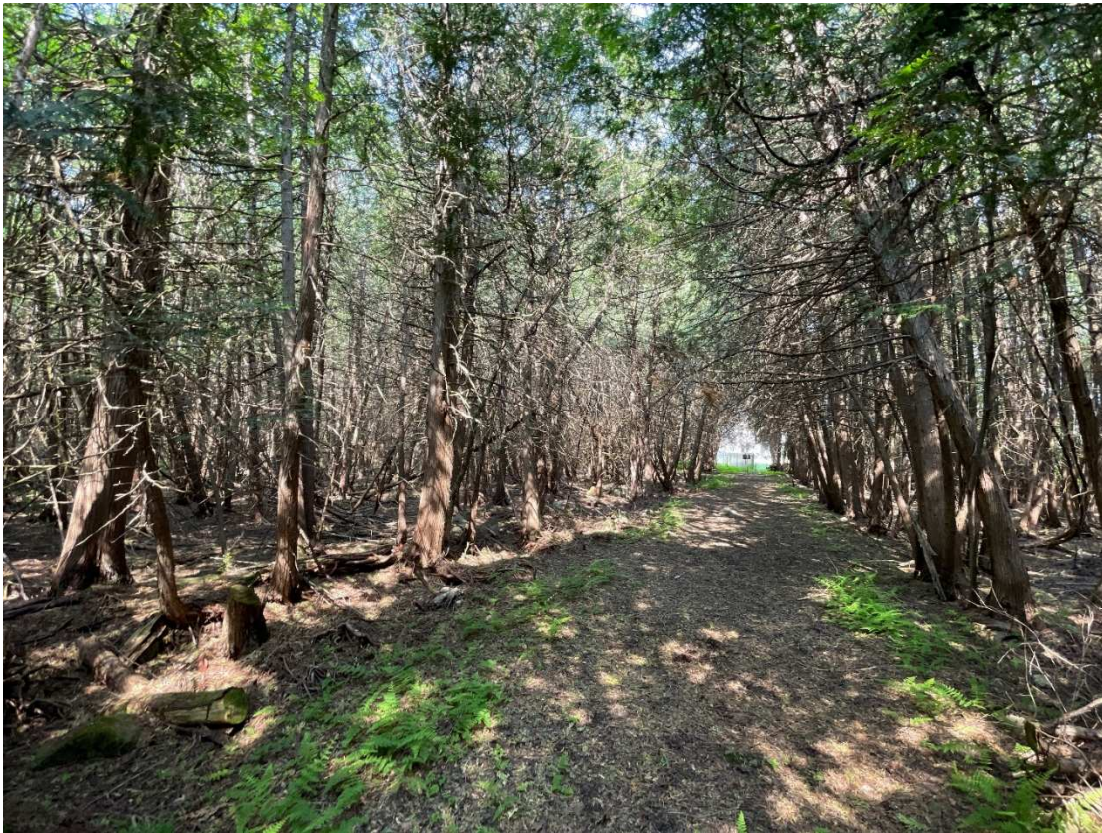
**Figure 9. White Cedar Mineral Coniferous Swamp (SWCM1-1)**

A White Cedar Mineral Coniferous Swamp (SWCM1-1) is located on Site (Figure 9). It is dominated by Eastern White Cedar (*Thuja occidentalis*) and has ground cover consisting of Bulblet Bladder Fern (*Cystopteris bulbifera*), Alder Buckthorn (*Rhamnus frangula*), Interrupted Fern (*Osmunda claytoniana*), Sensitive Fern (*Onoclea sensibilis*), and Poison Ivy (*Toxicodendron radicans*).

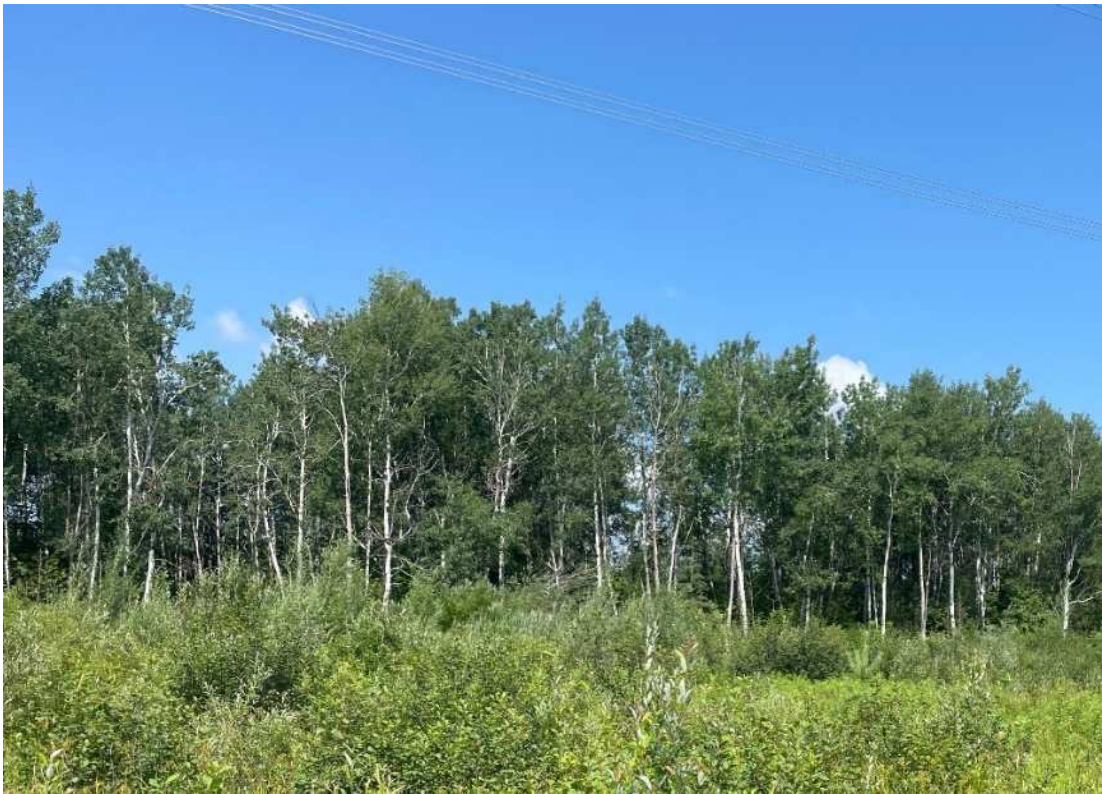
**Figure 10. Fresh – Moist Lowland Deciduous Forest Ecosite (FODM7)**

A Fresh-Moist Lowland Deciduous Forest Ecosite (FODM7) is located in the center of the Site (Figure 10). It is dominated by Trembling Aspen (*Populus tremuloides*) Eastern White Cedar (*Thuja occidentalis*), Butternut\* (*Juglans cinerea*), Black Ash\* (*Fraxinus nigra*), and Balsam Poplar (*Populus balsamifera*). Its ground cover consists of Common Buckthorn (*Rhamnus cathartica*), Poison Ivy (*Toxicodendron radicans*), White Panicle Aster (*Symphotrichum lanceolatum*), Riverbank Grape (*Vitis riparia*), Common Ragweed (*Ambrosia artemisiifolia*), and Yellow Sweet Clover (*Melilotus officinalis*).

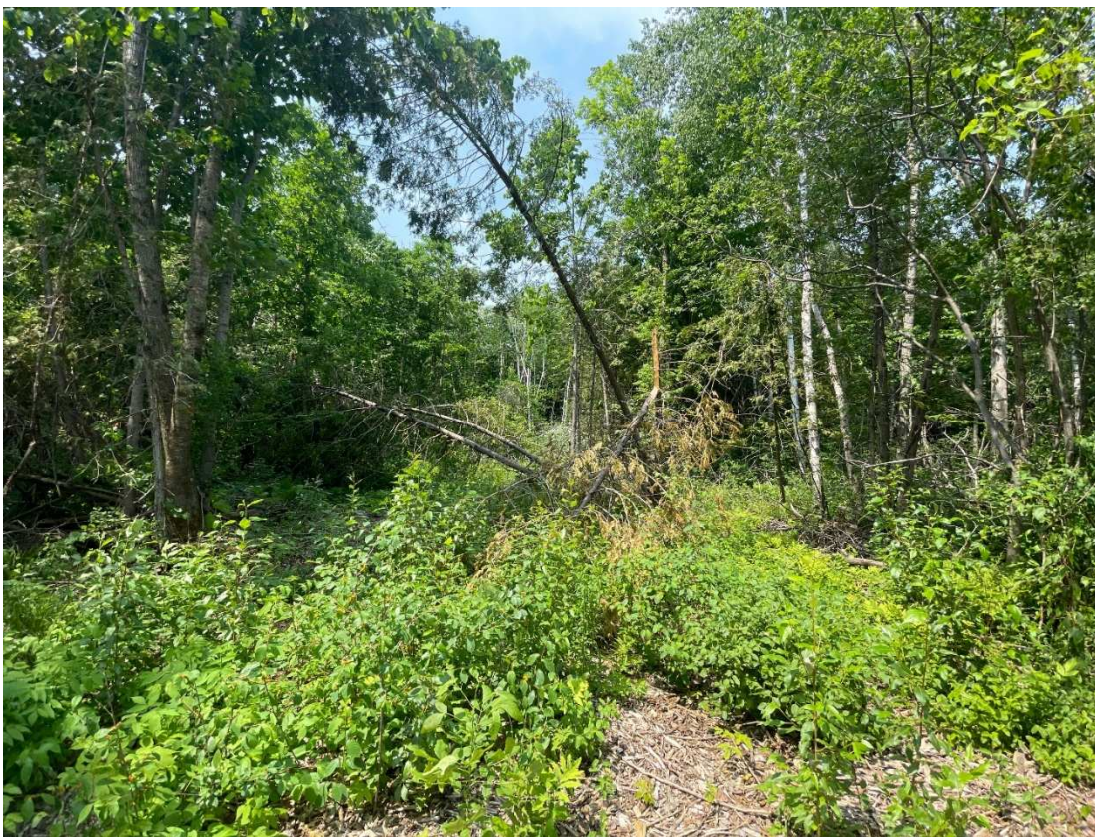
**Figure 11. Fresh – Moist Poplar Deciduous Forest Type (FODM8-1)**

A Fresh – Moist Poplar Deciduous Forest Type (FODM8-1; Figure 11) is located on Site and is dominated by Trembling Aspen (*Populus tremuloides*; 10-20 cm DBH), White Birch (*Betula papyrifera*; 10-20 cm DBH), Balsam Poplar (*Populus balsamifera*; 10-25 cm DBH), Butternut\* (*Juglans cinerea*; 10-20 cm DBH), Eastern White Cedar (*Thuja occidentalis*; 10-20 cm DBH), Basswood (*Tilia americana*; ~30 cm DBH), Red Maple (*Acer rubrum*; ~27 cm DBH), American Elm (*Ulmus americana*; 10-20 cm DBH), and Black Ash\* (*Fraxinus nigra*). Its dominant ground cover consists of Common Juniper (*Juniperus communis*), Trembling Aspen saplings (*Populus tremuloides*), Sensitive Fern (*Onoclea sensibilis*), Ostrich Fern (*Matteuccia struthiopteris*), Interrupted Fern (*Osmunda claytoniana*), Canada Goldenrod (*Solidago canadensis*), Poison Ivy (*Toxicodendron radicans*), Alder Buckthorn (*Rhamnus frangula*), Bloodroot (*Sanguinaria*), and Meadow Horsetail (*Equisetum pratense*).

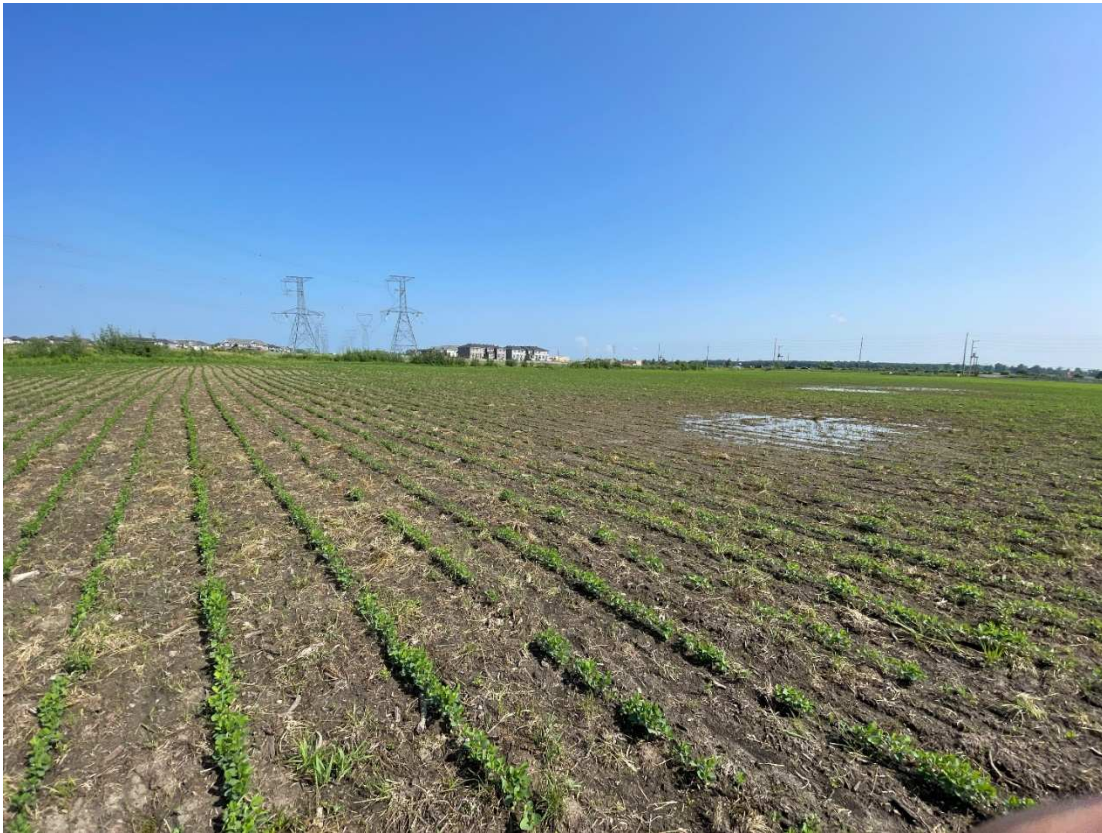
**Figure 12. Medium Mineral Open Pasture Type (OAGM4)**

A Medium Mineral Open Pasture Type (OAGM4) on Site (Figure 12) is dominated by planted crop cultivar and scattered shrub community species such as Canada Goldenrod (*Solidago canadensis*), Meadow Horsetail (*Equisetum pratense*), Purple Aster (*Symphyotrichum patens*), Common Mullein (*Verbascum thapsus*), Meadow Buttercup (*Ranunculus acris*), Wild Strawberry (*Fragaria vesca*), and Common Dandelion (*Taraxacum officinale*).

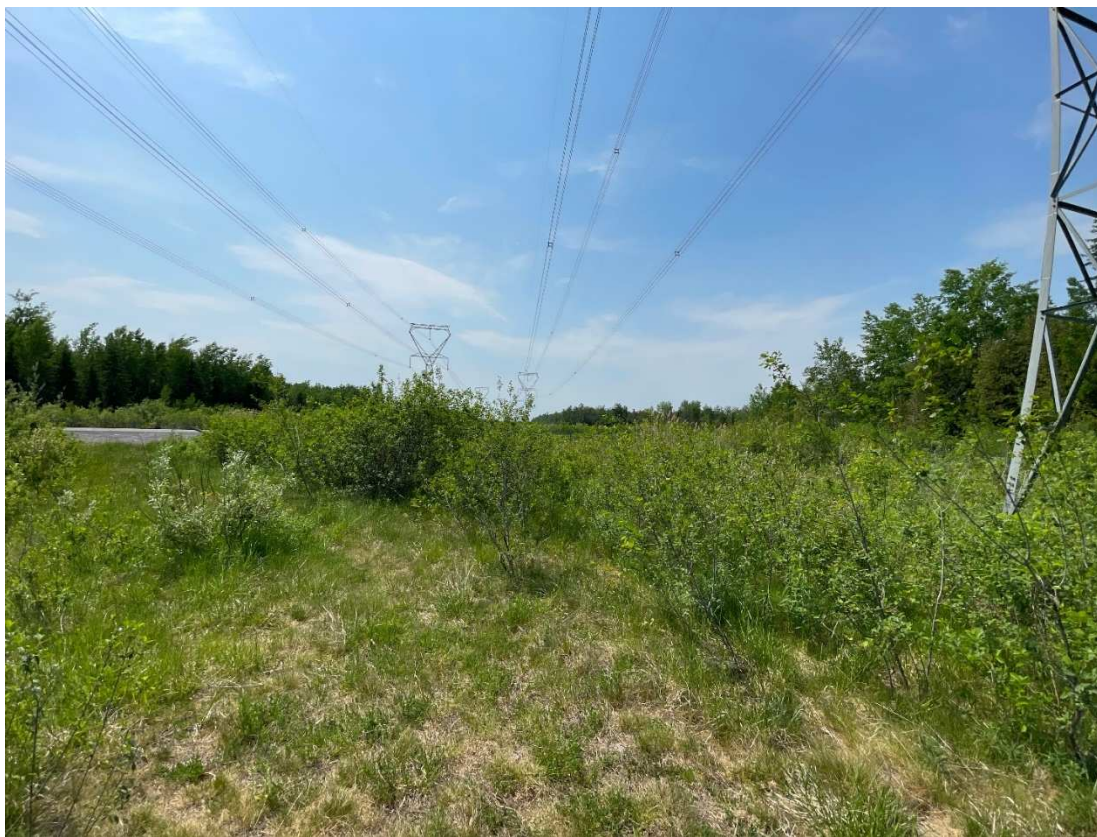
**Figure 13. Cultural Thicket Ecosite (CUT1)**

A Cultural Thicket Ecosite (CUT1; Figure 13) on Site is dominated by Bebb's Willow (*Salix bebbiana*), Alder Buckthorn (*Rhamnus frangula*), Trembling Aspen Saplings (*Populus tremuloides*), White Willow (*Salix alba*), White Meadowsweet (*Spiraea alba*), and Common Milkweed (*Asclepias syriaca*).
