June 25, 2026  
File: PE6465-LET.03

Subject: **Phase I - Environmental Site Assessment Update  
S-1 Lands (Quinn's Pointe Phase 6-8) -  
Part of 3882 Barnsdale Road and  
3933 Borrisokane Road  
Ottawa, Ontario**

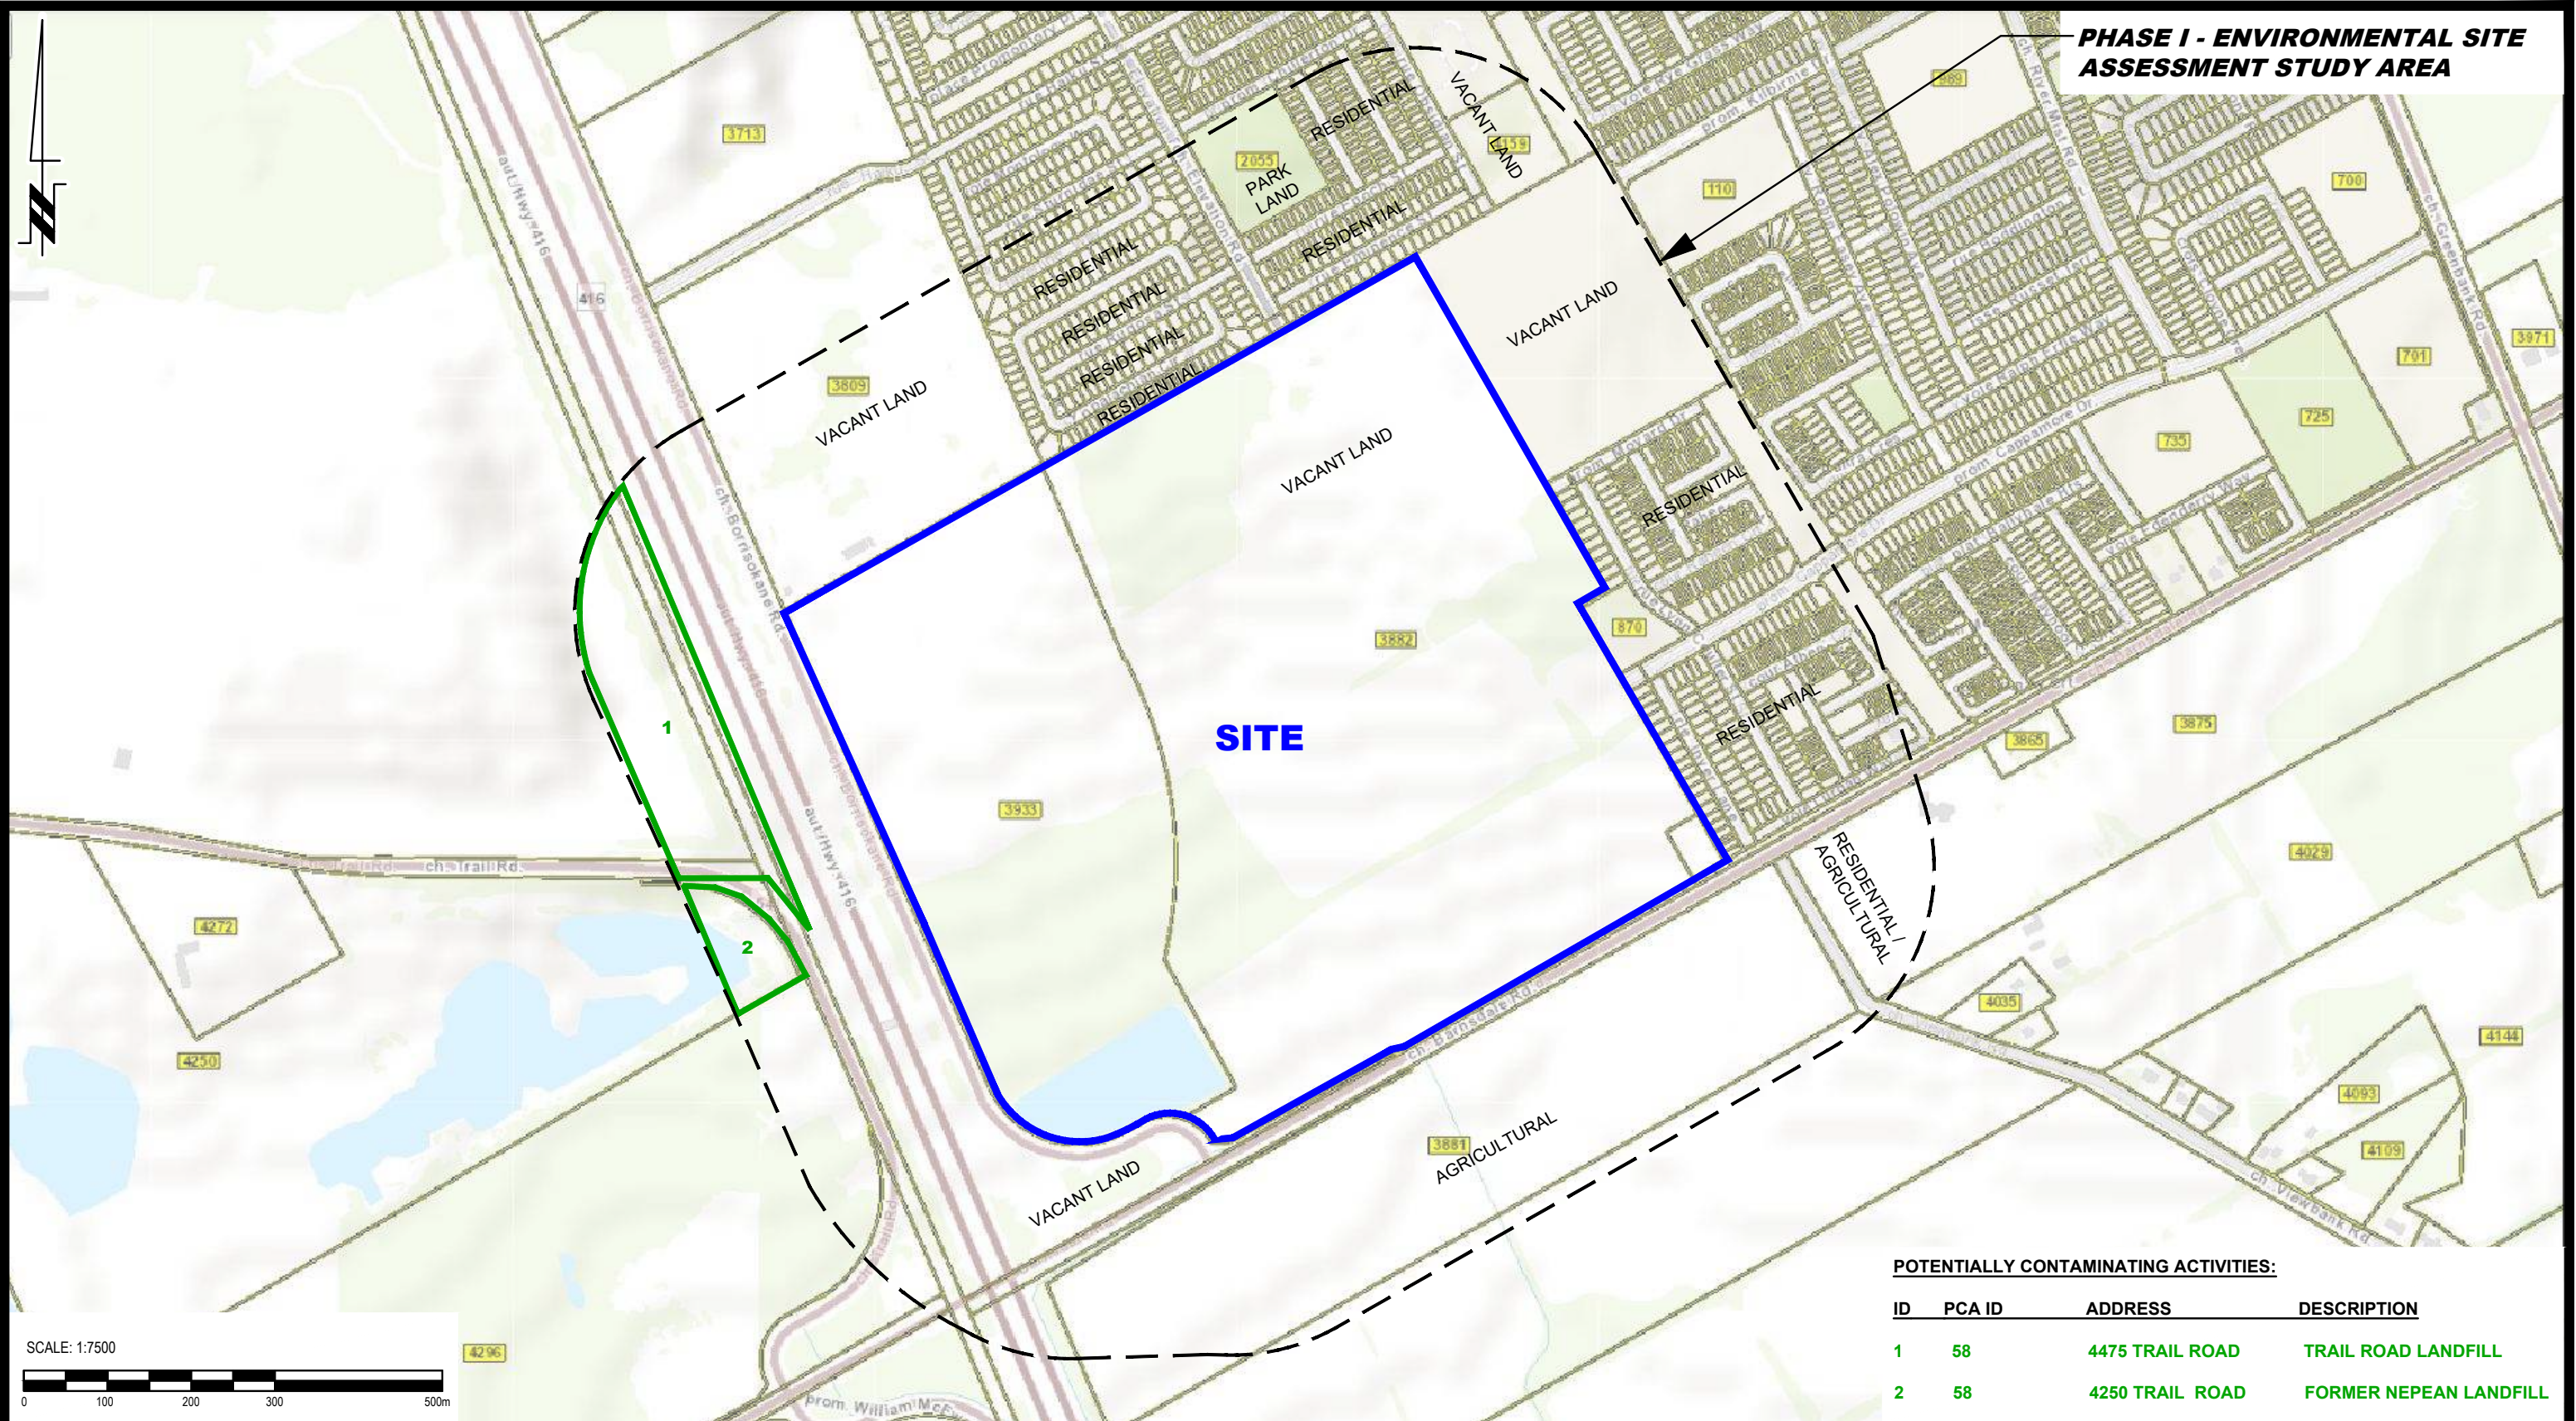
**PHASE I - ENVIRONMENTAL SITE ASSESSMENT STUDY AREA**

A radius of approximately 250 m was determined to be appropriate as a Phase I Study Area for this assessment. Properties outside the 250 m radius are not considered to have the potential to impact the Phase I Property, based on their separation distance.
