# PATERSON GROUP

April 30, 2024  
File: PE6465-LET.01

Subject: **Phase I - Environmental Site Assessment Update  
Quinn's Pointe S1 Lands -  
Part of 3960 Greenbank Road and  
3882 Barnsdale Road  
Ottawa, Ontario**

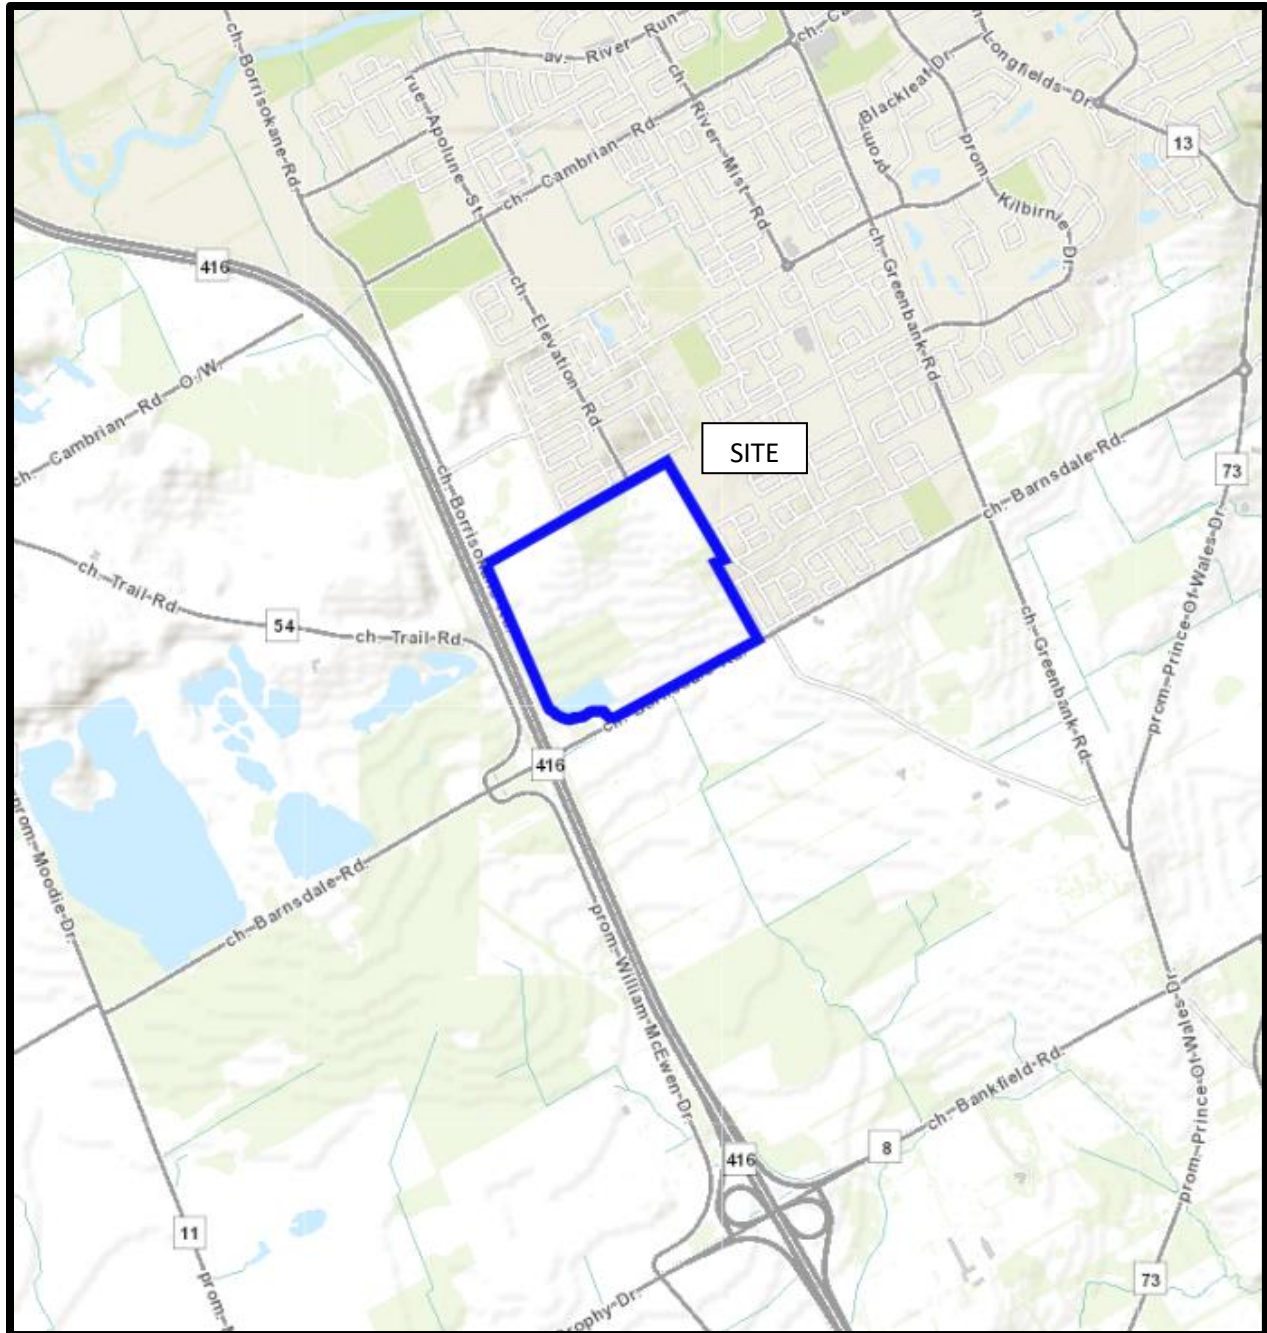
FIGURE 1  
**KEY PLAN**

The Phase I Property is located on the north side of Barnsdale Road and is bounded by Barnsdale Road and Borrisokane to the south and west, respectively, in the City of Ottawa, Ontario.

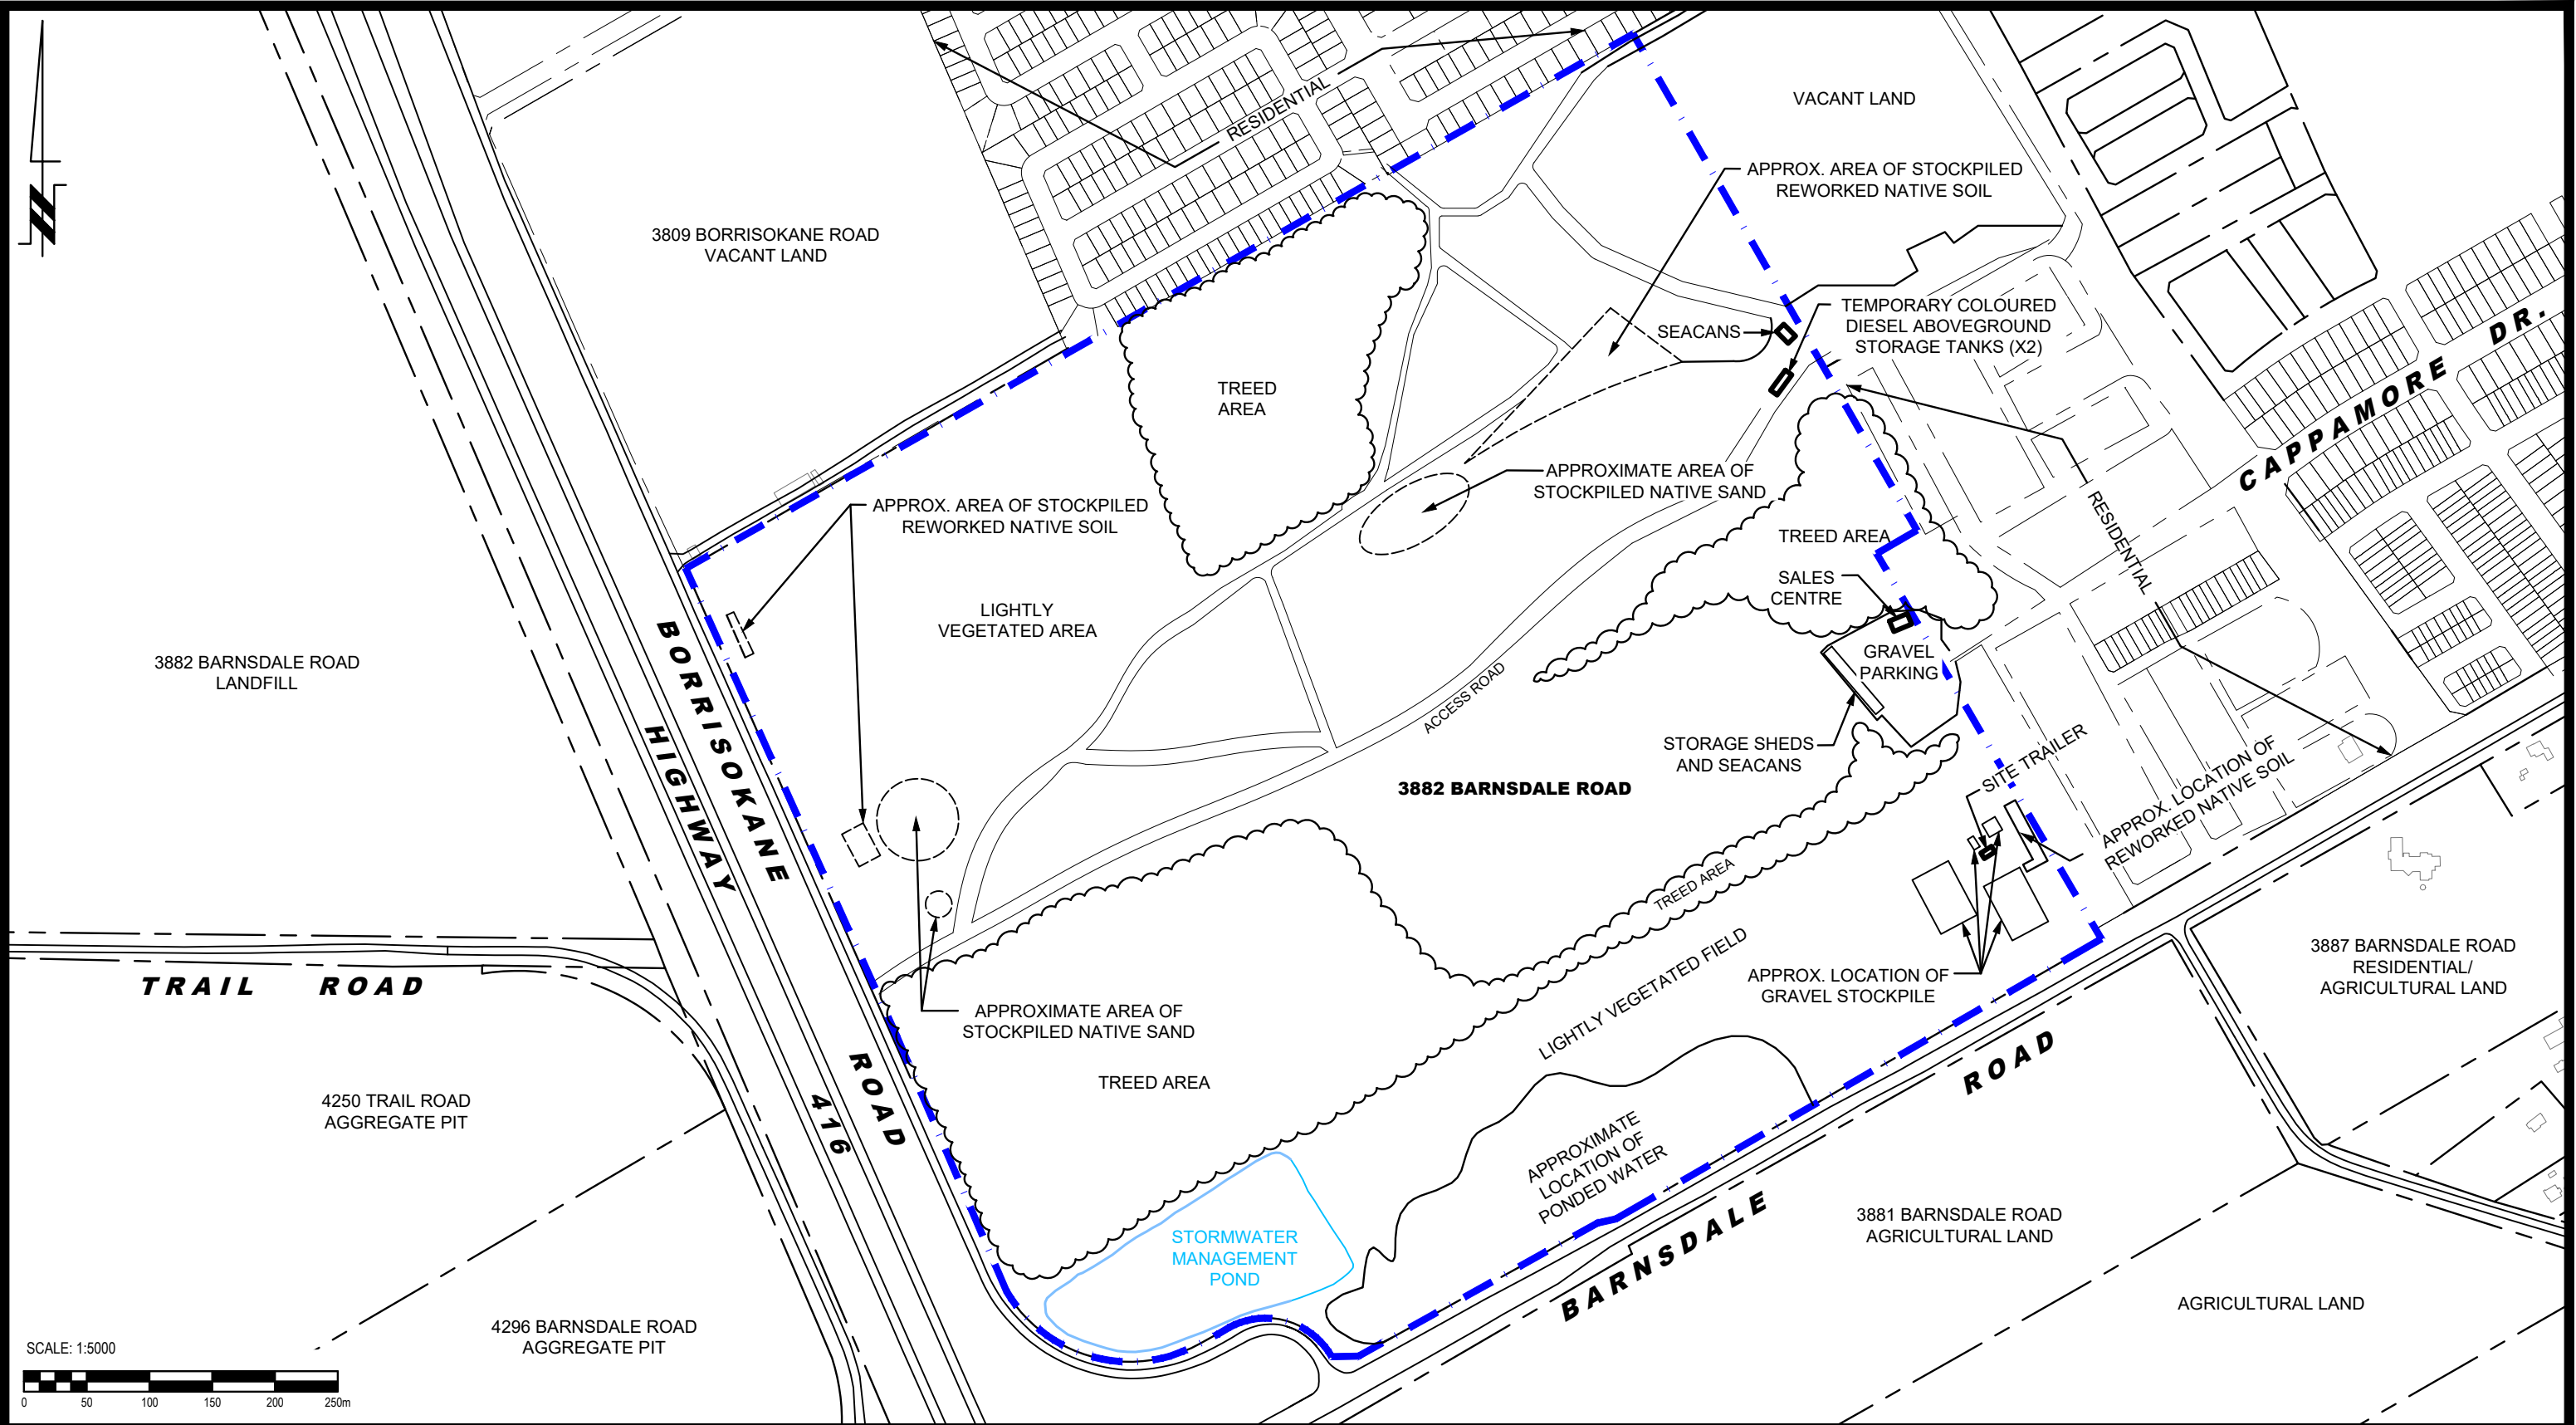
| Checked by: | JC | Dwg. No.: | <b>PE6465-1</b> |

No permanent buildings or structures were observed on the Phase I Property however, a construction trailer and sales centre were observed on the southeast and east-central portions of the Phase I Property, respectively. Additionally, several seacans and storage sheds were identified on the southeast, east-central and west-central portions of the Phase I Property.

Two active coloured diesel ASTs were identified on the east-central portion of the Phase I Property. The tanks were both double-walled, vacuum sealed and had a capacity of 2270 L. Paterson was informed that the tanks are used for fueling of various construction vehicles and equipment associated with the on-going residential development to the north and east of the Phase I Property. The tanks were noted to be in good condition at the time of the site inspection, with no signs of spills or staining observed in their vicinity. The presence of these tanks is not considered to represent an environmental concern to the Phase I Property.

Several monitoring wells were observed across the Phase I Property during the site visit. The monitoring wells were confirmed to have been recently installed as part of hydrogeological and geotechnical investigations on the Phase I Property. No potable wells or private sewage systems were observed on site, nor are any expected to be present, as the site has never been formally developed.

Stockpiles of native soil, native sand and gravel were observed in the western, eastern and central portions of the Phase I Property. The stockpiled material is not considered to represent an environmental concern on the Phase I Property.

The above-noted site features are shown on Drawing PE6465-1 - Site Plan.

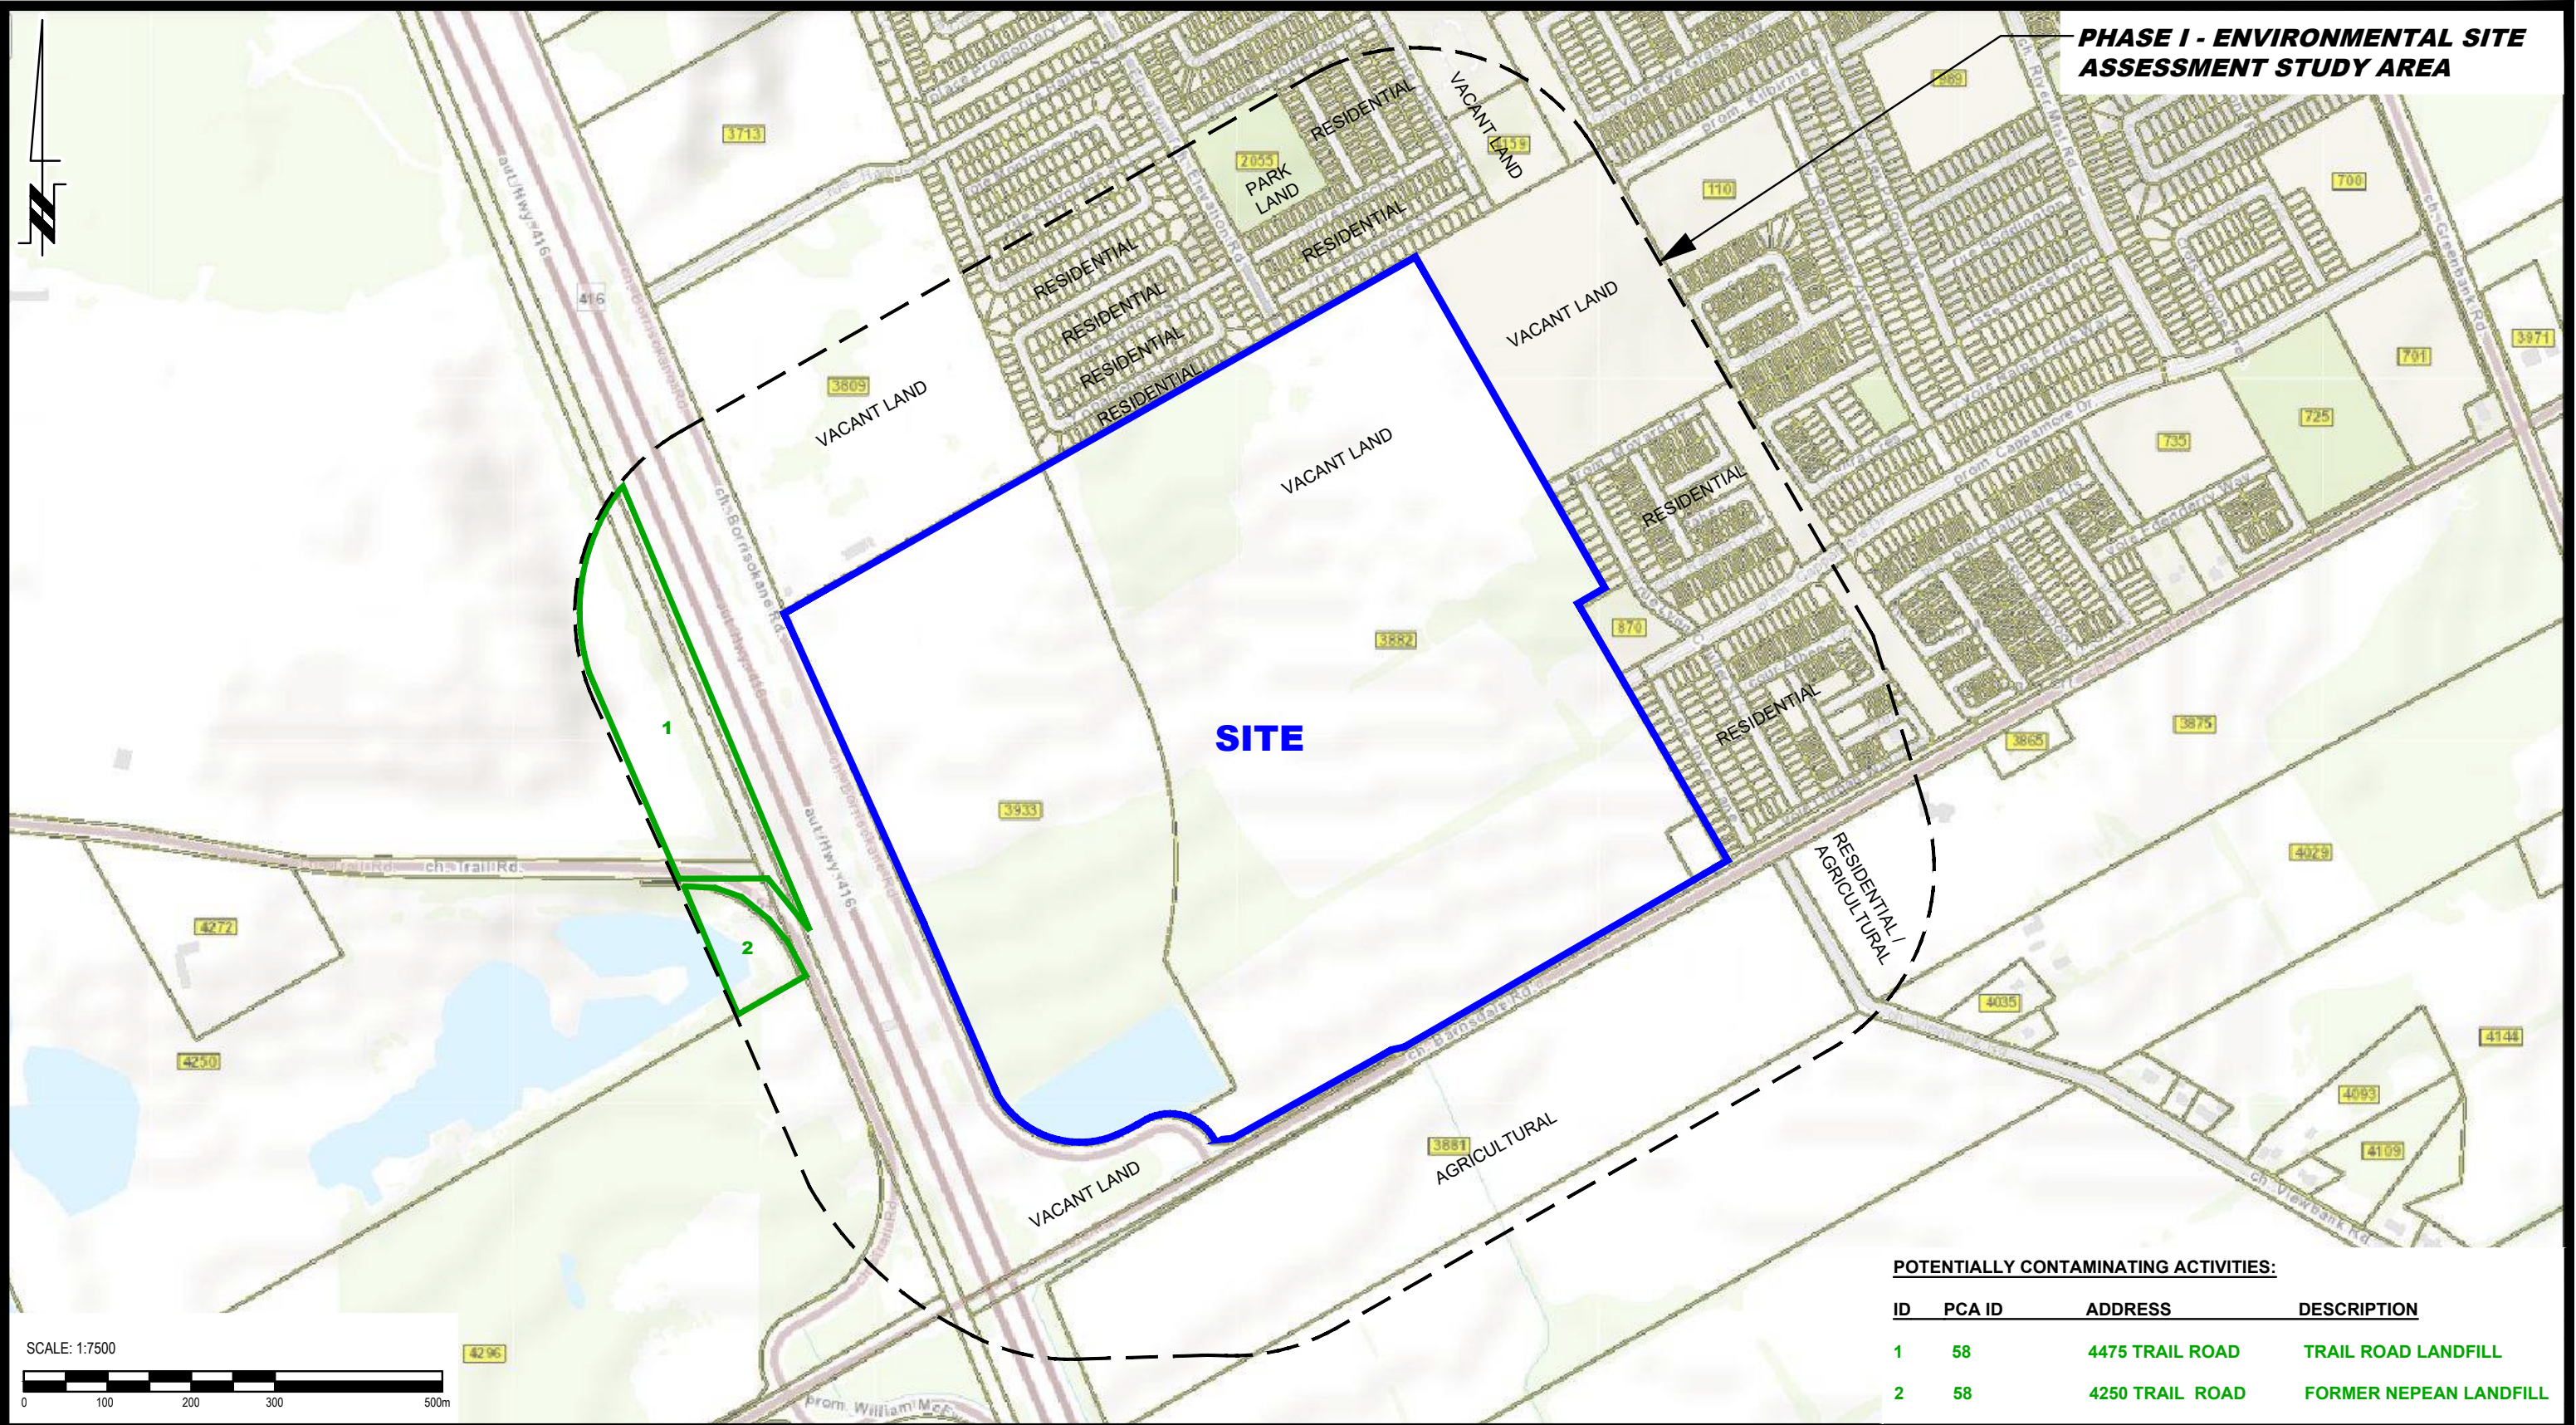
**PHASE I - ENVIRONMENTAL SITE ASSESSMENT STUDY AREA**
