## **Phase I Environmental Site Assessment**

4795 Bank Street and 3301 Blais Road  
Ottawa, Ontario

Prepared for Caivan

Report: PE6876-1  
January 28, 2025

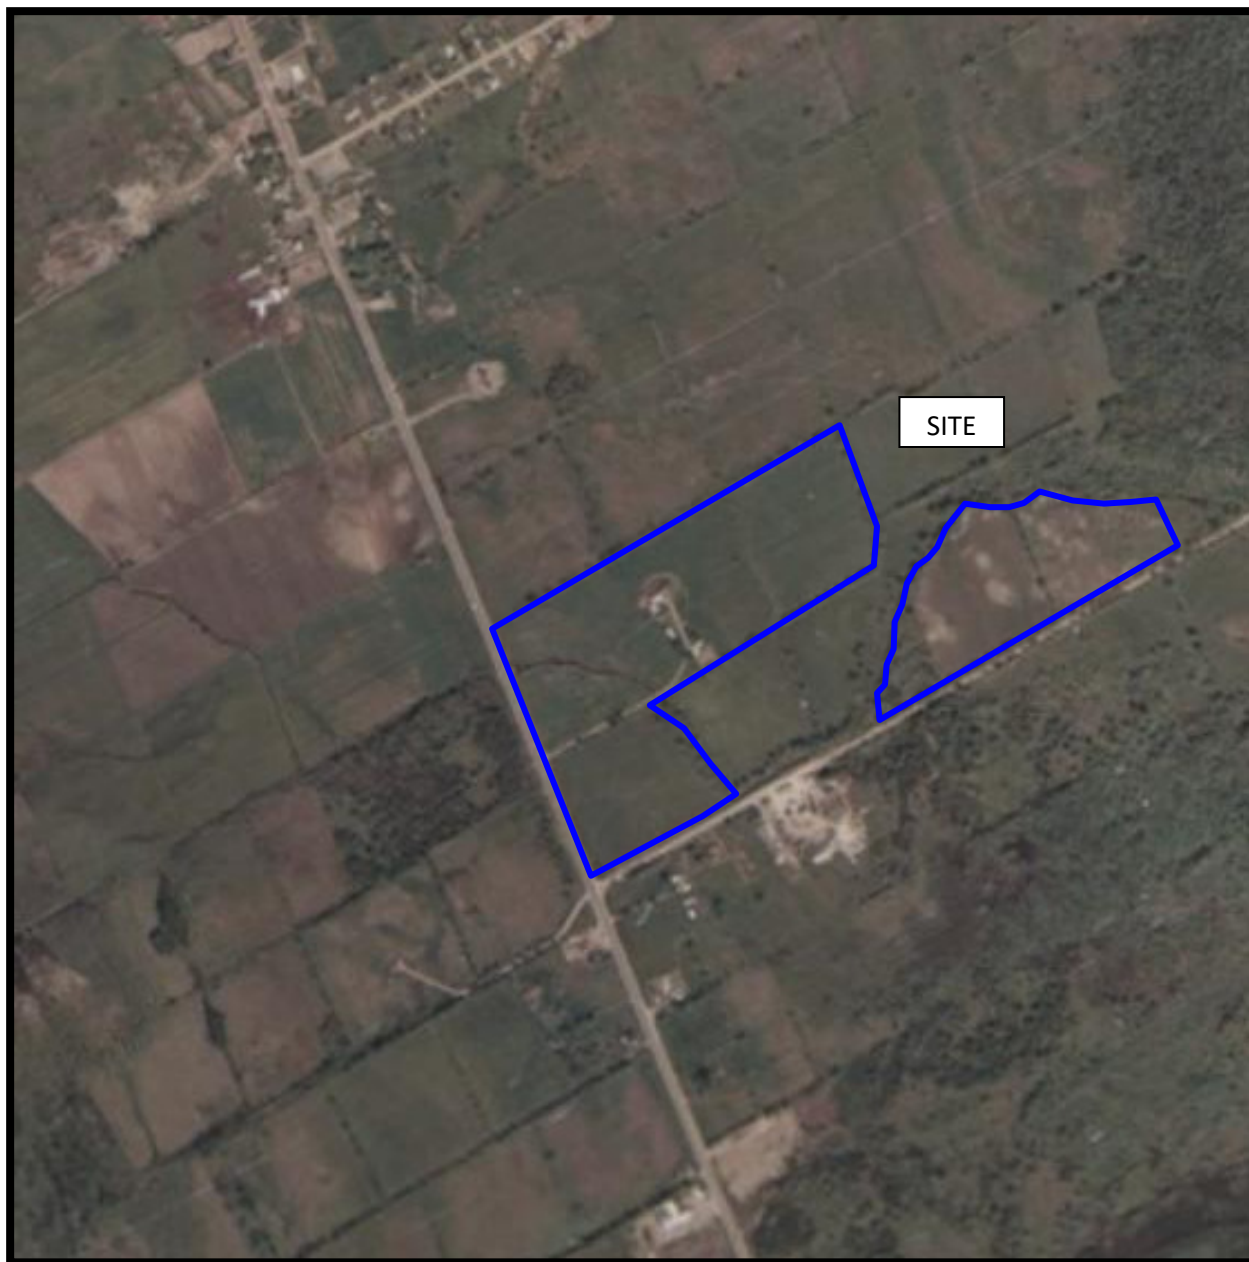
AERIAL PHOTOGRAPH  
1976

| 1976 | (geoOttawa, Poor Quality) No significant changes have been made to the Phase I Property. Several residential dwellings have been developed further to the north of the Phase I Property. Reworked material is observed to the south of the Phase I Property, along Blais Road. No other significant changes are apparent with respect to the surrounding properties. |

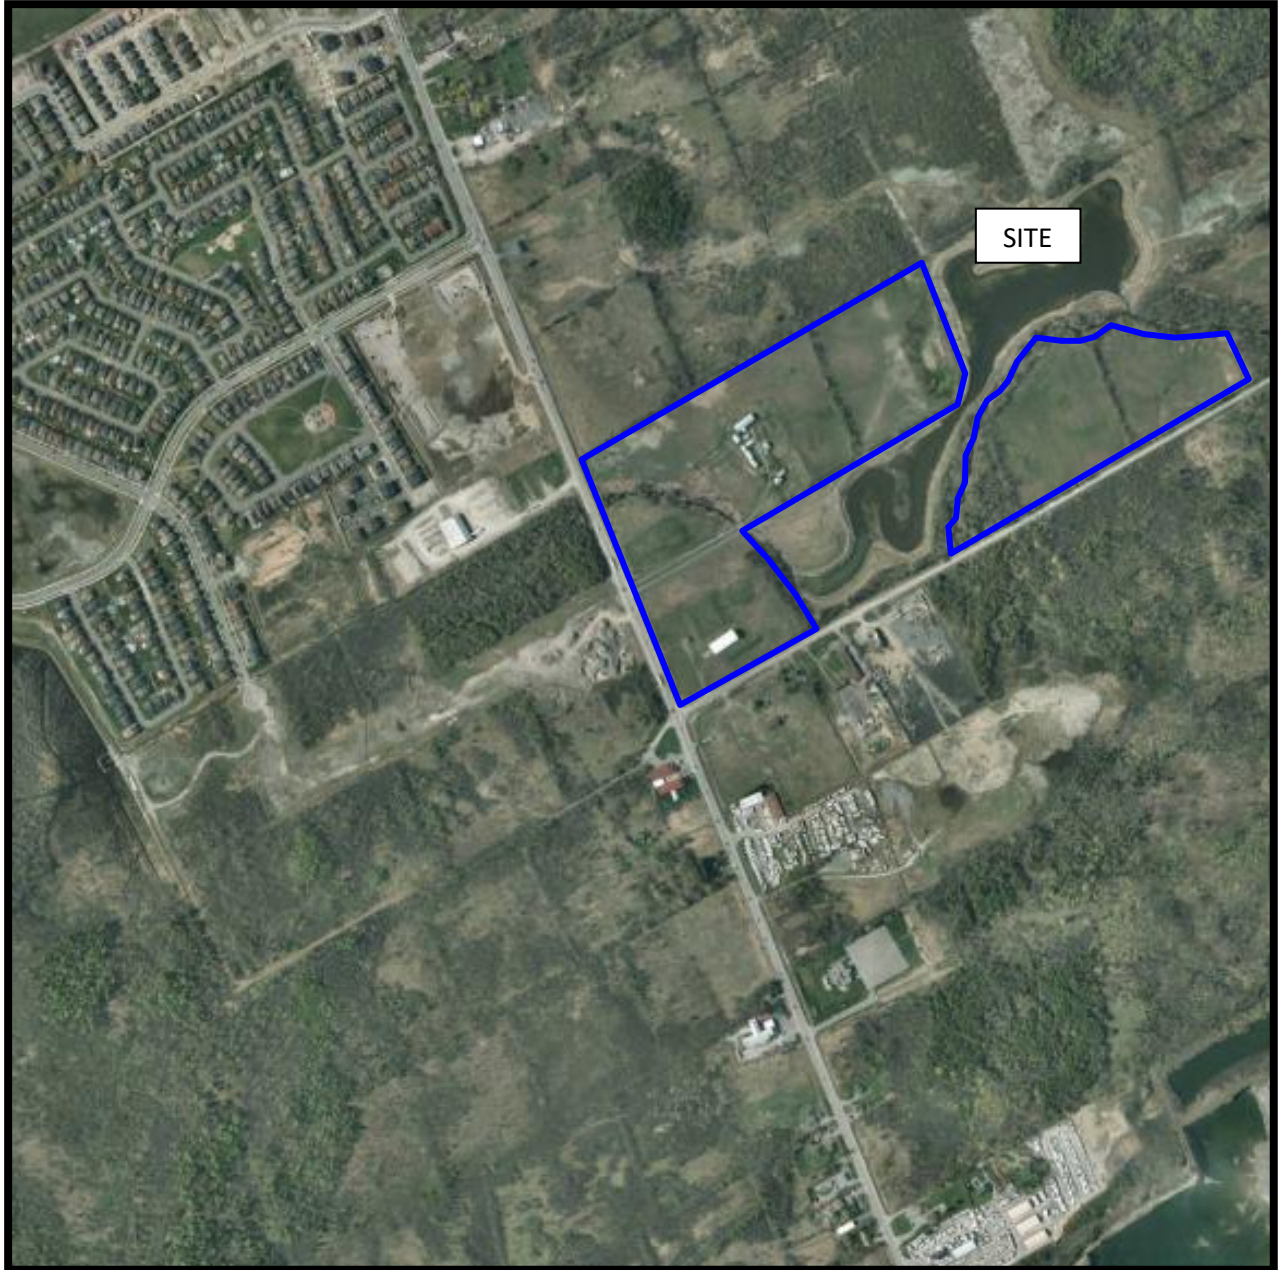
AERIAL PHOTOGRAPH  
2011

| 2011 | (geoOttawa) The southwest portion of the Phase I Property has been occupied by a barn structure and associated small building. A stormwater management pond has been developed directly adjacent to the east of the Phase I Property. Further residential development is observed to the northwest of the Phase I Property, with the Findlay Creek Community. The beginning stages of development of the Findlay Creek commercial plaza is observed to the northwest of the Phase I Property. Findlay Creek Drive has been constructed and is in its current orientation. No other significant changes have been made to the Phase I Property or surrounding properties. |

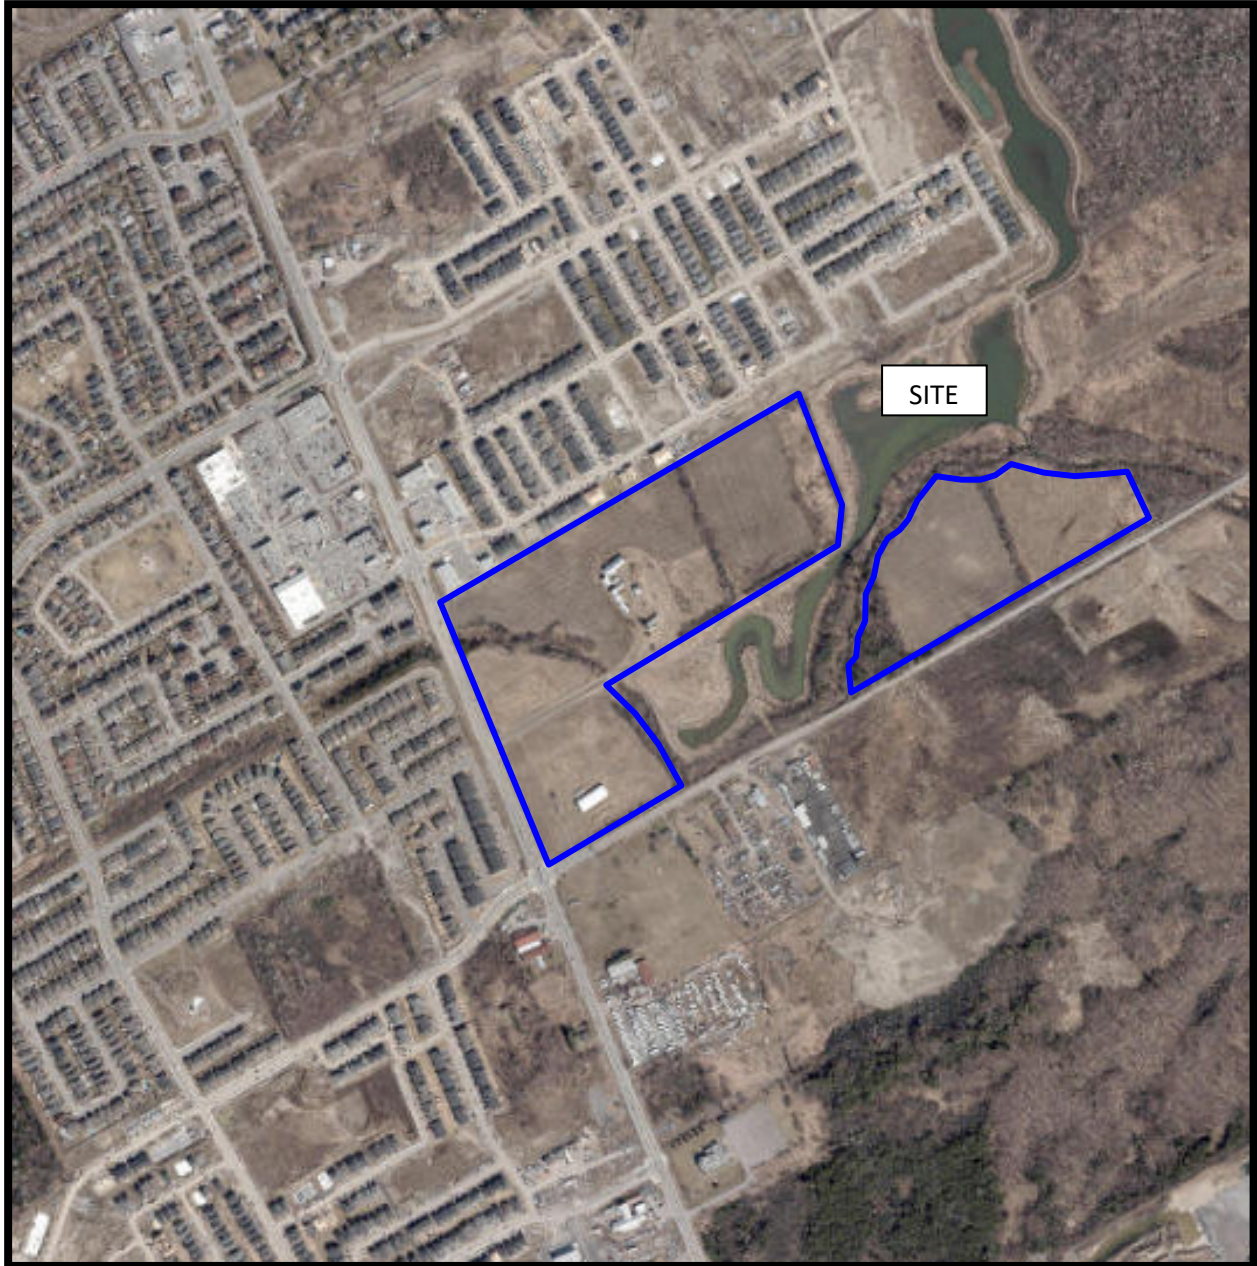
AERIAL PHOTOGRAPH  
2021

| 2021 | (geoOttawa) No significant changes have been made to the Phase I Property. Further residential development is observed to the north and west of the Phase I Property. The Findlay Creek commercial plaza has been developed to the northwest of the Phase I Property. Mikana Road is in its current orientation, observed to the southwest of the Phase I Property. No other significant changes appear to have been made to the Phase I Property or surrounding properties. |

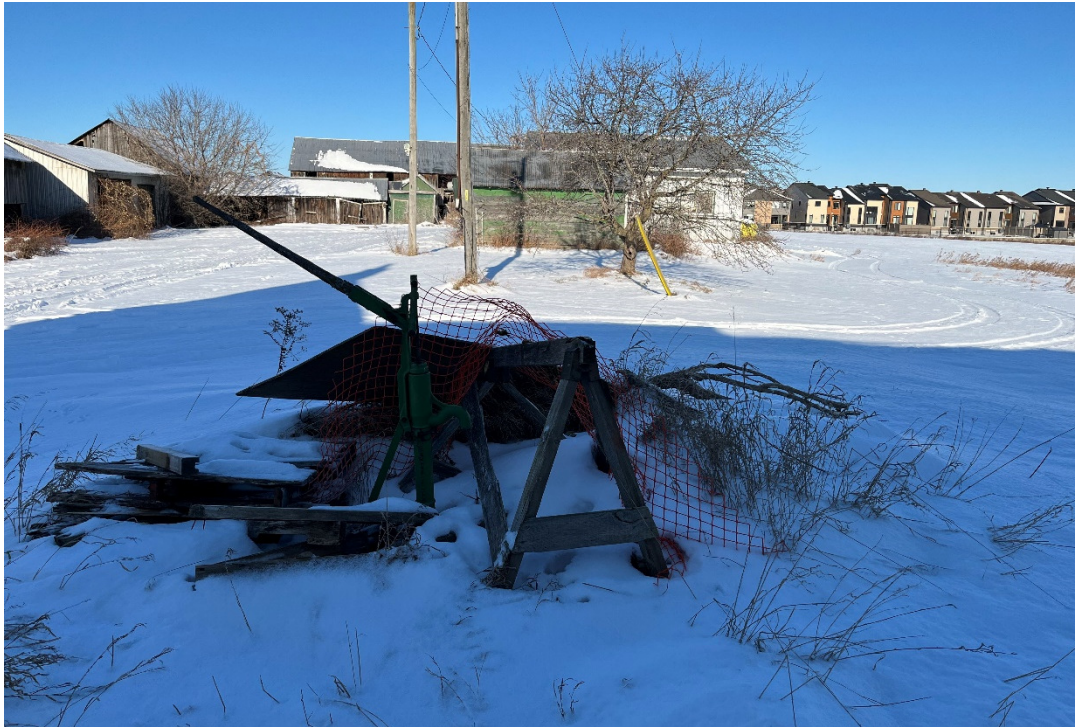
Photograph 1: View of northern central portion of the Phase I Property.

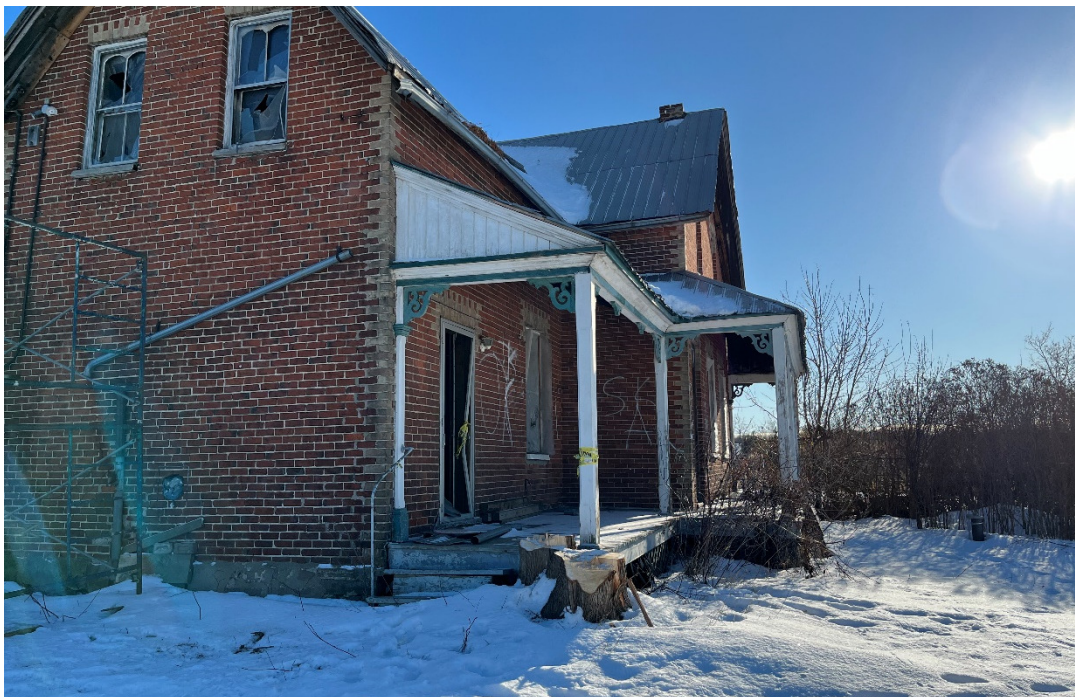
A two-storey farmhouse was observed onsite at the time of the site inspection. The farmhouse was constructed on stone with wood framing and brick siding. The farmhouse was observed to have an addition at the rear, constructed on grade with plywood siding. The roof of the farmhouse and addition was constructed with sheet metal. At the time of the inspection, the building was mostly gutted to its studs.

Photograph 2: View of vacant residential dwelling in the north central portion of the Phase I Property.

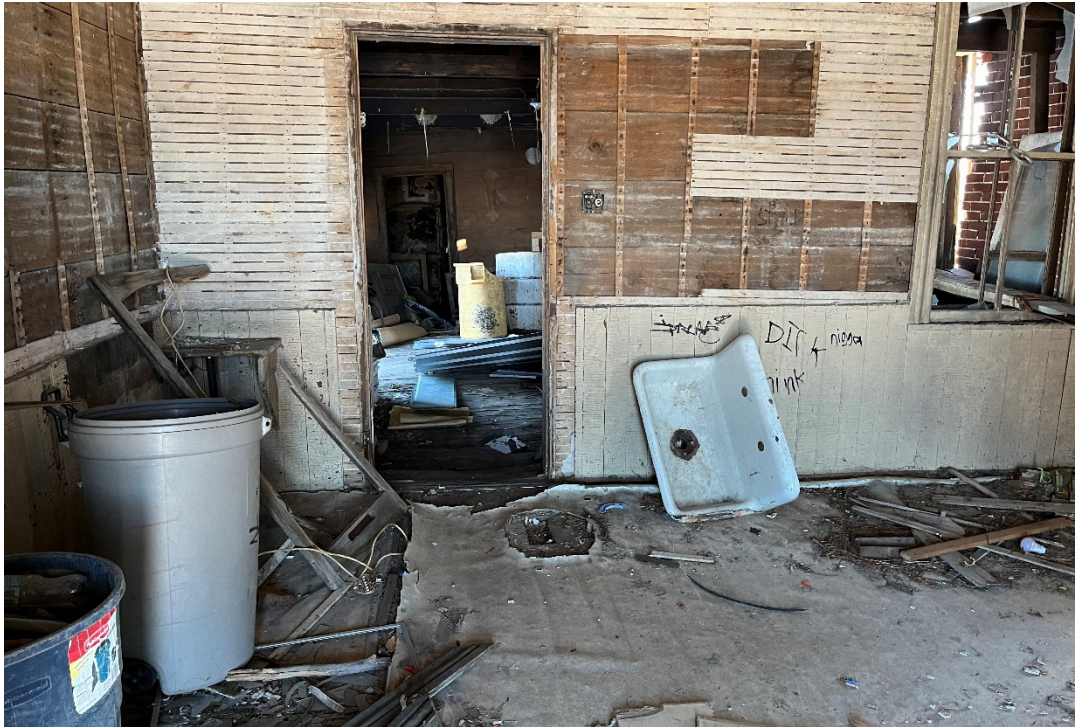
Based on the age of the farmhouse building (circa 1945), asbestos containing materials may be present. Potential ACMs observed in the subject building include lathe and plaster, and linoleum. These materials were observed in poor to fair condition at the time of the site inspection and do not pose an immediate concern as the building is currently un-inhabitable.

Based on the age of the farmhouse building (circa 1945), lead containing paints may be present on any original or older painted surfaces. Painted surfaces were generally observed in fair to good condition at the time of the site inspection and do not pose an immediate concern as the building is currently un-inhabitable.

Photograph 3: First floor interior of the farmhouse.

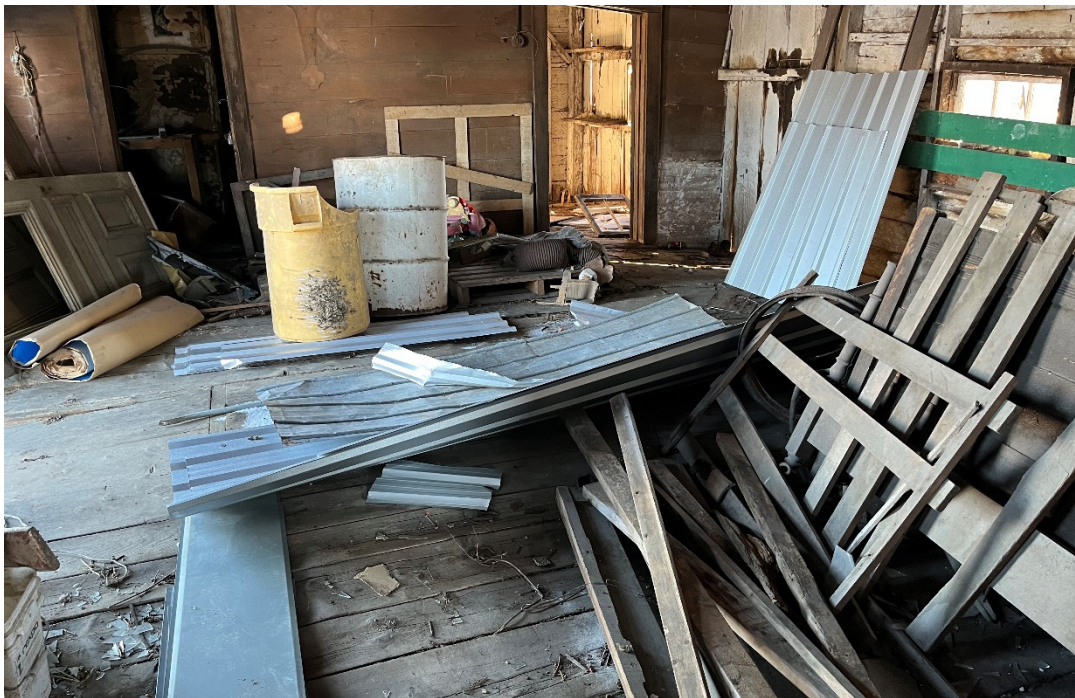
Photograph 4: View of interior of the addition to the farmhouse.

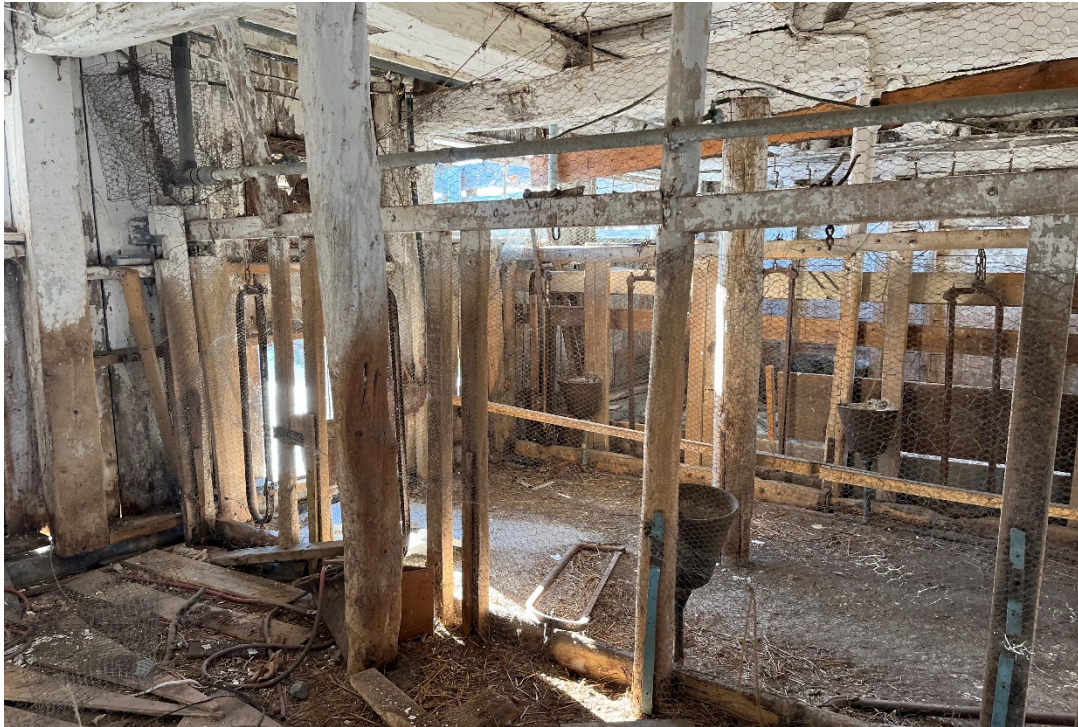
A large livestock barn was observed onsite at the time of the site inspection. The structure was constructed on a poured concrete slab on the western half of the building, with the remainder on grade. The building is constructed with a timber frame and plywood siding. The roof is constructed with sheet metal. At the time of the site inspection, the structure was empty, with the exception of minimal storage of wood on the eastern half of the building.

Photograph 5: View of the interior of the livestock barn on north central portion of the Phase I Property.

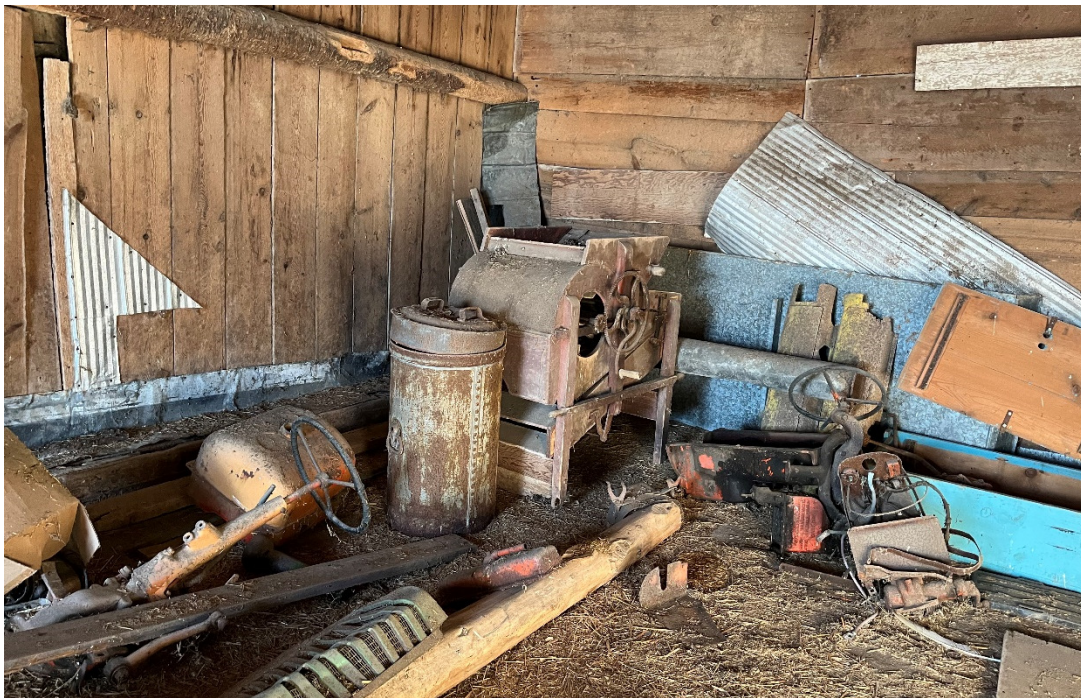
Photograph 6: Dilapidated farm equipment stored in the livestock barn.

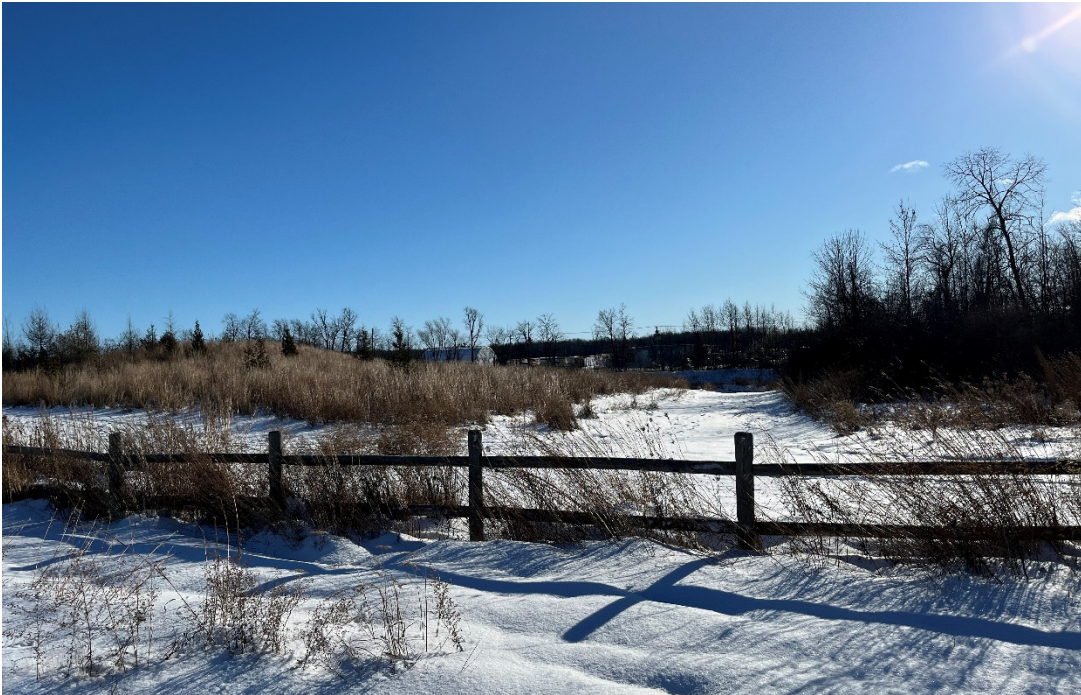
Photograph 7: View looking south from the north central portion of the property towards the stormwater management pond.

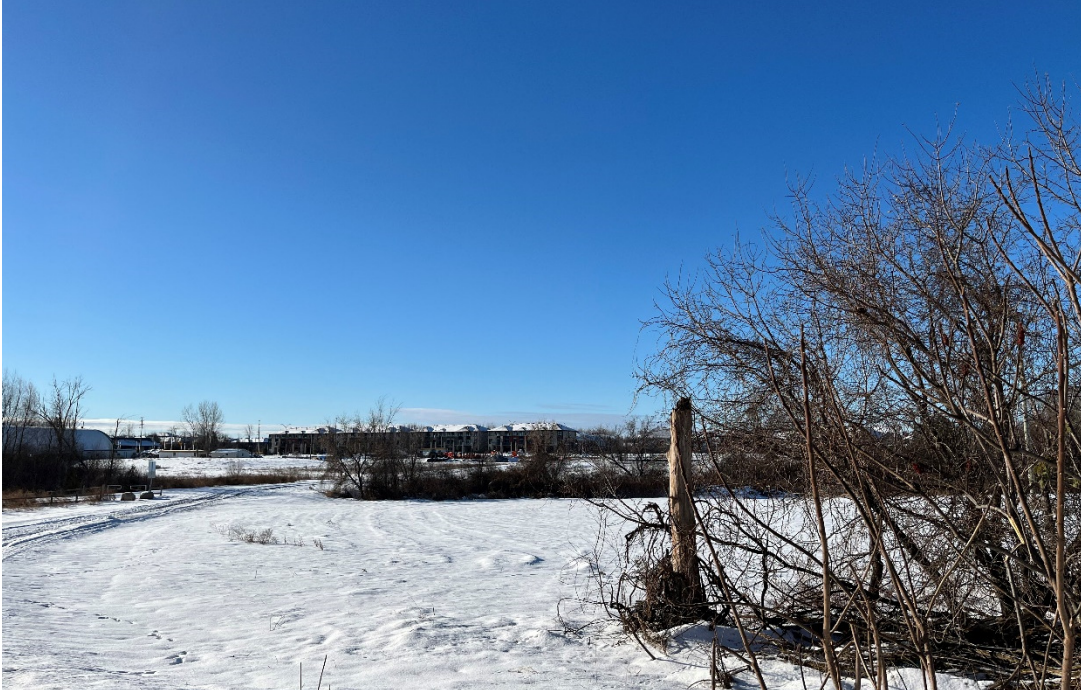
Photograph 8: View looking west from within the Phase I Property towards Bank Street, with an existing temporary construction staging area along western property limits.
