**McKINLEY**  
ENVIRONMENTAL  
SOLUTIONS

Combined Environmental Impact Study  
& Tree Conservation Report  
4795 Bank Street, Ottawa, ON

July 2026

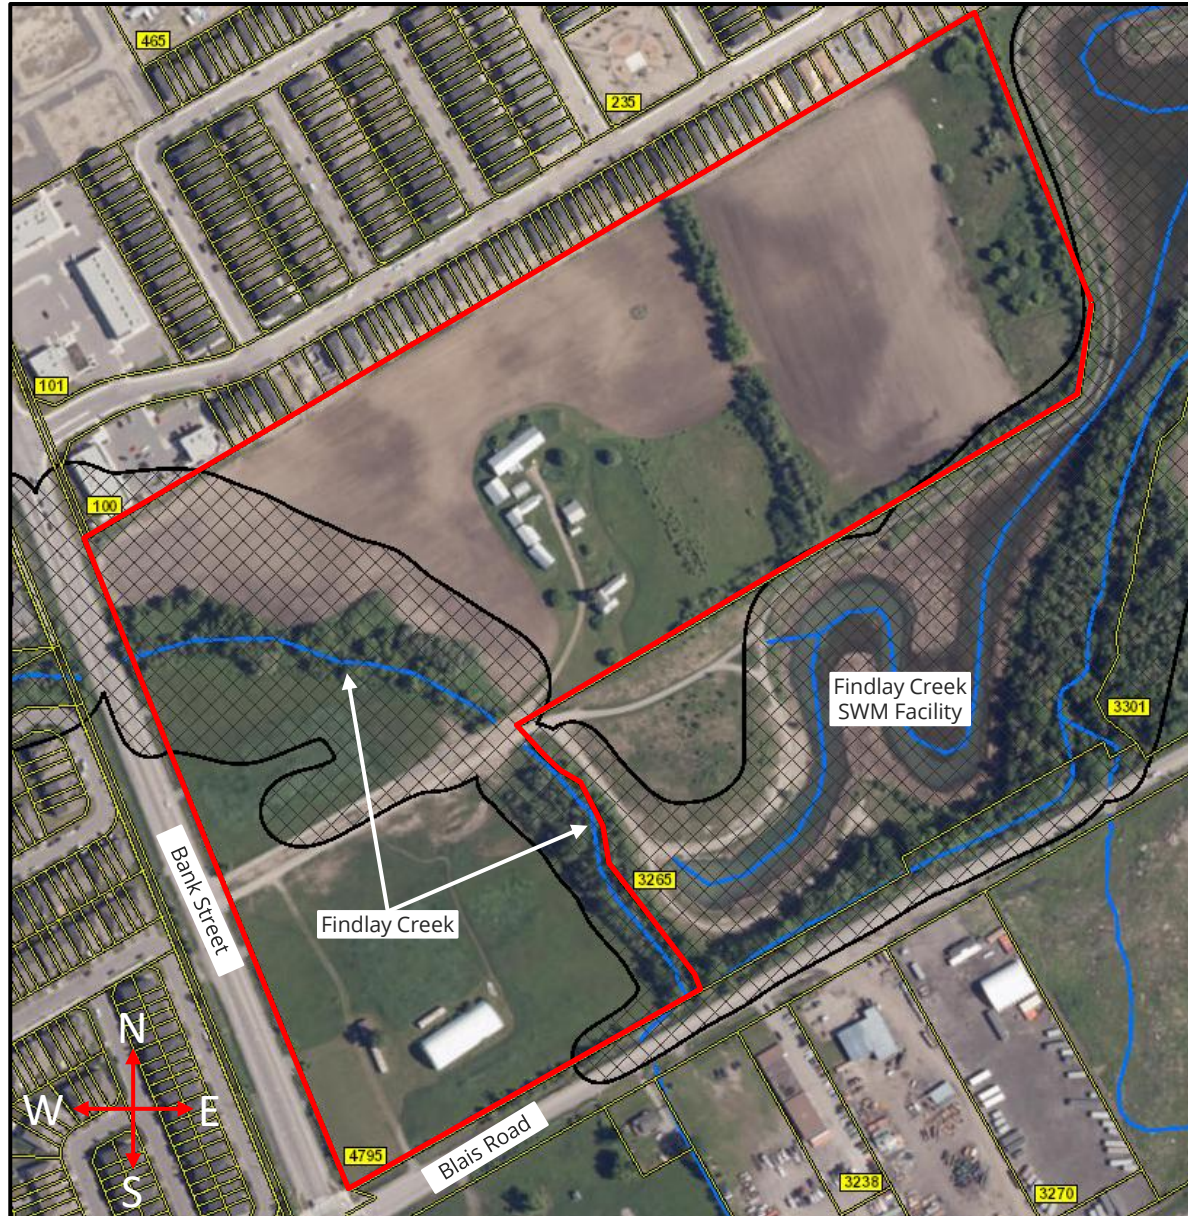
# FIGURE 1: SITE OVERVIEW & SNCA REGULATORY LIMITS

\*The 15 m wide Hazard Setback/SNCA Regulatory Limits are drawn relative to the 1:100 Year Floodplain of Findlay Creek. Mapping taken from City of Ottawa (2026). Please Note: This is not a legal land survey. All dimensions and locations are shown as approximate.

This Combined Environmental Impact Study (EIS) & Tree Conservation Report (TCR) was prepared to assess the property at 4795 Bank Street, Ottawa, ON (Lot 20, Concession 5 from Rideau River, Gloucester) (the Site) (Refer to Figure 1). The Site is approximately 17.2 hectares in size. The Site occurs within the urban area of the City of Ottawa and is currently zoned Rural (RU) with a future neighborhood overlay. Bank Street forms the western boundary of the Site, beyond which is a residential subdivision. The area to the north of the Site consists of a residential subdivision and developed commercial properties. The Findlay Creek Stormwater Management Facility is located east of the Site. Blais Road forms the southern boundary of the Site, beyond which is a mowed field and several developed commercial properties.

The majority of the surface area of the Site consists of Agricultural Fields and Cultural Meadow. Two Deciduous Hedgerows are present at the edges of the Site. Riparian (Deciduous) Hedgerows are also present along the banks of Findlay Creek. Several agricultural buildings occur within the Site. Findlay Creek flows through the Site in an approximately northwest to southeast direction. Portions of the western part of the Site are shown to be within the 1:100 Year Floodplain of Findlay Creek and the associated 15 m wide Hazard Setback/South Nation Conservation Authority (SNCA) Regulatory Limits (City of Ottawa 2026).

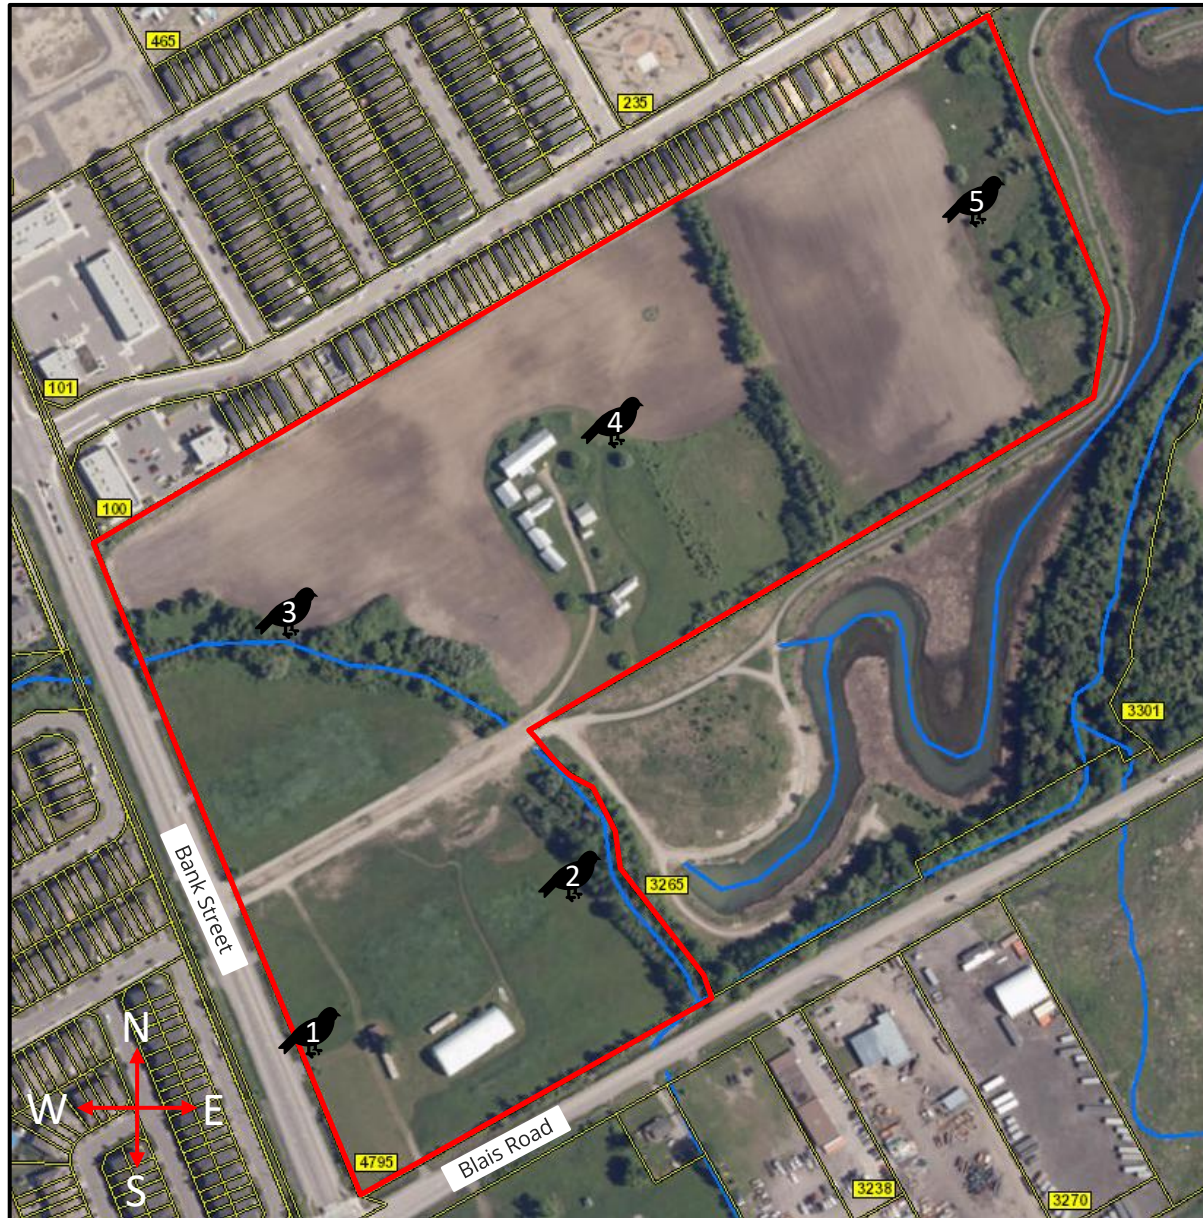
# FIGURE 2: BIRD SURVEY POINTS

Mapping taken from City of Ottawa (2026). Please Note: This is not a legal land survey. All dimensions and locations are shown as approximate.

- **Breeding Bird Surveys:** The Breeding Bird Surveys were undertaken following the *Ontario Breeding Bird Atlas – Point Count Surveys Method* (Birds Ontario 2021). The timing and methodology of the surveys followed the requirements outlined in the OMNRF *Survey Methodology under the Endangered Species Act: Dolichonyx oryzivorus (Bobolink)* (OMNRF 2011). The Breeding Bird Surveys were completed on May 25<sup>th</sup> (Overcast, 18 °C), June 2<sup>nd</sup> (Mostly Sunny, 18 °C), and June 10<sup>th</sup> (Mostly Sunny, 21 °C), 2025. The Breeding Bird Survey points are shown below in Figure 2. The Breeding Bird Surveys included the following:

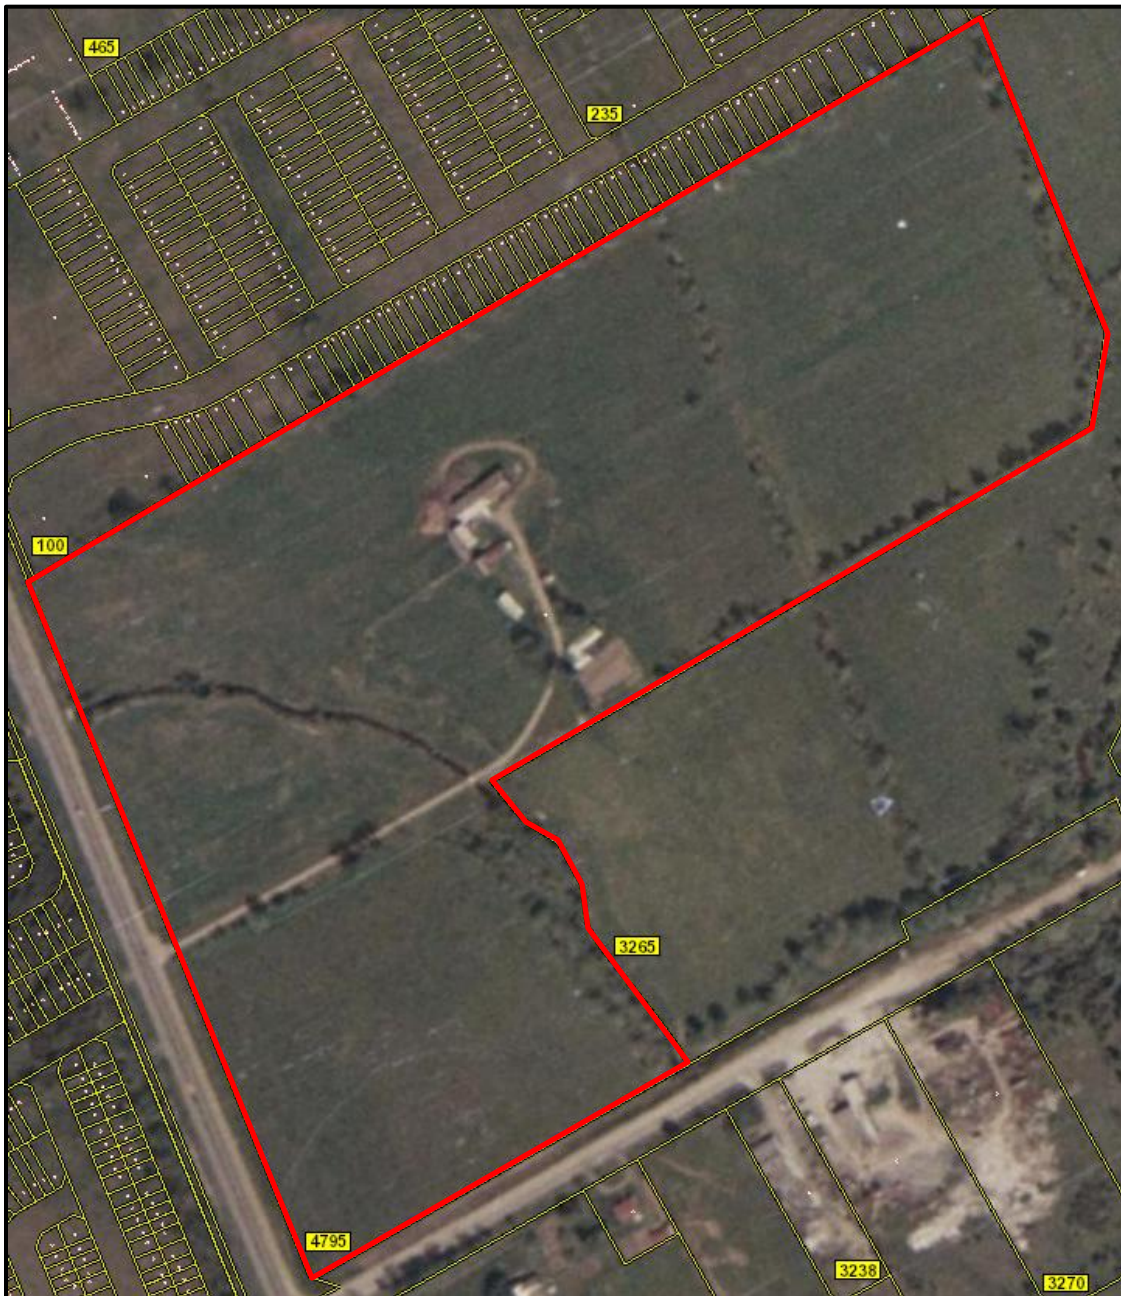
**Historic Air Photograph 1:** Historic Air Photo from 1976 (Site limits shown in red). Note that the Site was farmed in 1976. In 1976 there were very few mature trees visible in the current locations of the Deciduous Hedgerows and the Riparian (Deciduous) Hedgerows (Photo from City of Ottawa 2026).

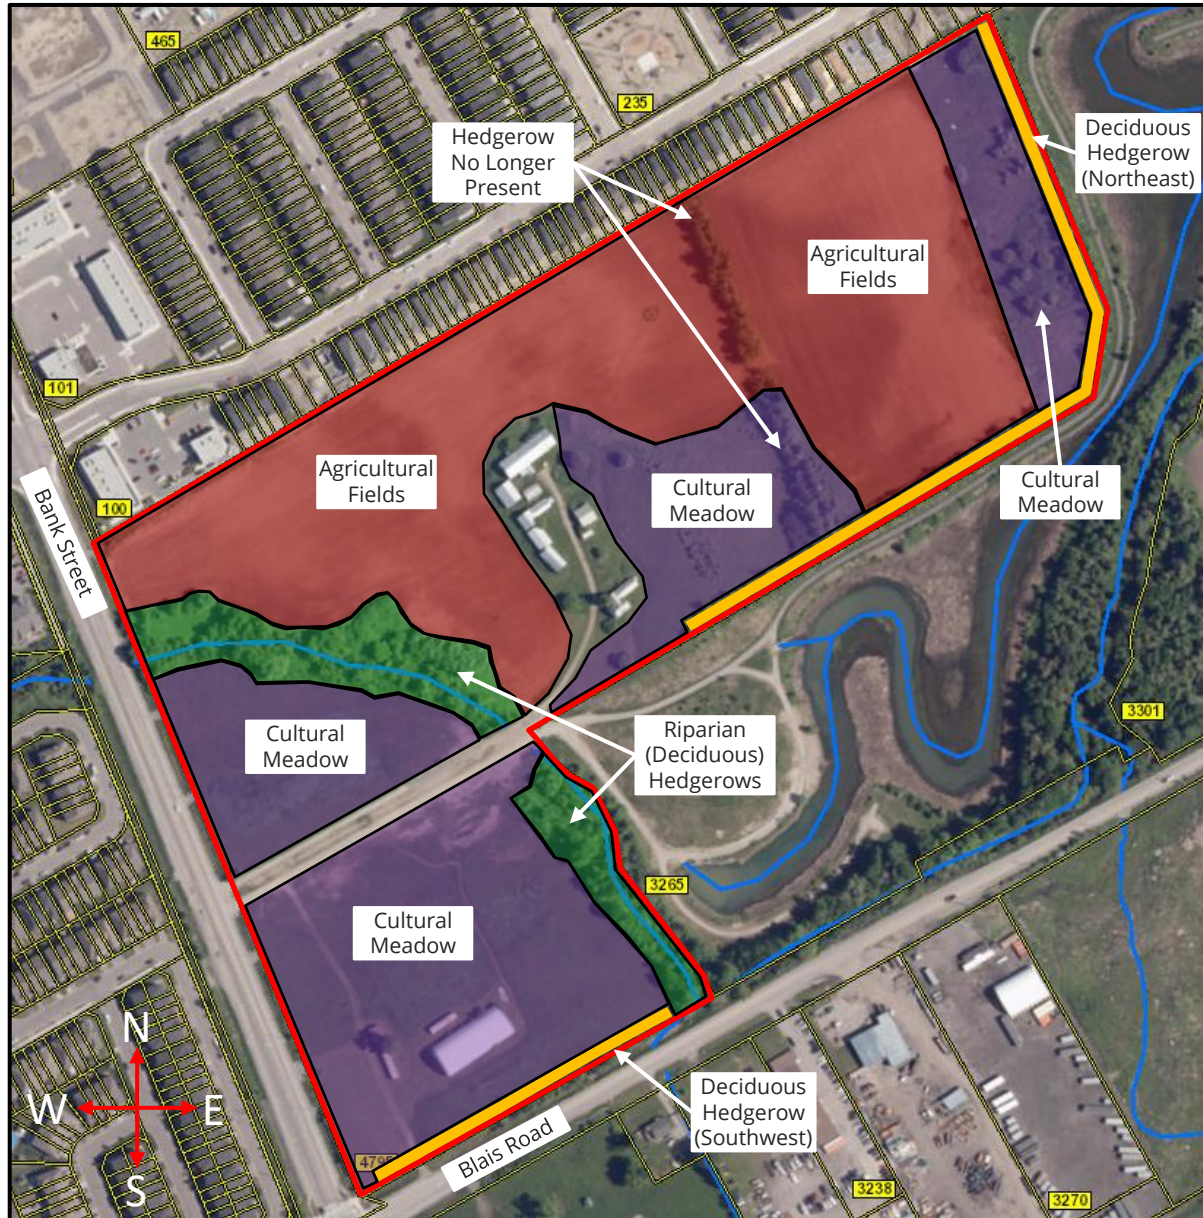
# FIGURE 3: VEGETATION COMMUNITIES

Mapping taken from City of Ottawa (2026). Please Note: This is not a legal land survey. All dimensions and locations are shown as approximate.

The vegetation communities are shown below in Figure 3. Table A (below) provides an inventory of the trees within the Deciduous Hedgerows and the Riparian (Deciduous) Hedgerows. Refer to Appendix A for a list of the plant species that were observed within the Site. The following is a summary of the vegetation communities that occur within the Site:

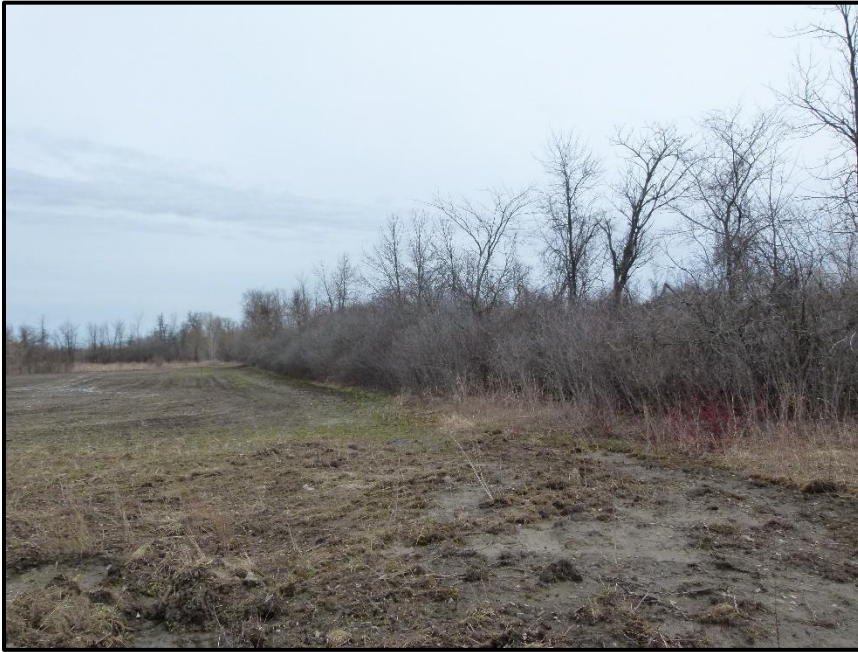
**Photograph 7:** Looking east at the Deciduous Hedgerow (Northeast) (April 21<sup>st</sup>, 2025).

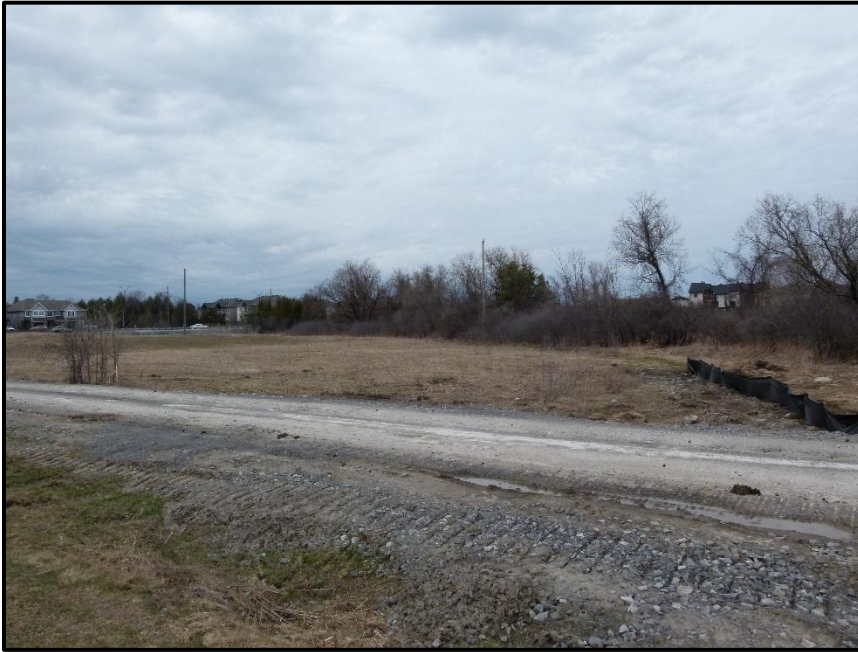
**Photograph 11:** Looking north at the northern part of the Riparian (Deciduous) Hedgerows (April 21<sup>st</sup>, 2025).

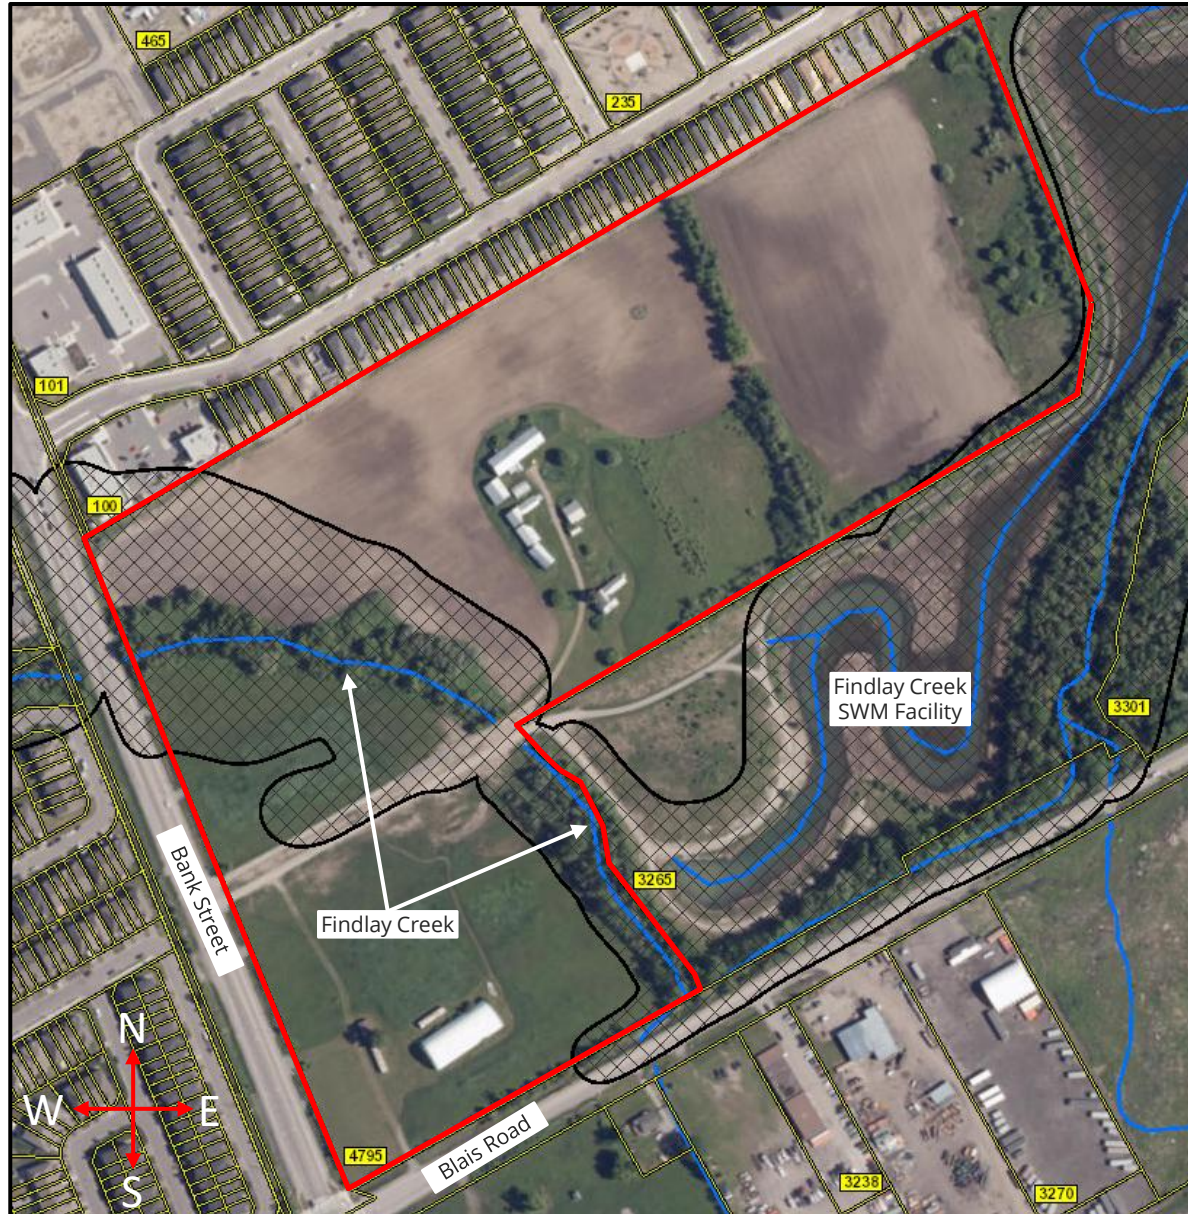
# FIGURE 4: WATERCOURSES & SNCA REGULATORY LIMITS

\*The 15 m wide Hazard Setback/SNCA Regulatory Limits are drawn relative to the 1:100 Year Floodplain of Findlay Creek. Mapping taken from City of Ottawa (2026). Please Note: This is not a legal land survey. All dimensions and locations are shown as approximate.

As shown below in Figure 4, Findlay Creek flows in an approximately northwest to southeast direction through the Site. Portions of the western part of the Site are shown to be within the 1:100 Year Floodplain of Findlay Creek and the associated 15 m wide Hazard Setback/SNCA Regulatory Limits (City of Ottawa 2026). Findlay Creek was observed to have a wetted width between approximately 1.5 m and 3 m during the early spring (April 21<sup>st</sup>, 2025). The maximum observed water depth varied between approximately 60 cm during the early spring (April 21<sup>st</sup>, 2025) and approximately 30 cm during the early summer (June 10<sup>th</sup>, 2025). The watercourse had moderate flow volumes throughout the survey period and is likely to be hydrated year-round. The substrate of the watercourse includes a mix of silt, boulder, gravel, and detritus. The majority of the channel is heavily shaded and lacks in-stream aquatic vegetation. The riparian vegetation surrounding Findlay Creek is described above in Section 3.3 (i.e. the Riparian (Deciduous) Hedgerows). Within the Site, the watercourse flows through a large box culvert under the driveway that leads to the old farmhouse. The farmhouse driveway and box culvert will be removed during the future development of the Site. Findlay Creek flows through the roadside ditch of Blais Road immediately downstream of the Site. The watercourse flows into the Findlay Creek Municipal Drain further downstream.

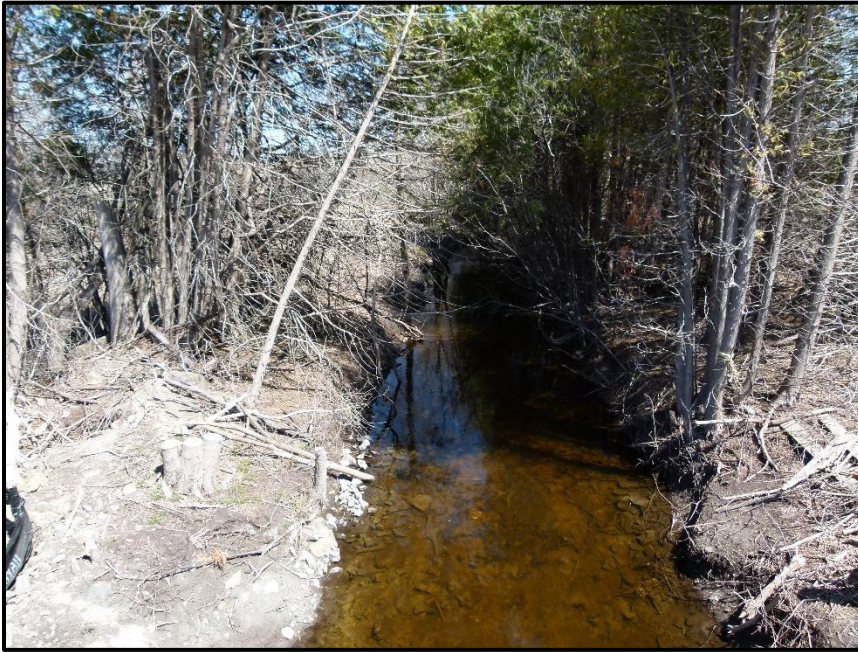
**Photograph 15:** Looking downstream along Findlay Creek in the northwestern part of the Site (April 28<sup>th</sup>, 2025).

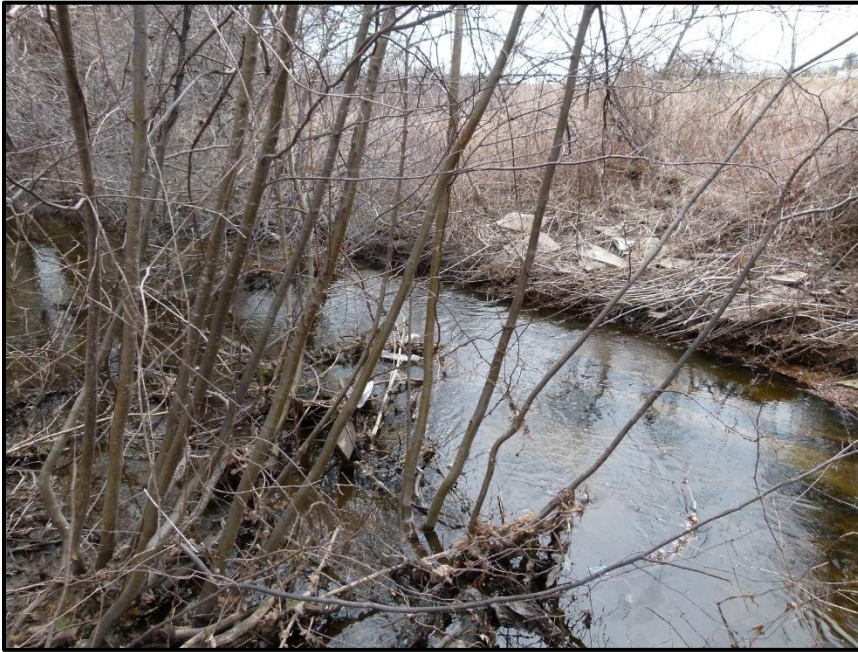
**Photograph 17:** Looking upstream along Findlay Creek in the northwestern part of the Site (April 21<sup>st</sup>, 2025).

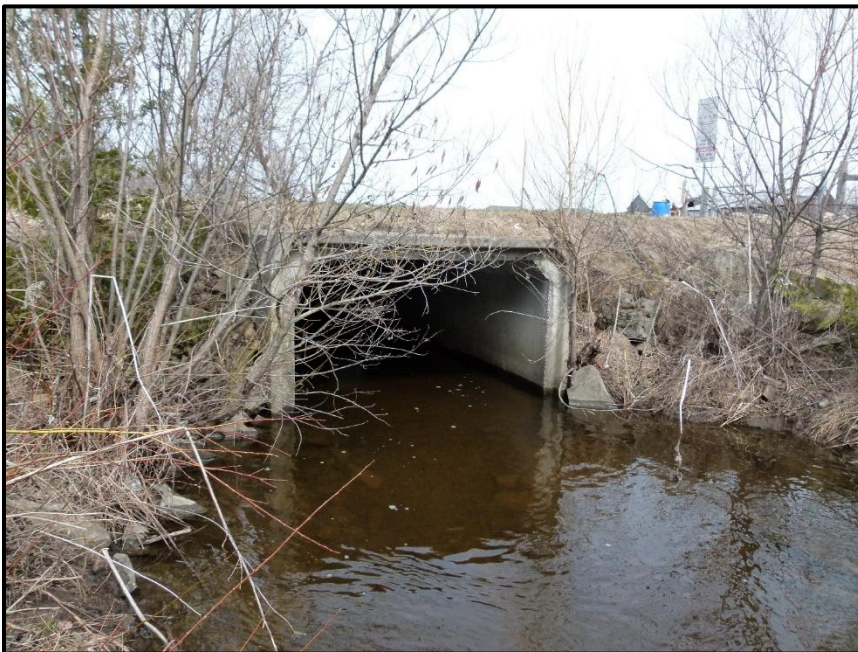
**Photograph 18:** Looking upstream at the large box culvert under the driveway that leads to the old farmhouse (April 21<sup>st</sup>, 2025).

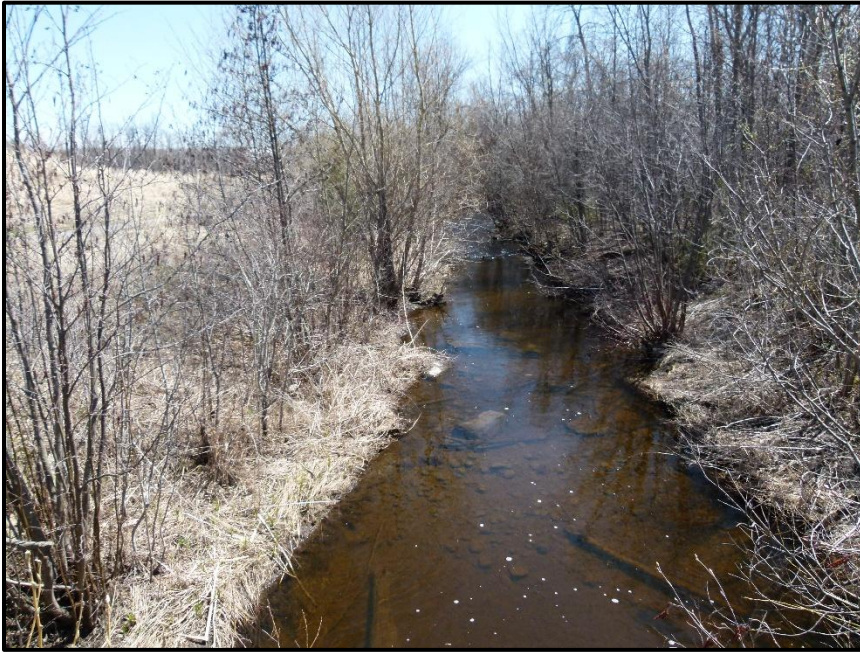
**Photograph 19:** Looking downstream along Findlay Creek in the southeastern part of the Site (April 28<sup>th</sup>, 2025).

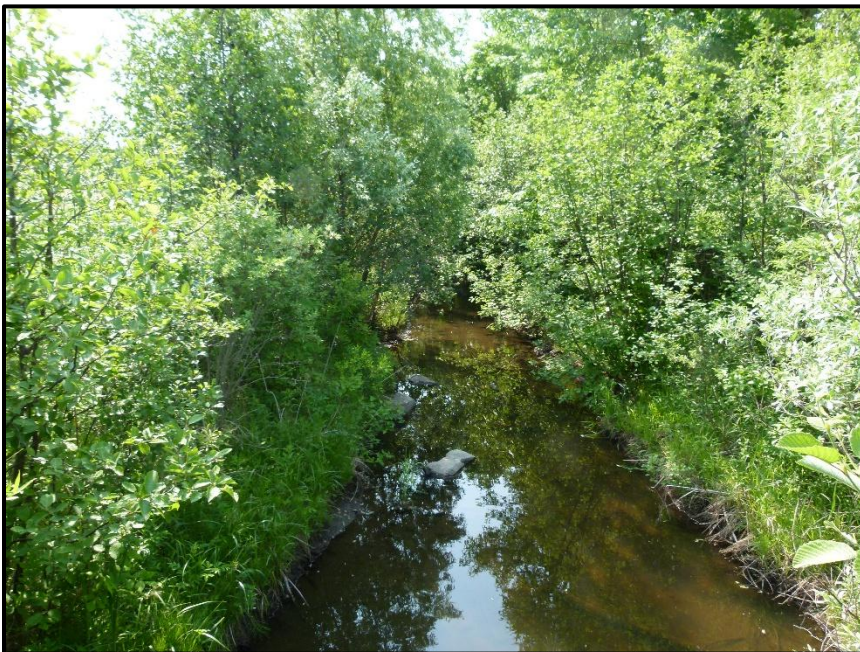
**Photograph 20:** Looking downstream along Findlay Creek in the southeastern part of the Site (June 10<sup>th</sup>, 2025).

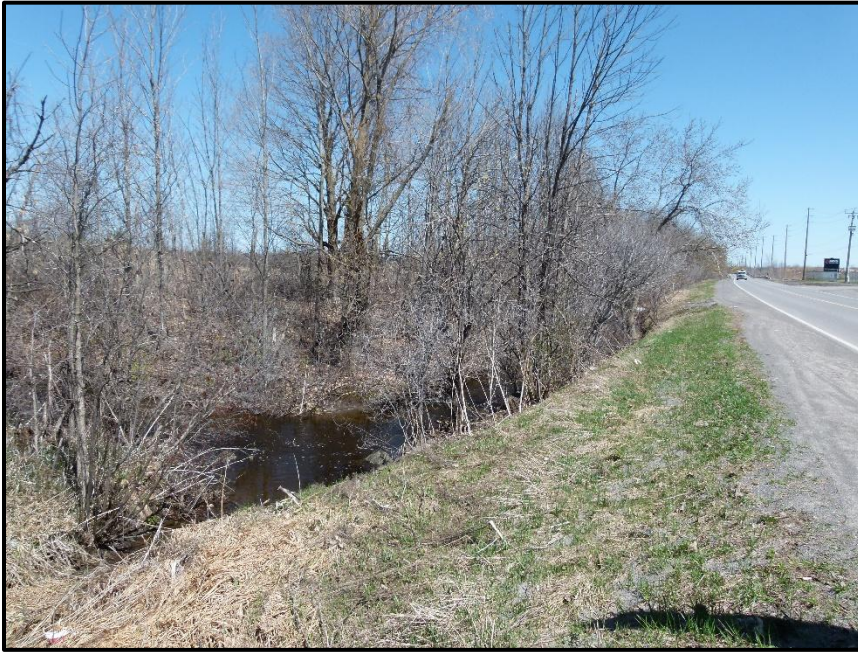
**Photograph 21:** Looking downstream along Findlay Creek where it flows through the Blais Road ditch (April 28<sup>th</sup>, 2025).

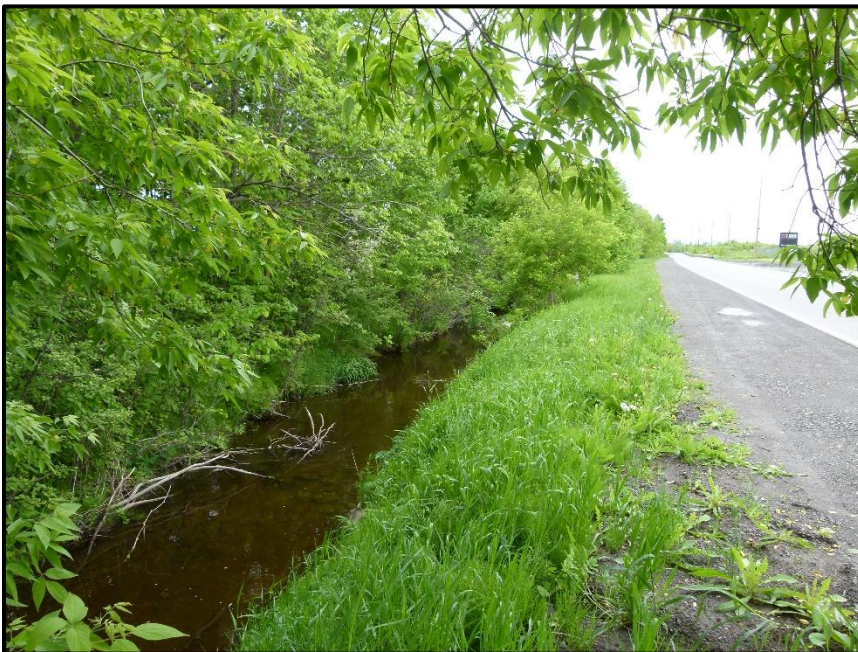
**Photograph 22:** Looking downstream along Findlay Creek where it flows through the Blais Road ditch (June 2<sup>nd</sup>, 2025).

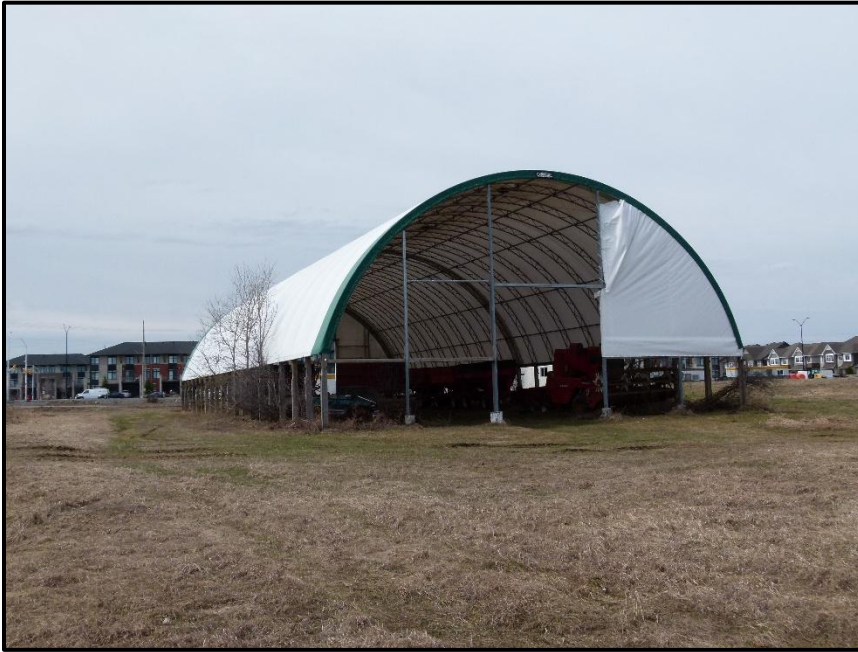
- **Building #1:** Building #1 is a large Quonset hut constructed from galvanized metal and plastic sheeting. The Quonset hut is open at the bottom. No evidence of Barn Swallow nesting was observed within Building #1.

**Photograph 23:** Looking west at Building #1. No evidence of Barn Swallow nesting was observed within Building #1 (April 21<sup>st</sup>, 2025).

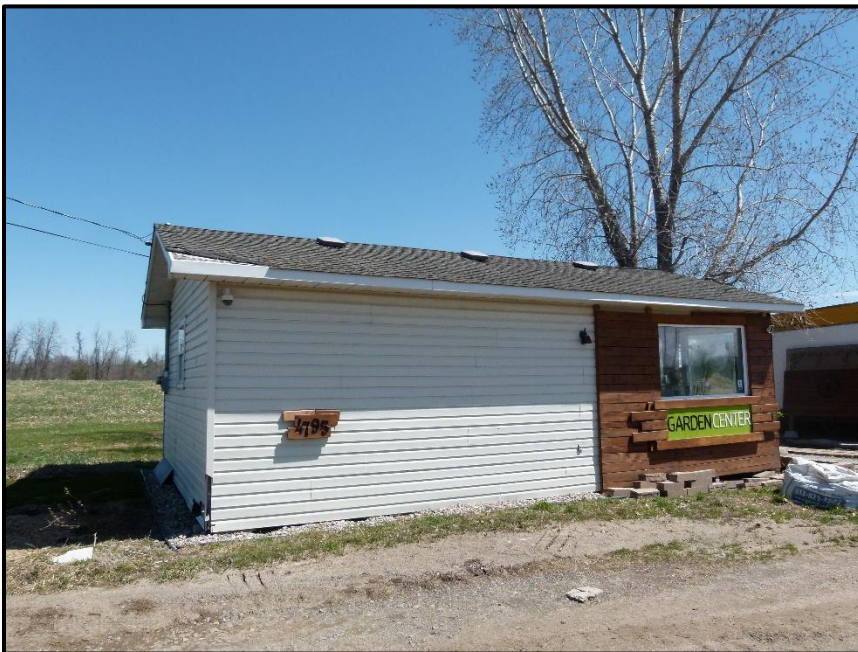
- **Building #2:** Building #2 is a small bungalow with vinyl siding and a shingled roof. The bungalow is well sealed and well maintained. The bungalow does not have a chimney. No evidence of Barn Swallow nesting was observed within Building #2.

**Photograph 24:** Looking east at Building #2. No evidence of Barn Swallow nesting was observed within Building #2 (April 28<sup>th</sup>, 2025).

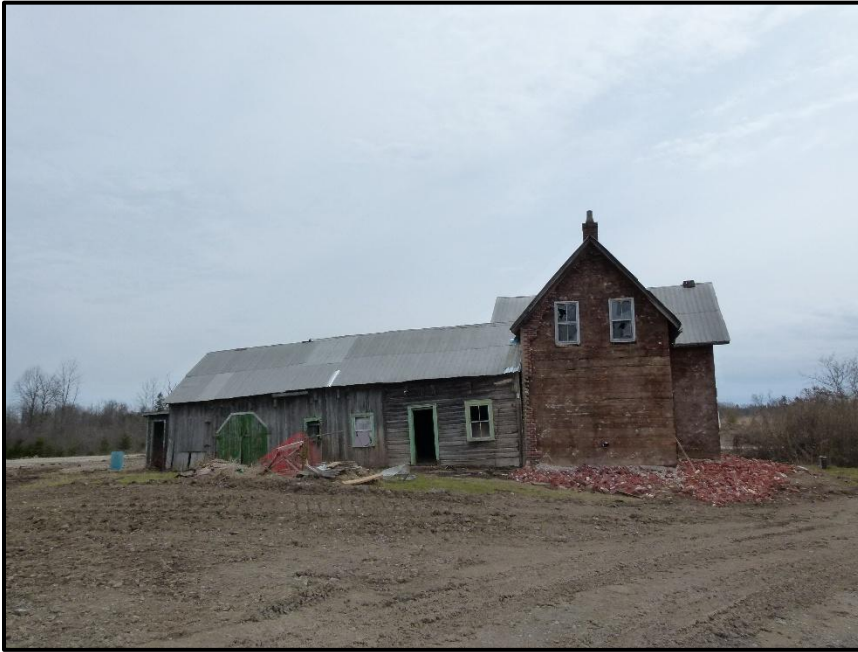
- **Building #3:** Building #3 is a farmhouse with brick walls and a metal roof. The farmhouse has an attached garage/workshop with wooden walls and a metal roof. The farmhouse has been partially demolished and is accessible through open doors and windows. Active Barn Swallow nests were observed within the garage/workshop attached to the farmhouse. The chimney of the farmhouse has a metal cap and therefore it is not suitable for Chimney Swift nesting.

**Photograph 25:** Looking south at Building #3. Active Barn Swallow nests were observed within the garage/workshop attached to the farmhouse (April 21<sup>st</sup>, 2025).

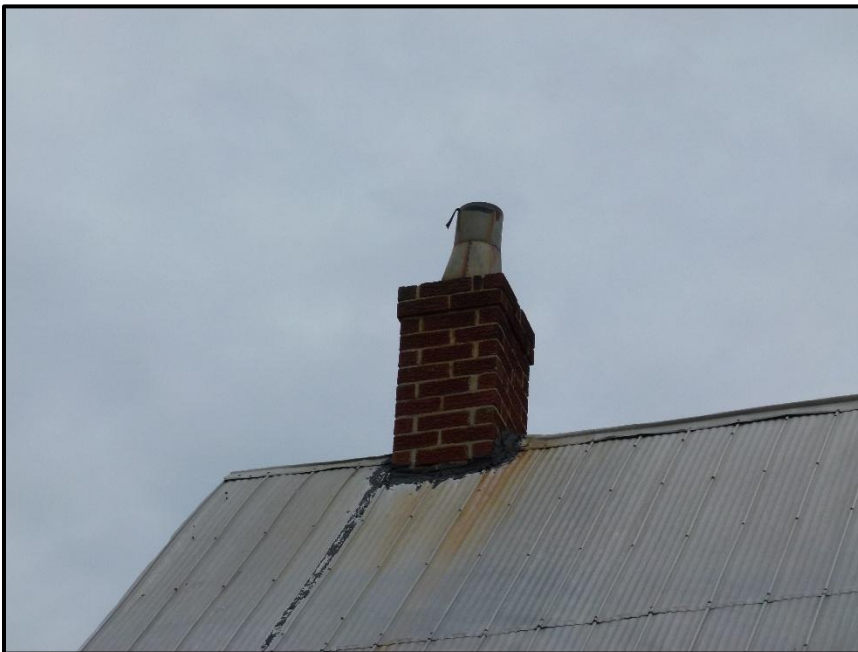
**Photograph 26:** A close-up of the metal cap on the chimney of Building #3 (April 21<sup>st</sup>, 2025).

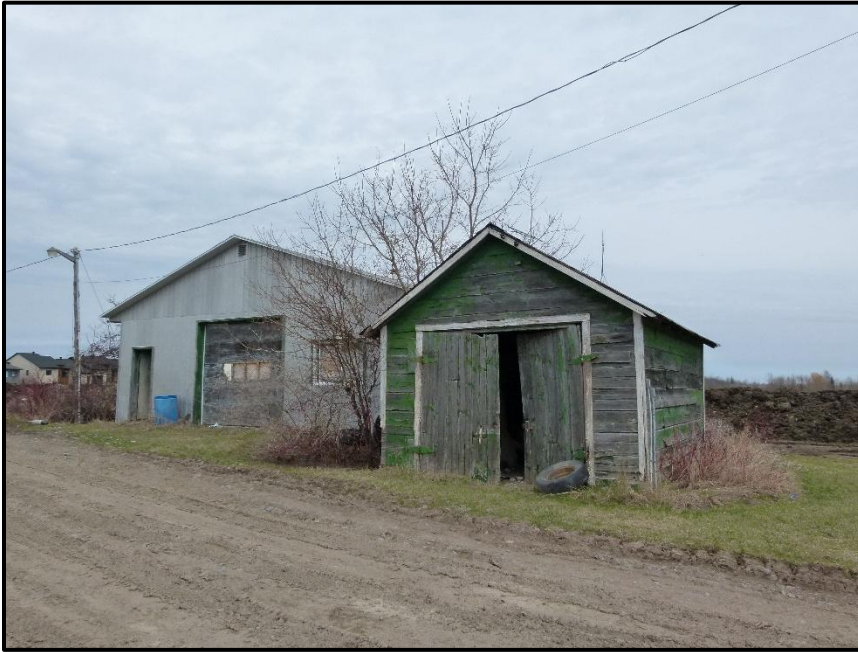
- **Building #4:** Building #4 includes two adjacent storage sheds that are made from wood and galvanized metal. The doors of the storage sheds are open and accessible. Several inactive Barn Swallow nests were observed within the smaller shed, indicating that Barn Swallows historically nested in the smaller shed.

**Photograph 27:** Looking east at Building #4. Inactive Barn Swallow nests were observed in the smaller shed (April 21<sup>st</sup>, 2025).

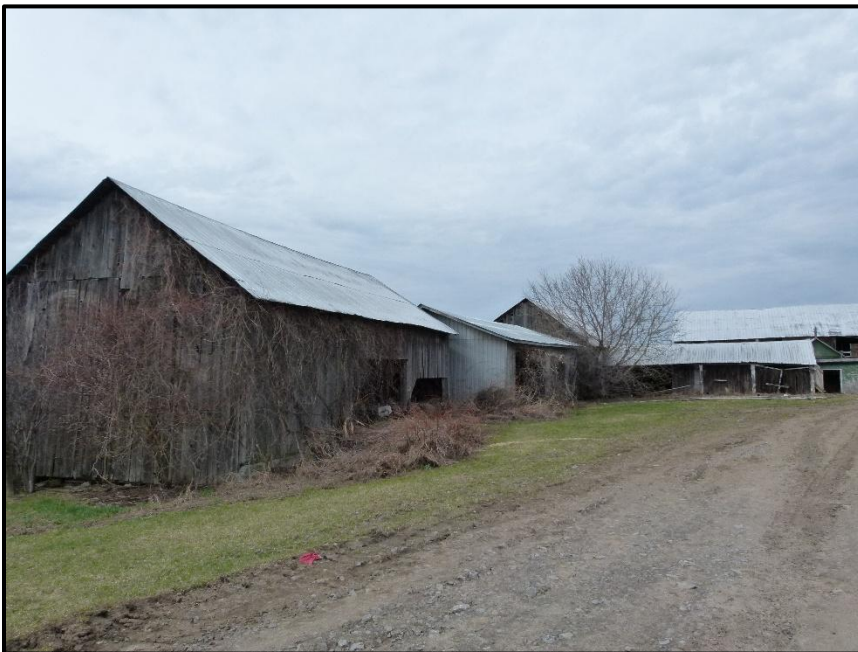
**Photograph 28:** Looking northwest at Building #5. Active Barn Swallow nests were observed within Building #5 (April 21<sup>st</sup>, 2025).

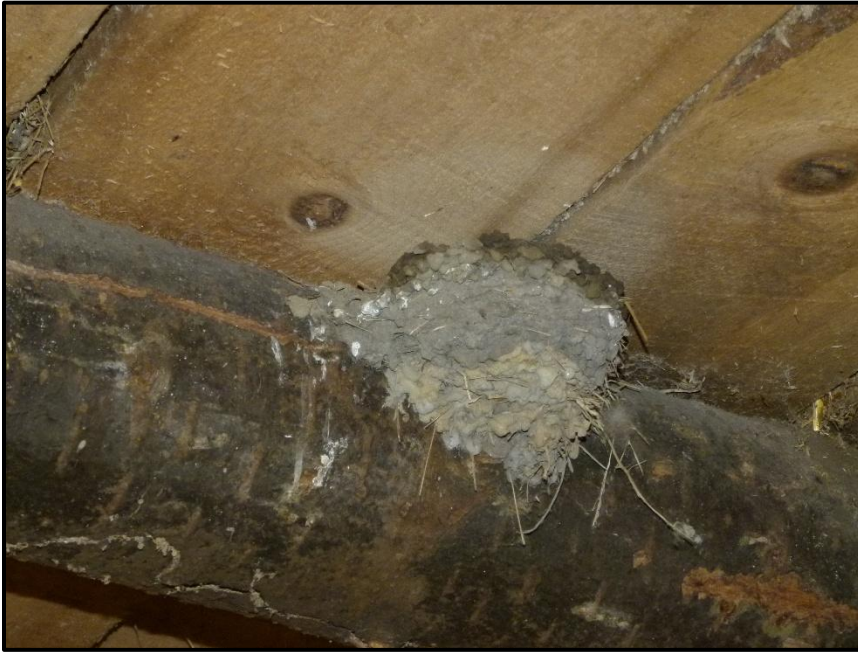
**Photograph 29:** An active Barn Swallow nest within Building #5 (May 16<sup>th</sup>, 2025).

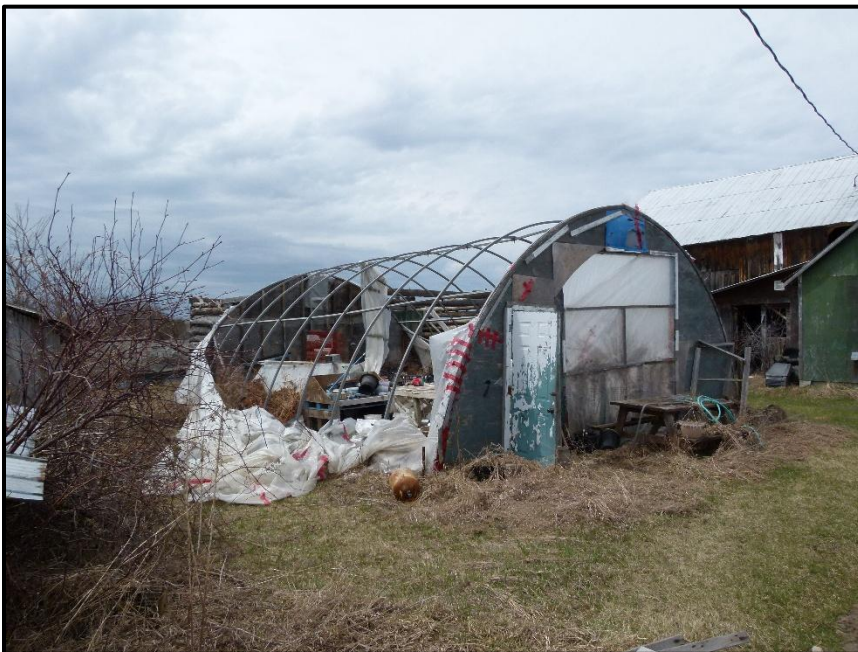
**Photograph 30:** Looking northwest at Building #6. No evidence of Barn Swallow nesting was observed within Building #6 (April 21<sup>st</sup>, 2025).

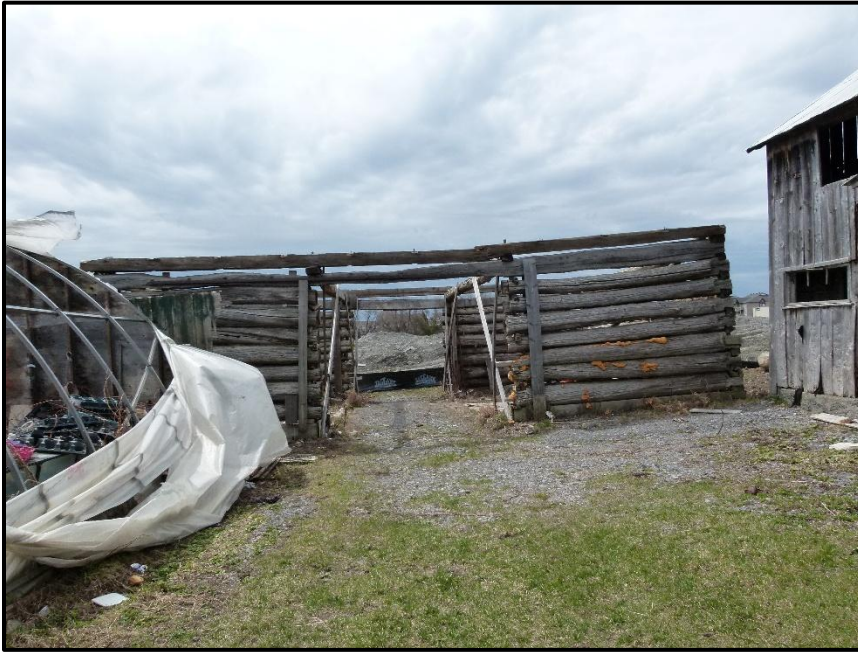
**Photograph 31:** Looking west at Building #7. No evidence of Barn Swallow nesting was observed within Building #7 (April 21<sup>st</sup>, 2025).

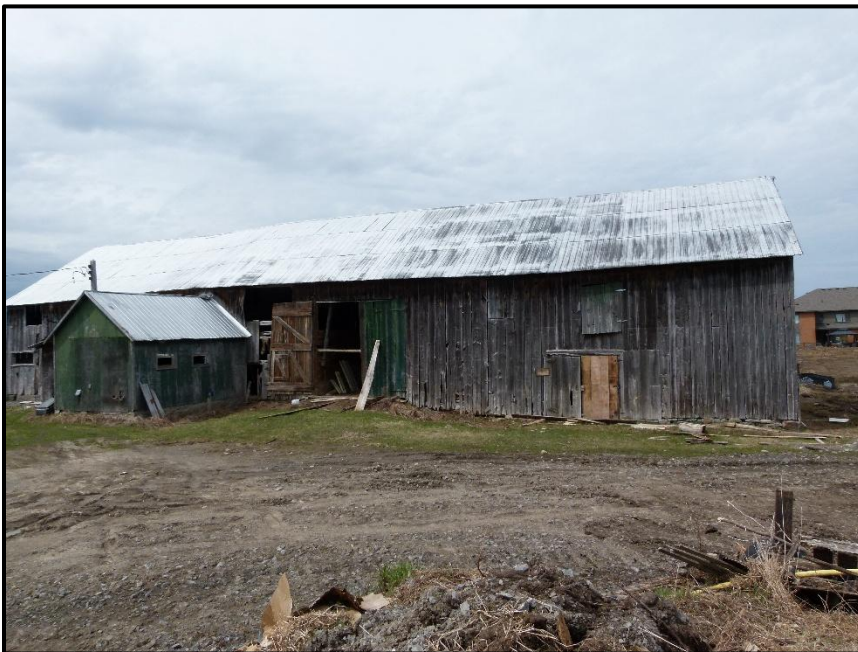
**Photograph 32:** Looking north at Building #8. Active Barn Swallow nests were observed within Building #8 (April 21<sup>st</sup>, 2025).

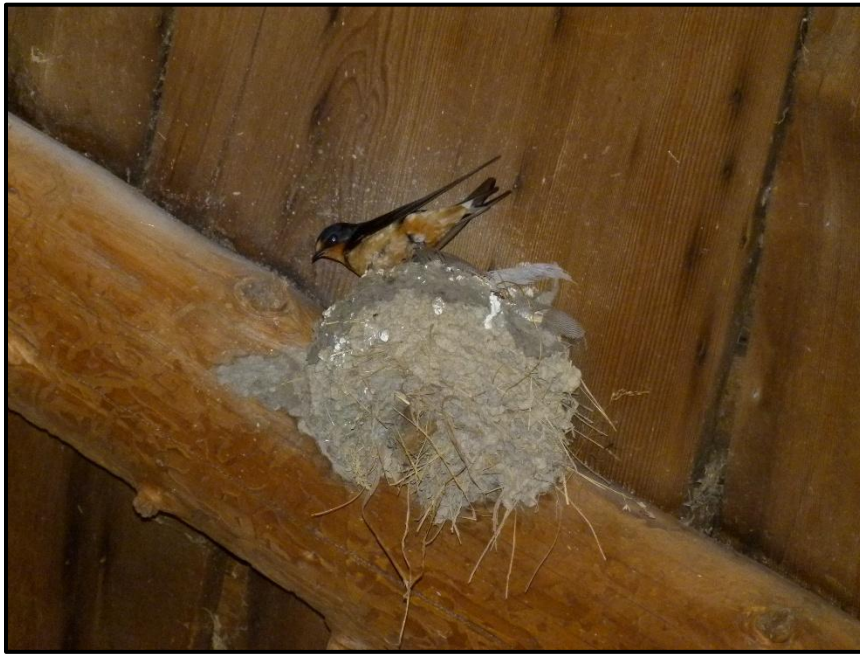
**Photograph 33:** An adult Barn Swallow roosting in an active nest within Building #8 (June 10<sup>th</sup>, 2025).

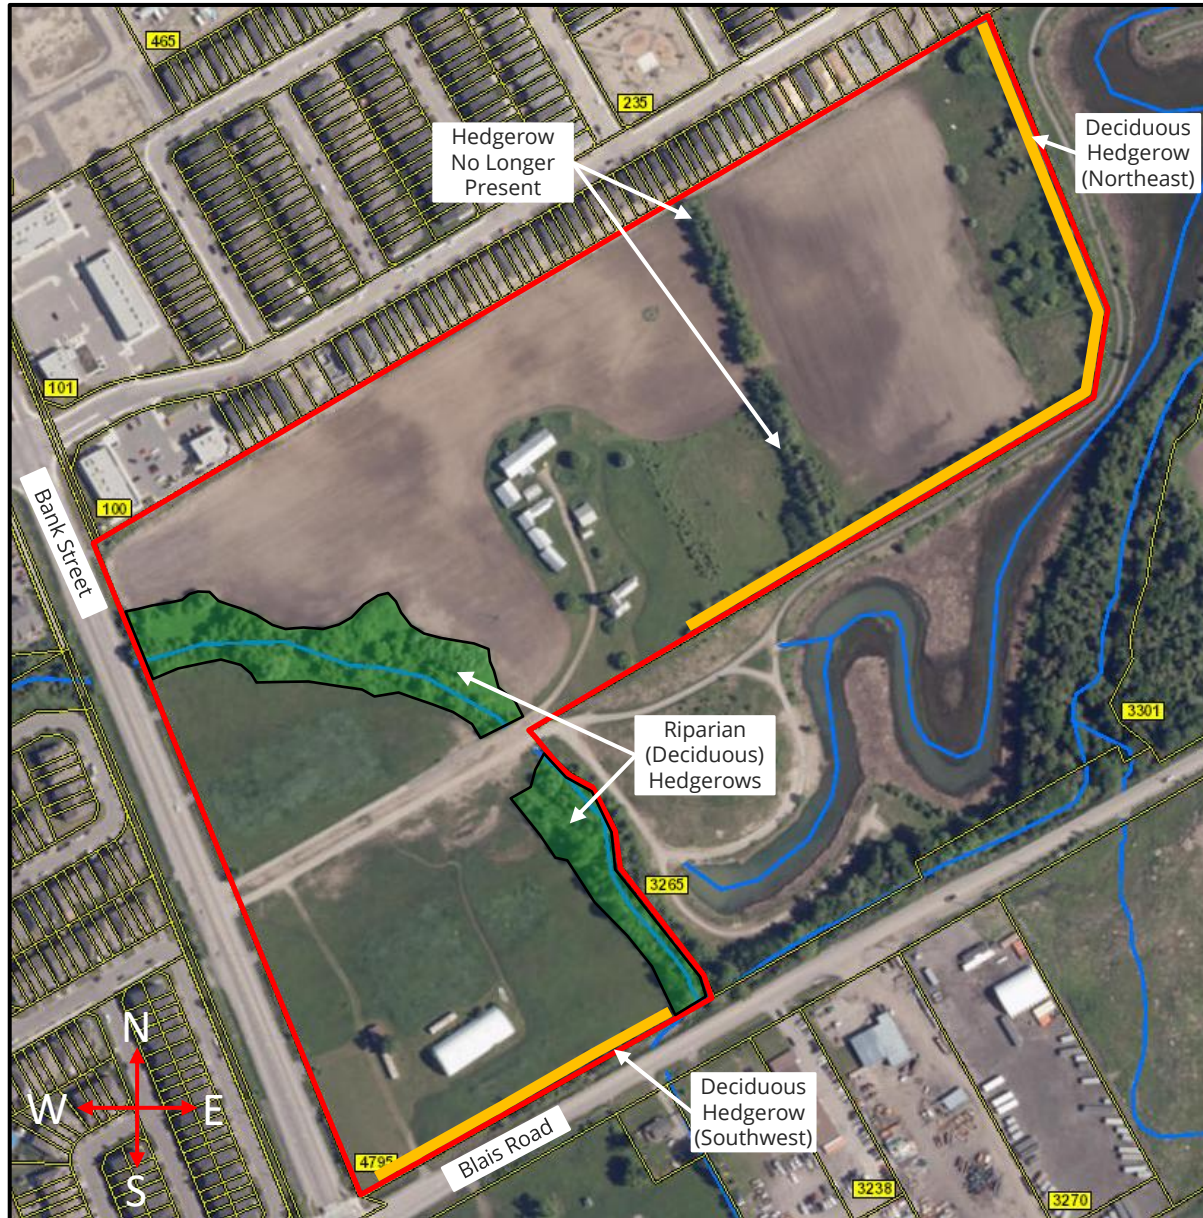
# FIGURE 6: PRE-DEVELOPMENT TREE COVER

Mapping taken from City of Ottawa (2026). Please Note: This is not a legal land survey. All dimensions and locations are shown as approximate.

The pre-development tree cover is shown below in Figure 6. As described above in Section 3.3, the majority of the Site consists of open habitats that lack mature tree cover. The mature tree cover within the Site is limited to the two Deciduous Hedgerows and the Riparian (Deciduous) Hedgerows. The two Deciduous Hedgerows overlap future development areas and therefore they will be removed as part of the future development of the Site. The two Deciduous Hedgerows are not significant ecological features, and therefore their removal is not anticipated to have a significant ecological impact. The Riparian (Deciduous) Hedgerows will be removed during the construction of the Findlay Creek enhanced channel corridor. As described above in Section 3.3, the Riparian (Deciduous) Hedgerows surrounding Findlay Creek are highly degraded and vary between approximately 10 m and 40 m wide. Restoration planting will be undertaken throughout the 53 m wide enhanced channel corridor, which will improve the quality and quantity of the riparian vegetation community. Refer to Section 4.2.1 for additional details. All trees that are proposed to be removed are privately owned and occur within the Site.
