**McKINLEY**  
ENVIRONMENTAL  
SOLUTIONS

Combined Environmental Impact Study  
& Tree Conservation Report  
4795 Bank Street, Ottawa, ON

July 2026

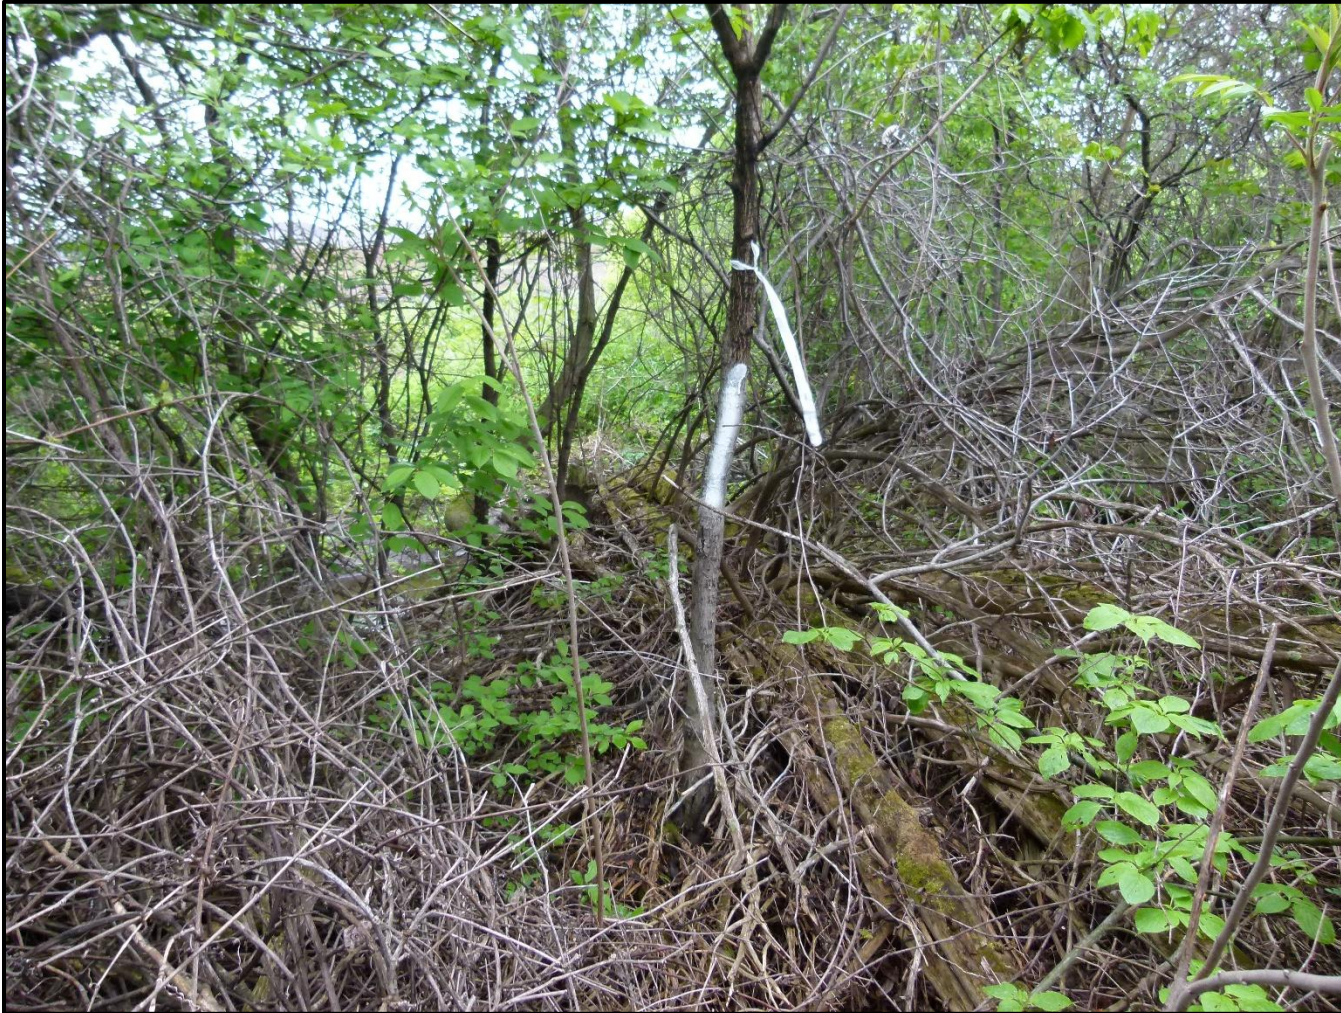
Photograph 1: Butternut Tree #1 – assessed as Category 1 (non-retainable) (May 23<sup>rd</sup>, 2025).

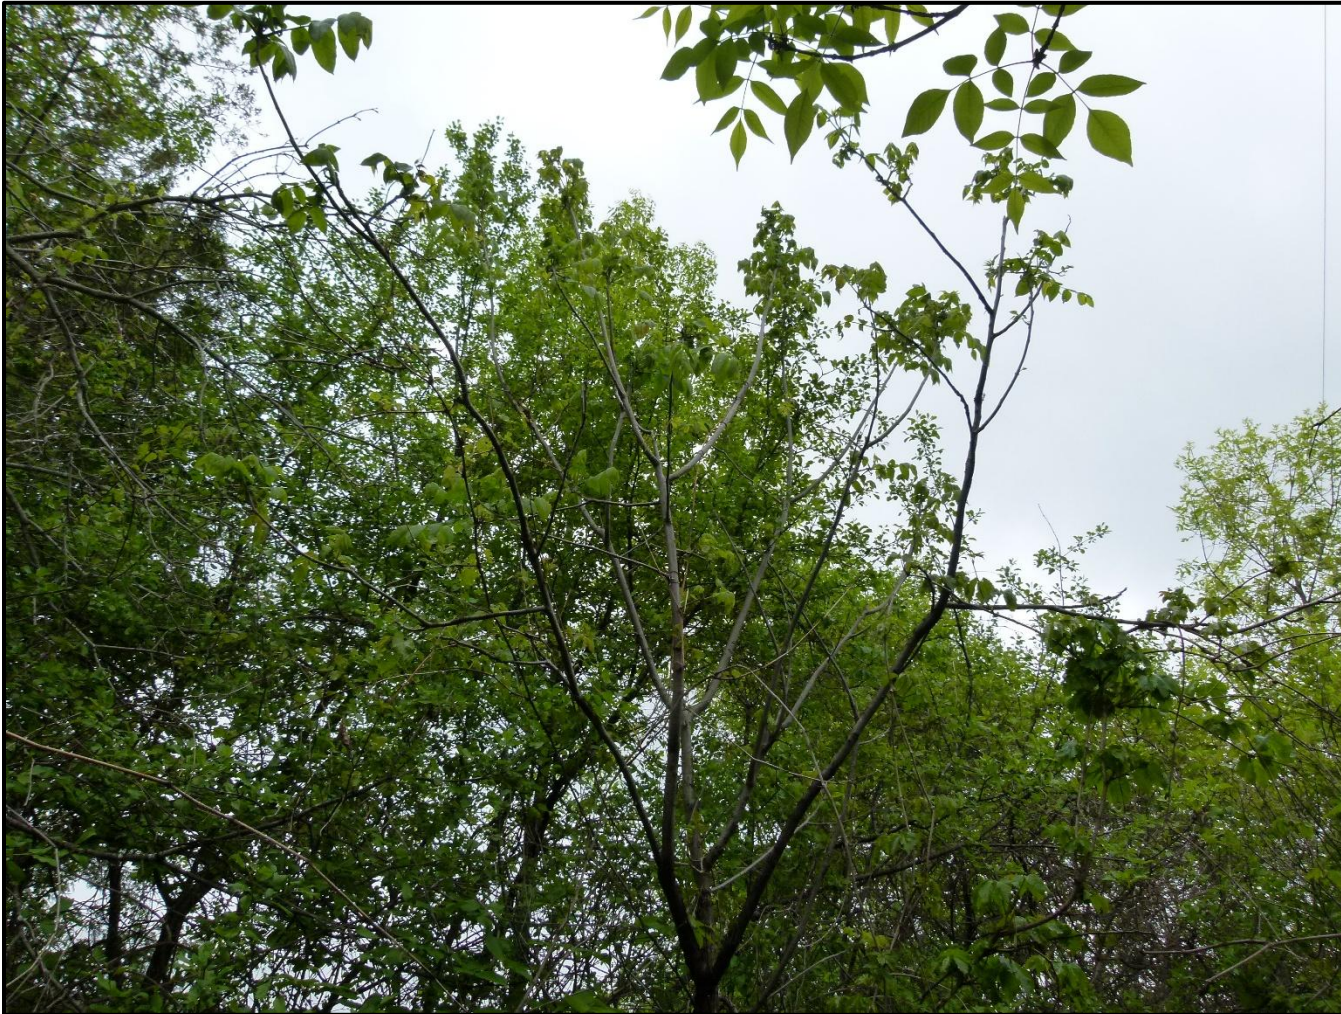
Photograph 2: Butternut Tree #1 – assessed as Category 1 (non-retainable). The live crown is relatively healthy (May 23<sup>rd</sup>, 2025).

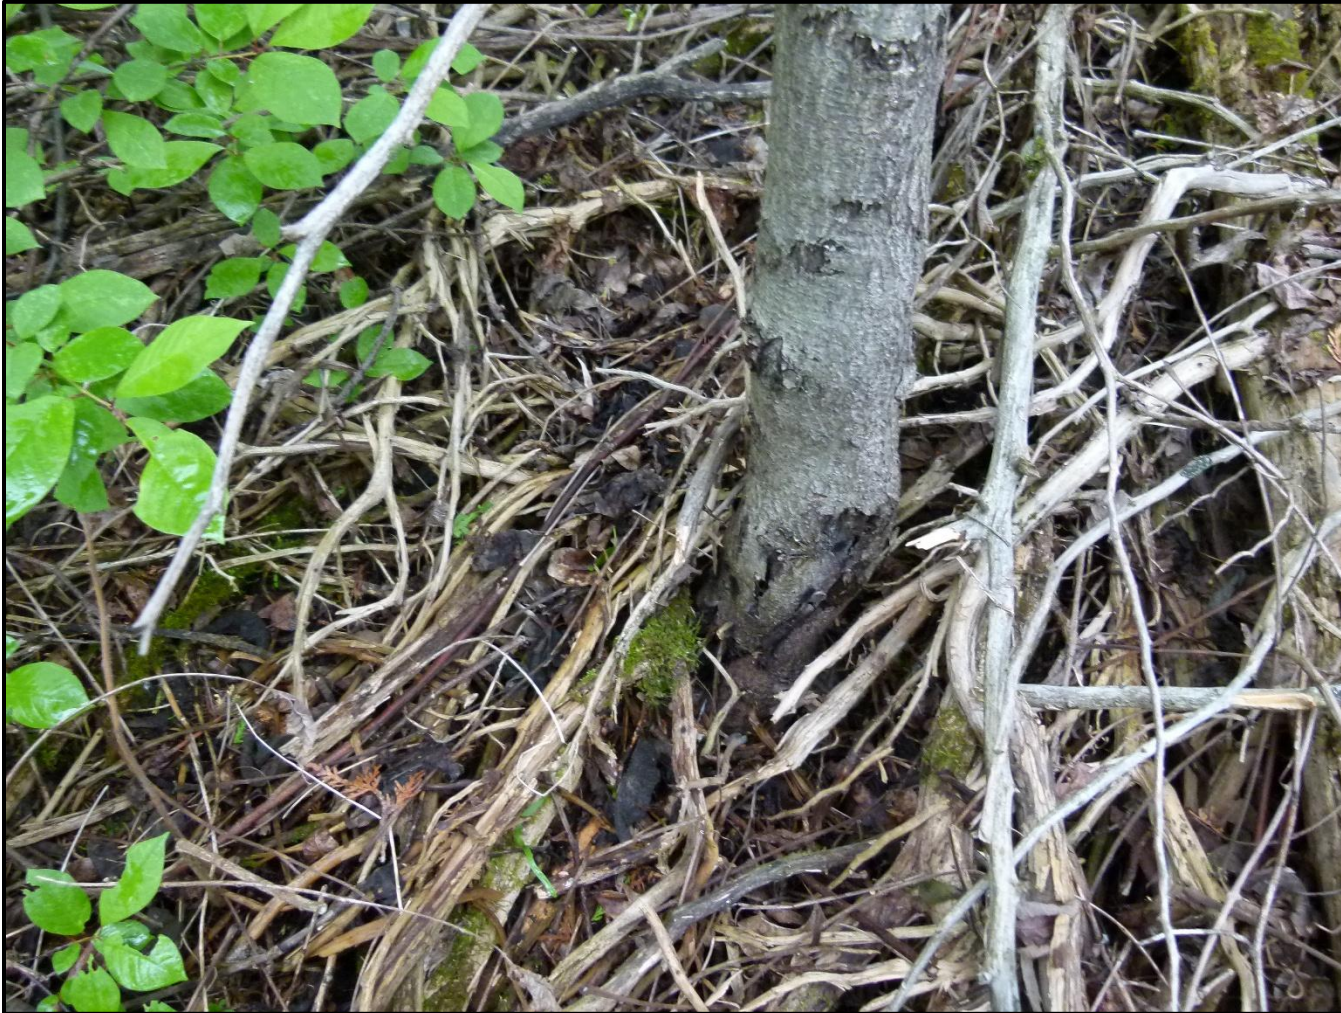
Photograph 3: Butternut Tree #1 – assessed as Category 1 (non-retainable). Extensive canker on the root flare and lower stem is visible (May 23<sup>rd</sup>, 2025).

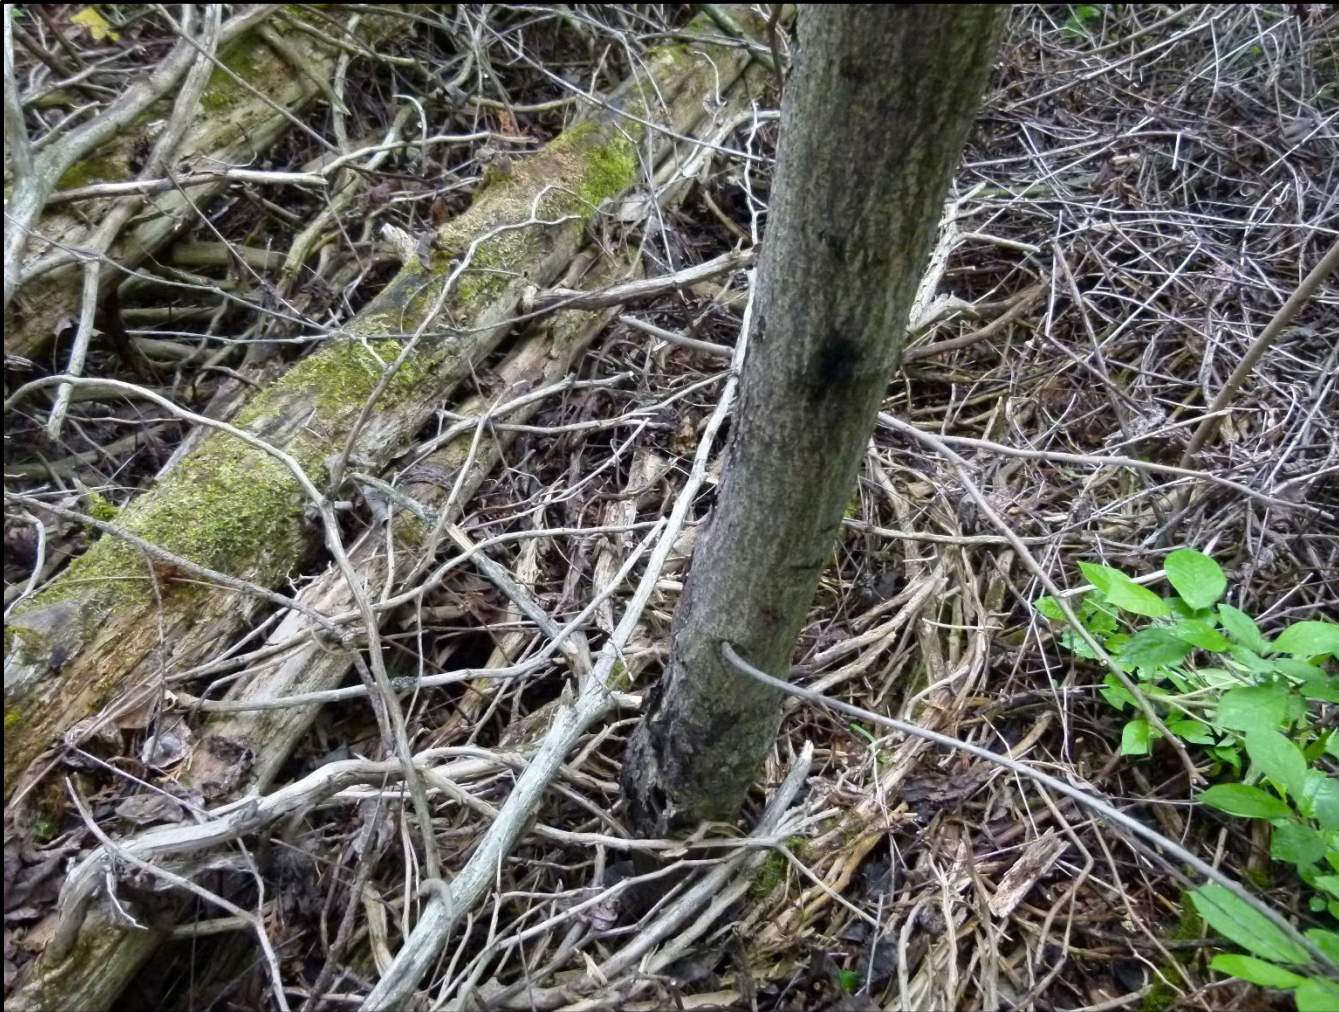
Photograph 4: Butternut Tree #1 – assessed as Category 1 (non-retainable). Extensive canker on the lower stem is visible (May 23<sup>rd</sup>, 2025).

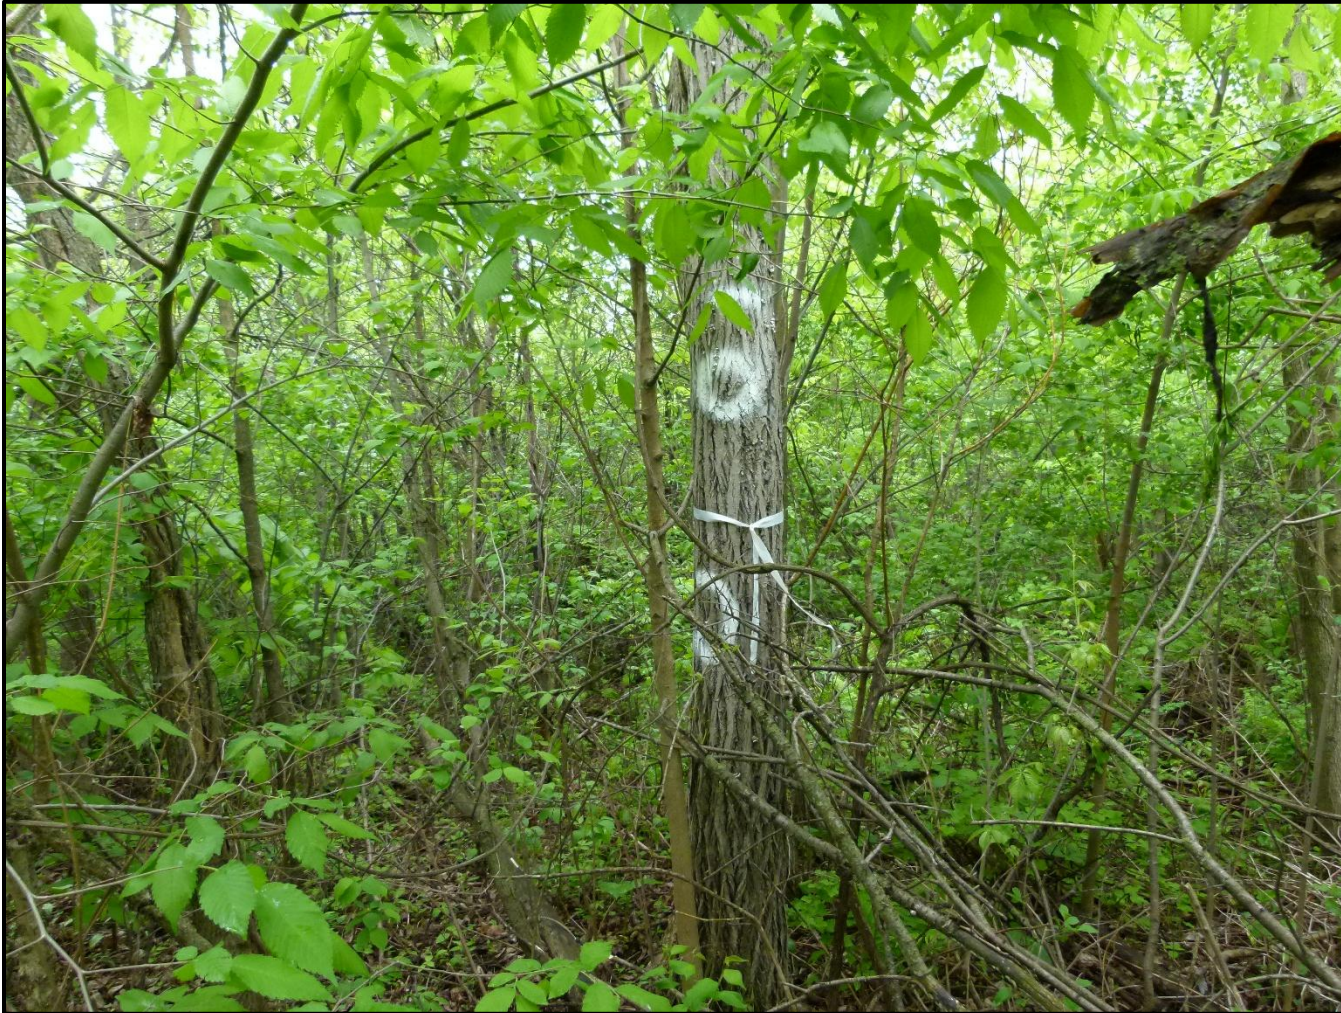
Photograph 5: Butternut Tree #2 – assessed as Category 1 (non-retainable) (May 23<sup>rd</sup>, 2025).

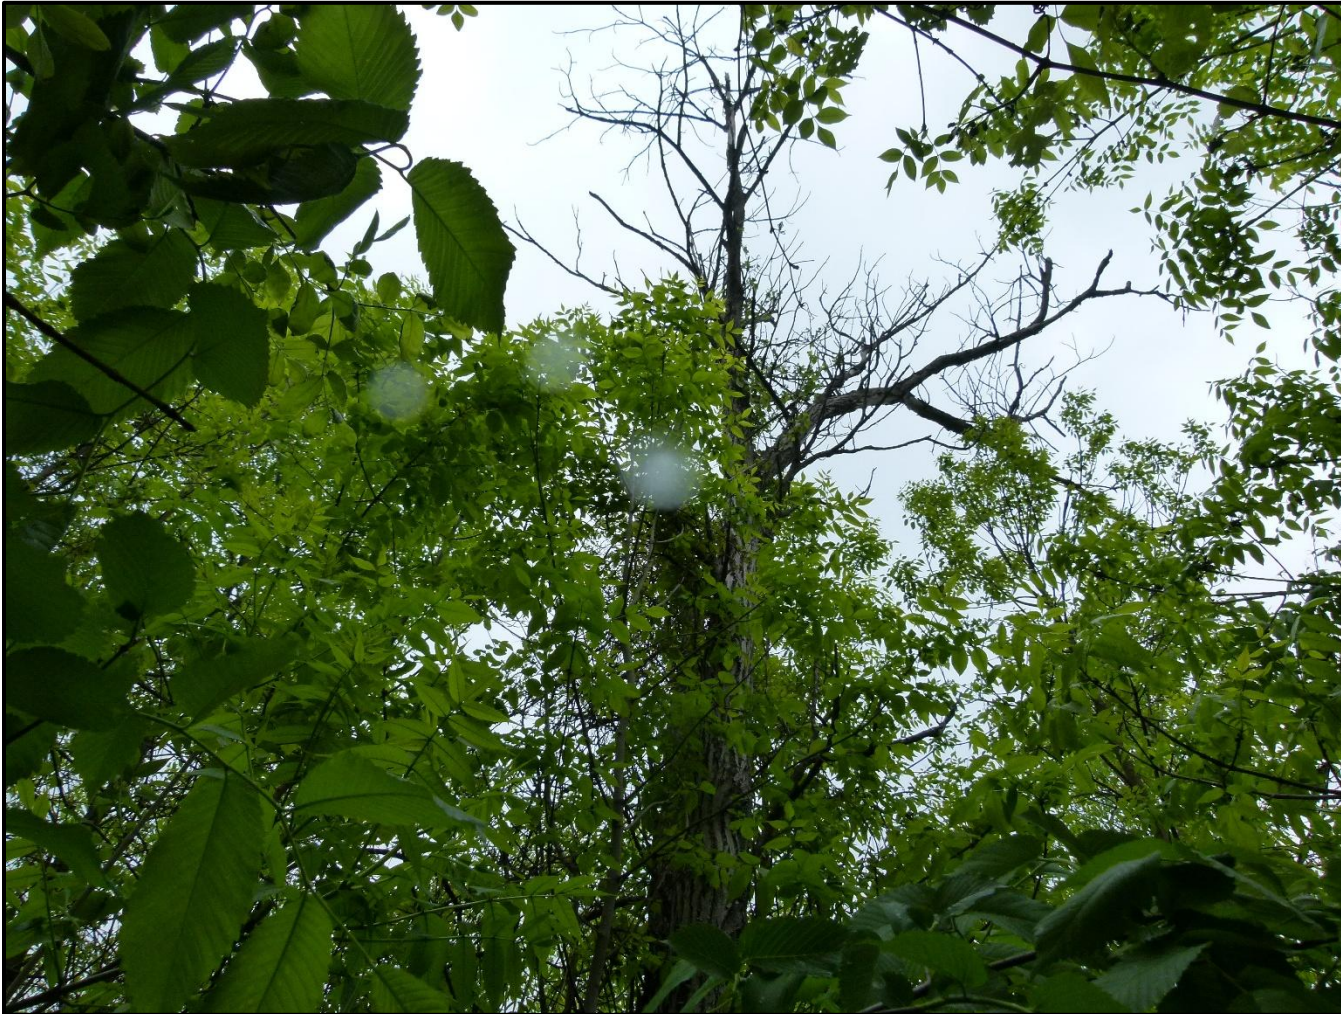
Photograph 6: Butternut Tree #2 – assessed as Category 1 (non-retainable). The crown is completely dead (May 23<sup>rd</sup>, 2025).

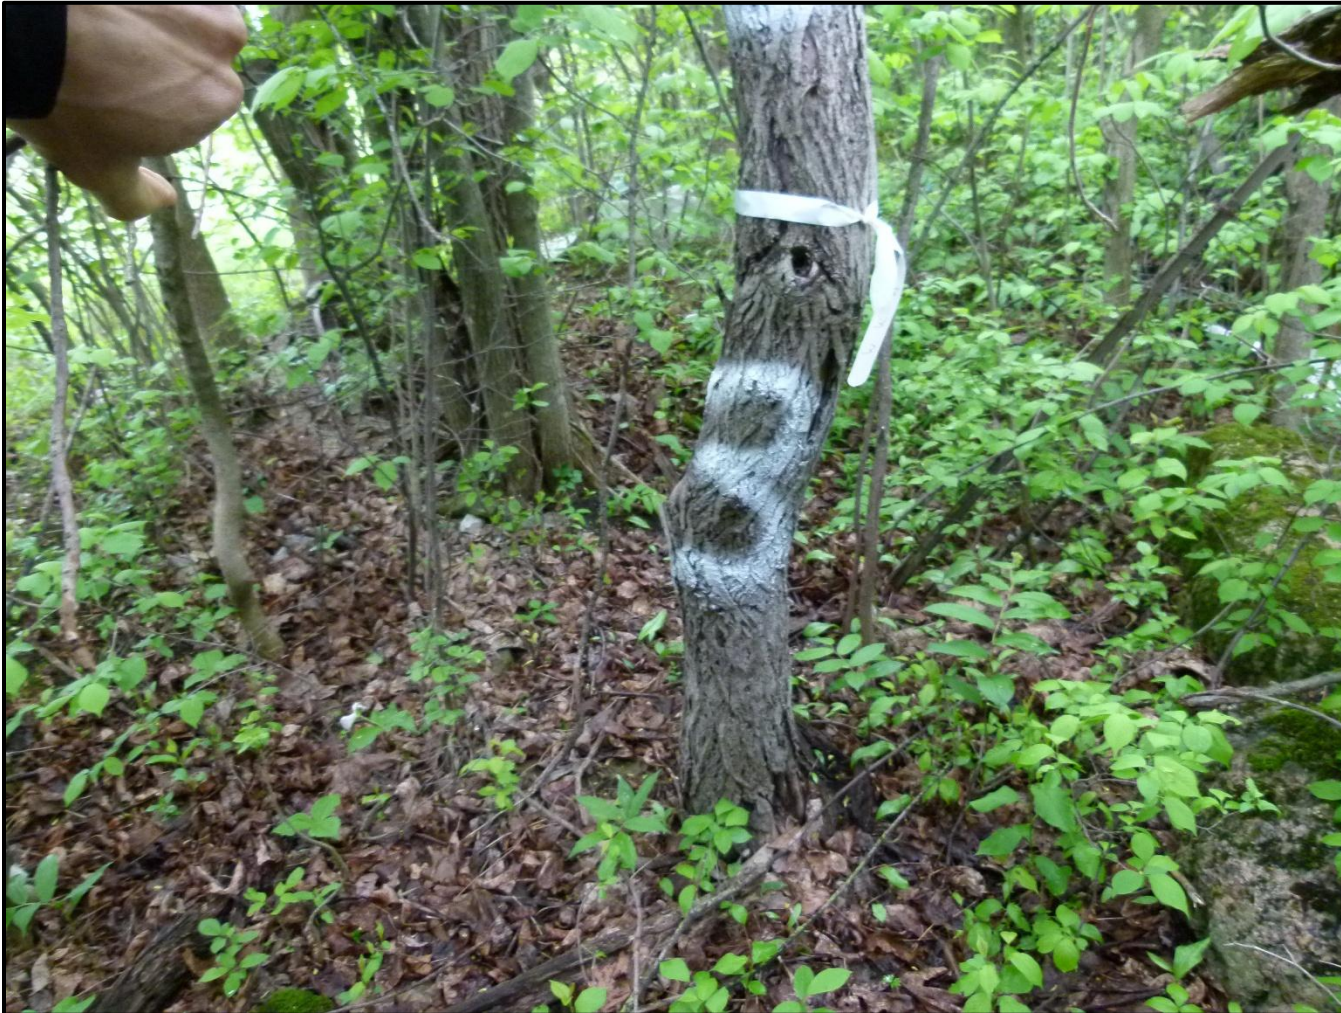
Photograph 7: Butternut Tree #3 – assessed as Category 1 (non-retainable) (May 23<sup>rd</sup>, 2025).

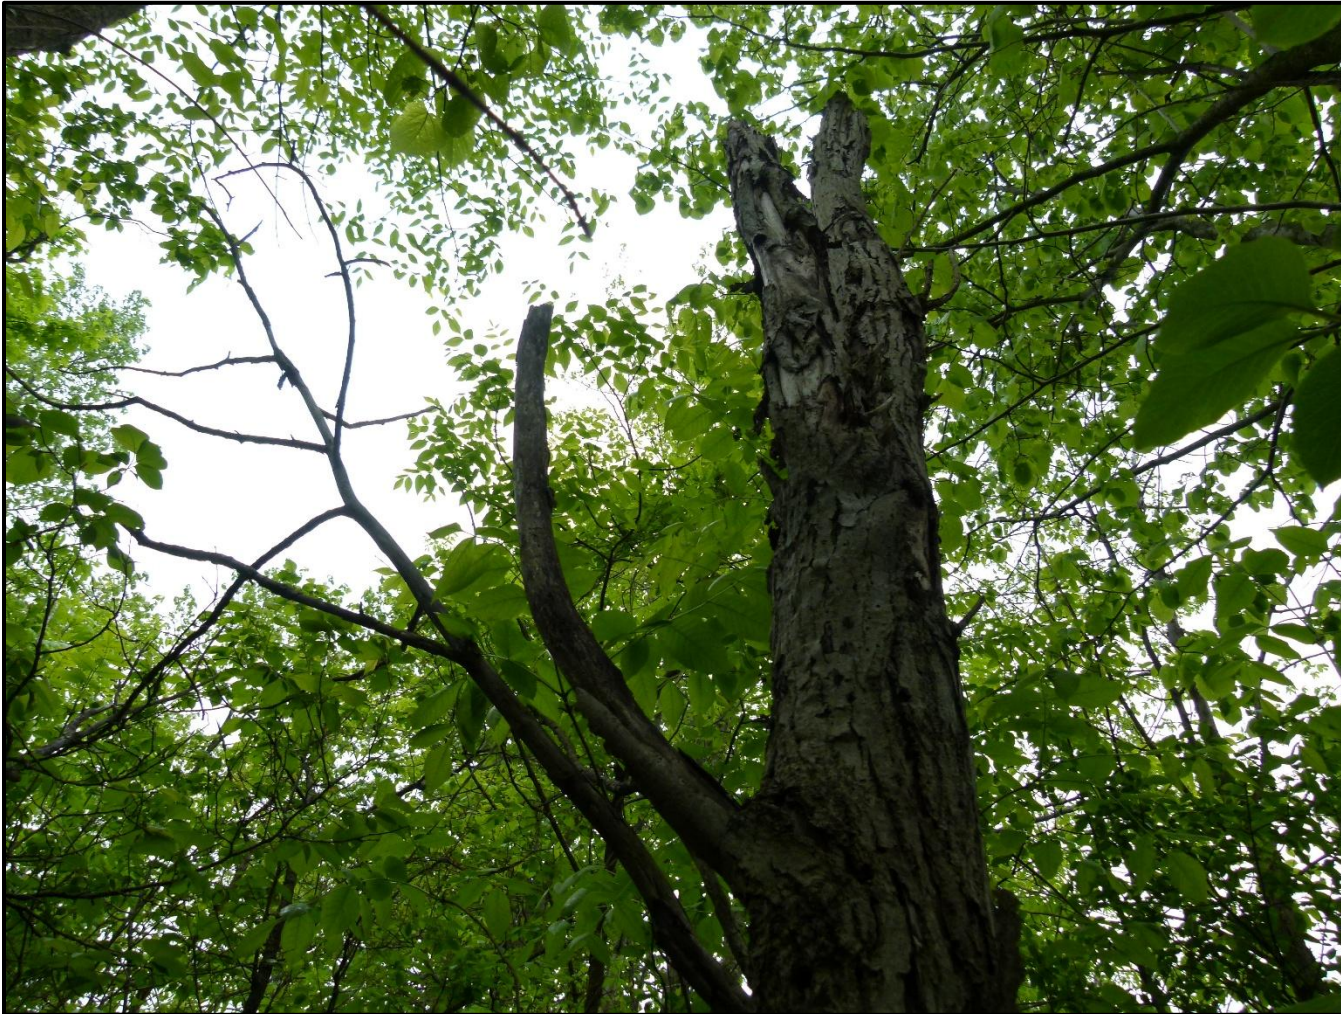
Photograph 8: Butternut Tree #3 – assessed as Category 1 (non-retainable). The crown is completely dead (May 23<sup>rd</sup>, 2025).

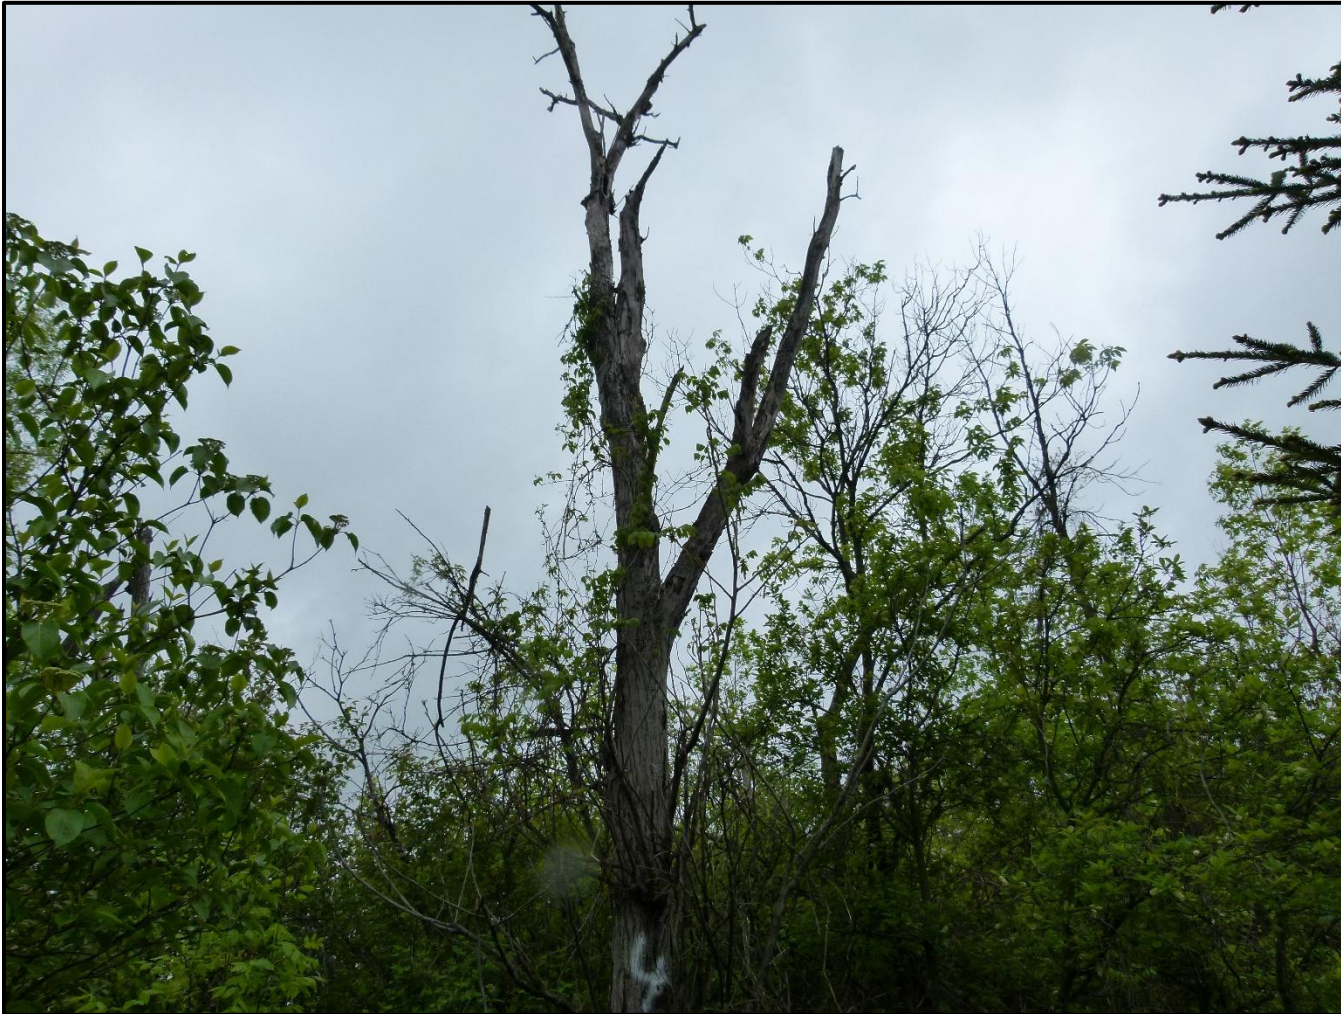
Photograph 9: Butternut Tree #4 – assessed as Category 1 (non-retainable). The crown is completely dead (May 23<sup>rd</sup>, 2025).

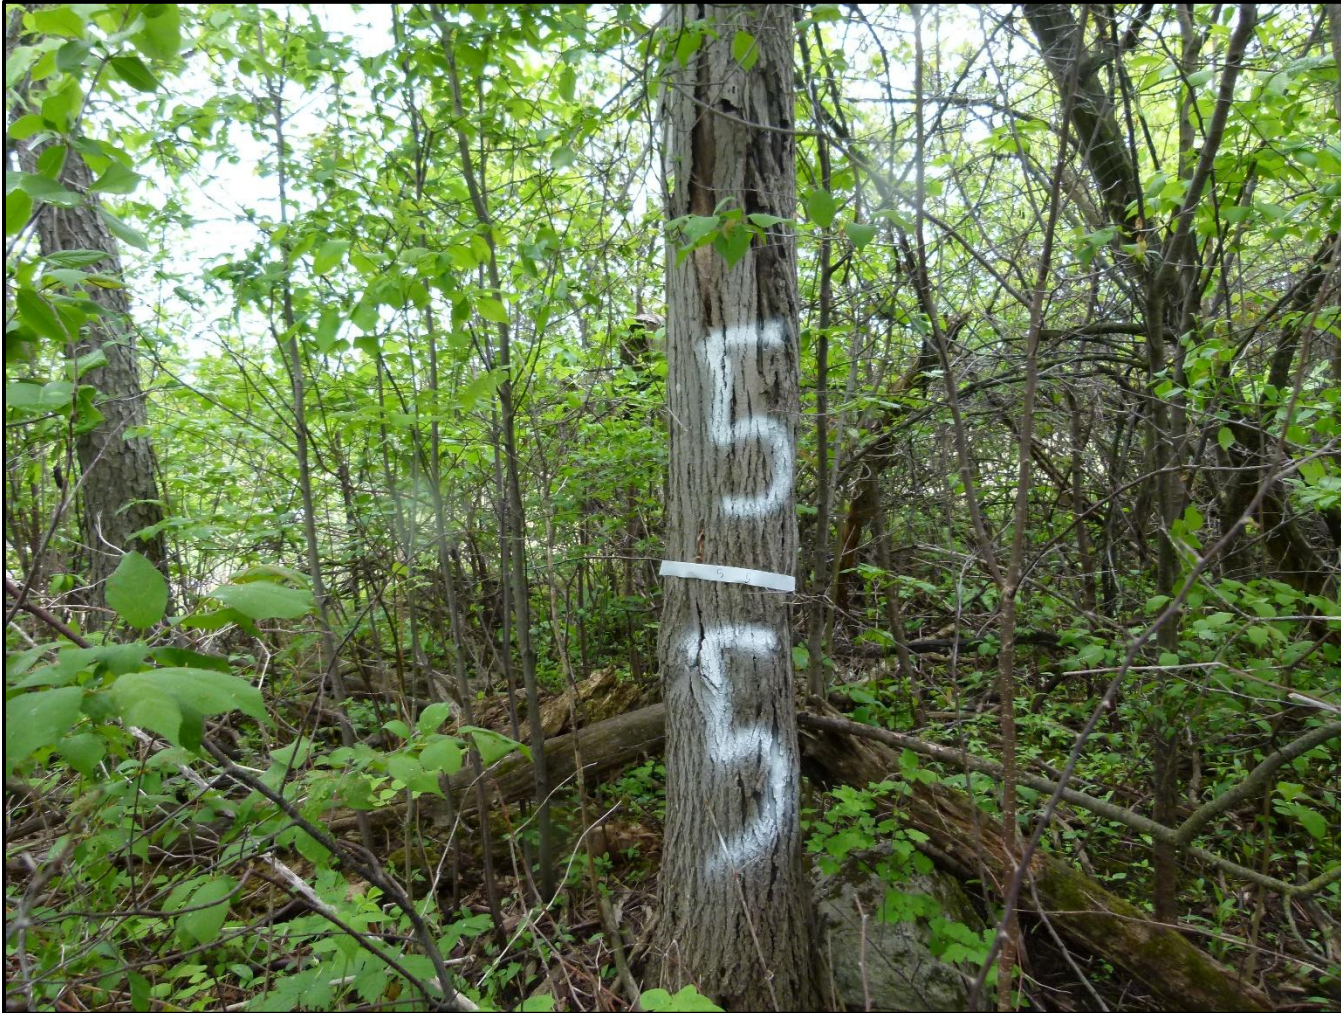
Photograph 10: Butternut Tree #5 – assessed as Category 1 (non-retainable). The stem shows extensive canker damage (May 23<sup>rd</sup>, 2025).

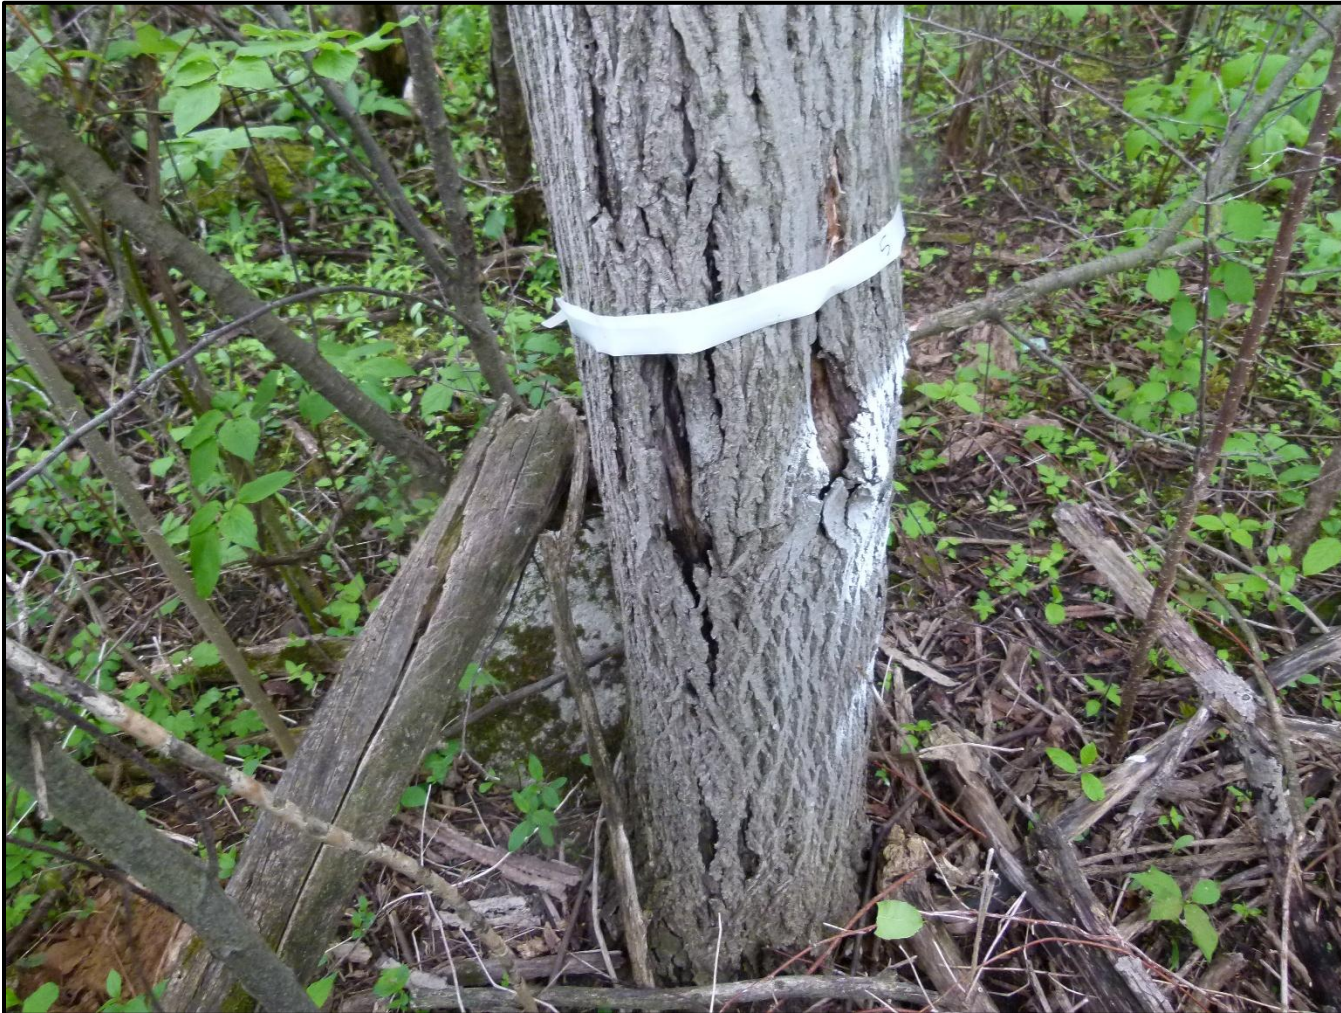
Photograph 11: Butternut Tree #5 – assessed as Category 1 (non-retainable). The stem shows extensive canker damage (May 23<sup>rd</sup>, 2025).

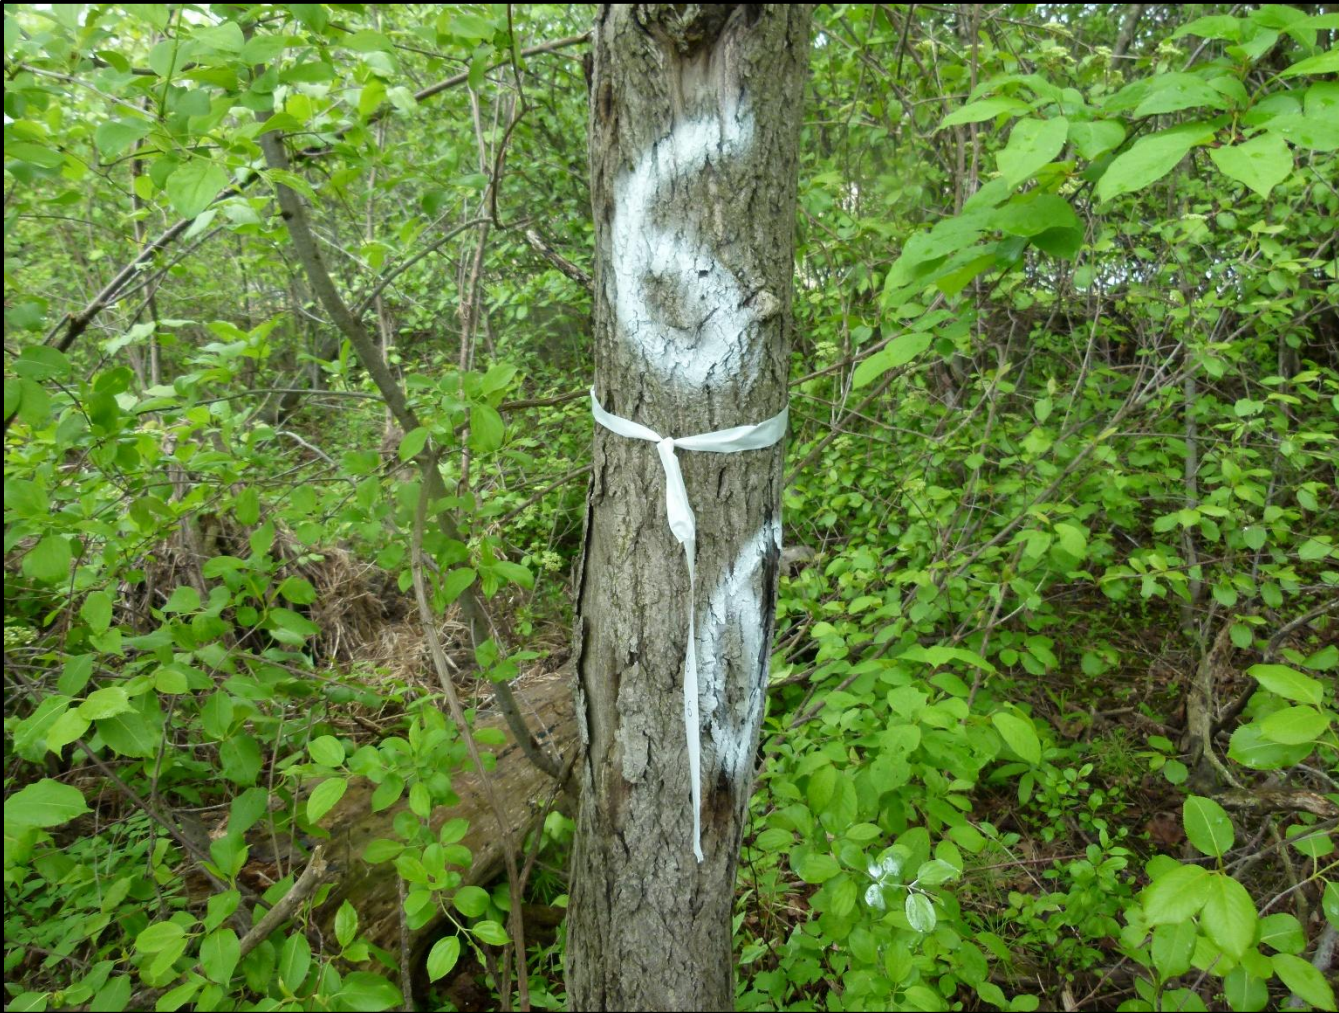
Photograph 12: Butternut Tree #6 – assessed as Category 1 (non-retainable). Extensive canker is visible on the lower stem (May 23<sup>rd</sup>, 2025).

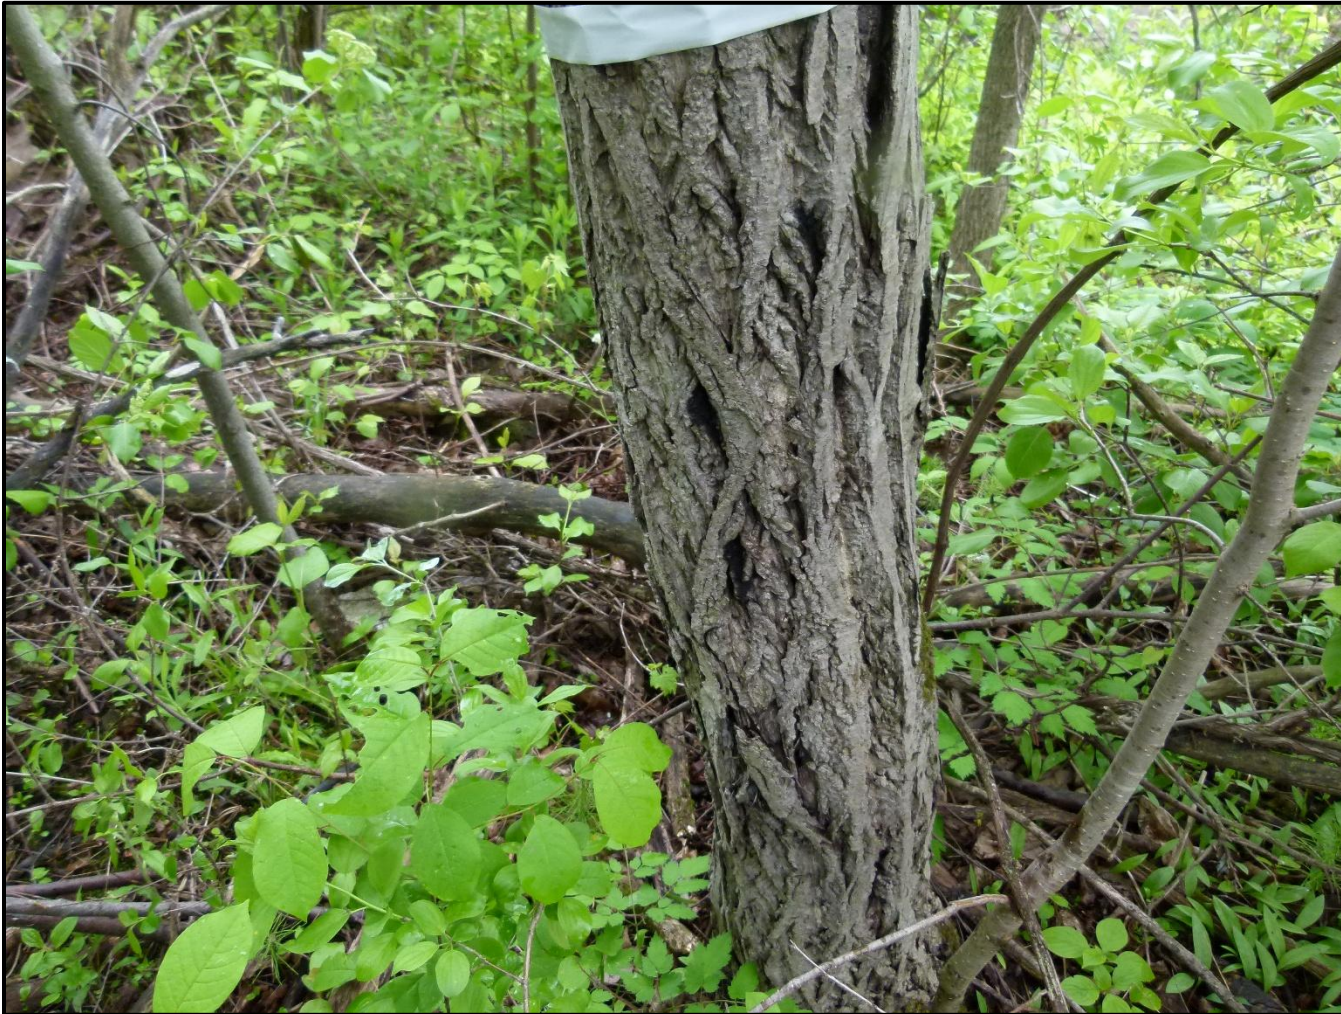
Photograph 13: Butternut Tree #6 – assessed as Category 1 (non-retainable). Extensive canker is visible on the lower stem (May 23<sup>rd</sup>, 2025).

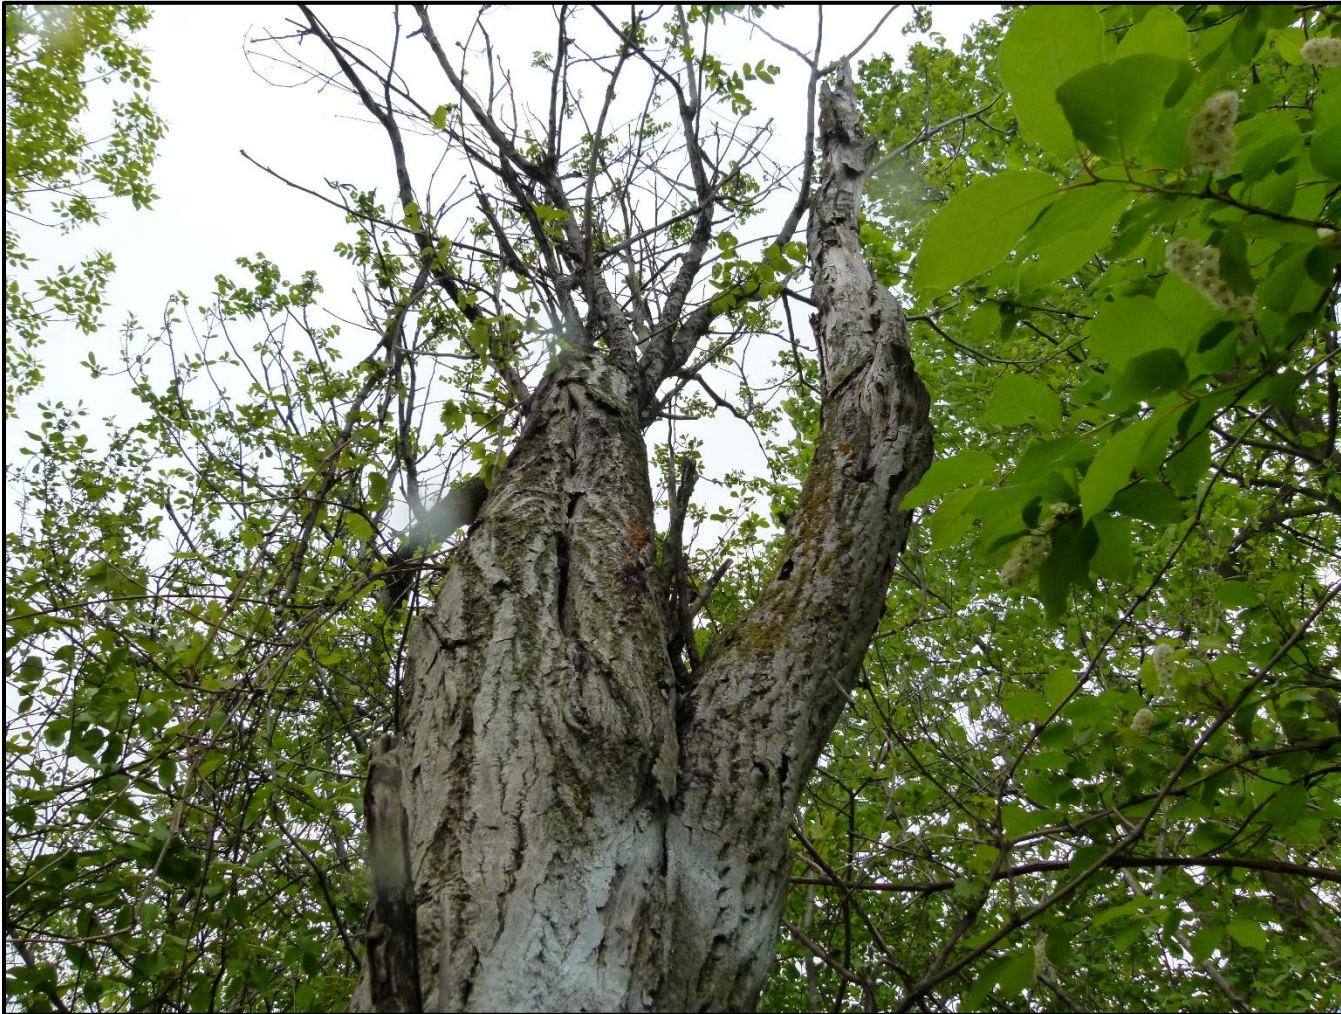
Photograph 14: Butternut Tree #6 – assessed as Category 1 (non-retainable). The upper stem and crown are in poor condition (May 23<sup>rd</sup>, 2025).

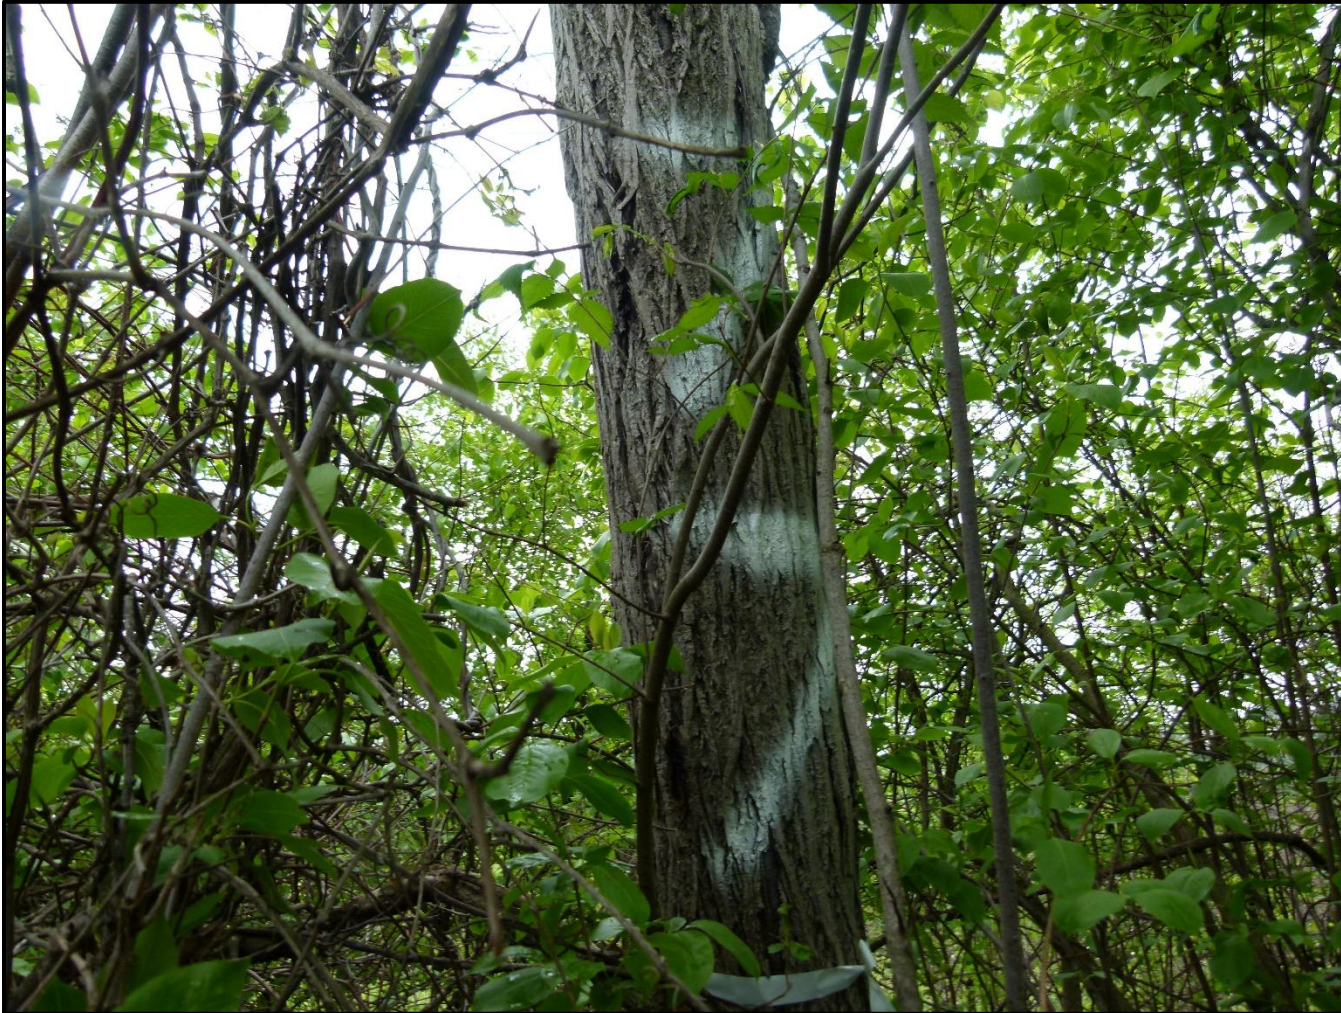
Photograph 15: Butternut Tree #7 – assessed as Category 1 (non-retainable). Extensive canker is visible on the lower stem (May 23<sup>rd</sup>, 2025).

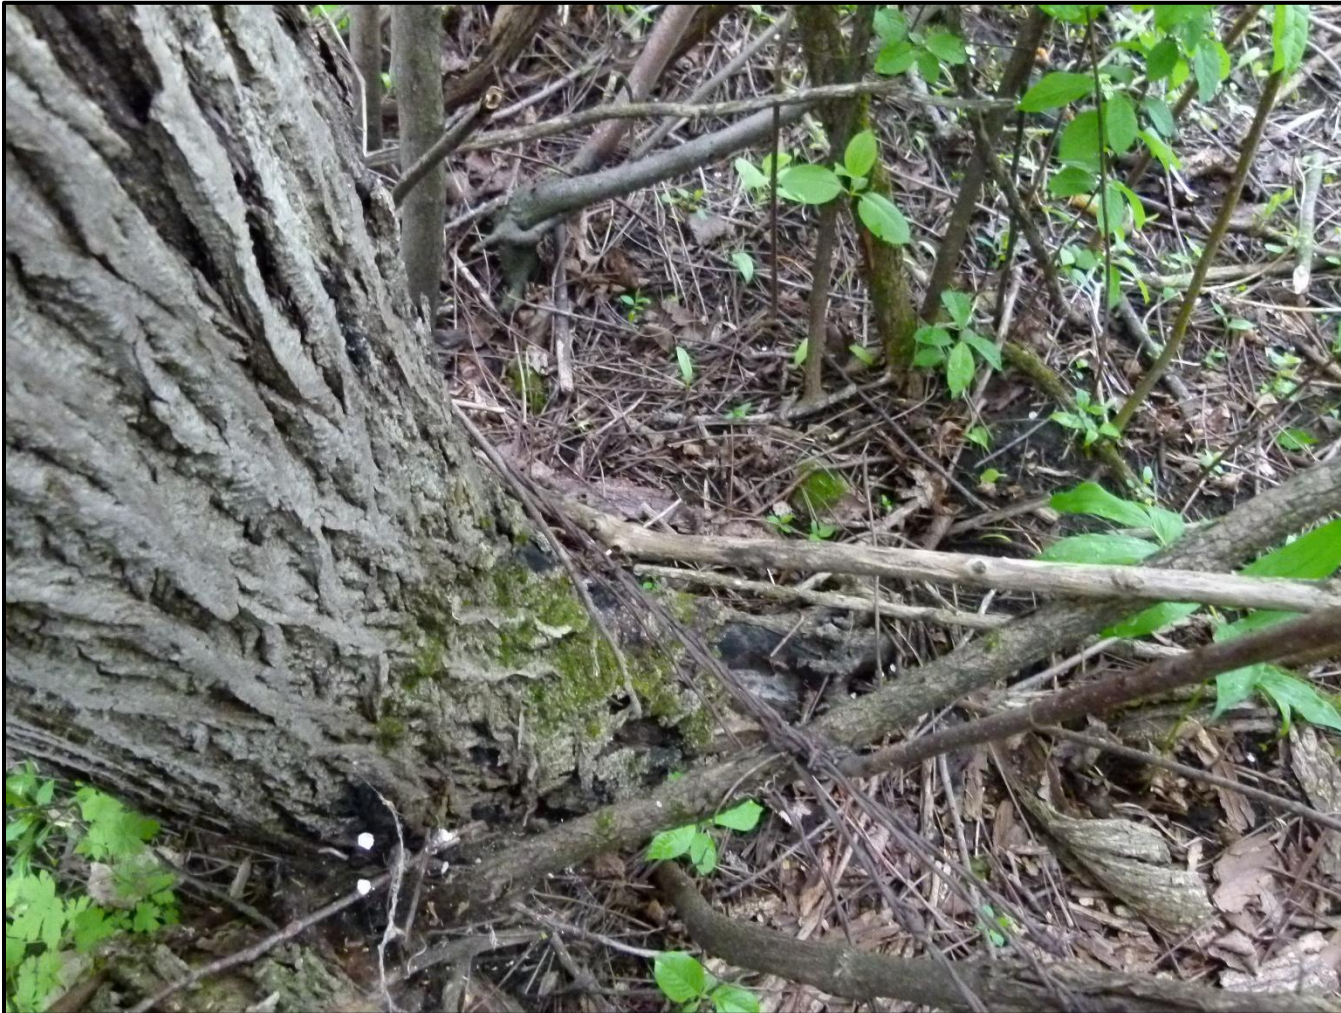
Photograph 16: Butternut Tree #7 – assessed as Category 1 (non-retainable). Extensive canker is visible on the root flare (May 23<sup>rd</sup>, 2025).
