**McKINLEY**  
ENVIRONMENTAL  
SOLUTIONS

Combined Environmental Impact Study  
& Tree Conservation Report  
4795 Bank Street, Ottawa, ON

July 2026

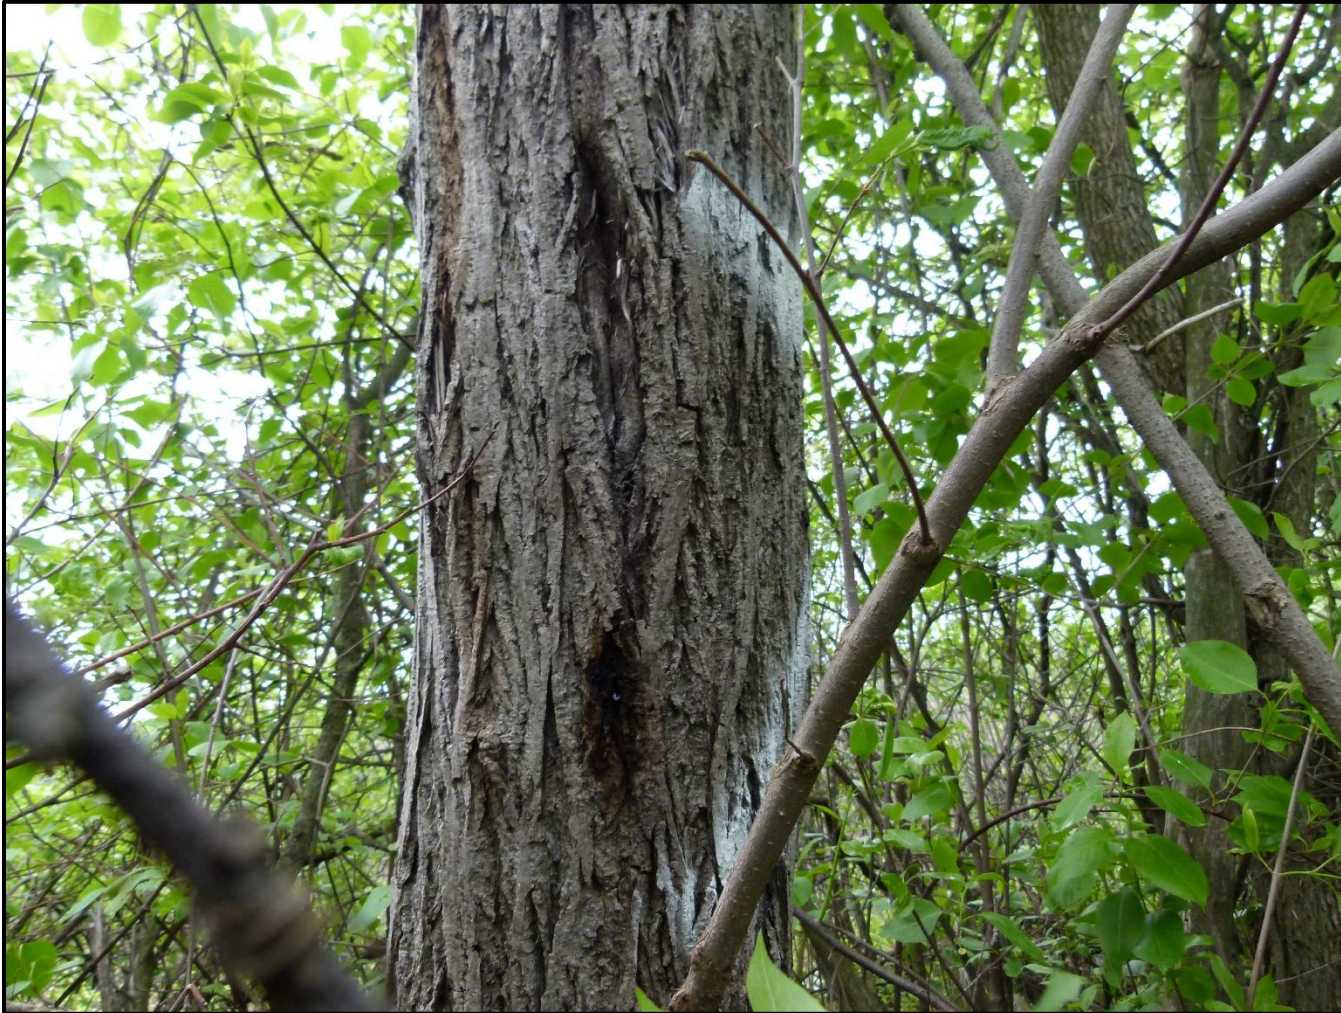
Photograph 17: Butternut Tree #7 – assessed as Category 1 (non-retainable). Extensive canker is visible on the lower stem (May 23<sup>rd</sup>, 2025).

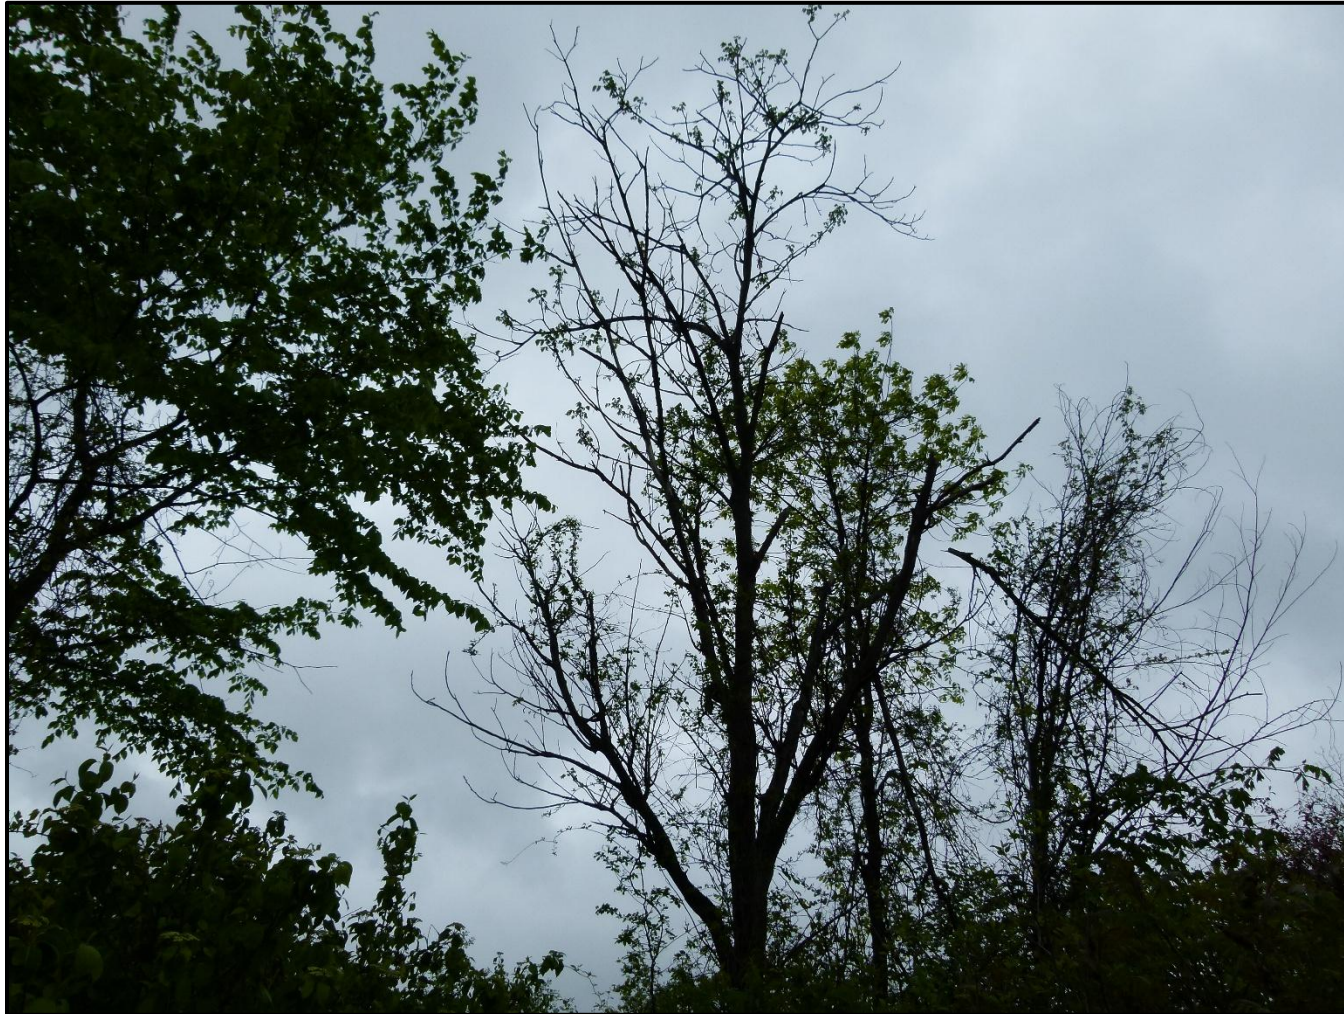
Photograph 18: Butternut Tree #7 – assessed as Category 1 (non-retainable). The crown is in poor condition (May 23<sup>rd</sup>, 2025).

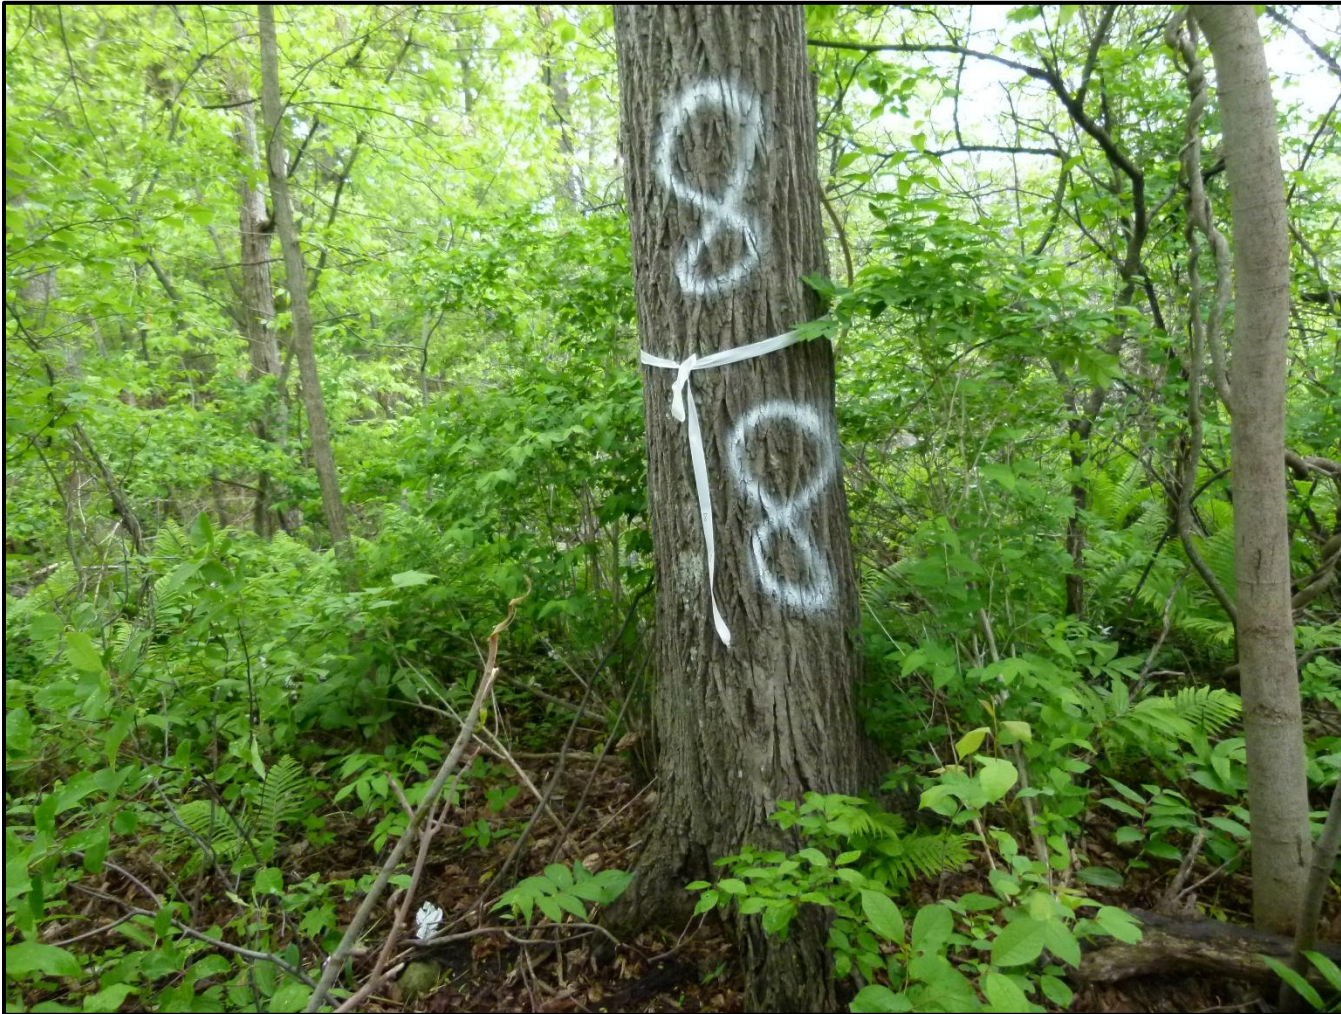
Photograph 19: Butternut Tree #8 – assessed as Category 1 (non-retainable) (May 23<sup>rd</sup>, 2025).

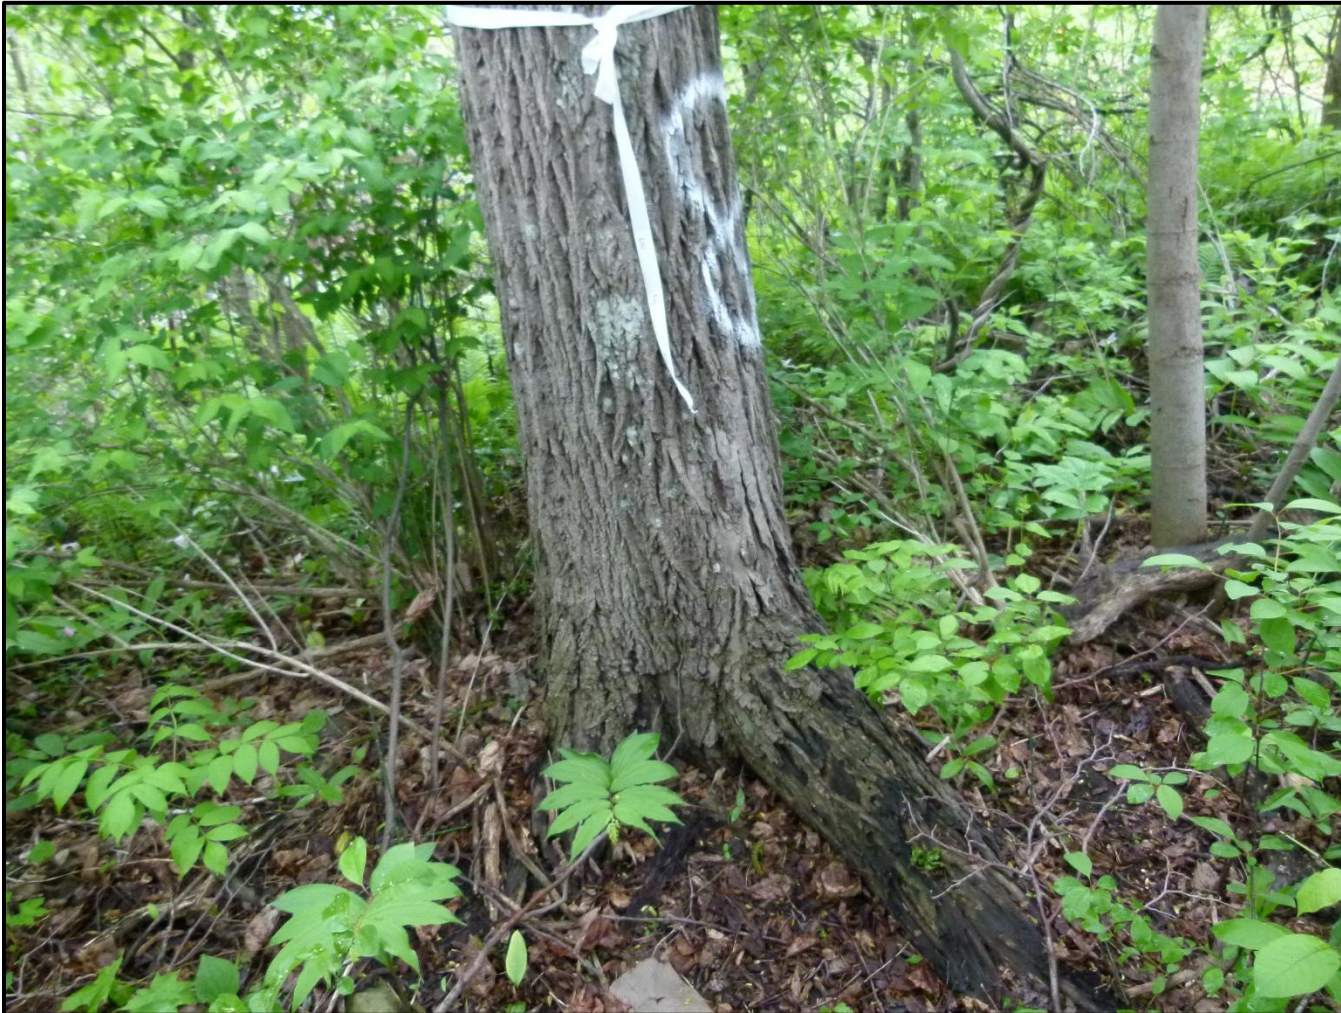
Photograph 20: Butternut Tree #8 – assessed as Category 1 (non-retainable). Extensive canker is visible on the root flare (May 23<sup>rd</sup>, 2025).

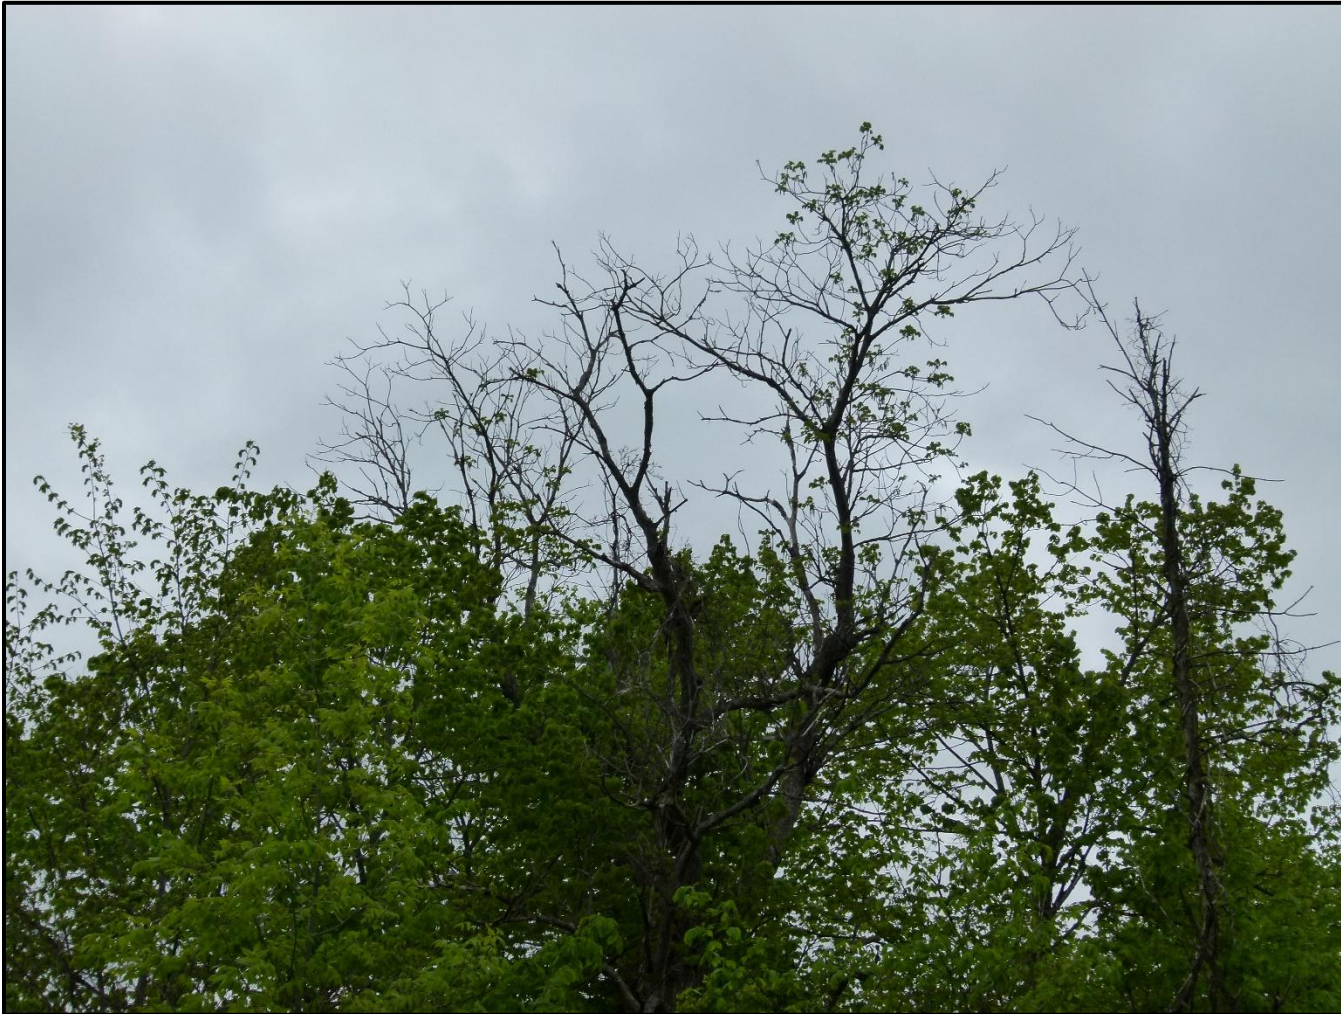
Photograph 21: Butternut Tree #8 – assessed as Category 1 (non-retainable). The crown is in poor condition (May 23<sup>rd</sup>, 2025).
