# ALBERTA LAND SURVEYOR'S REAL PROPERTY REPORT

LOT: 44
BLOCK: 6
PLAN: 821 0961

37 TARAGLEN ROAD N.E.
CALGARY, ALBERTA
CLIENT: [redacted]

FIELD: A.L.
DRAWN BY: N.R.
FILE NO: 2026-0734

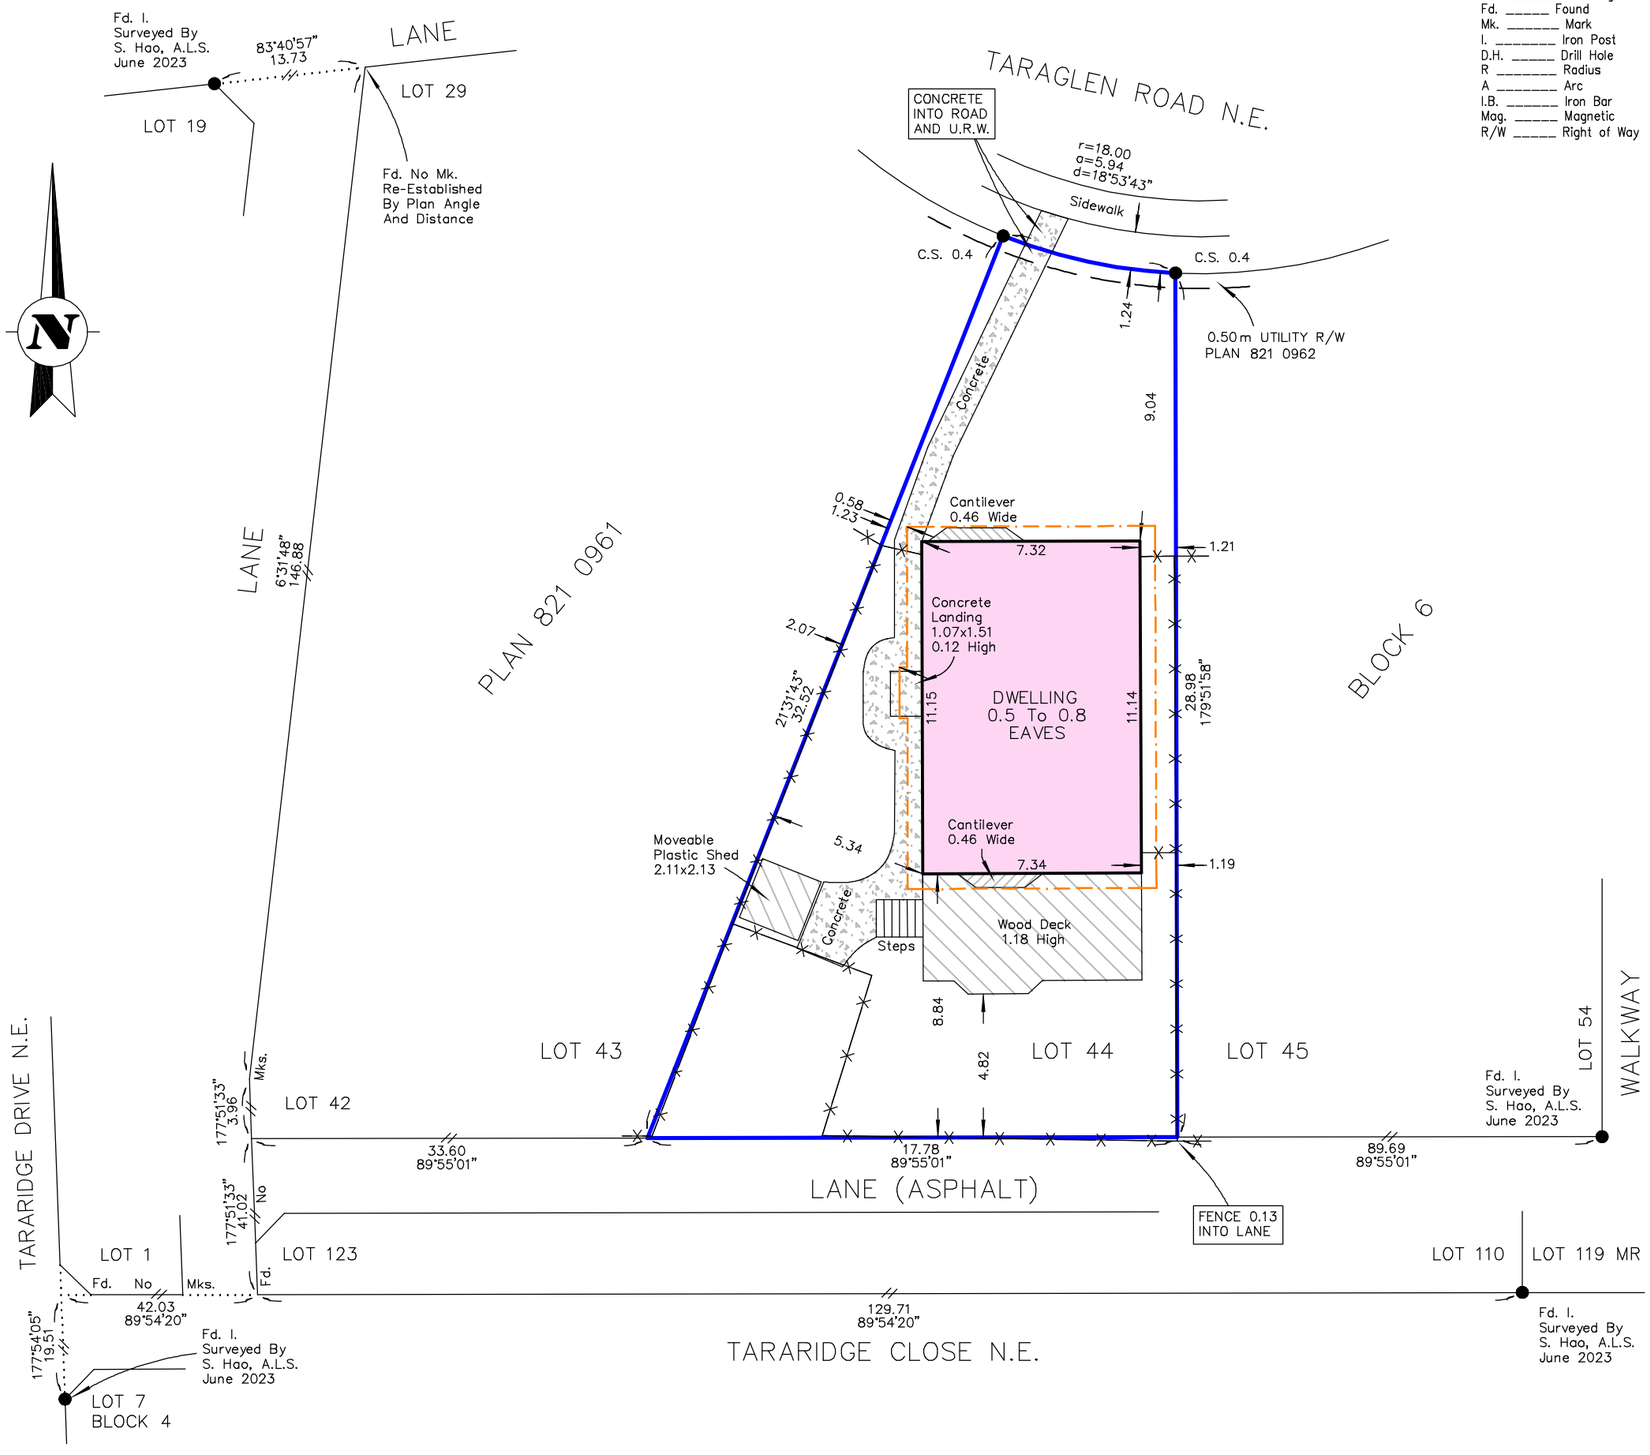
1. the plan illustrates the boundaries of the Property, the improvements as defined in Part C, Section 6.5 of the Alberta Land Surveyors' Association's Manual of Standard Practice, and registered easements and rights-of-way affecting the extent of the title to the Property;
2. the improvements are entirely within the boundaries of the Property
   EXCEPT CONCRETE INTO ROAD AND FENCE INTO LANE
3. no visible encroachments exist on the Property from any improvements situated on an adjoining property
4. no visible encroachments exist on registered easements or rights-of-way affecting the extent of the Property
   EXCEPT CONCRETE INTO U.R.W.
