ALBERTA LAND SURVEYOR'S REAL PROPERTY REPORT

LOT	2
BLOCK	2
PLAN	081 3998

MUNICIPAL ADDRESS:
89 Evergreen Mount S.W.
Calgary, Alberta

GRSI. FILE NO. 26CR0906

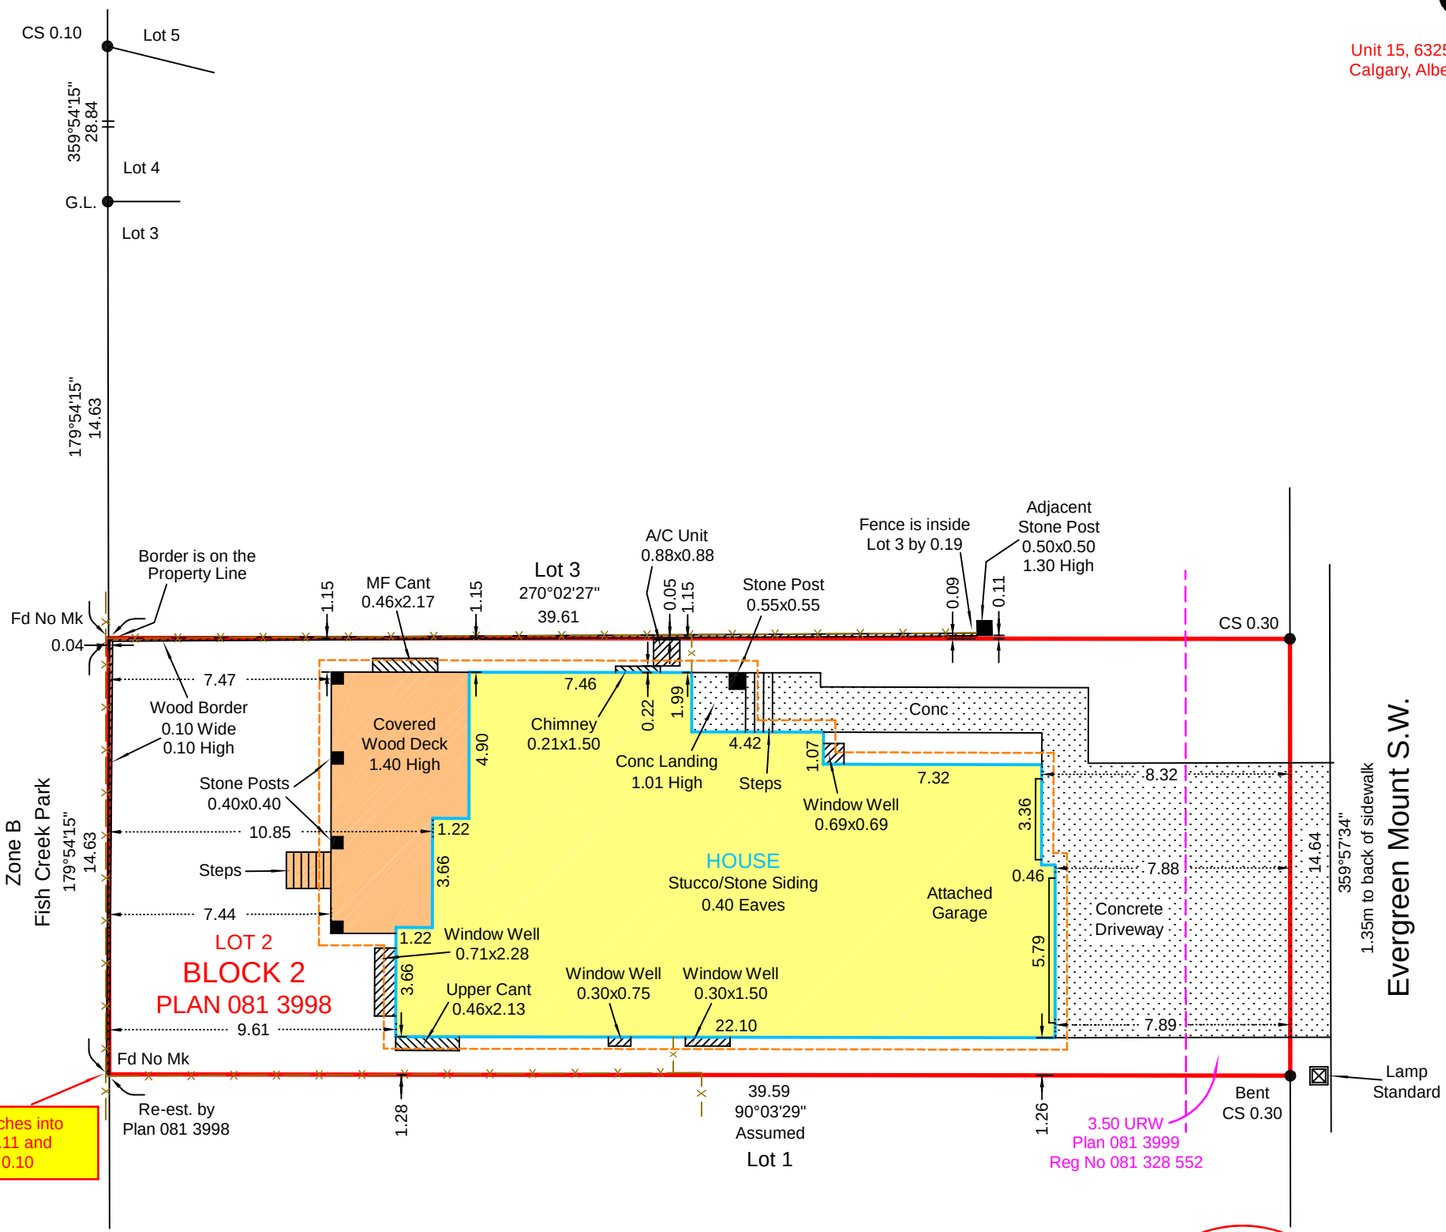
11. Property is subject to Caveat Reg. No. 081 328 558
    RE: Restrictive Covenant
12. Fence and Border from the subject property encroach into Zone B as shown.

Fence encroaches into Zone B by 0.11 and Border by 0.10
