Phase Two
Environmental Site Assessment

593, 601 & 603 Laurier Ave W
Ottawa, Ontario

LRL File No.: 240447

October 18, 2024

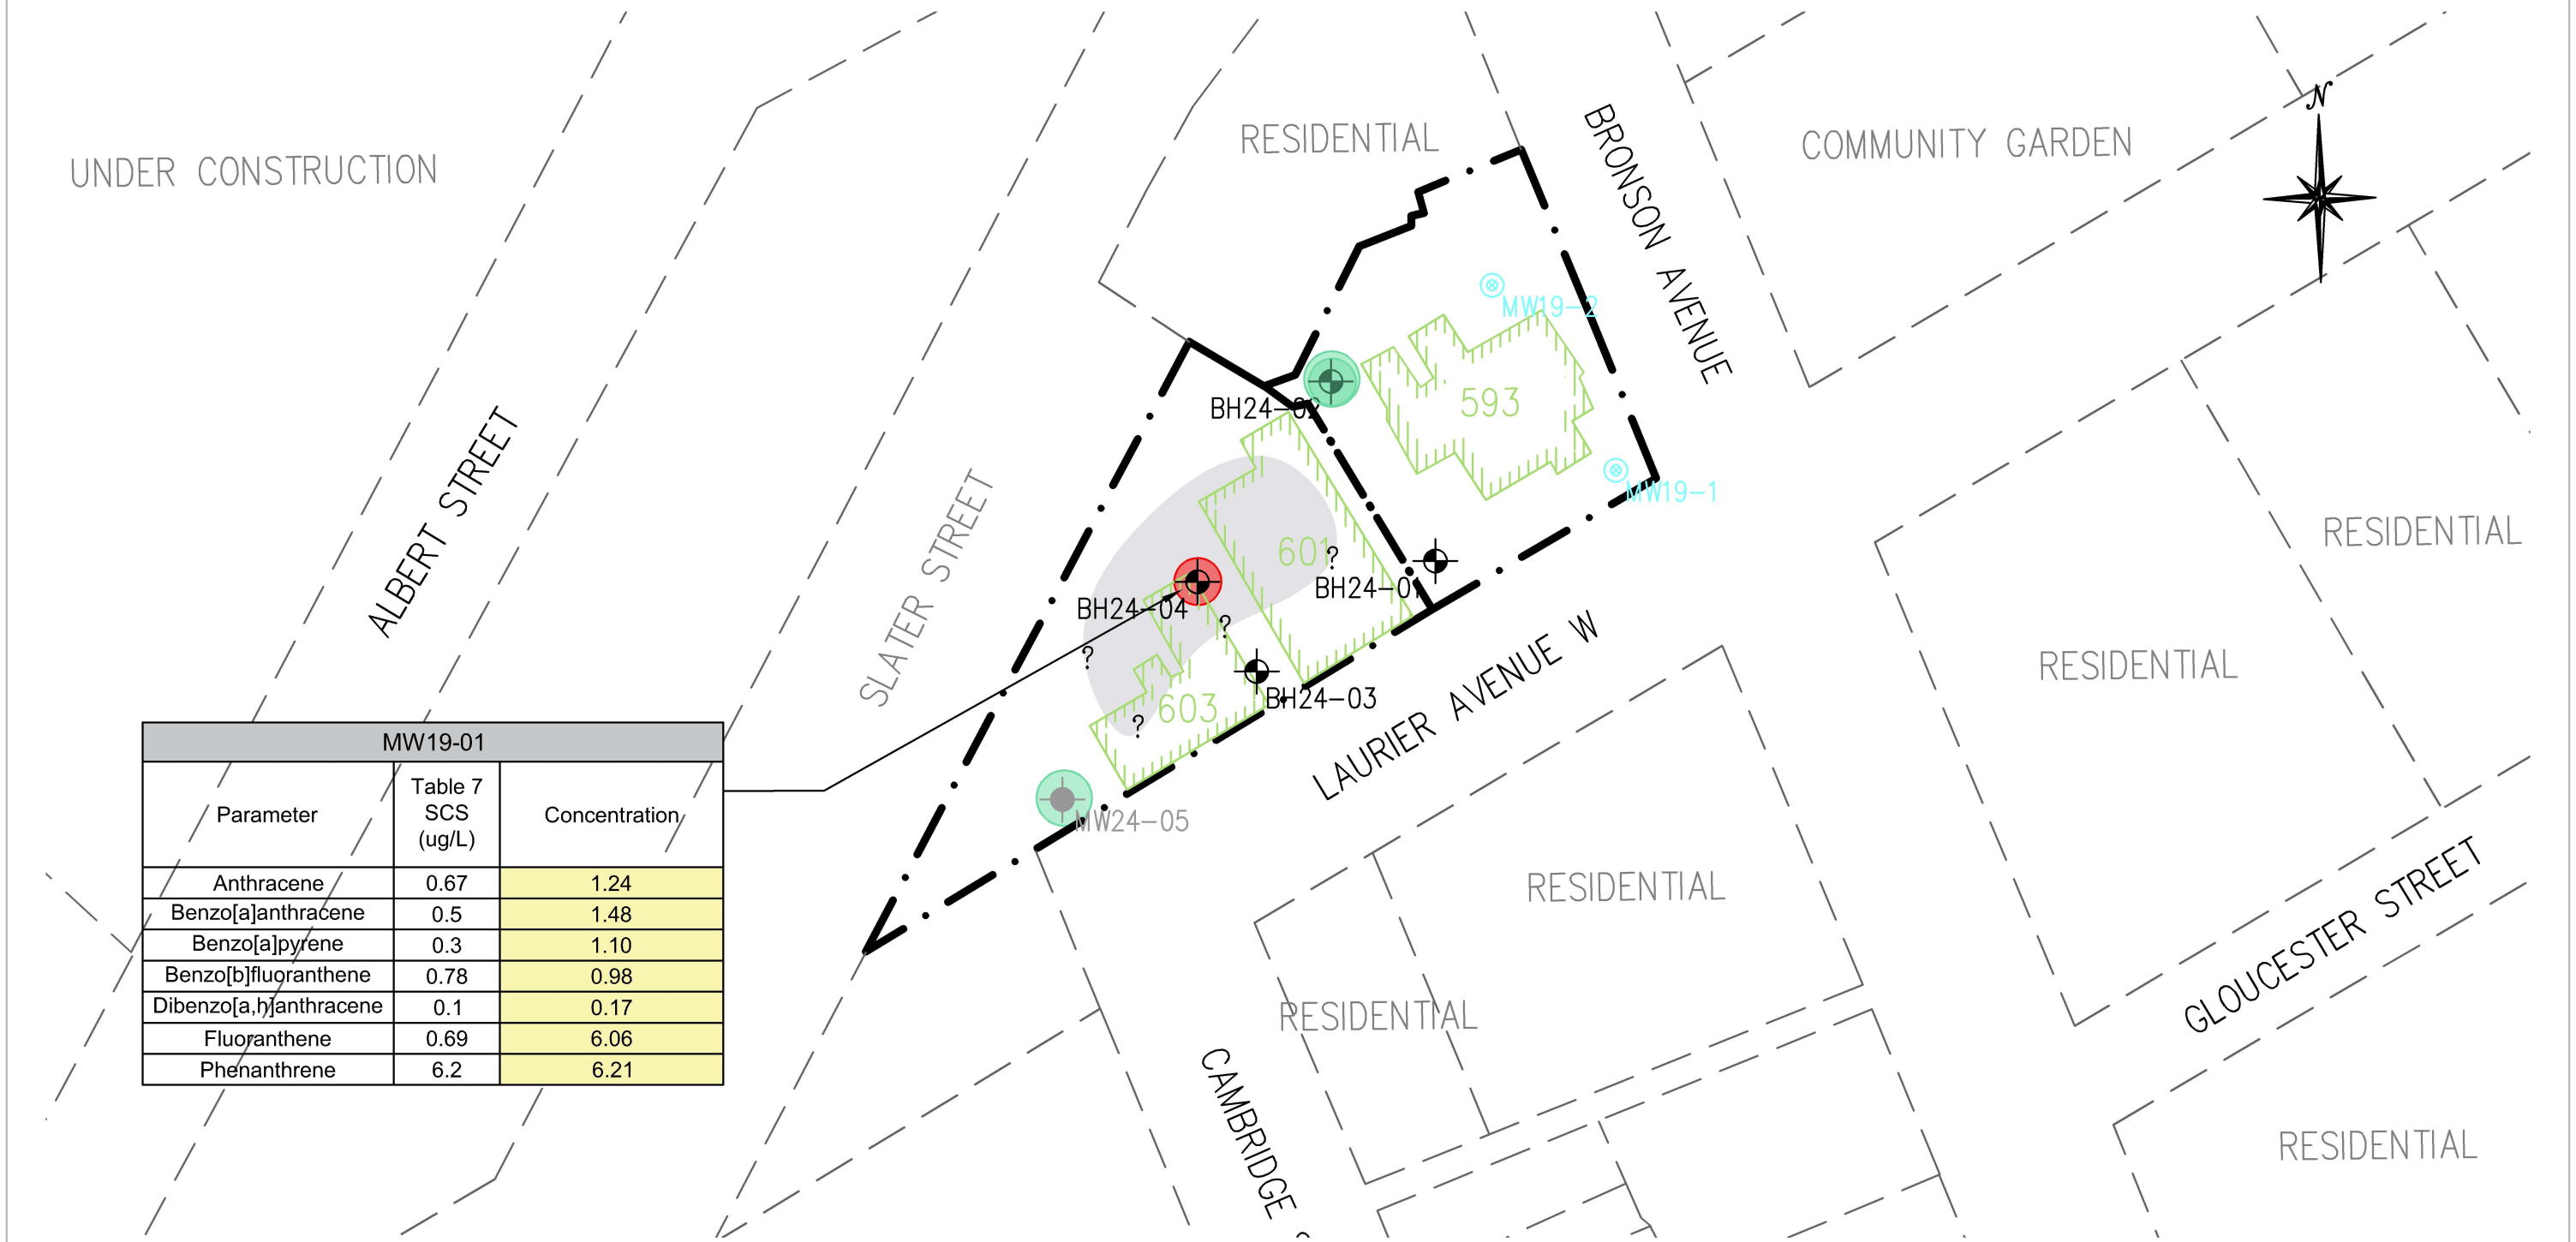
FIGURE8B

MW19-01		
Parameter	Table 7 SCS (ug/L)	Concentration
Anthracene	0.67	1.24
Benzo[a]anthracene	0.5	1.48
Benzo[a]pyrene	0.3	1.10
Benzo[b]fluoranthene	0.78	0.98
Dibenzo[a,h]anthracene	0.1	0.17
Fluoranthene	0.69	6.06
Phenanthrene	6.2	6.21
