PHASE ONE ENVIRONMENTAL SITE ASSESSMENT

441-443 ECHO DRIVE,
OTTAWA, ON K1S 1N6

April 2026

Project No.: 2512064

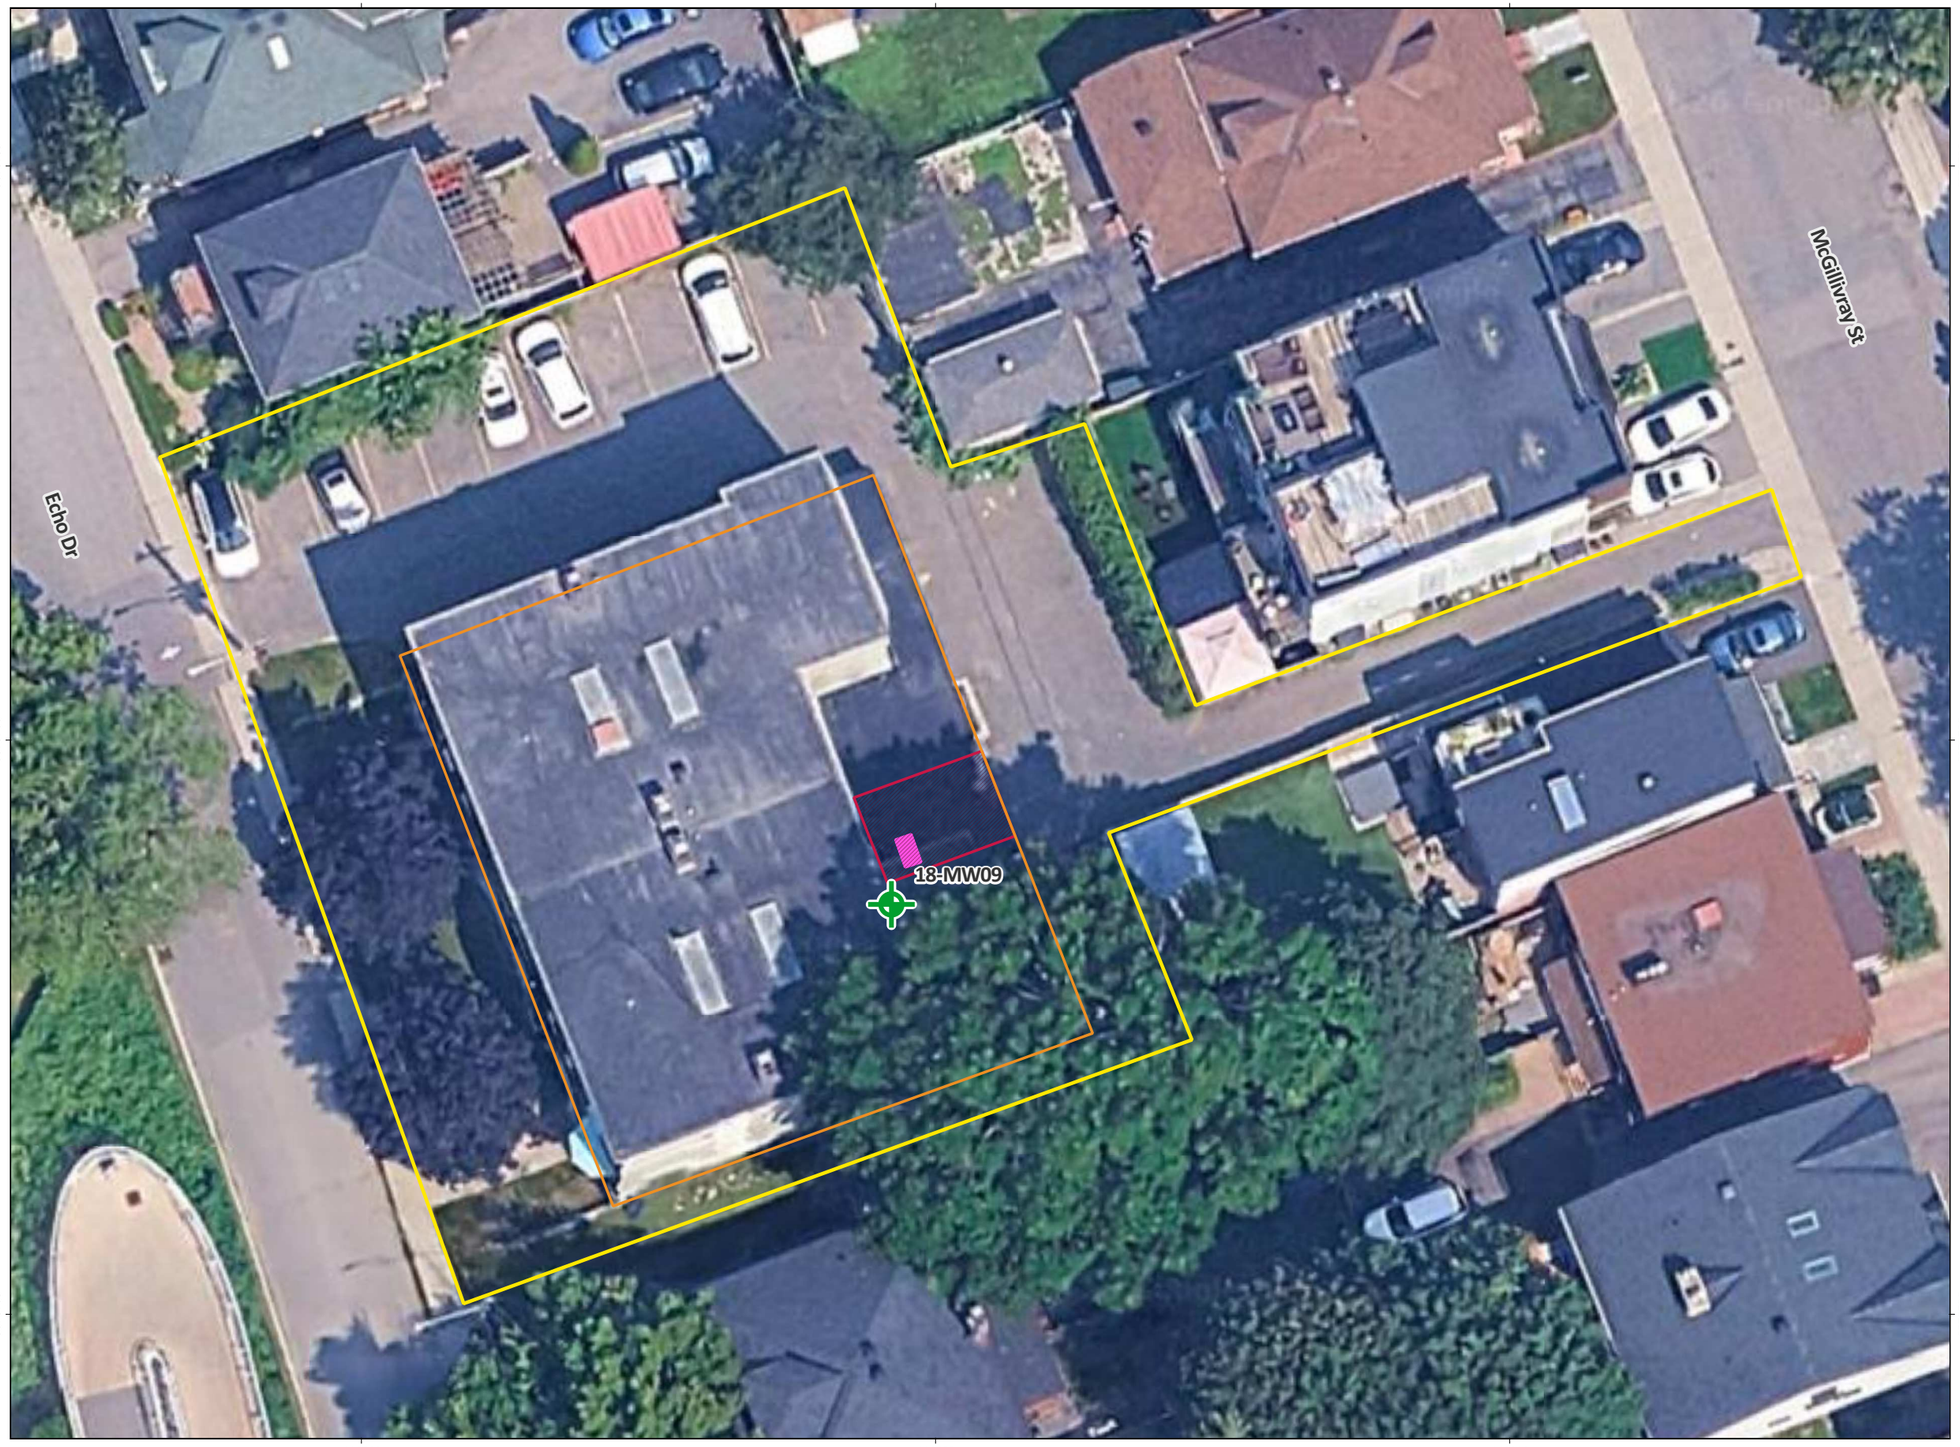
- Property Boundary
- Building 1: 441-443 Echo Drive
- Location of Former Underground Storage Tank
- Apprixmate Extent of Historical Remedial Excavation
- Groundwater Meets Applicable Table 3 Site Condition Standards (Concentric Geoscience, 2021)
- Groundwater Exceeds Applicable Table 3 Site Condition Standards
- Approximate Location of Previously Impacted Monitoring Well Used For Remedial Injection Program (Concentric Geoscience, 2018-2020)

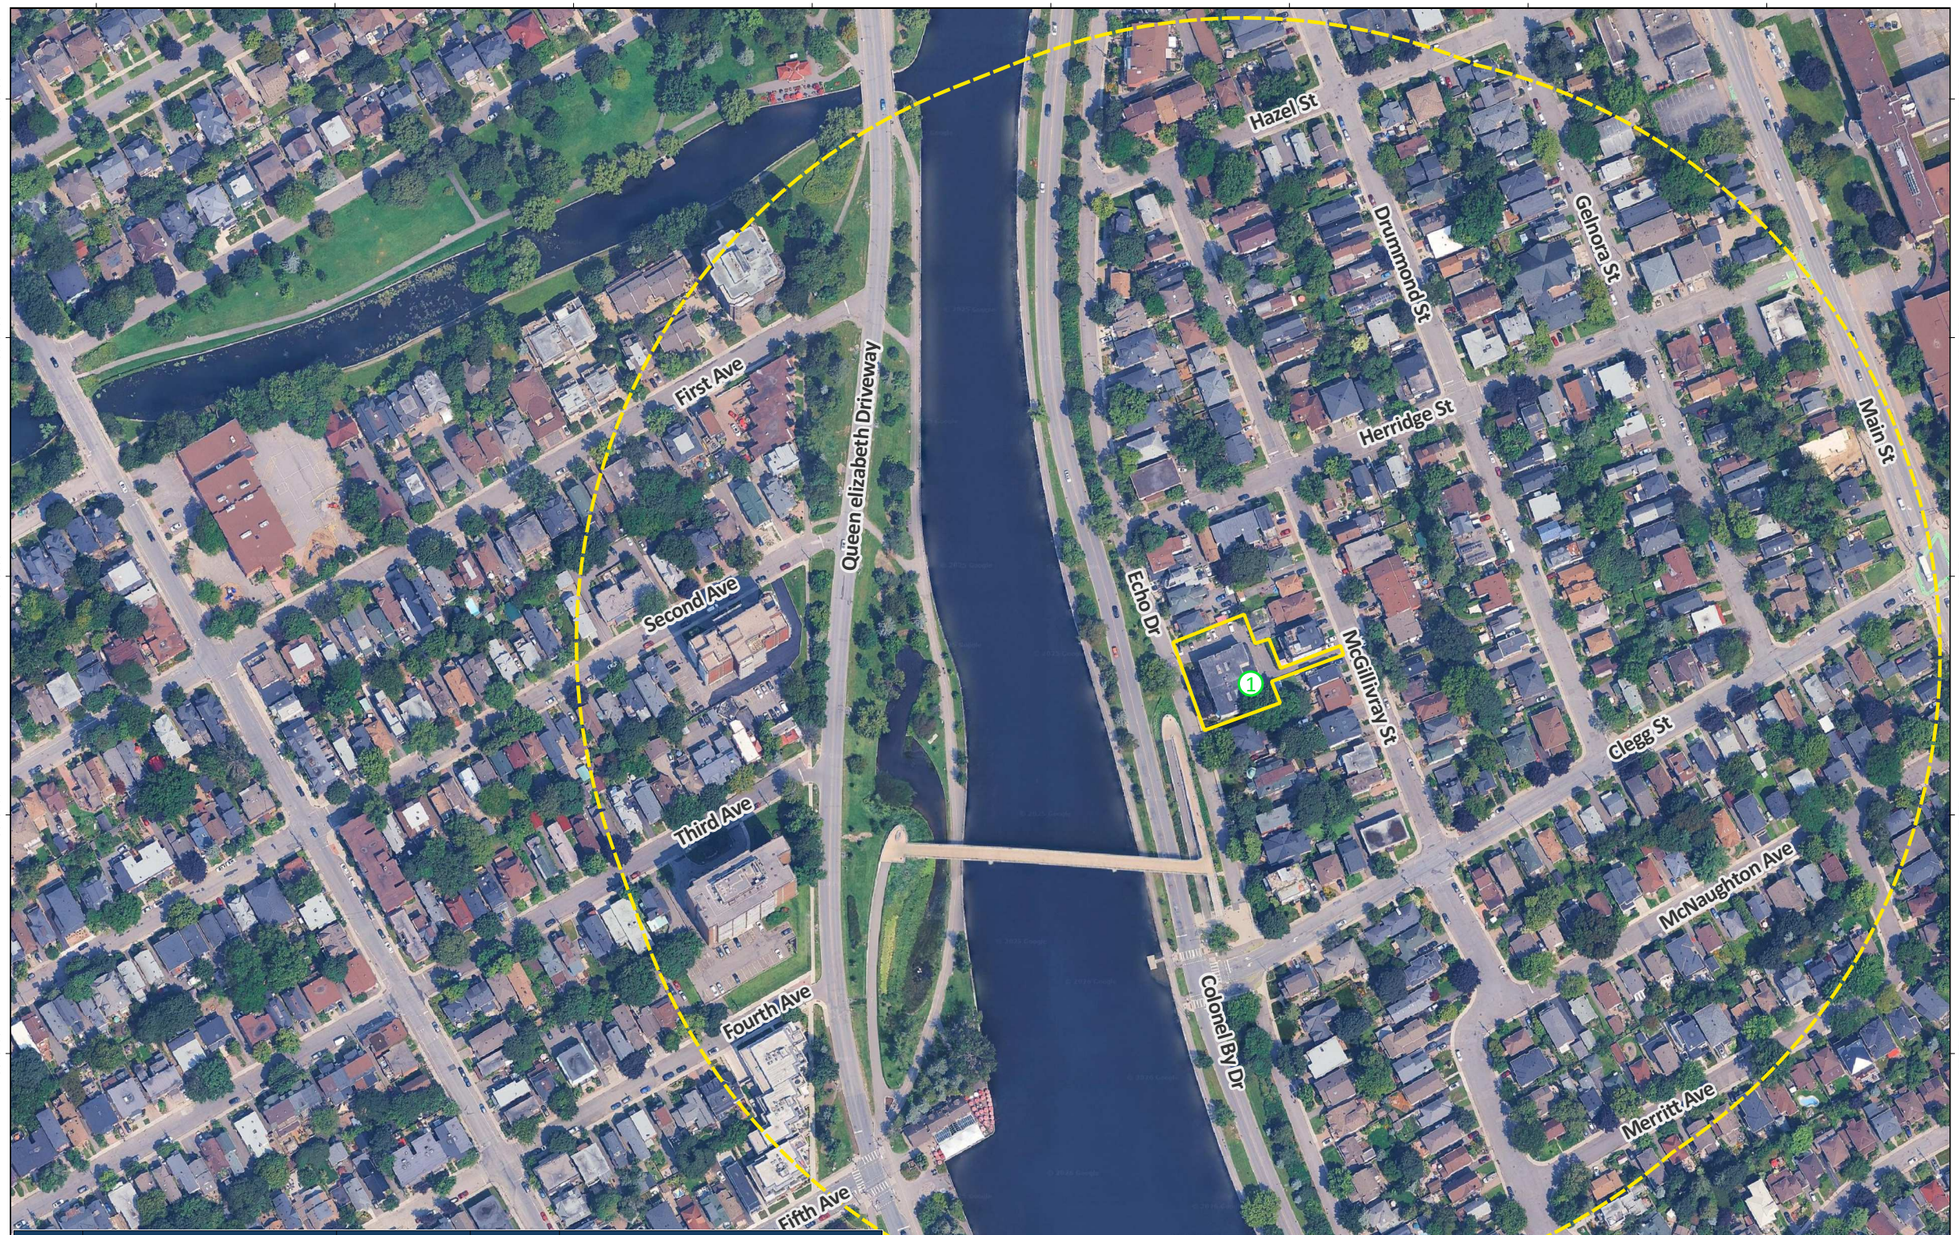
NO.	DESCRIPTION	LOCATION	RESULTS IN APEC	RATIONALE
PCA 1	*Item 28 - Gasoline and Associated Products Storage in Fixed Tanks* The former presence, and historical spill, of an on-site fuel oil UST	On-site Southeast portion of the Site	No	The UST was removed from the Site in 2016, and Site remediation in response to the UST was completed in 2021

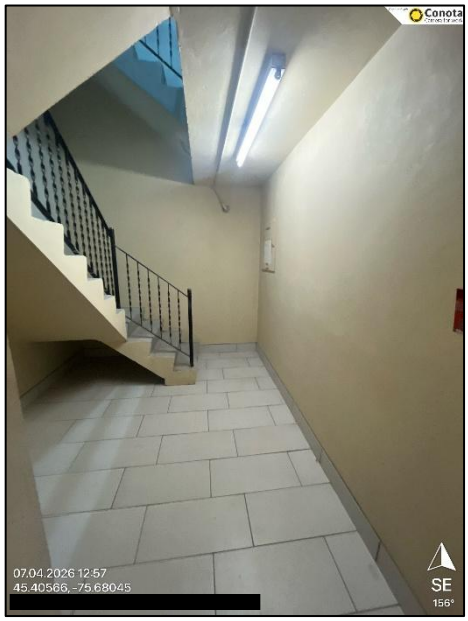
Photograph 3

Example photo of the interior of the on-site residential building

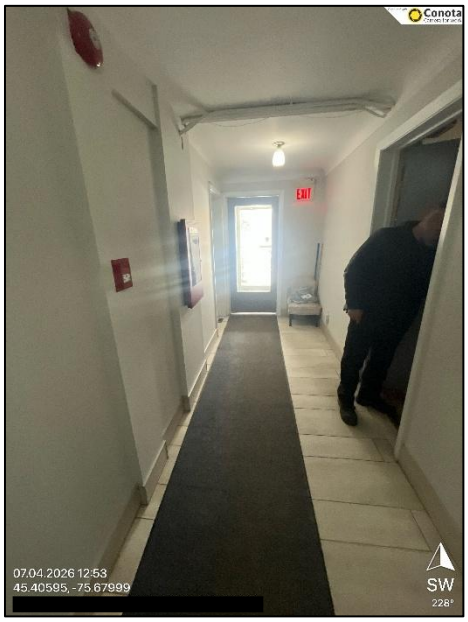
Photograph 4

Example photo of the interior of the on-site residential building

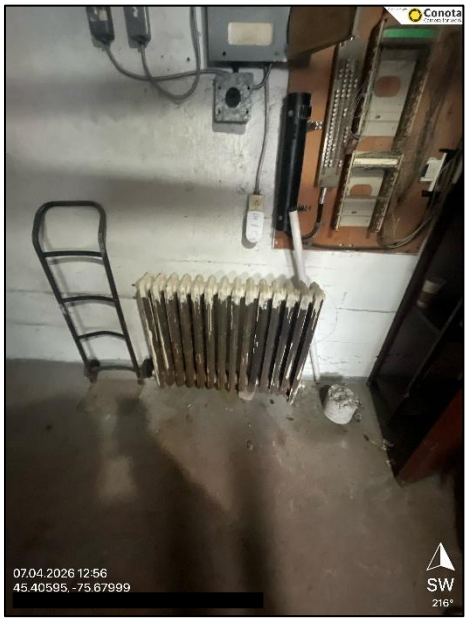
Photograph 6

Example of the heating units observed throughout the on-site residential building
