Phase I – Environmental Site Assessment

75 Breezehill Avenue

Ottawa, Ontario

Report: PE6049-1
August 8, 2023

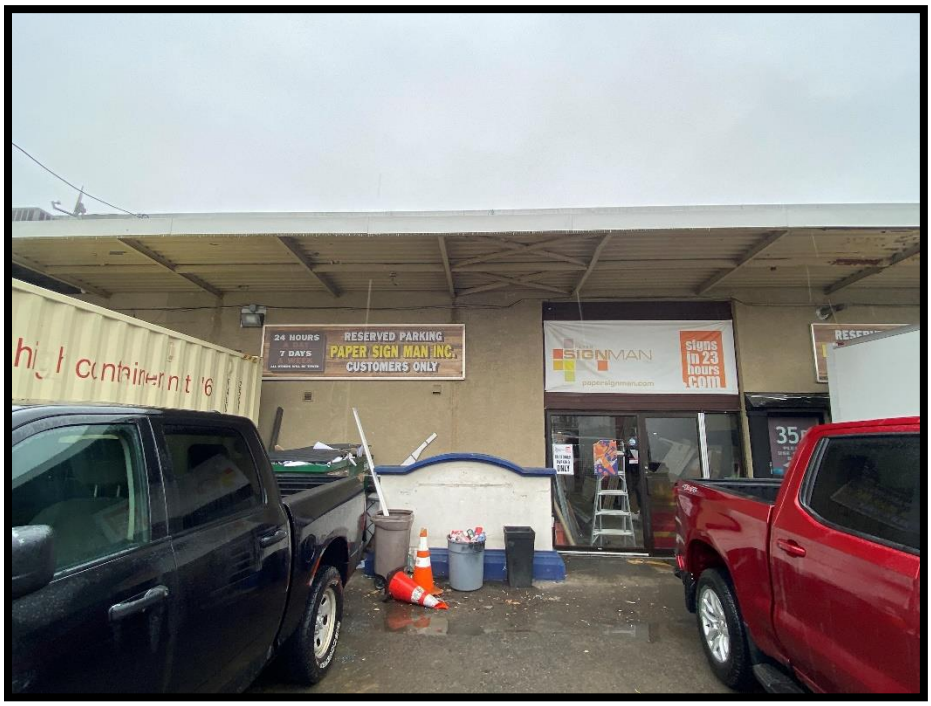
Photograph 2: View of the Phase I Property and west adjacent property, facing South West from John Cavanaugh Drive.
