Phase One Environmental Site Assessment
Proposed Development
5872, 5880, and 5884 Hazeldean Road and 7 Savage Drive
Ottawa, Ontario

September 26, 2025
Project: 104054.001

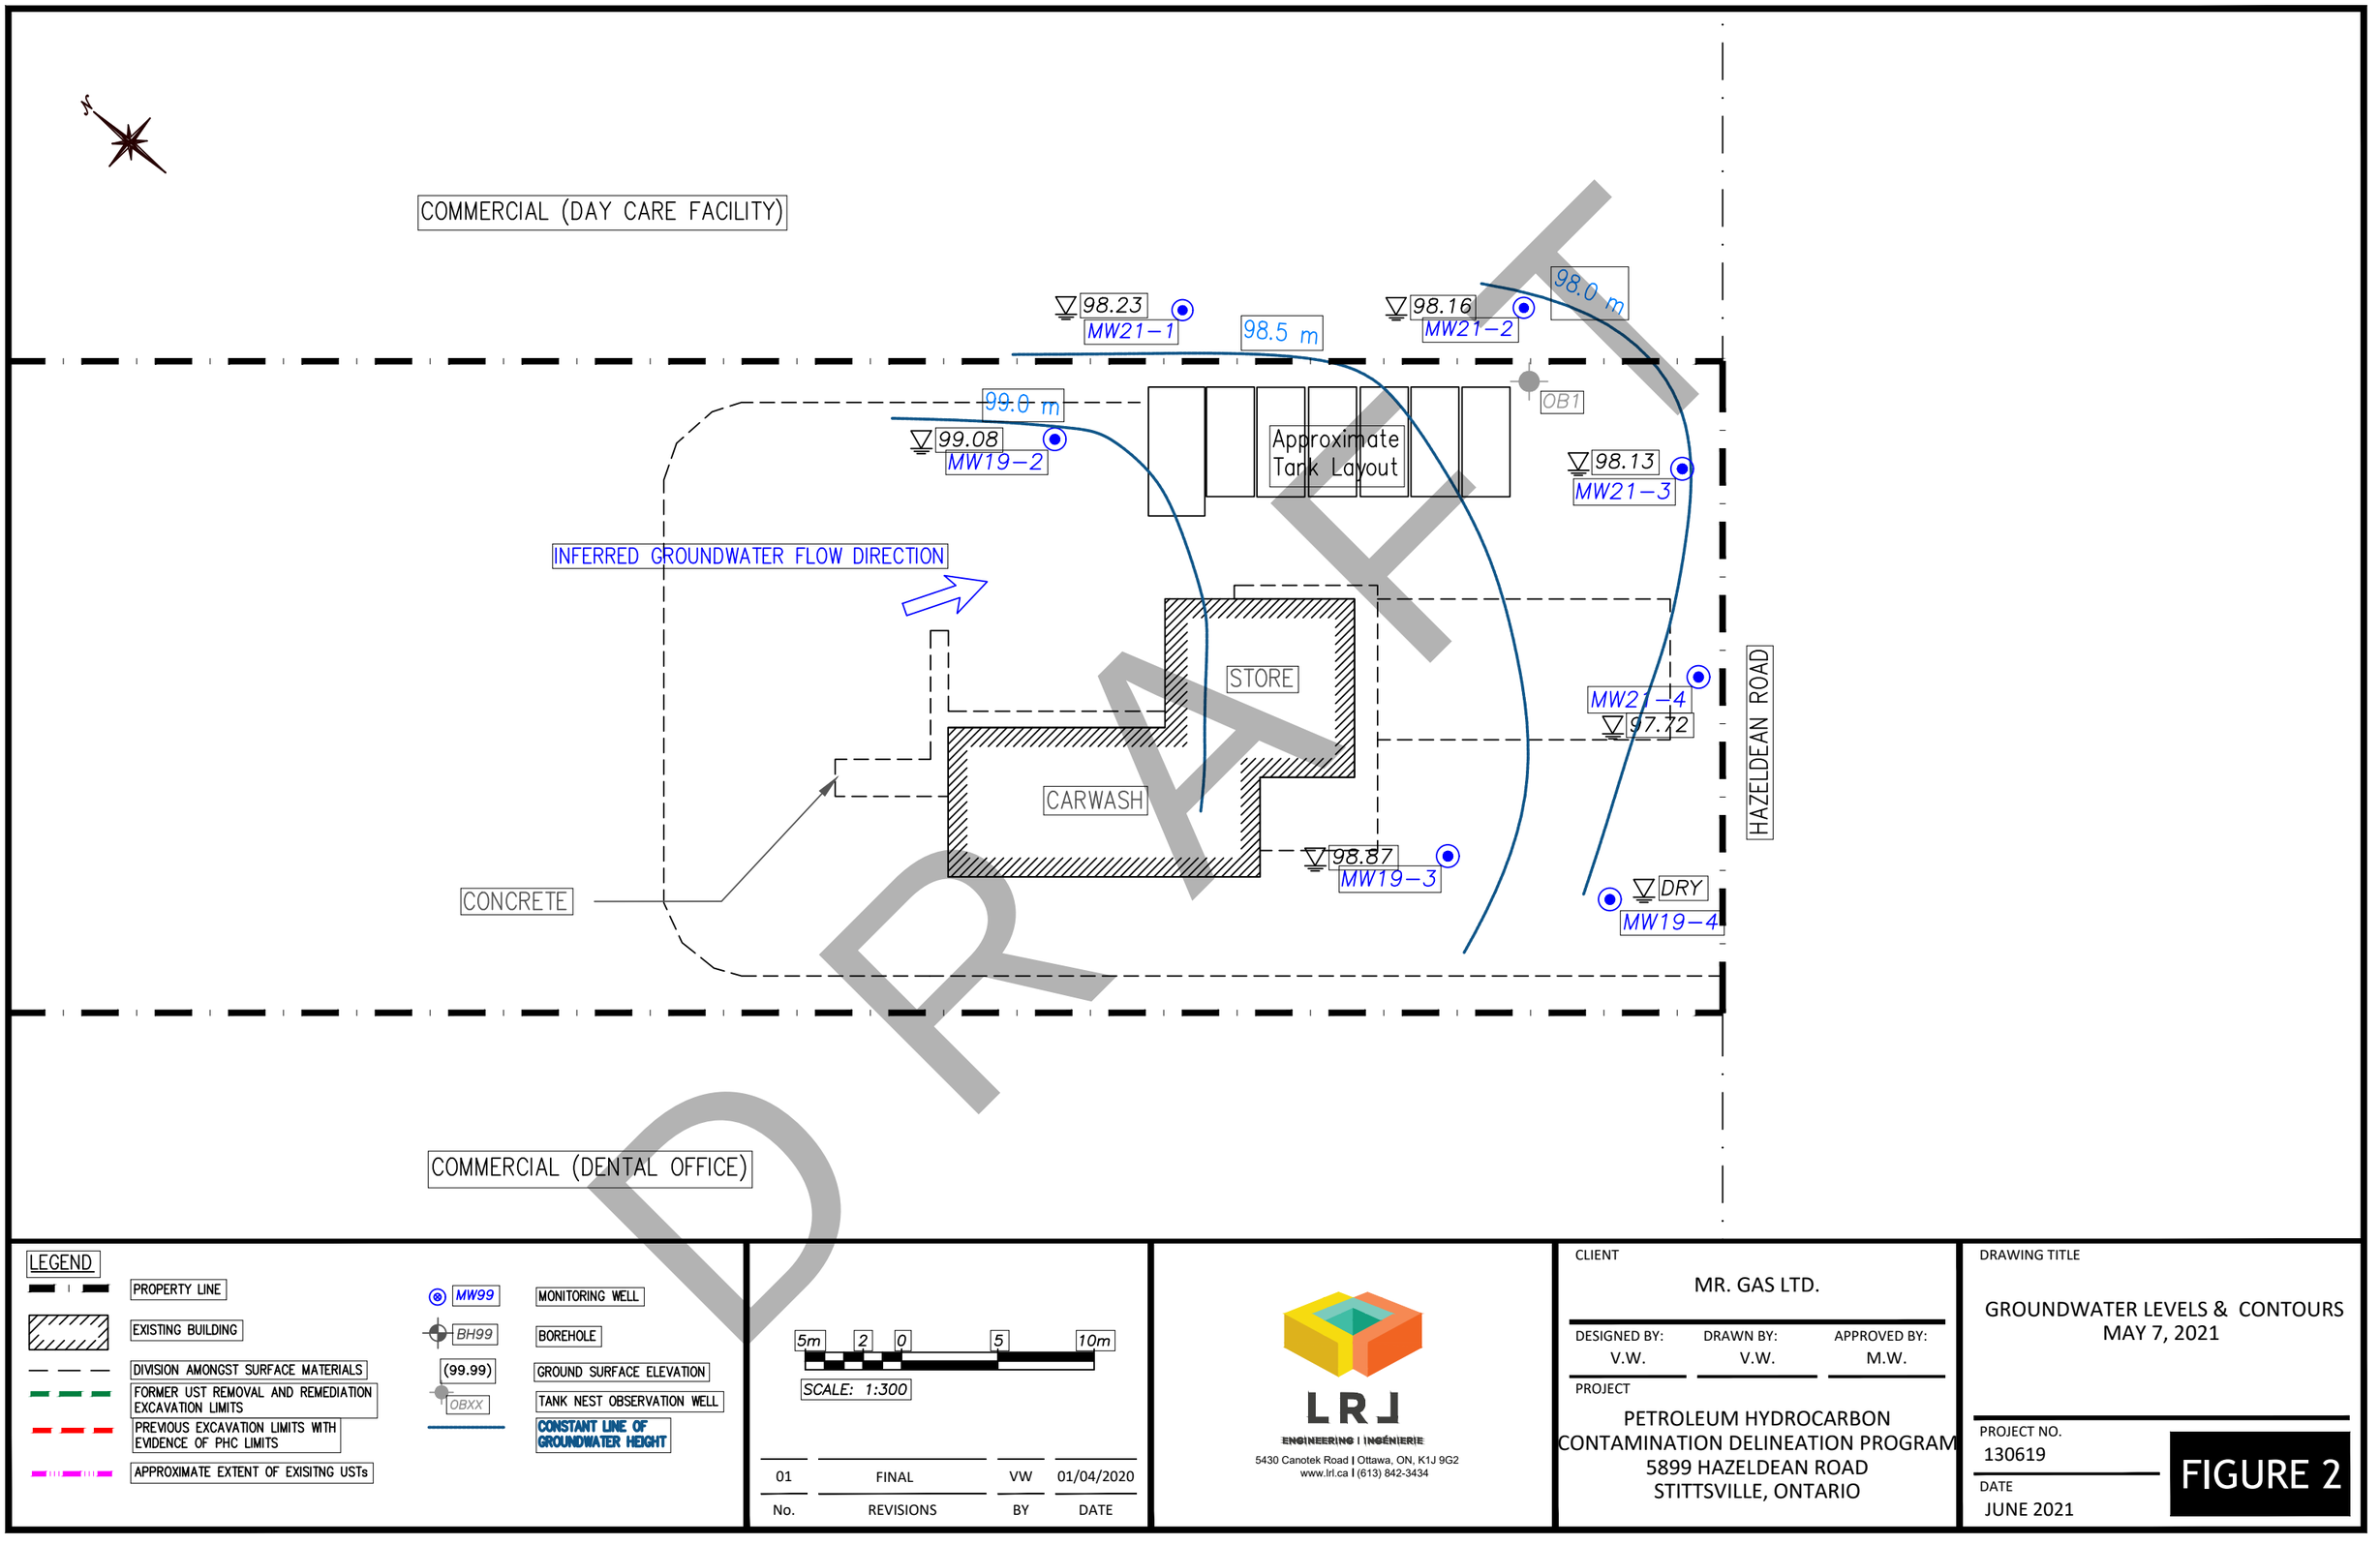
DRAWING TITLE
GROUNDWATER LEVELS & CONTOURS
MAY 7, 2021
PROJECT NO.
130619
DATE
JUNE 2021
FIGURE 2
DRAFT

MW21-3 Water Sample EXCEEDANCES		
Groundwater Parameter	Table 3 SCS (µg/L)	Value (µg/L)
		5/21/2021
PHC F1	750	2325

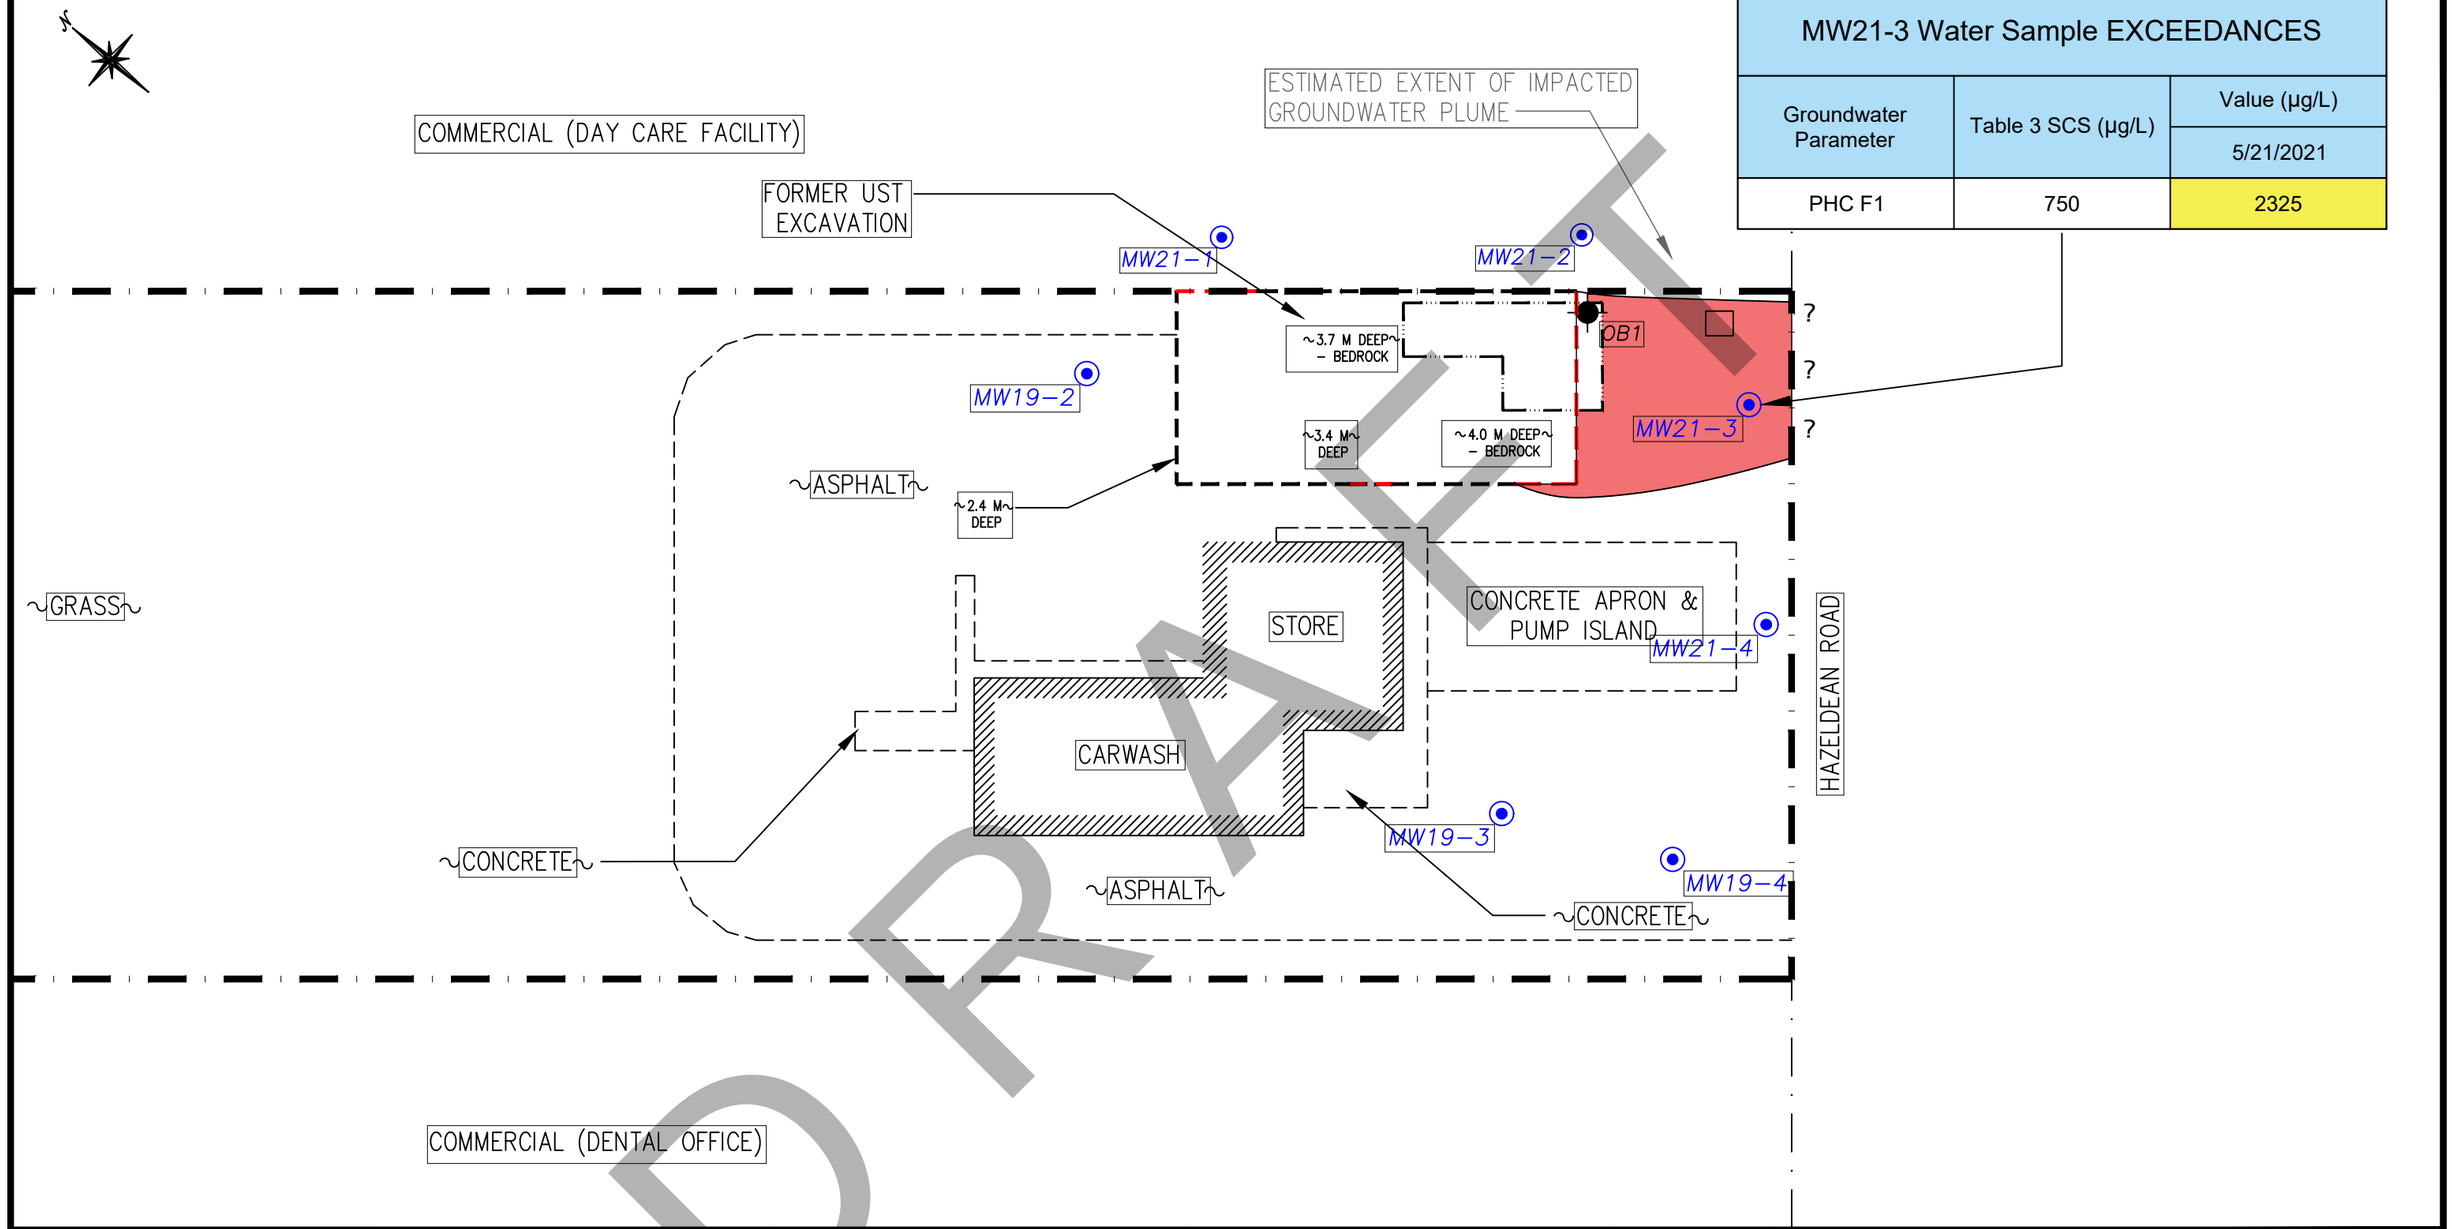
FIGURE 3

Static groundwater levels measured at all monitoring wells at the time of the sampling event on May 7, 2021 are summarized in **Table 1**. Groundwater depths measurements were between 1.45 and 2.73m bgs, which corresponded to elevations between 97.72 and 99.08 m. Groundwater elevations are shown in **Figure 3**. Based on these elevations, the groundwater flow direction on the Site is interpreted to be towards the south to southwest.

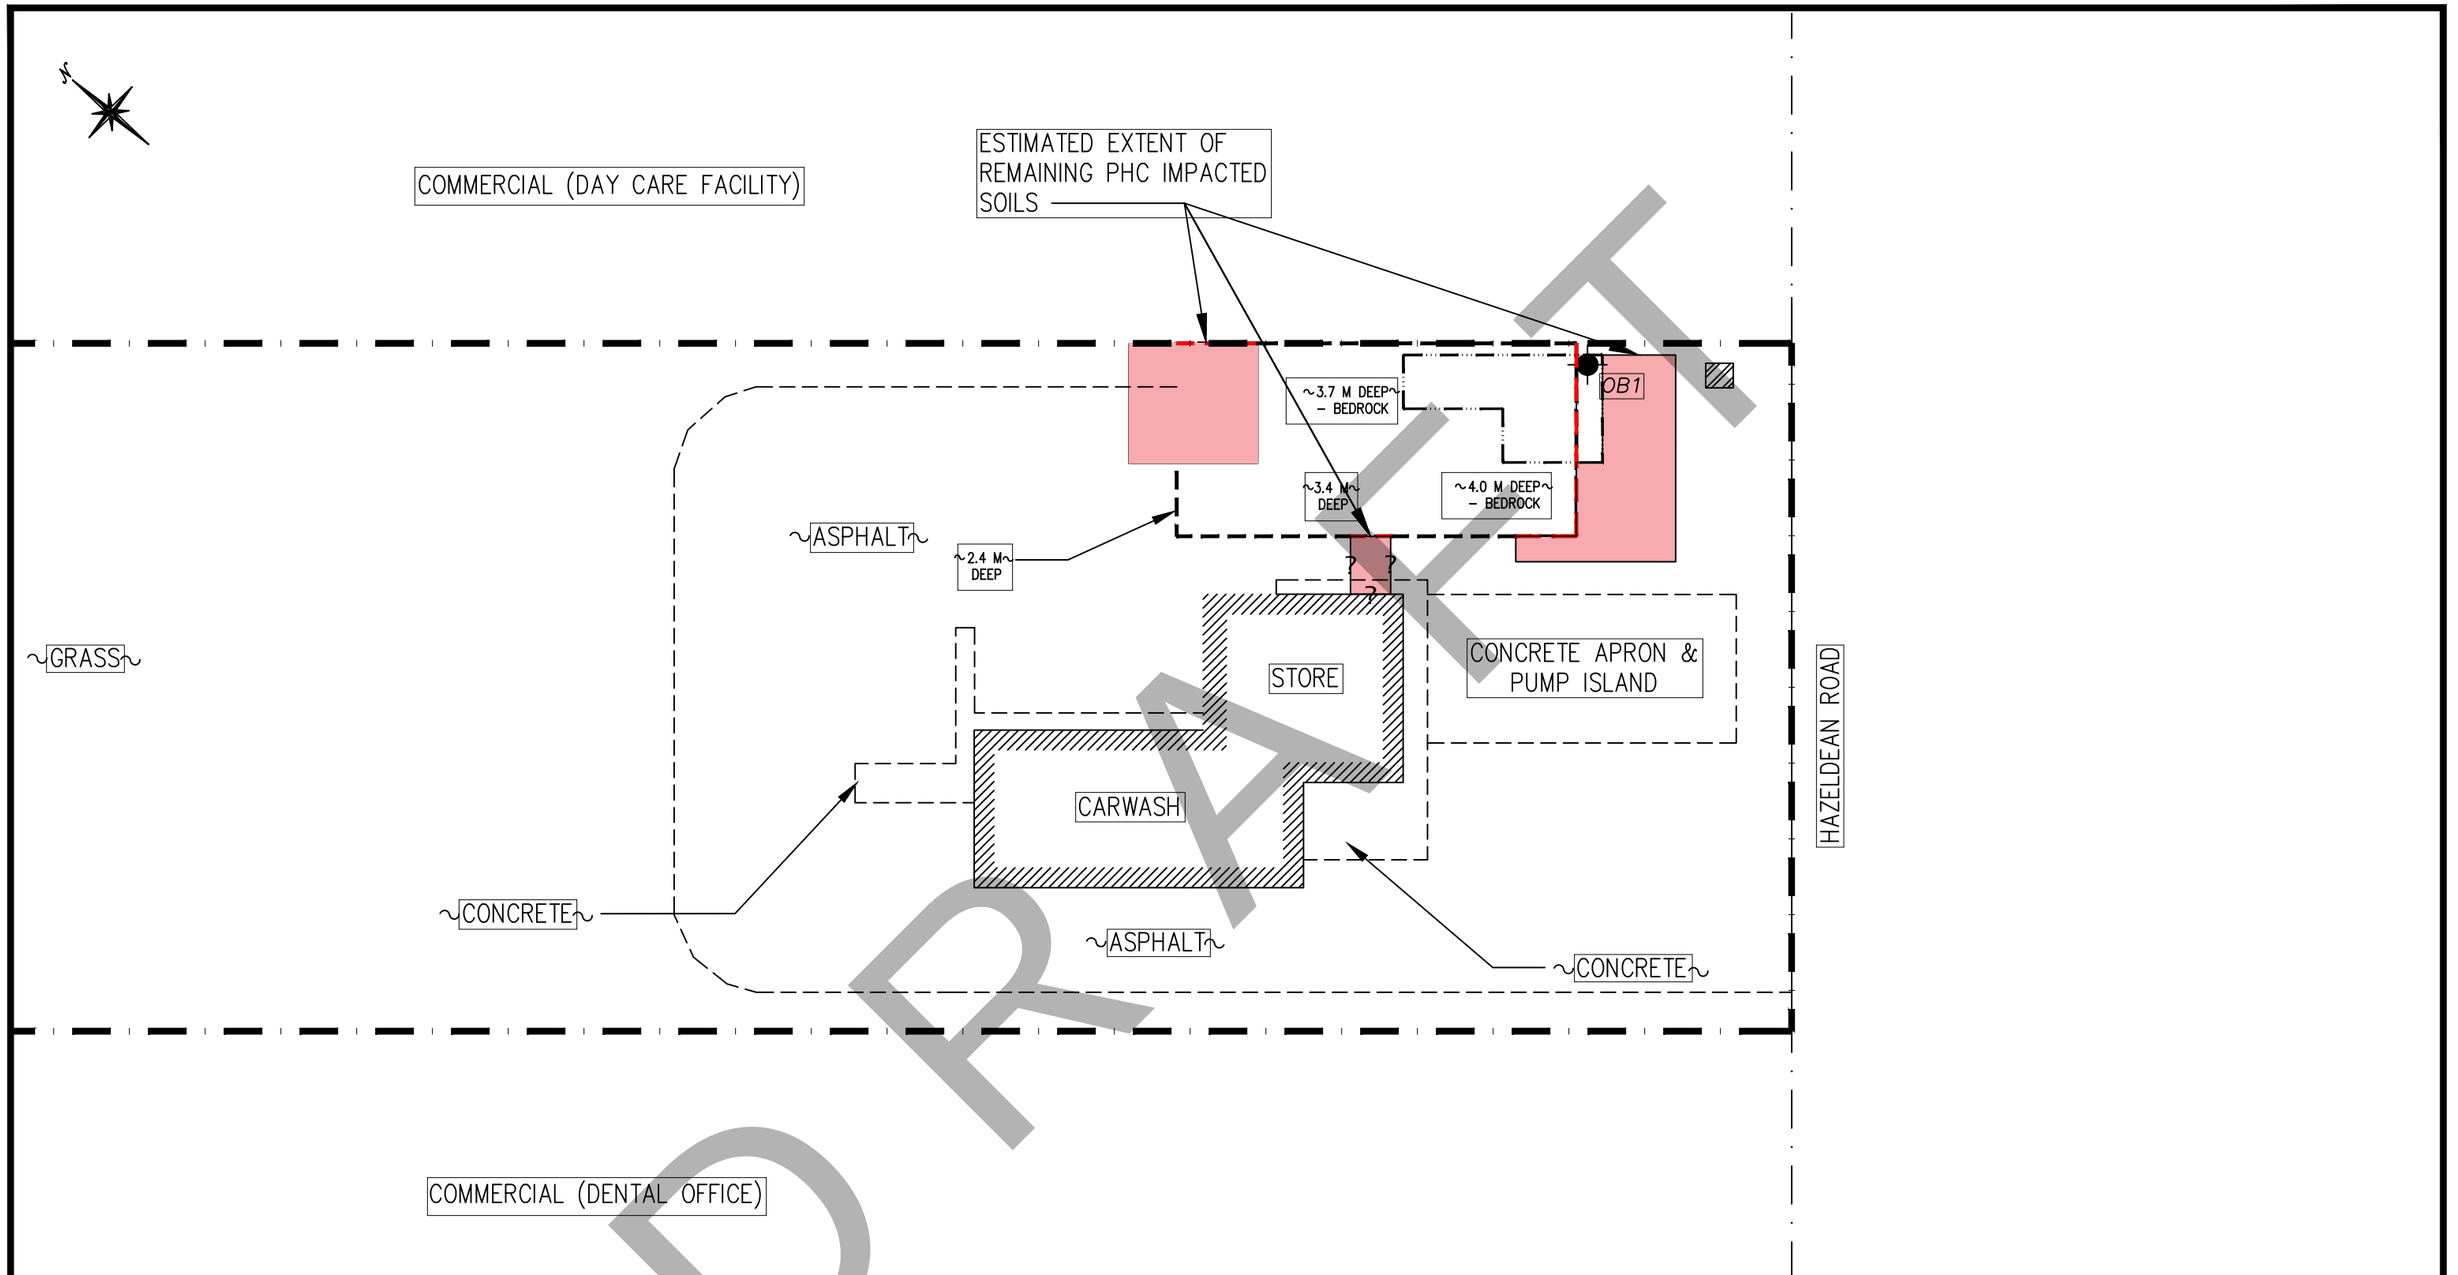
FIGURE 4

Based on our field observations and laboratory analyses, PHCs, VOCs and lead were not detected above the applicable standards in the soil samples submitted from the four new boreholes. Previous investigations have shown that petroleum-impacted soils remain along the final southern wall of the former UST excavation, as well as along the southern portions of the east and west walls and the base of the northern portion of the excavation. The 2021 soil data confirms that the soil impacts are limited to the Site and do not extend off Site to the east or south. Based on the information available to date and using a conservative approach to estimate the extent of the remaining impacts (halfway to the known clean location), it is estimated that approximately 290 m^3 of petroleum hydrocarbon impacted soils remain on the Site. It has not been verified if remaining impacts extend beneath the existing store structure. The estimated extent of remaining PHC impacted soil is presented in **Figure 4**.

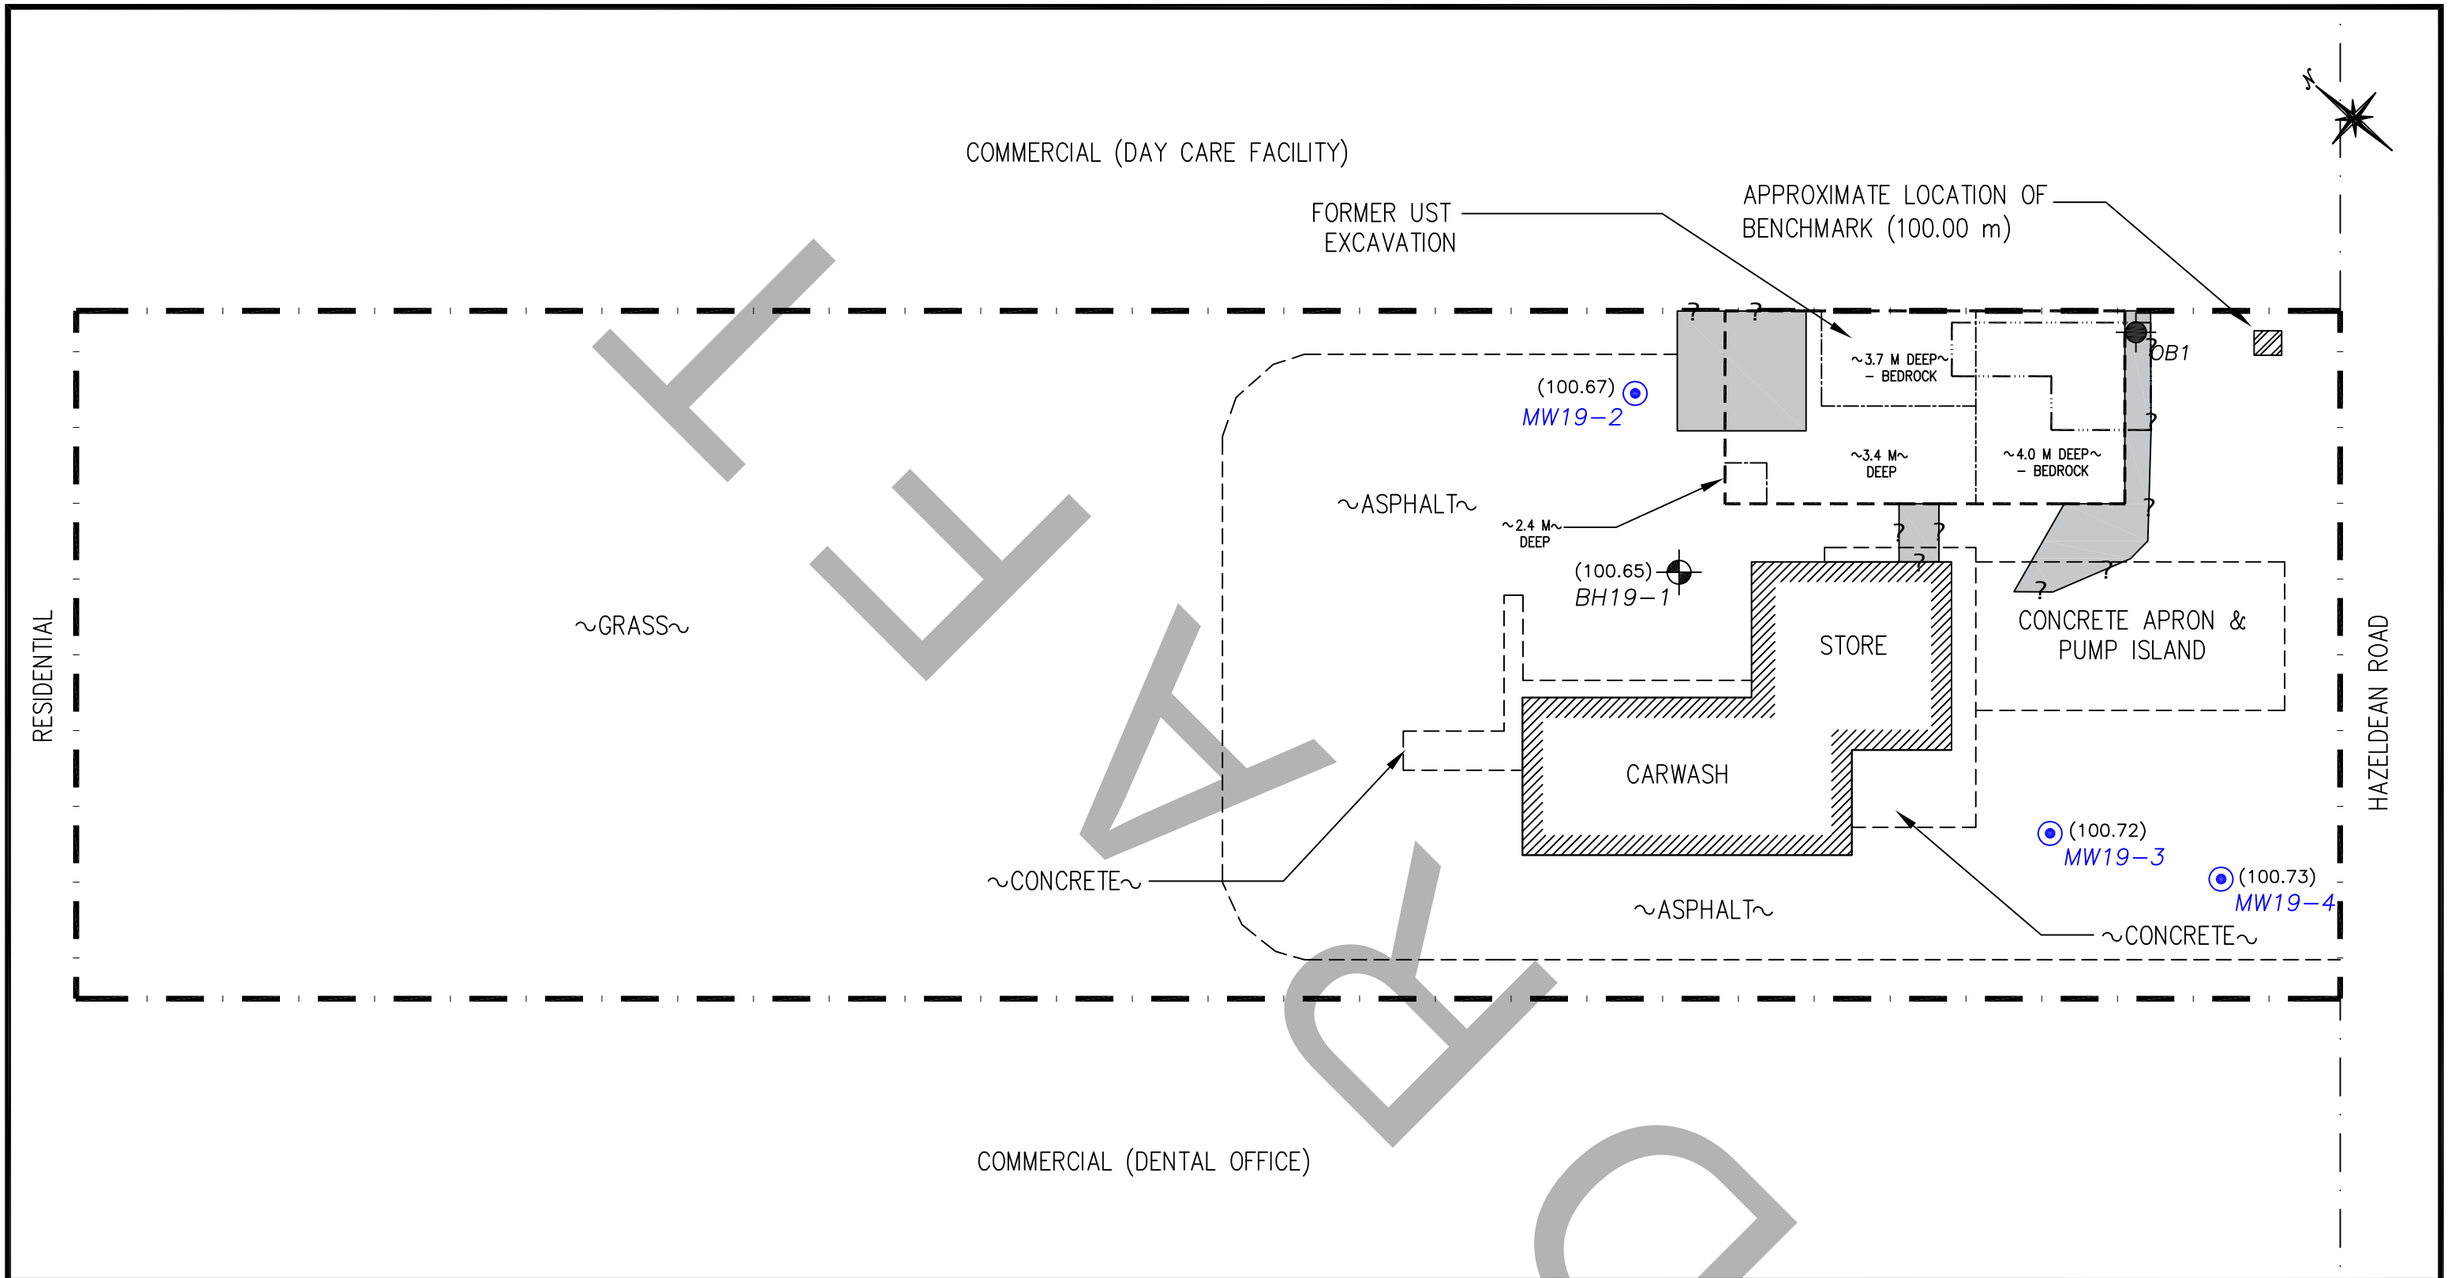
Previous investigations have shown that petroleum-impacted soils remain along the final southern wall of the former UST excavation, as well as along the southern portions of the east and west walls and the base of the northern portion of the excavation. This infers that residual soil impacts extend from the former UST excavation southeastward, possibly off-Site toward Hazeldean Road, as well as southward toward the existing pump island and eastward, possibly off-Site toward the eastern property. Based on the information available to date and using a conservative approach to estimate the extent of the remaining impacts (halfway to the known clean location), it is estimated that approximately 290 m^3 of petroleum hydrocarbon impacted soils remain on the Site. The full extent to the east and south is not confirmed, nor has it been verified if remaining impacts extend beneath the existing store structure. The estimated extent of remaining PHC impacted soil is presented in **Figure 4**.

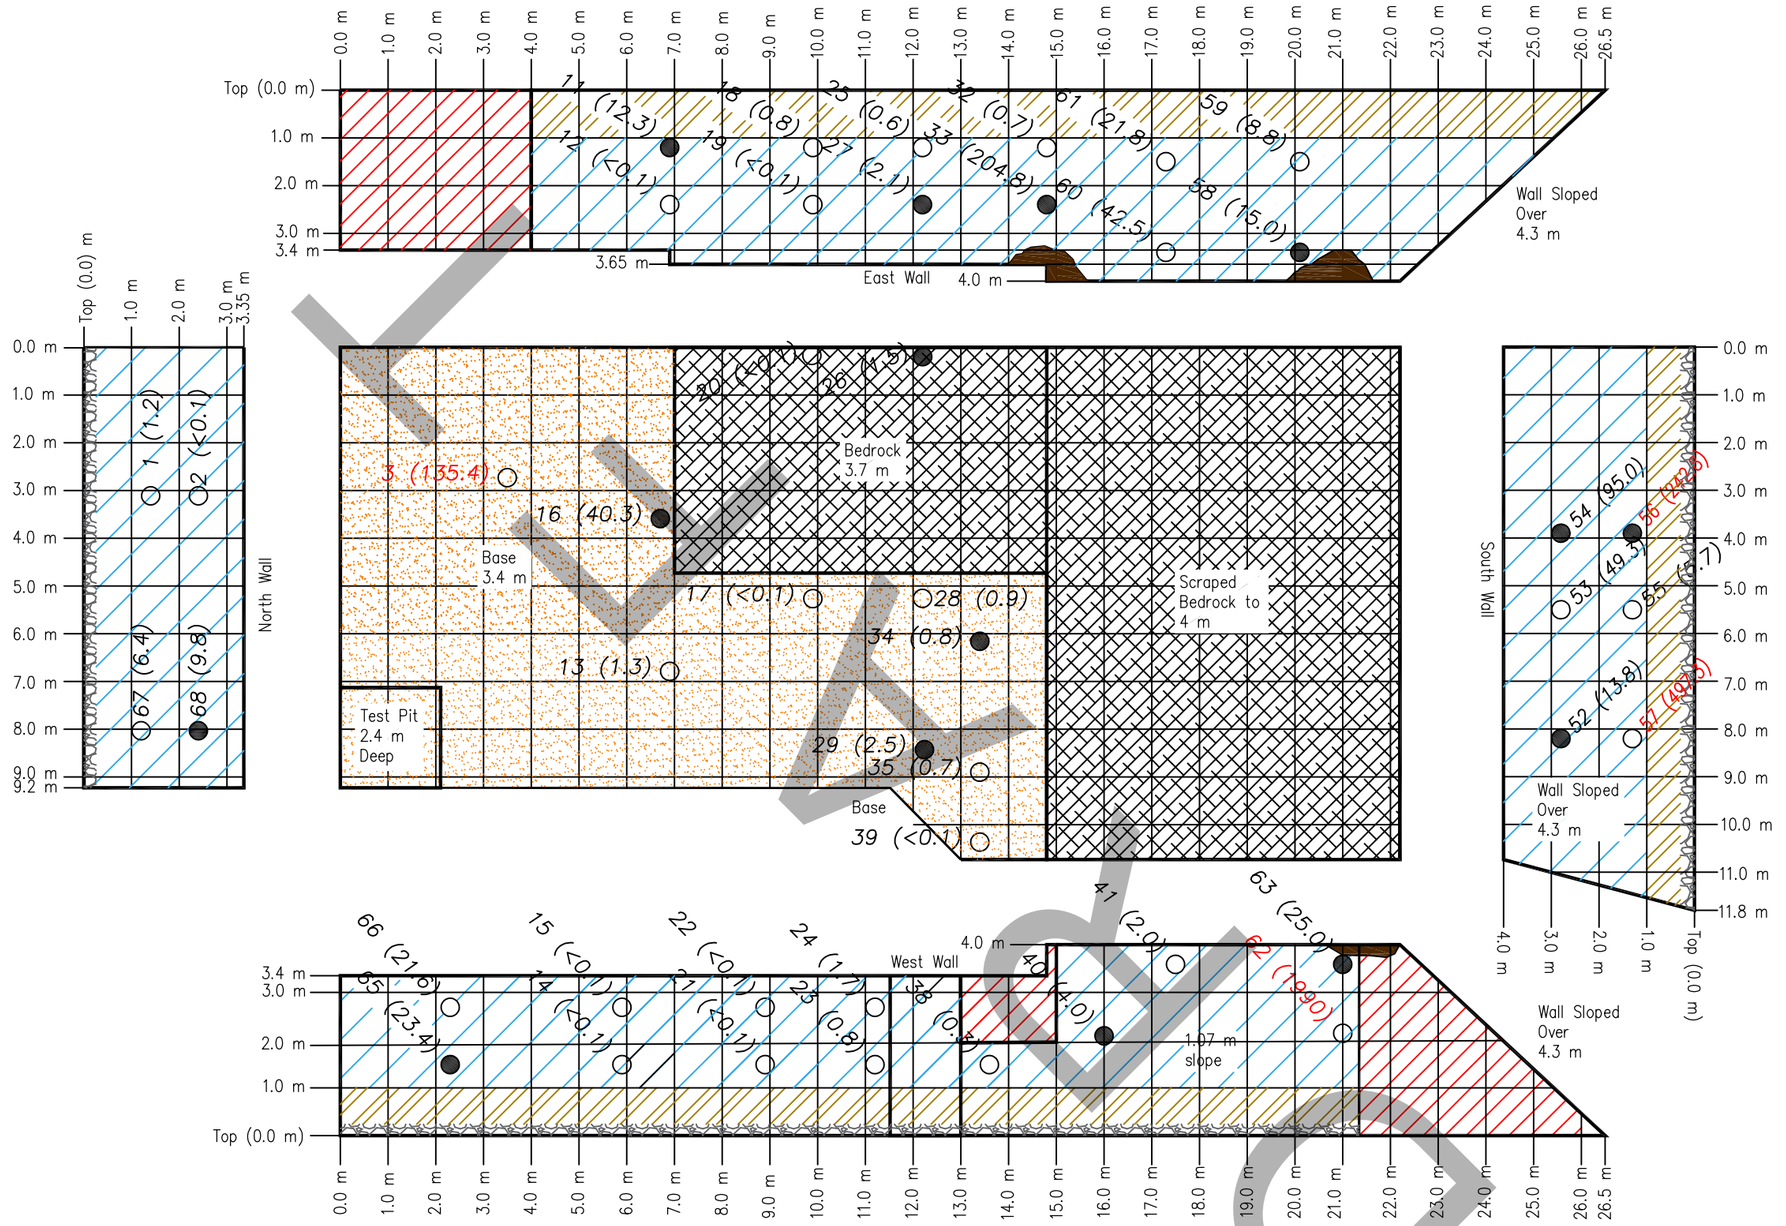
FIGURE 4

The excavation activities commenced at the northern portion of the tank nest continued south toward Hazeldean Road. Final dimensions of the tank nest excavation were 22.2 m long (north-south) by 9.2 m wide (east-west) at the thinnest portion, and 10.7 m wide at the widest portion. The excavation was dug to a depth of 3.4 m bgs toward the northern portion and 4.0 m bgs toward the southern portion, at which point bedrock was reached. A portion of the excavation (the northwestern-most corner) was dug as a test pit to 2.4 m bgs to allow access to a previously inaccessible corner of the excavation. The excavation was extended until either no visual or olfactory evidence of petroleum hydrocarbon impacts were observed, or the excavation reached property lines or structures, where the integrities of which could not be compromised. A total of approximately 1,268 metric tonnes of soil was removed from the Site and disposed of at Waste Connections of Canada Inc. (Navan, Ontario), an MECP-licensed soil disposal facility. The location of the excavation and its dimensions are presented in the attached **Figure 3** and **Figure 4**.

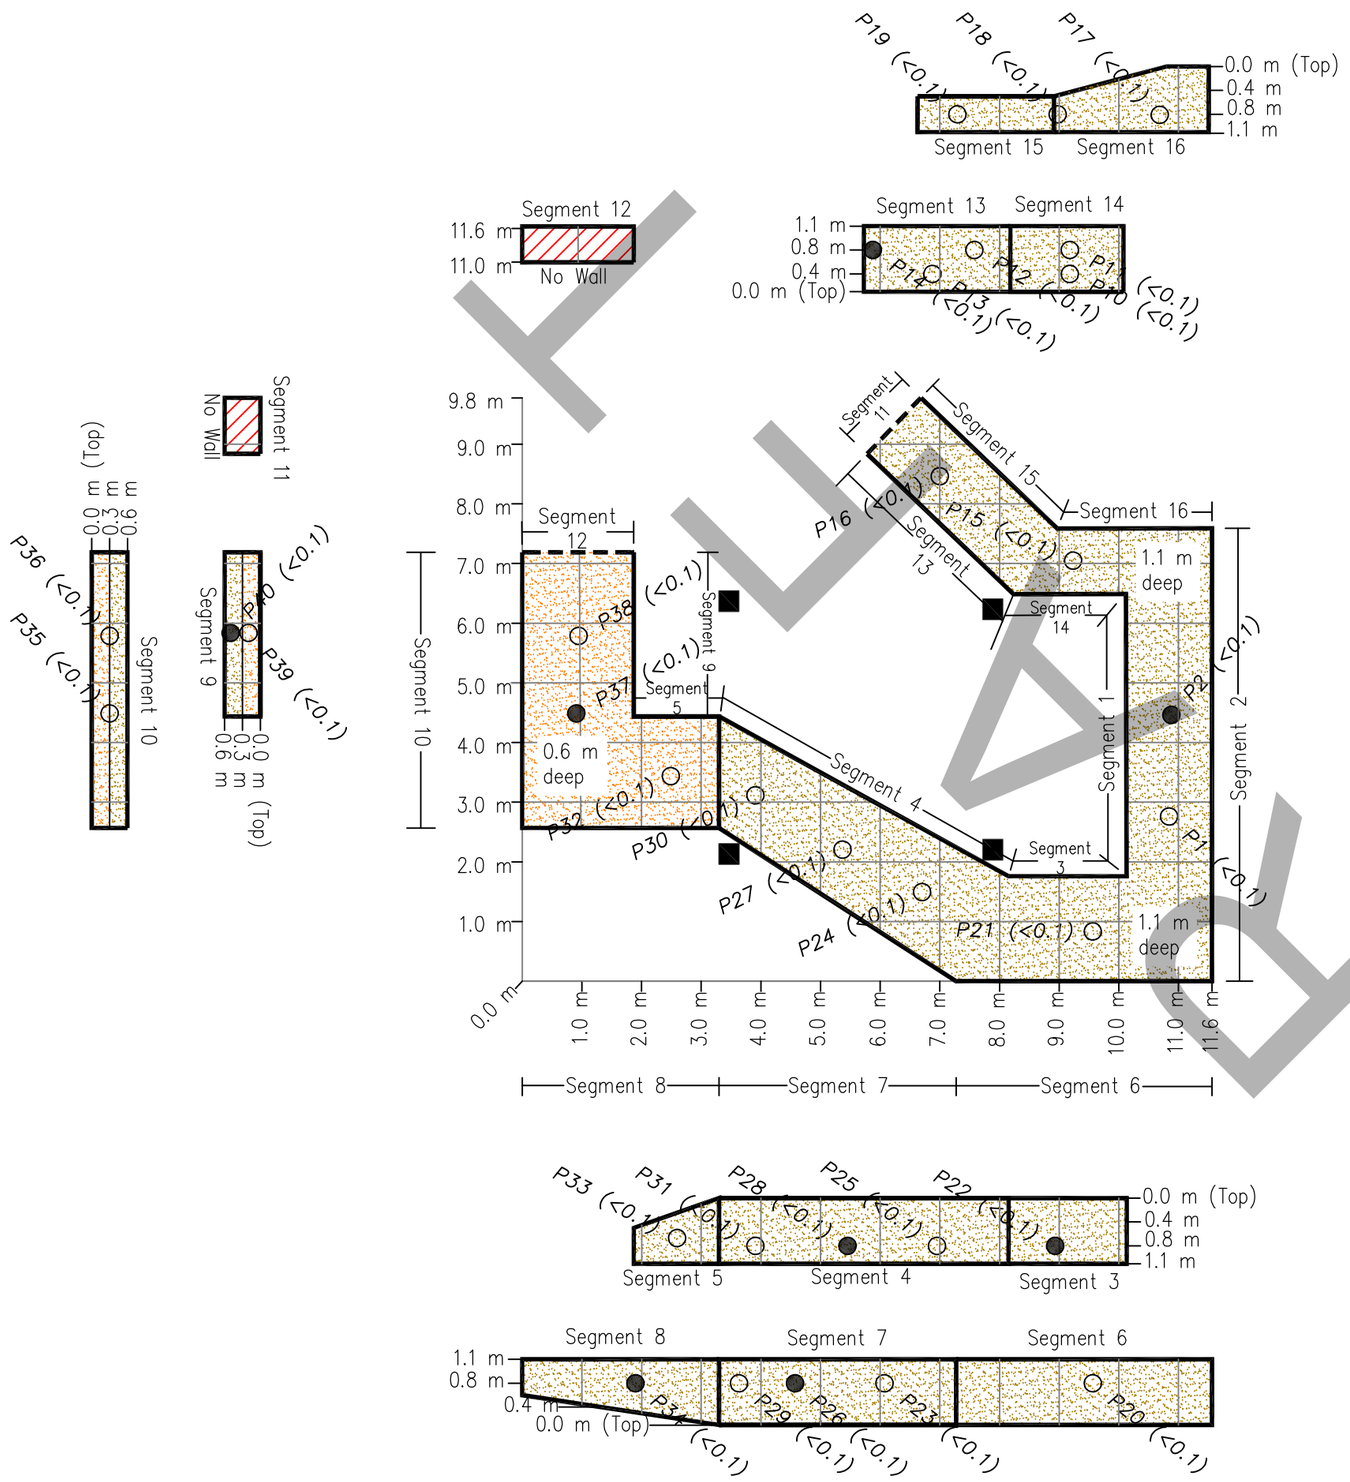
FIGURE5

Fuel dispensing pumps and associated pump island were removed prior to LRL's arrival to the Site allowing for samples to be collected along trenches dug beneath the former pump and piping locations. The location of the excavation and its dimensions are presented in the attached **Figure 3** and **Figure 5**.

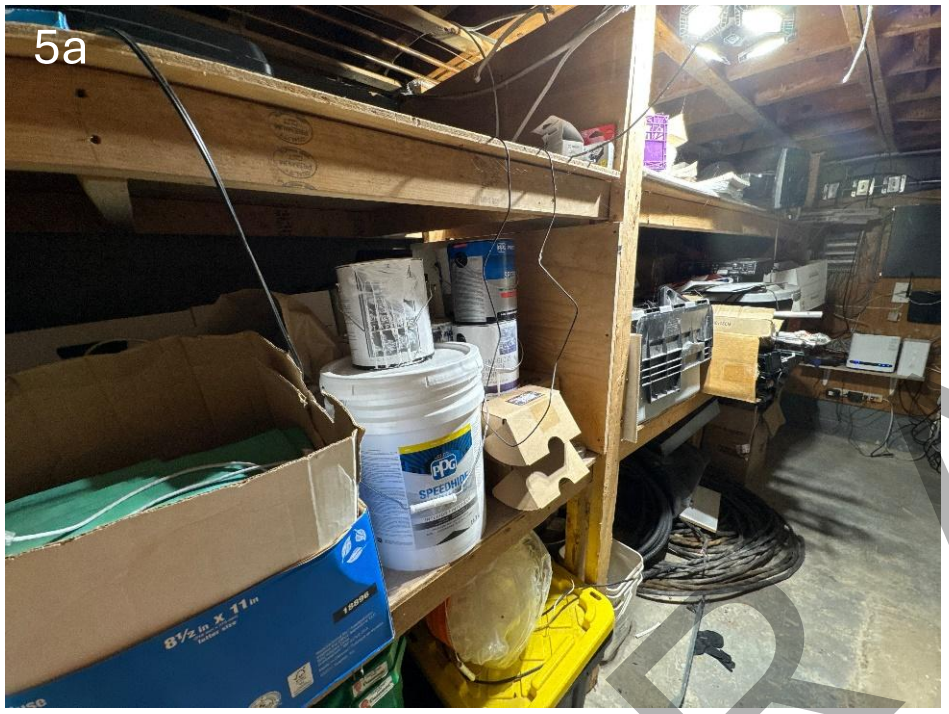
Gas cannisters, paints, and lubricants stored in the basement of the Westend Automotive office building.

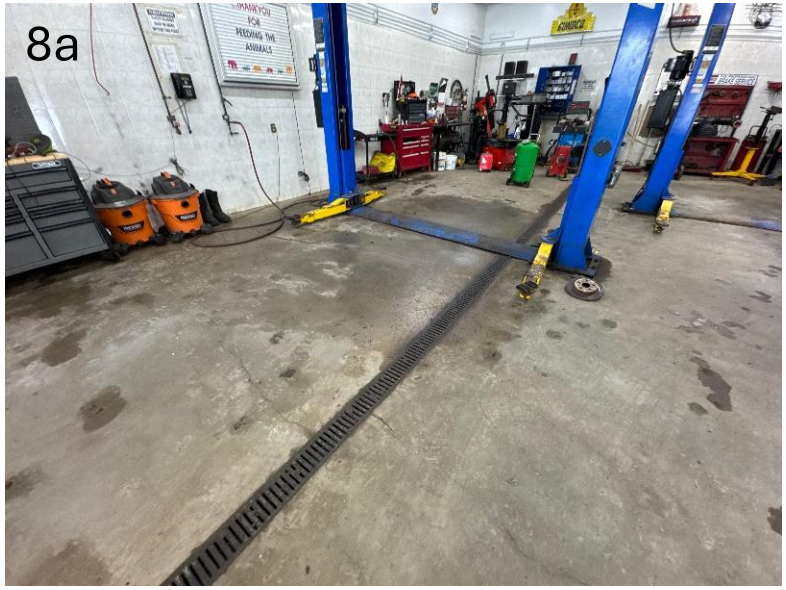
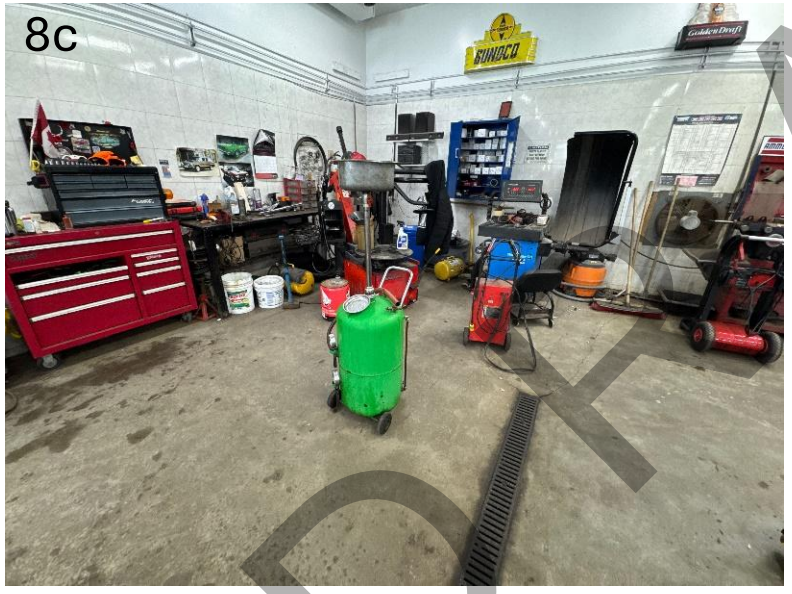
Photos from inside the Westend Automotive garage building at 5872 Hazeldean Road. The photographs illustrate the hydraulic lift, drain, multiple tools, oils, lubricants and other materials ritually used for vehicle maintenance. Note: No photo of the oil water separator is available since it was floored over and not accessible.
