# Phase One Environmental Site Assessment

1010 Somerset Street West, Ottawa, Ontario

July 2021 – 21-1685

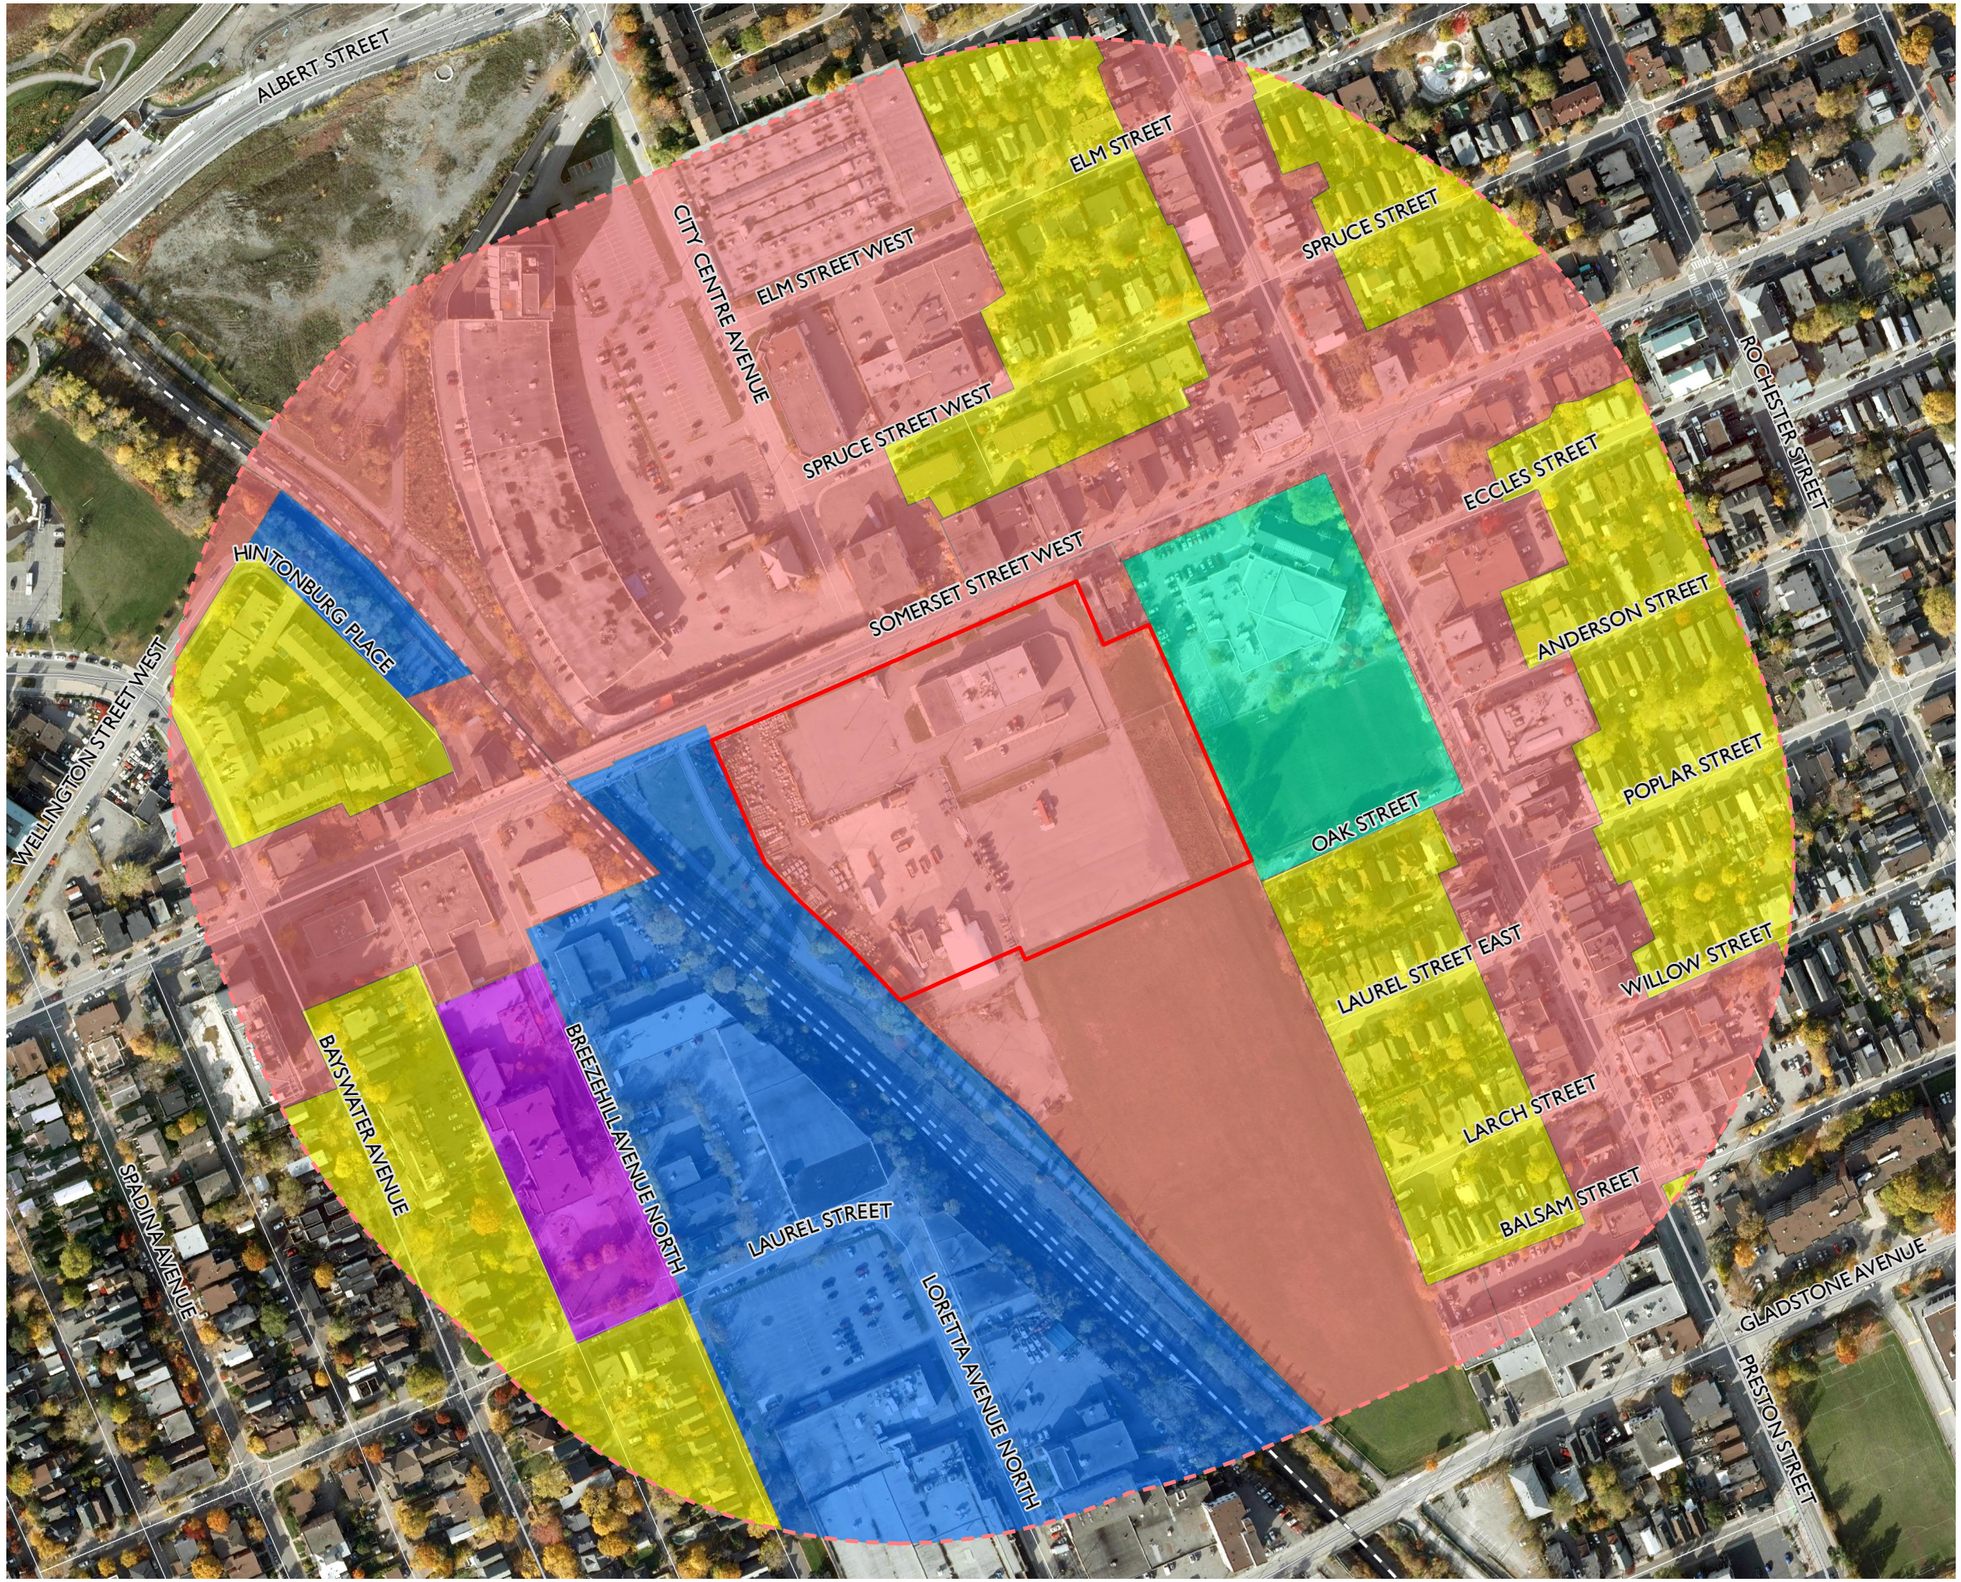
**FIGURE 2**
**AERIAL OVERLAY**

| Municipal Addresses | 1010 Somerset Street West, Ottawa, Ontario |
|---|---|
| **General Site Description** | As shown on **Figure 2**, the RSC Property consists of a 2.83 hectare parcel (comprised of three different PINs) located at 1010 Somerset Street West, in Ottawa, Ontario. The RSC Property was observed to consist of an office building (used by government staff prior to the Covid-19 pandemic), a few smaller sheds, storage lockers and sea cans, a paved parking area, landscaped areas and areas of overgrown vegetation. The RSC Property is surrounded by residential, parkland and commercial land use. |

The Phase One Study Area includes the RSC Property and properties that include lands located wholly or partially within 250 m of the RSC Property boundary. For the purposes of determining the Phase One Study Area, a 250 m buffer was extended from the RSC Property and all properties located wholly or partially within that area were included. The portions of right-of-ways within this area were also included. The area that this encompasses is presented on **Figure 2**.

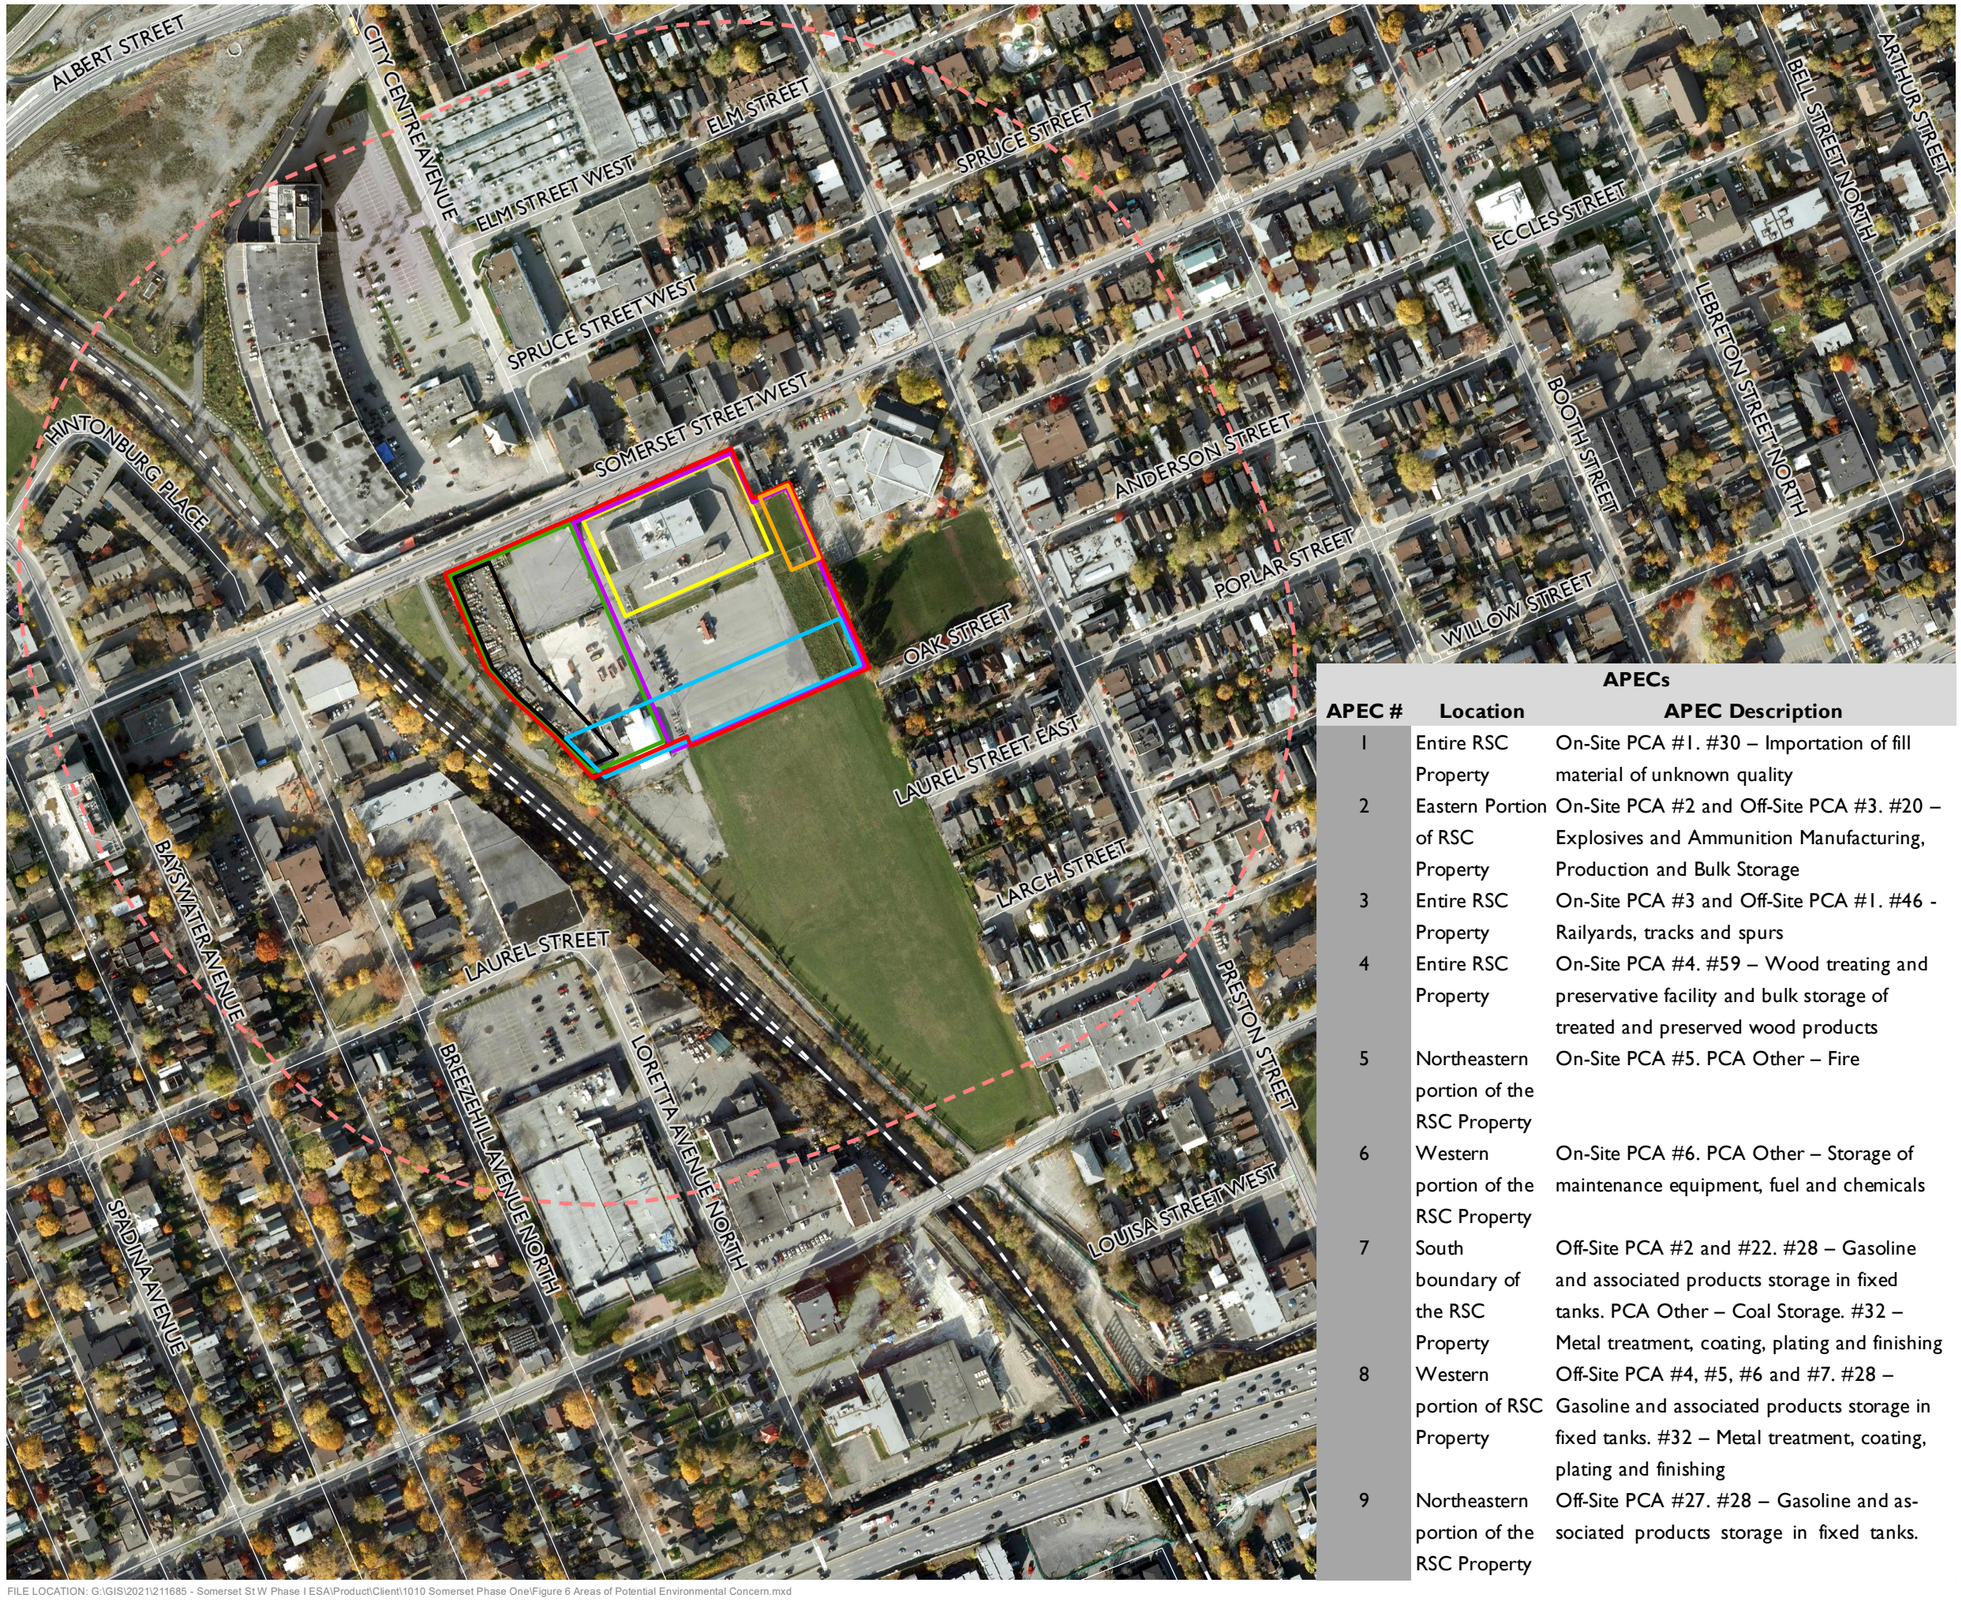
**FIGURE 5**
**POTENTIALLY CONTAMINATING ACTIVITIES**

Off-site PCAs for the Phase One Study Area are summarized in **Table 11** and on **Figure 5**. It should be noted that property addresses in the Phase One Study Area have changed and amalgamated over the years. As such, addresses provided in this section match what is provided in current property parcel plans provided by the City of Ottawa, and not necessarily what is indicated in records described in **Section 3.2.**

The PCAs and APECs are illustrated on **Figure 5** and **Figure 6**, respectively. In addition to these APECs, based on the age of the office building on-site there may be hazardous building materials present at the RSC Property. A Designated Substance Survey (DSS) should be completed prior to construction/ demolition work on this building.

**Figures 5** and **6** show the interpreted locations of PCAs and APECs at the RSC Property, respectively. A detailed description of PCAs and potential contaminants of concern are provided in the previous sections of the report.

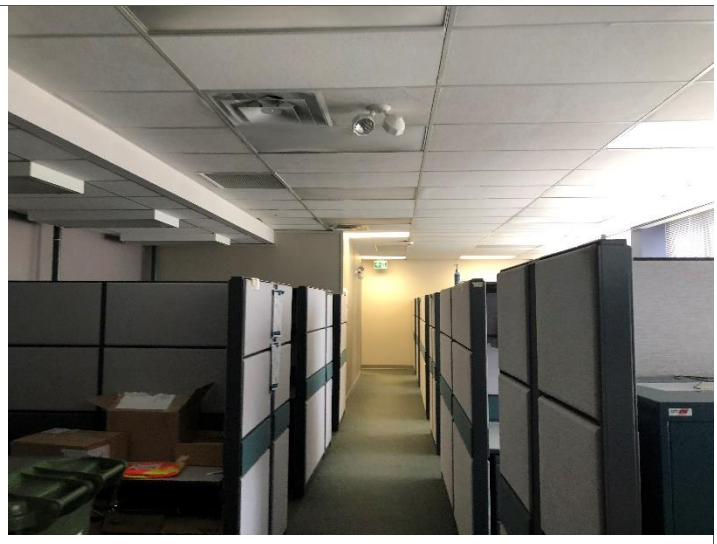
Picture 1 – Office Building on RSC Property (facing east)

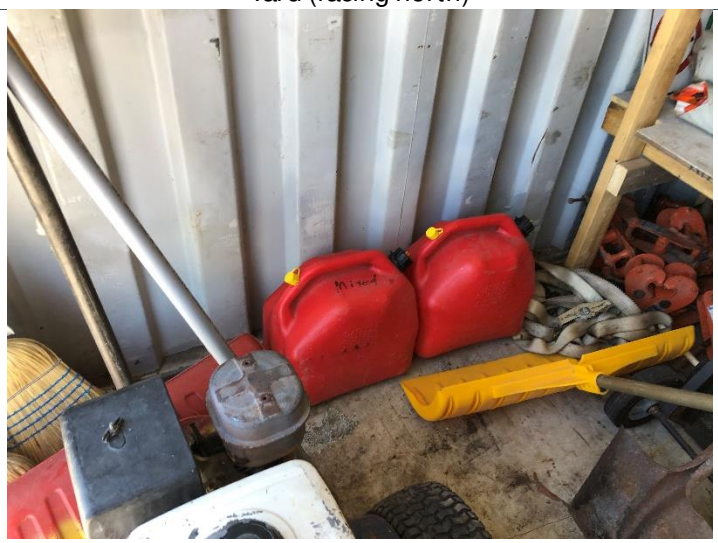
Picture 19 – Fuel Jerry Cans Within Storage Locker in Public Works Yard
