Geotechnical Investigation

Proposed Residential Development

319 Huntmar Drive
Ottawa, Ontario

Report PG7718-1 Revision 3 dated October 23, 2026

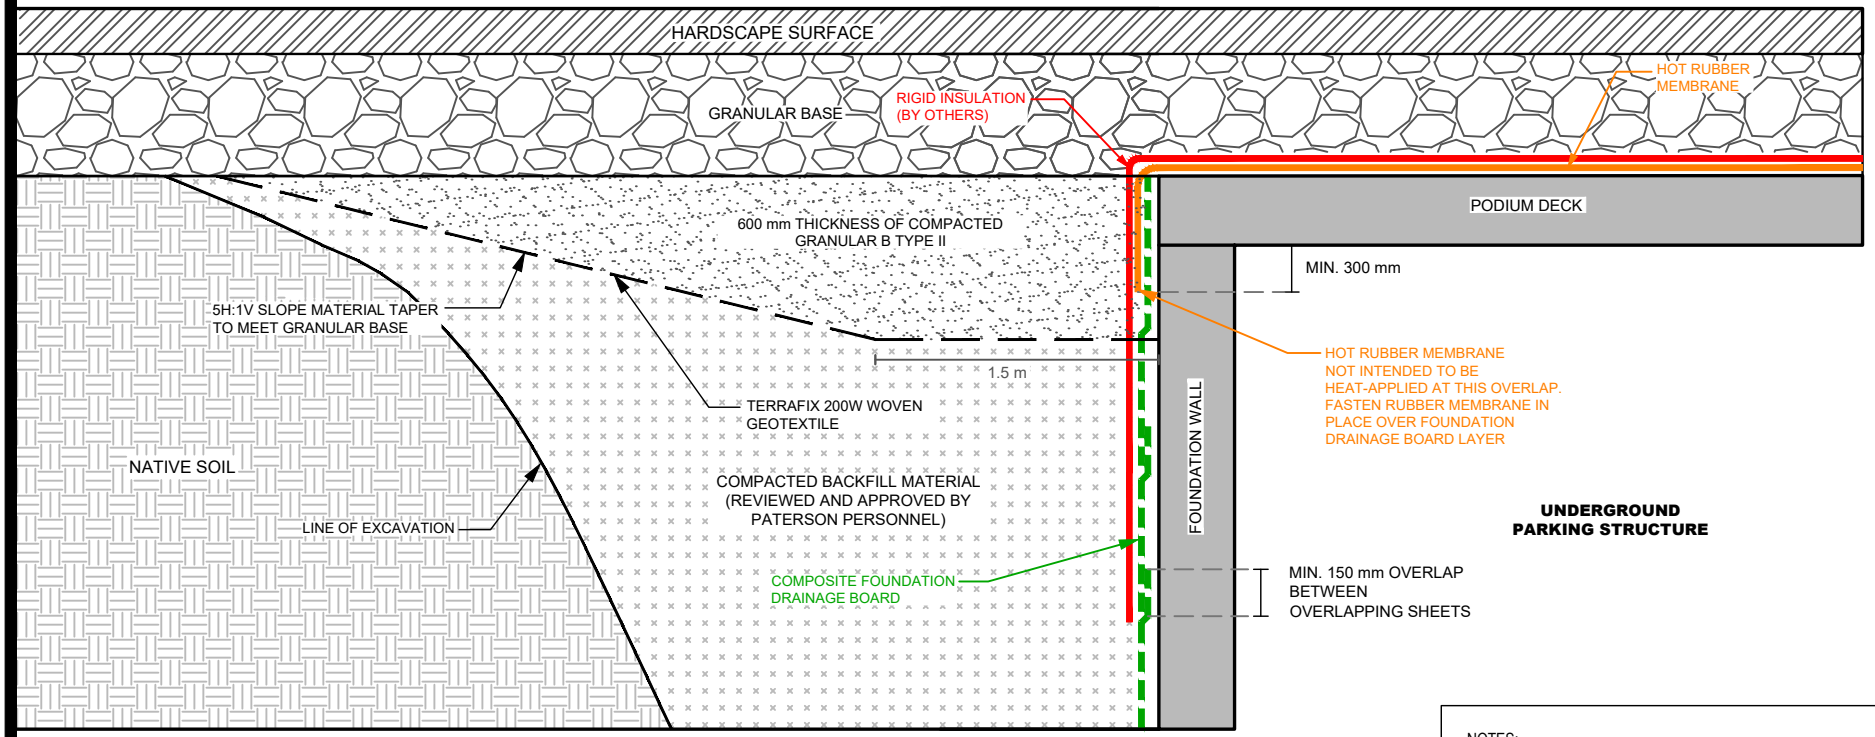
ALL PORTIONS OF THE ABOVE-NOTED DETAIL (INSULATION OF FOUNDATION DRAINAGE BOARD, HOT-RUBBER MEMBRANE OVER SLAB AND FOUNDATION WALL CONSTRUCTION JOINT AND OVERLAPPING/SHINGLING OF DRAINAGE BOARD SHOULD BE REVIEWED AT THE TIME OF CONSTRUCTION BY PATERSON PERSONNEL.
