**PATERSON
GROUP**

June 19, 2026
PG6557-LET.01 Revision 4

Subject: **Preliminary Geotechnical Investigation
Proposed Commercial Development
2175 Prince of Wales Drive – Ottawa, Ontario**

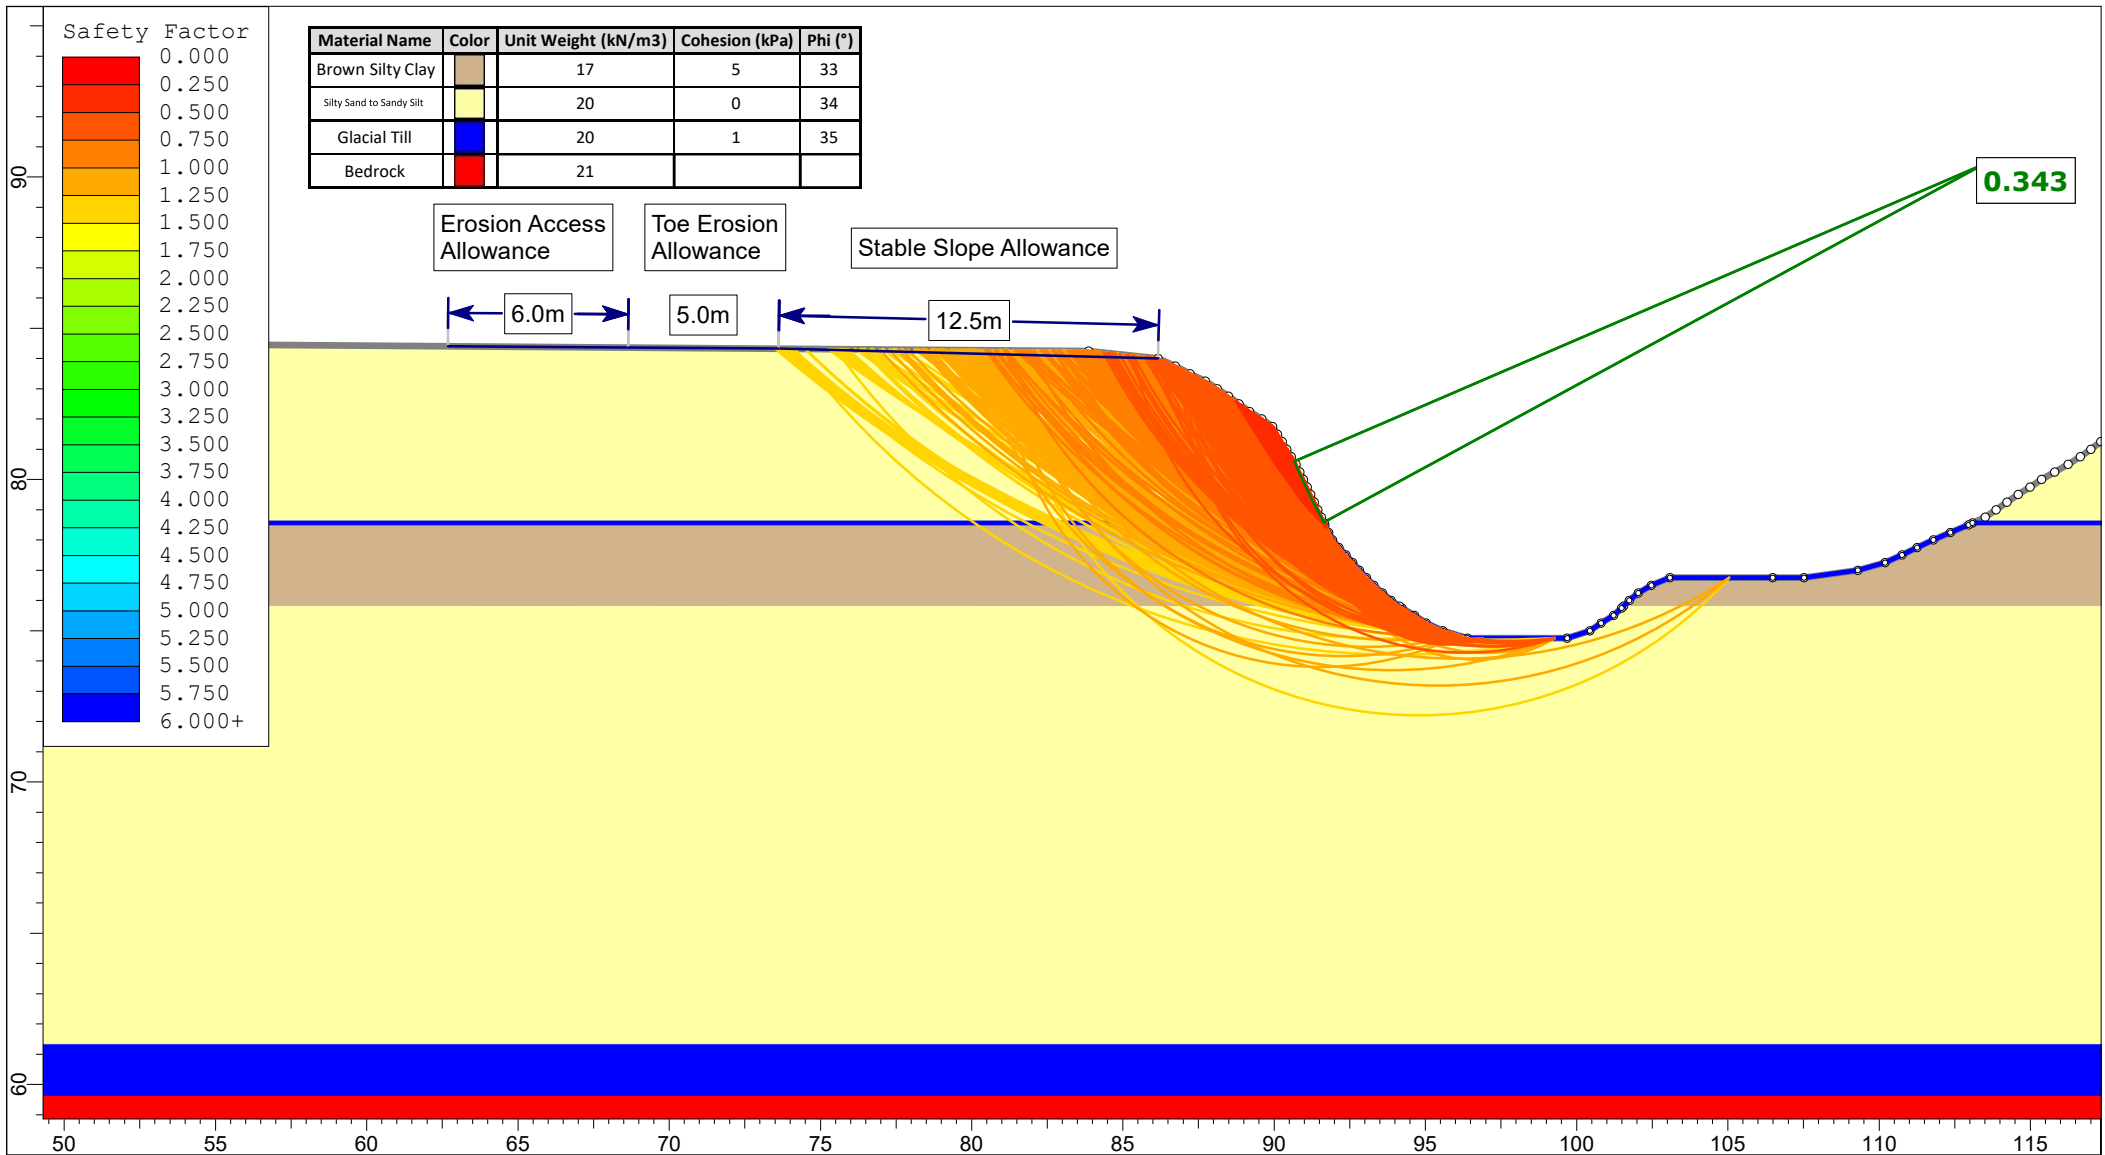
Project No.: Myers Automotive Group Slope Stability Analysis 2175 Prince of Wales Drive, Ottawa, Ontario
	Drawing No.: Figure 1A - Section A - Static Loading
	Prepared By: NFRV File No.: PG6557

The results of the existing slope conditions under static loading at Sections A, B, C, D, and E, are shown in Figures 1A, 2A, 3A, 4A, and 5A, respectively, and are attached to the present report. The overall slope stability factors of safety for the subject sections were found to be less than 1.5. The stable slope allowance from the top of slope required for slopes with a minimum factor of safety of 1.5 is identified for each profile in the attached figures.

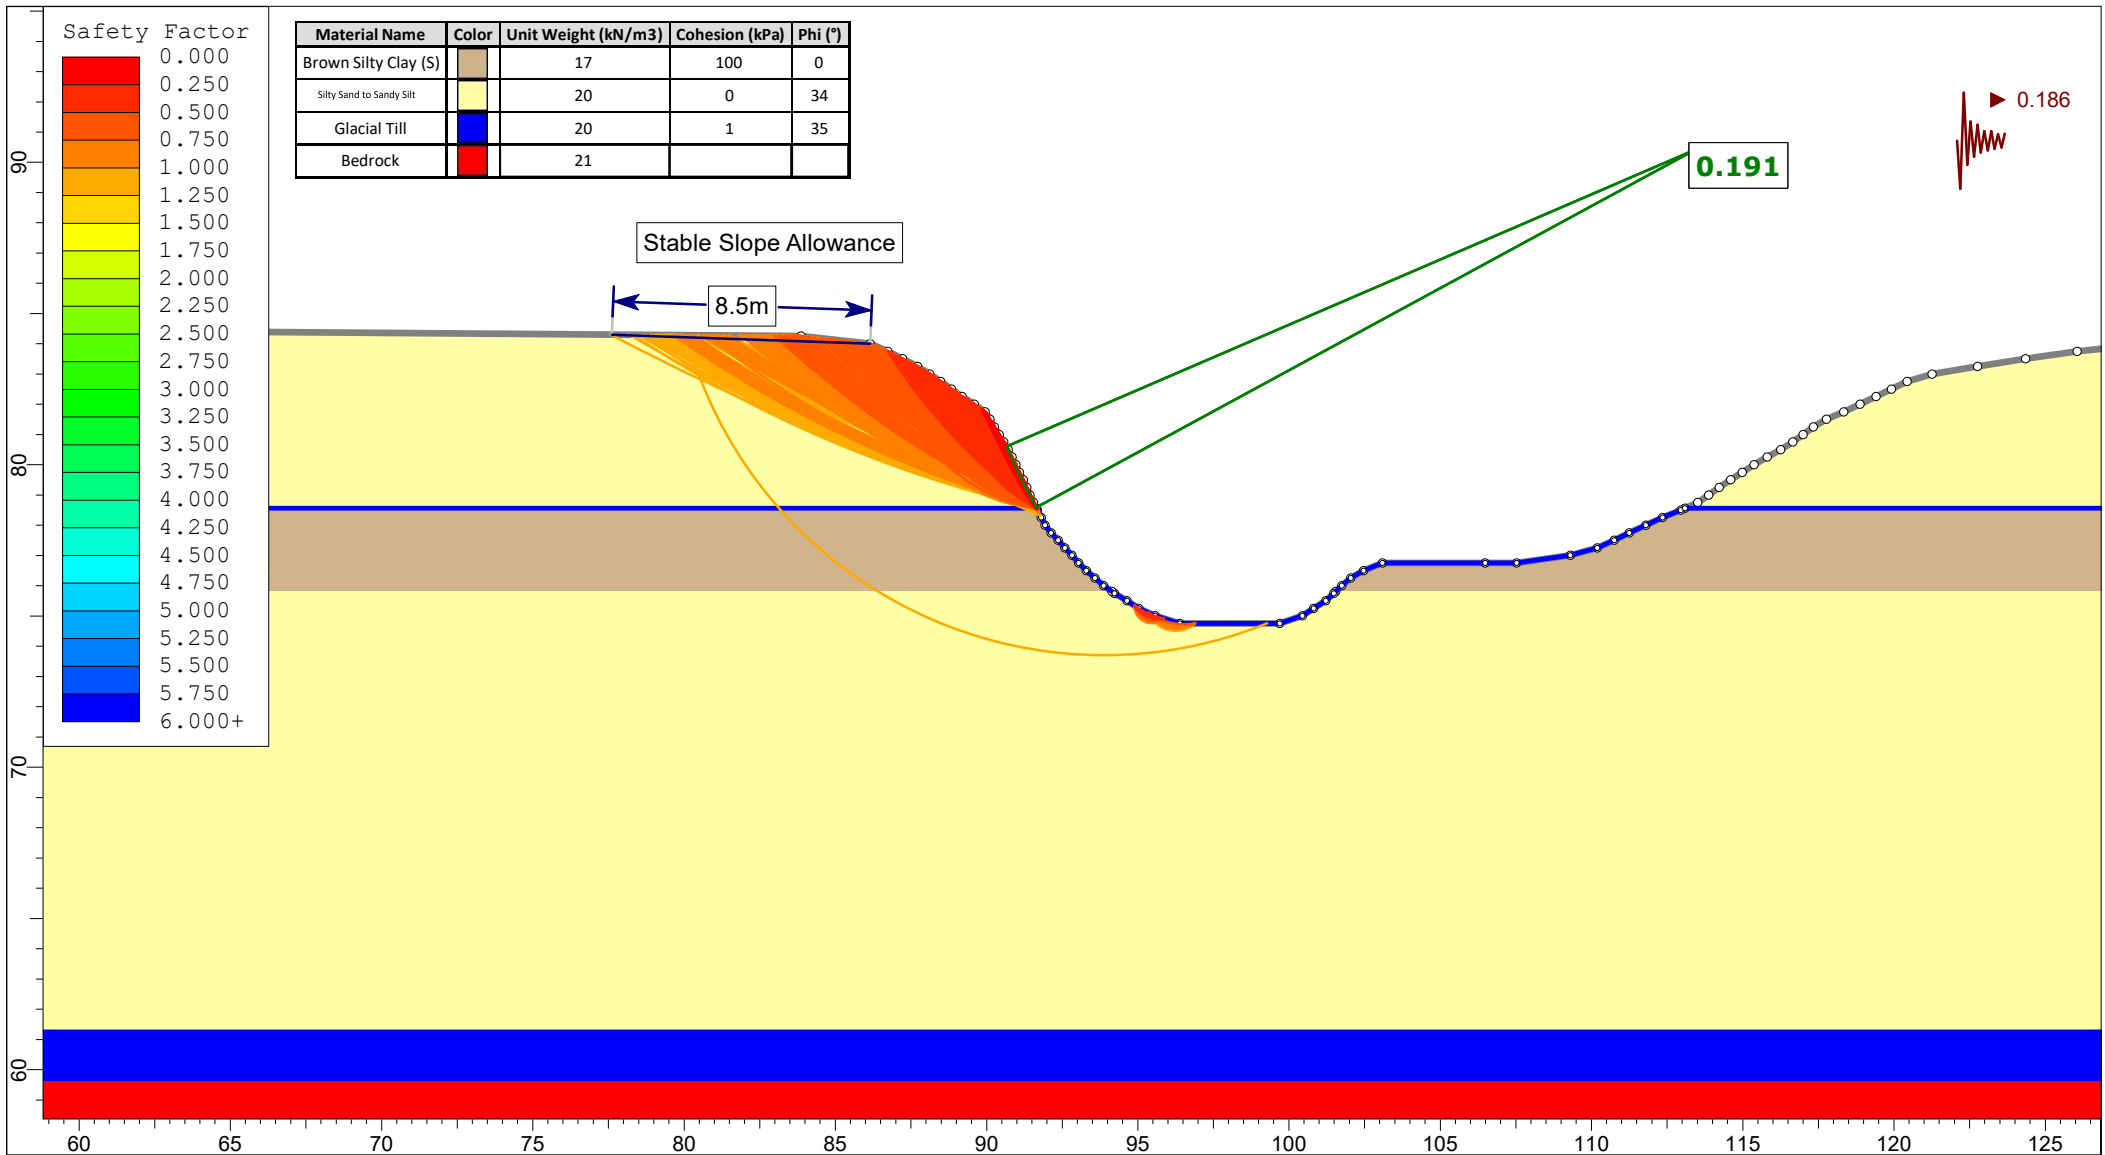
<i>Project No.:</i> Myers Automotive Group Slope Stability Analysis 2175 Prince of Wales Drive, Ottawa, Ontario
	<i>Drawing No.:</i> Figure 1B - Section A - Seismic Loading
	<i>Prepared By:</i> NFRV <i>File No.:</i> PG6557

An analysis considering seismic loading was also completed as part of the slope stability analysis. A horizontal seismic loading acceleration, K_h , of 0.186g was considered for the analyzed sections. A factor of safety of 1.1 is considered to be satisfactory for stability analysis including seismic loading. The results of the analysis including seismic loading, are shown in Figures 1B, 2B, 3B, 4B, and 5B for the slope sections. Where the minimum factor of safety is less than 1.1, the stable slope allowance from the top of slope required for the slope section is identified in the attached figures.
