**PATERSON
GROUP**

February 20, 2026
PG6557-LET.01 Revision 2

Subject: **Preliminary Geotechnical Investigation
Proposed Commercial Development
2175 Prince of Wales Drive – Ottawa, Ontario**

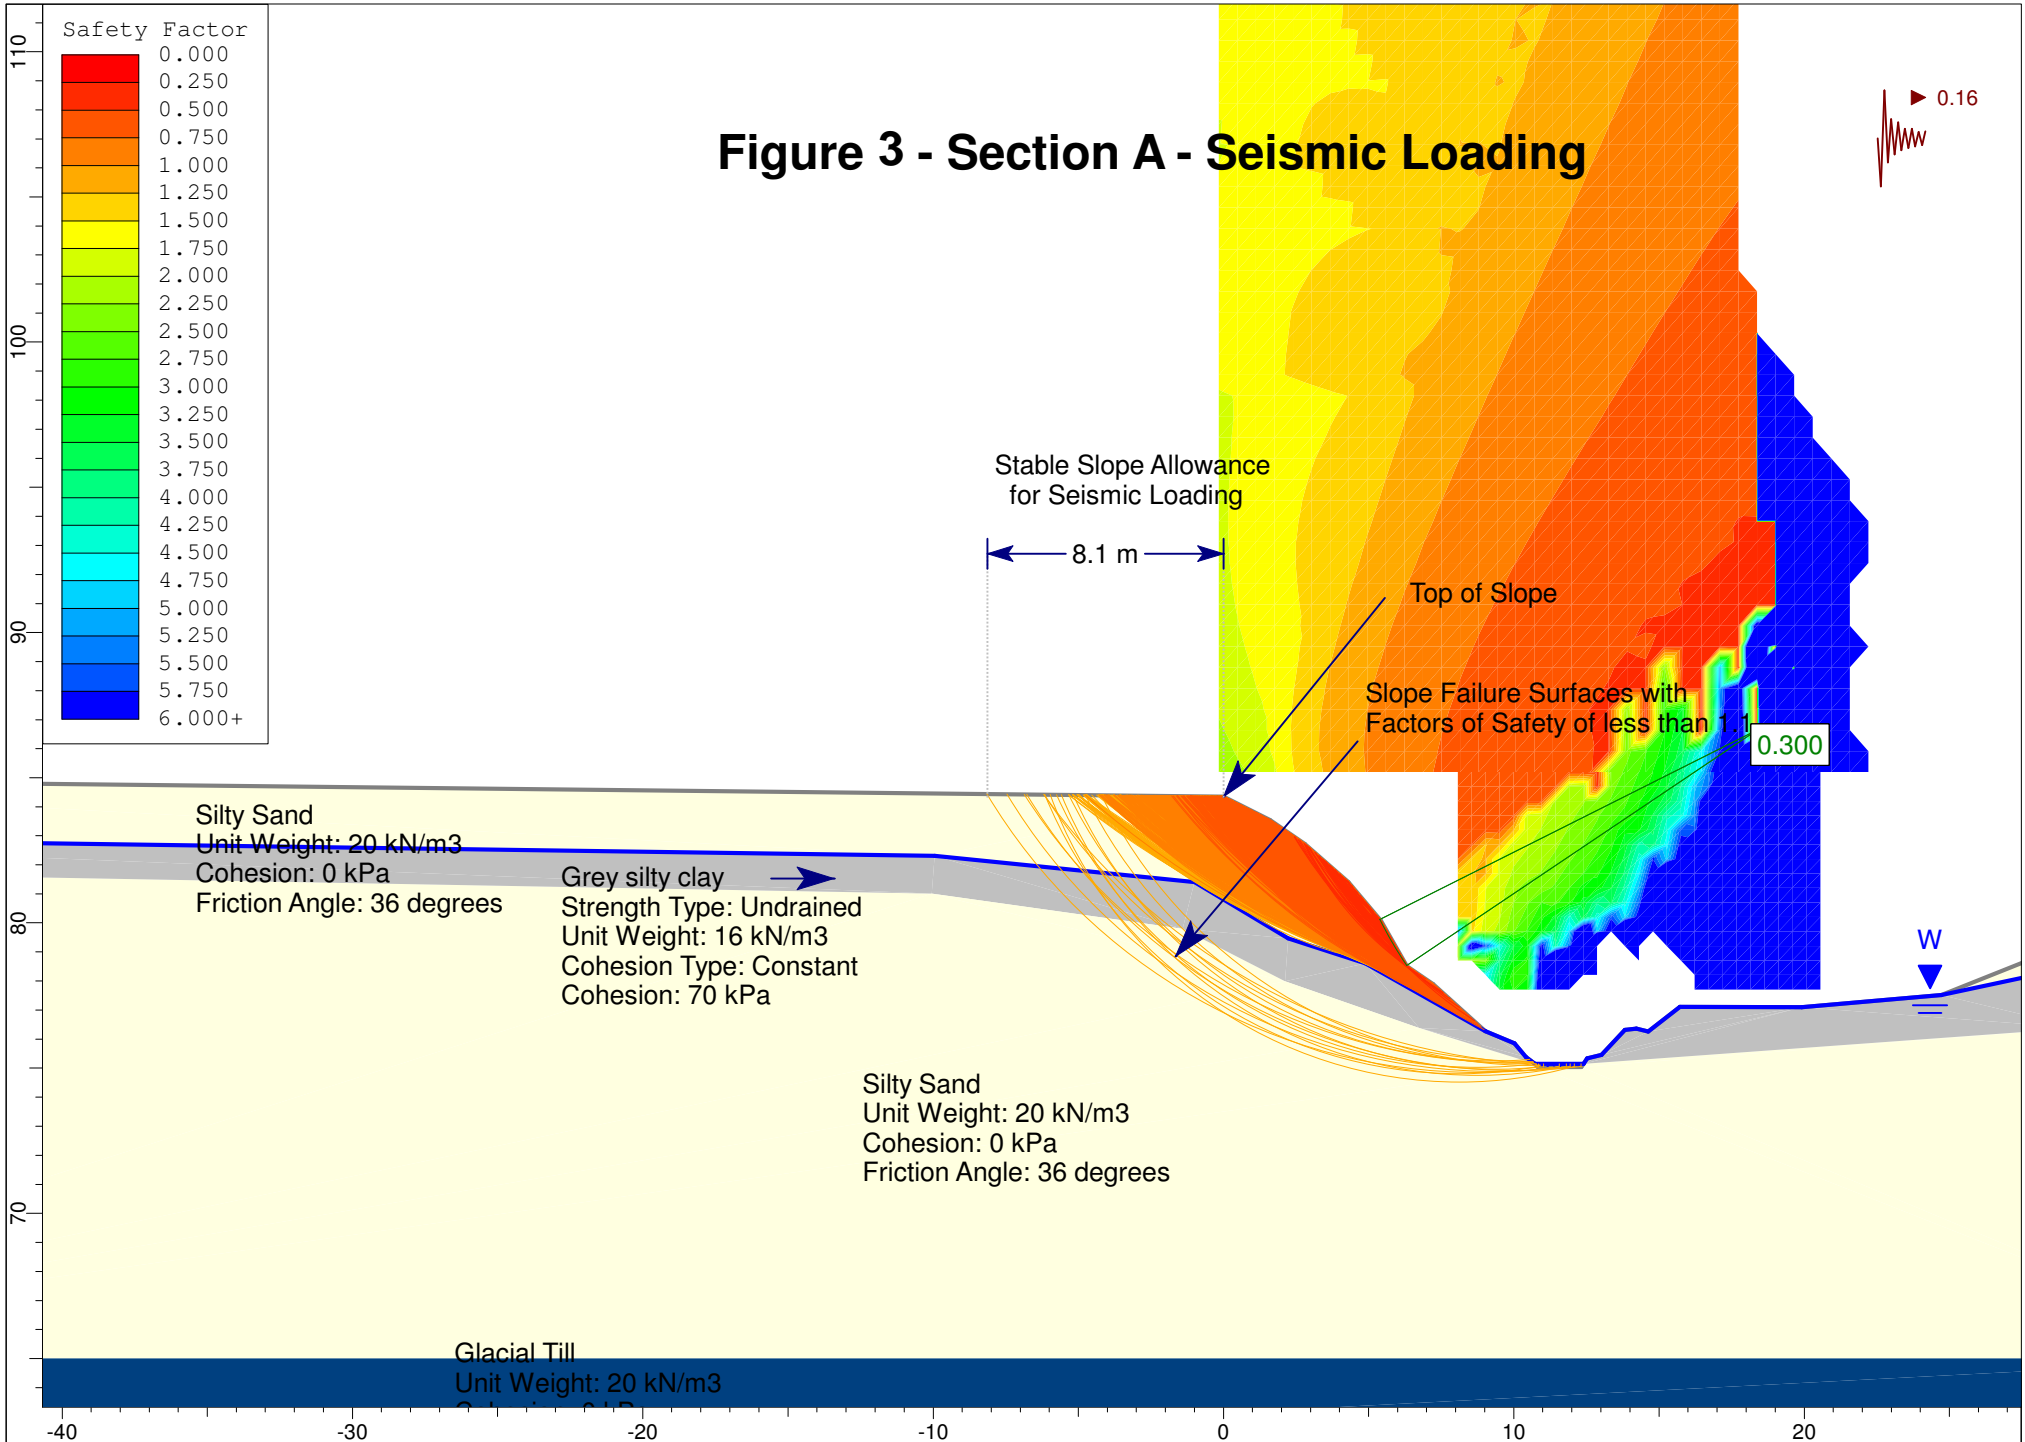
Figure 3 - Section A - Seismic Loading

The results of the analysis including seismic loading, are shown in Figures 3, 5, and 7 for the slope sections. Where the minimum factor of safety is less than 1.1, the stable slope allowance from the top of slope required for the slope section is identified in the attached figures.

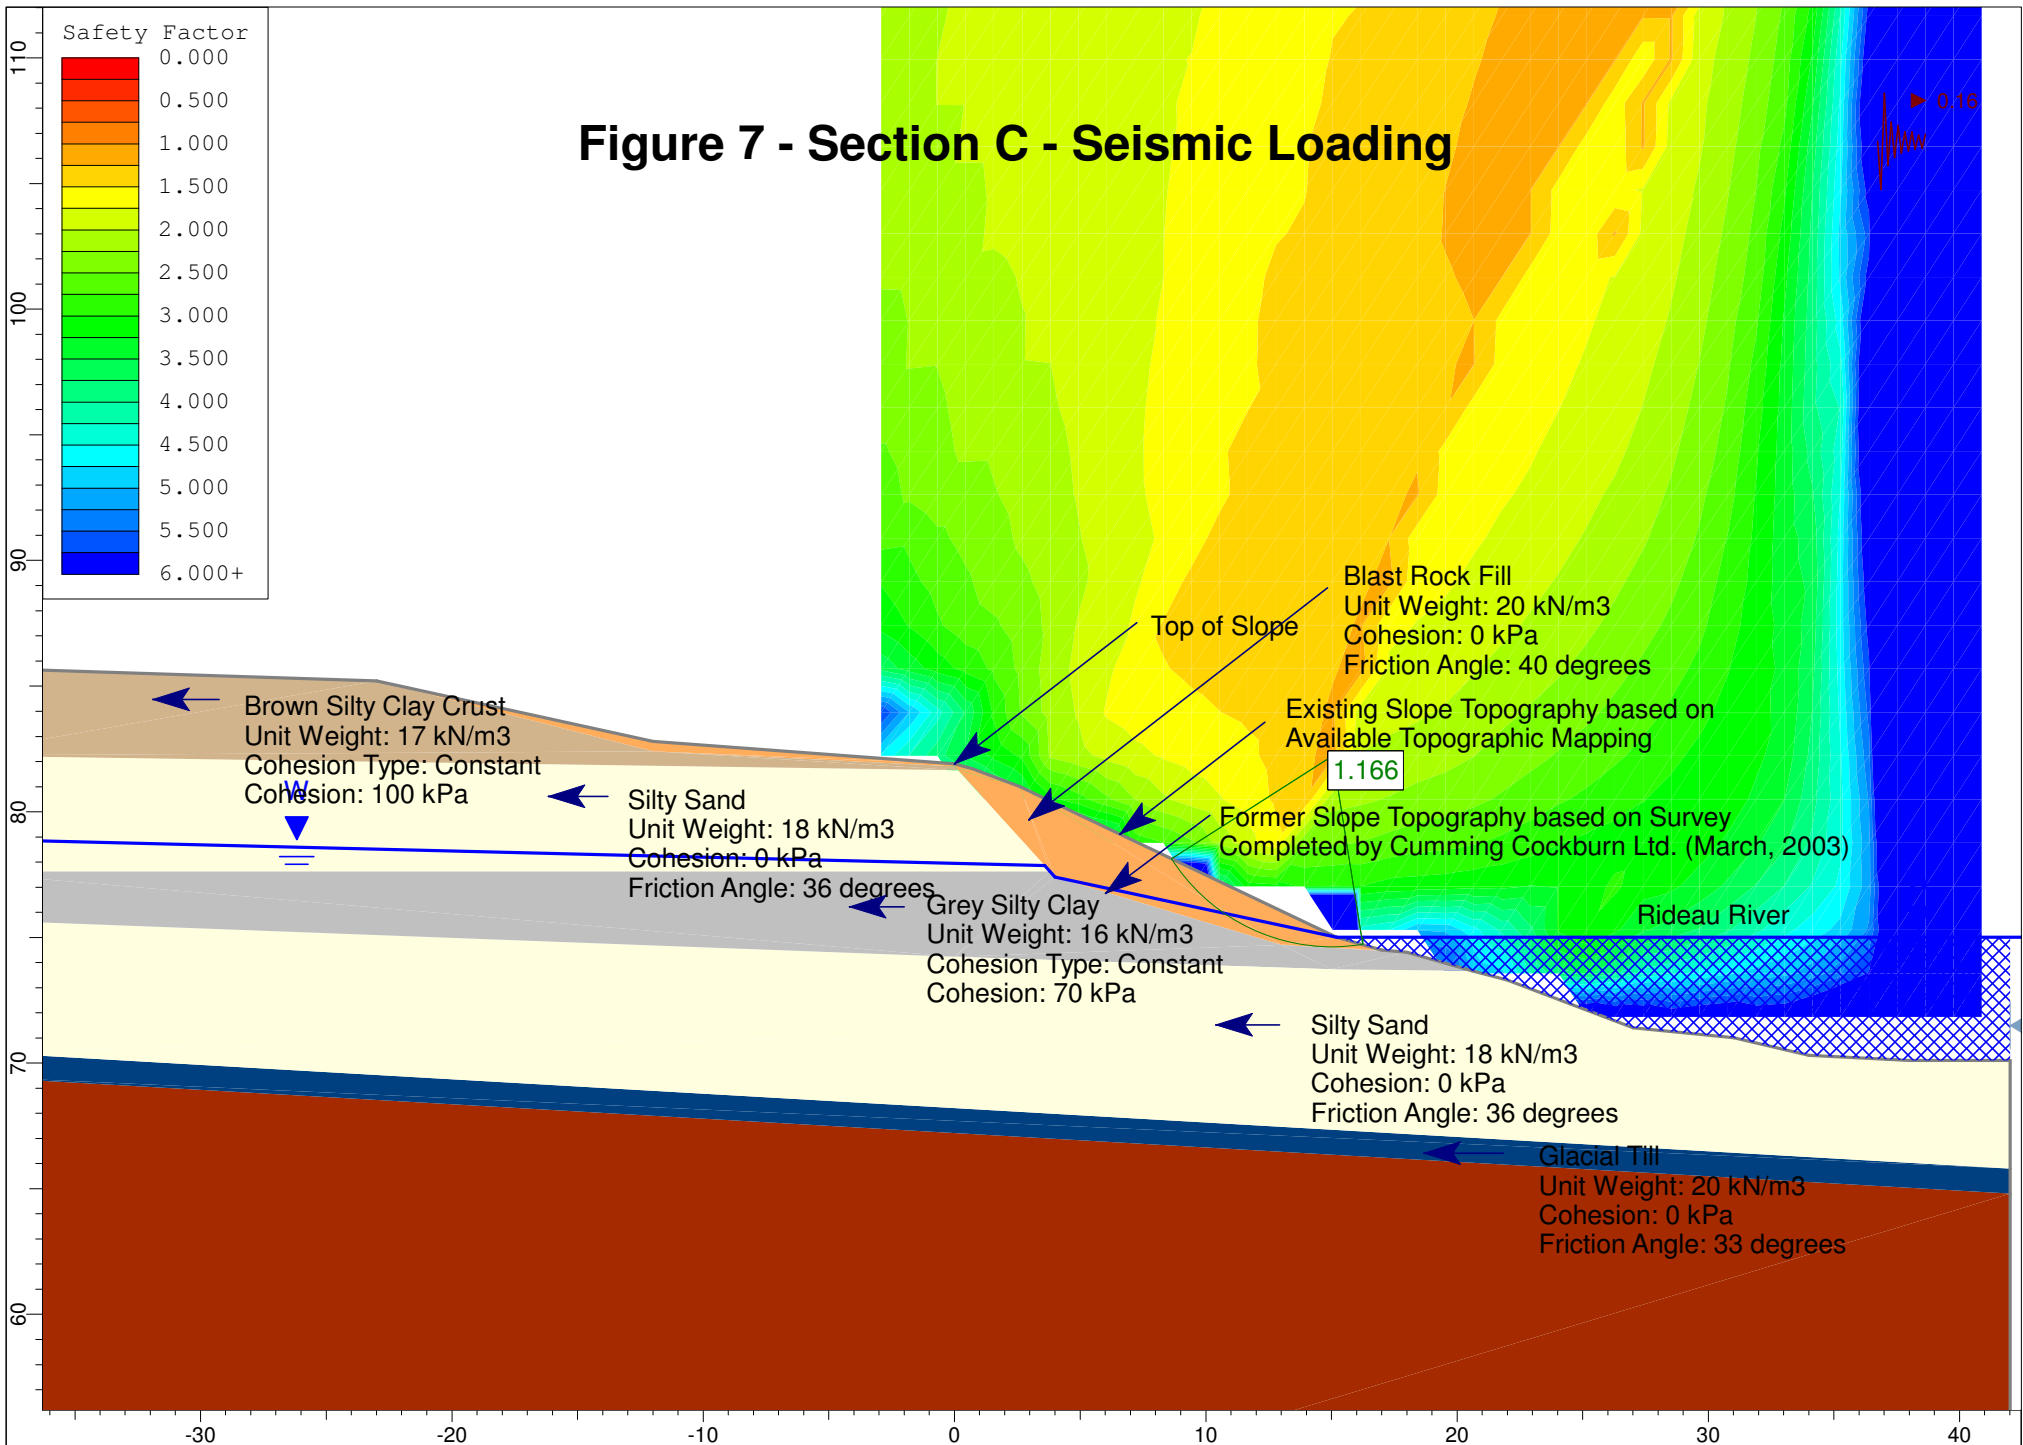
Figure 7 - Section C - Seismic Loading

Along the east property boundary, the west valley corridor wall of the Rideau River is undergoing some active erosion with some subsequent undercutting of the toe of the slope. It is expected that historical erosional activities have resulted in a relatively steep slope along the subject section of the Rideau River. At the present time, the majority of banks are vegetated with brush and mature trees. It should be noted that a slope remedial program was initiated near the southeast corner of the subject site during the summer of 2003 and consisted of modifying the existing slope and reinstating it with blast rock. Reference should be made to Section C present in Figure 6 and Figure 7, which is located on our attached drawing, PG6557-1 – Test Hole Location Plan.
