# 2510 St. Laurent Blvd – Tree Conservation Report

Prepared for Claridge Homes  
by Arcadis | IBI Group

March 19, 2026

<b>CLIENT:</b>	Claridge Homes
<b>PROJECT NAME:</b>	Walkley Conroy
<b>REPORT TITLE:</b>	2510 St Laurent Blvd - Tree Conservation Report
<b>ARCADIS REFERENCE:</b>	140253
<b>VERSION:</b>	5.0
<b>ORIGINATOR:</b>	Brittany Semmler, Ecologist (Edited by Brenda Van Ryswyk)
<b>REVIEWER:</b>	Casey Little, Senior Ecologist, Certified ISA Arborist

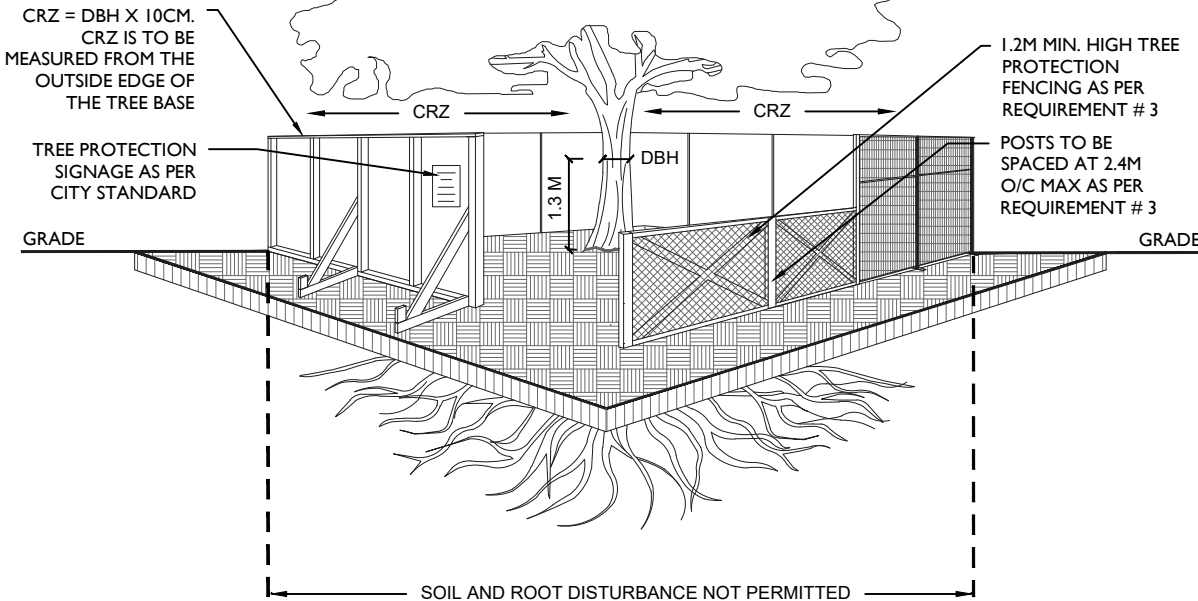
PLAN VIEW

CRZ = DBH X 10CM.  
CRZ IS TO BE MEASURED FROM THE OUTSIDE EDGE OF THE TREE BASE

TREE PROTECTION SIGNAGE AS PER CITY STANDARD
