# TREE CONSERVATION REPORT

Tree Conservation Report submitted as Partial Requirements for a Site Plan Control Application, Elmwood School, 261 Buena Vista Road.

# Tree Conservation Report

**Address:** Elmwood School, 261 Buena Vista Road

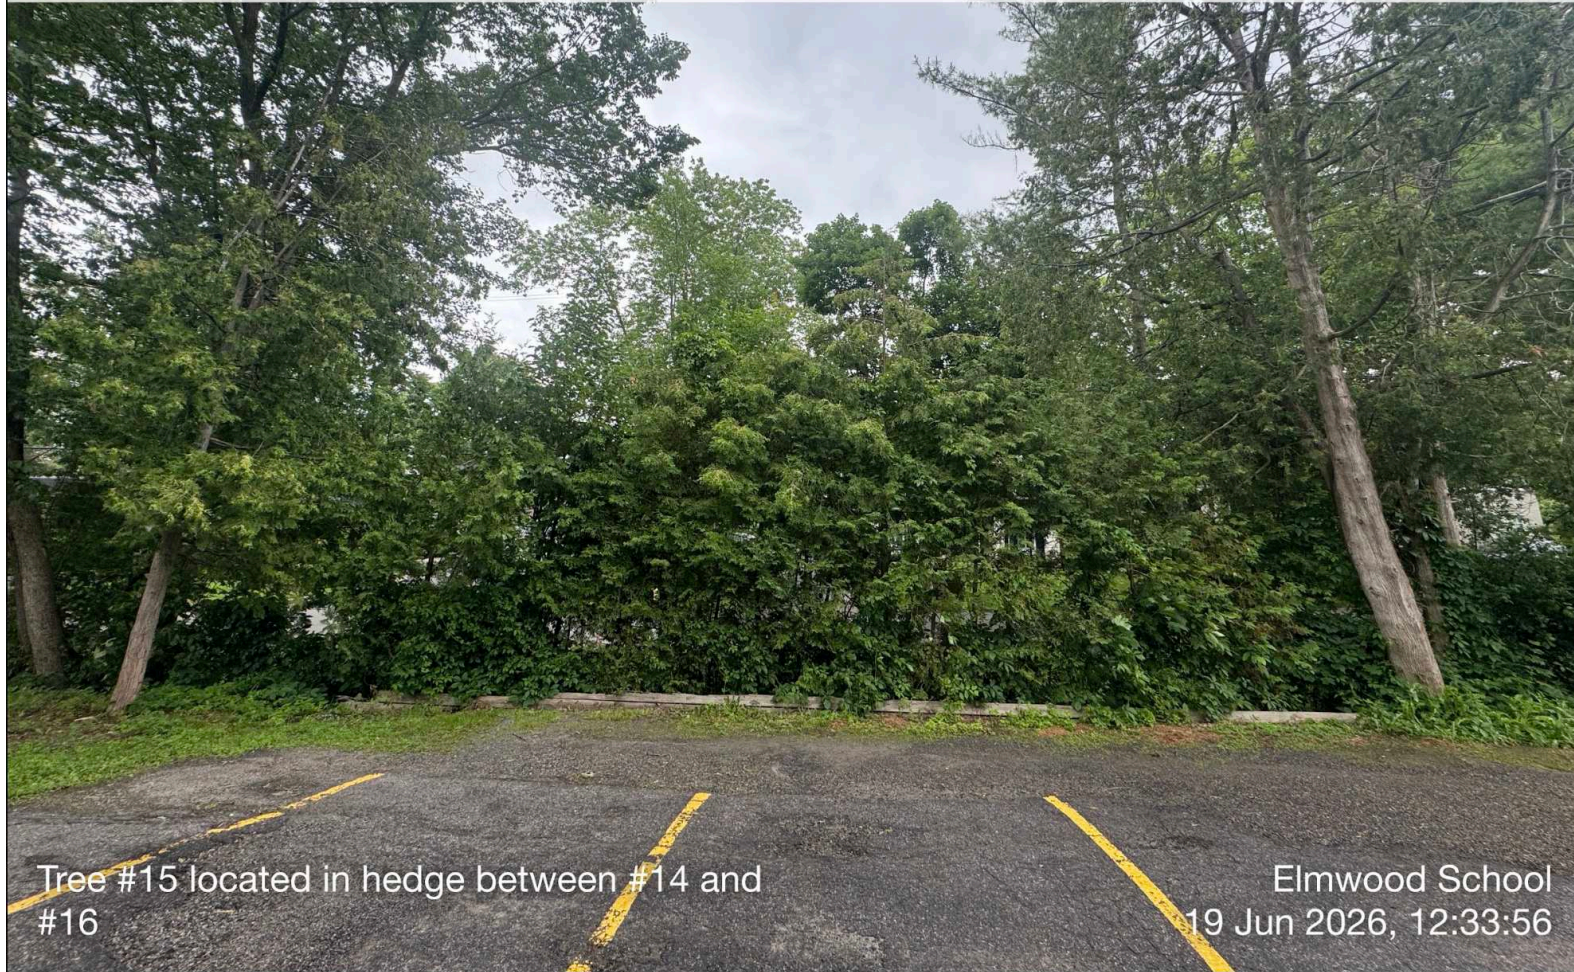
Tree #15 located in hedge between #14 and  
#16

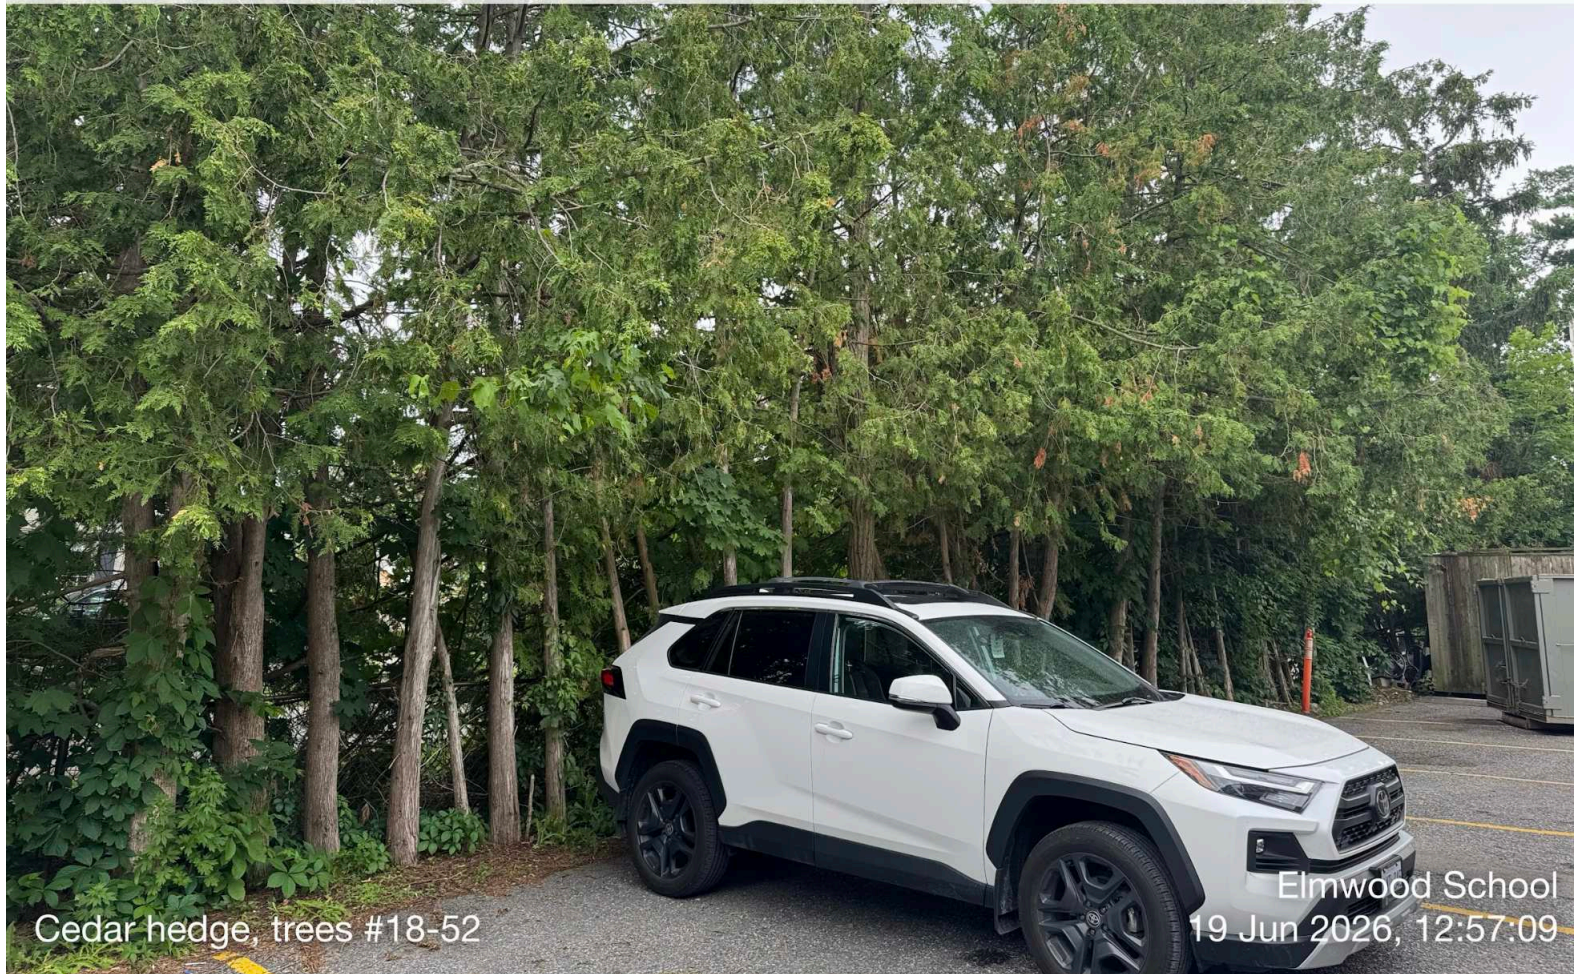
| 18 <sup>4</sup> | Eastern white cedar | <i>Thuja occidentalis</i> | 26 | Subject Property | Fair | Cedar hedge, generally fair condition. Occasional dead stems, insect damage. | Retain | n/a |

Cedar hedge, trees #18-52
