September 20, 2021

**RE: Arborist Report for Rositch Hemphill Architects - For property located at 1511 West 47 Ave., & 6151 - 6261 Granville St., Vancouver, BC**

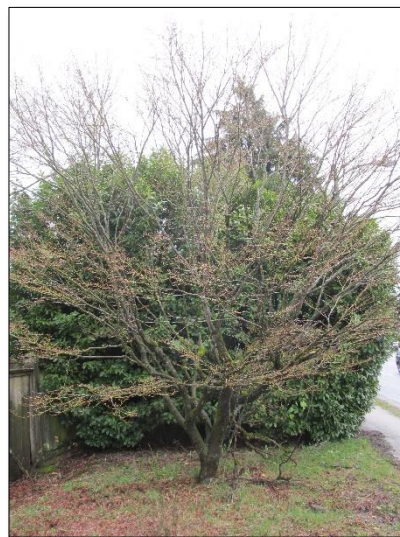
**April 6/17 – Hedge #111**

| TREE # | SPECIES | DBH (cm) | HEIGHT (m) est. | CRZ (ft.) radius | Condition | OBSERVATIONS & RECOMMENDATIONS |
|---|---|---|---|---|---|---|
| | | | | | | <p>property line; this hedge is within the line of excavation.</p> <p><b>RECOMMENDATIONS:</b></p> <p><b>REMOVE.</b> Obtain consent from the City and remove hedge to enable the lines of excavation and the proposed parkade.</p> |

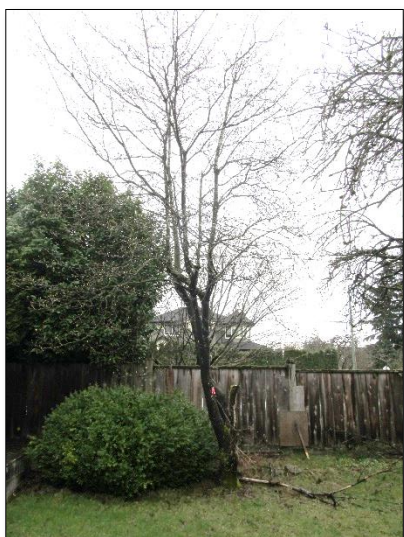
**April 6/17 - Tree #112**

| TREE # | SPECIES | DBH (cm) | HEIGHT (m) est. | CRZ (ft.) radius | Condition | OBSERVATIONS & RECOMMENDATIONS |
|---|---|---|---|---|---|---|
| 112 | Japanese Maple<br>( <i>Acer palmatum</i> ) | 33<br>combined<br>(17+8+8) | 7 | 6.8' | Fair | <p>This tree has two stems commencing at the base; these stems are fused to 1ft. The east side of the canopy has been cut back to provide clearance to the City sidewalk. There is minor branch dieback throughout the canopy, which is most likely as a result of Verticillium wilt; this will continue to cause dieback and the tree will decline over time. This tree is within a dedication. The Critical Root Zone radius is 6.8ft. The footprint of the proposed underground parkade is 16.5ft from the west side of the stem, not including the excavation required, which will extend immediately adjacent to the east property line.</p> <p><b>RECOMMENDATIONS:</b></p> <p><b>REMOVE.</b> Remove tree as it is not a good candidate for long-term retention due to disease, which will cause the tree to decline over time. Removal is also necessary to enable the lines of excavation and the proposed parkade.</p> |

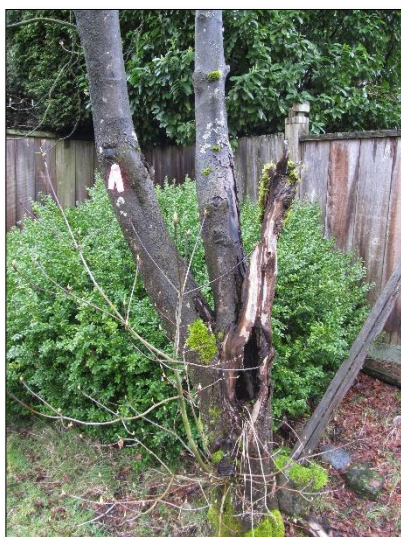
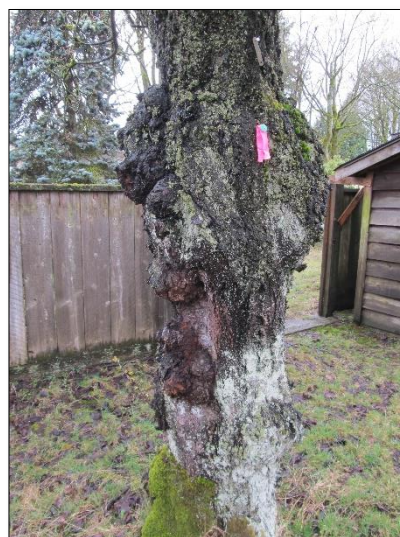
**April 6/17 – Tree #113**

| TREE # | SPECIES | DBH (cm) | HEIGHT (m) est. | CRZ (ft.) radius | Condition | OBSERVATIONS & RECOMMENDATIONS |
|---|---|---|---|---|---|---|
| 113 | Dogwood<br>( <i>Cornus sp.</i> ) | 35<br>combined<br>(18+17) | 8 | 7.2' | Poor | <p>This tree has three stems commencing at 3.5ft; decay within the union was observed. The south stem is dead and has failed at 5ft. This tree has a corrected lean to the north. There is cavity of decay on the south side of the stem at 2ft, which extends upward into each stem. The Critical Root Zone radius is 7.2ft. This tree is within the footprint of the proposed underground parkade.</p> <p><b>RECOMMENDATIONS:</b></p> <p><b>REMOVE.</b> Remove tree due to poor structure and condition. The structural integrity of this tree is compromised due to the defects noted and the presence of decay, which puts this tree at risk of failure. Also, removal of this tree is necessary to enable the proposed parkade.</p> |

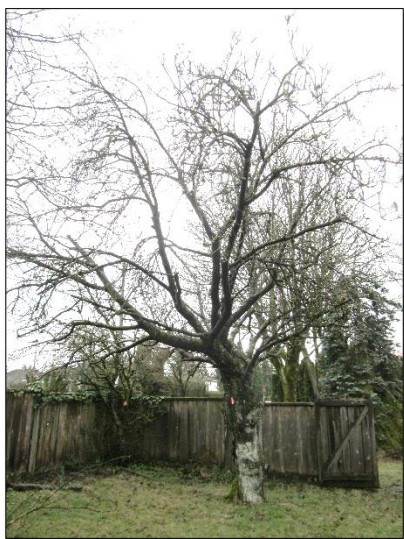
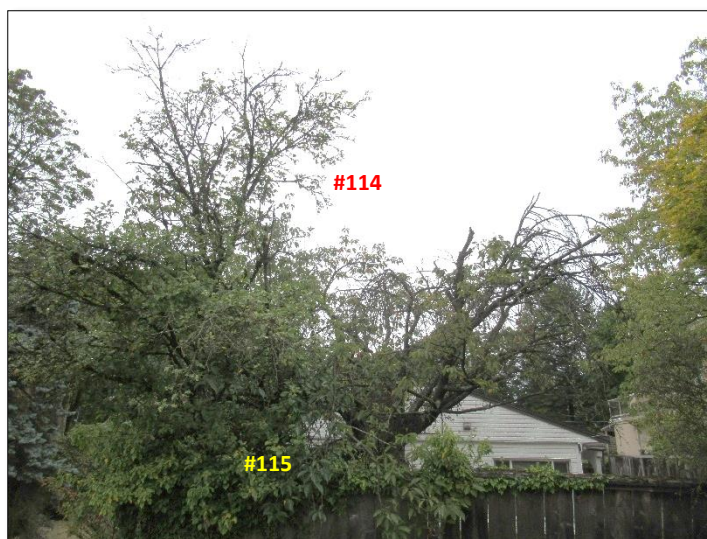
**April 6/17 - Tree #114**

| TREE # | SPECIES | DBH (cm) | HEIGHT (m) est. | CRZ (ft.) radius | Condition | OBSERVATIONS & RECOMMENDATIONS |
|---|---|---|---|---|---|---|
| 114 | Cherry<br>( <i>Prunus sp.</i> ) | 48 | 7 | 9.9' | Declining | <p>This tree is in decline. It has been previously topped at multiple heights and cut back on all sides to contain; the pruning sites have not callused over, and decay is present. The canopy is sparse, and it lacks vigor. There is branch dieback throughout the canopy, which has begun to fail. The trunk appears somewhat abnormal and swollen; there are multiple burls along the stem. There is evidence of Tortrix borer, and it has extensive canker. The Critical Root Zone radius is 9.9ft. This tree is within the footprint of the proposed underground parkade.</p> <p><b>RECOMMENDATIONS:</b></p> <p><b>REMOVE.</b> Remove tree since it is in decline and to enable the proposed parkade.</p> |

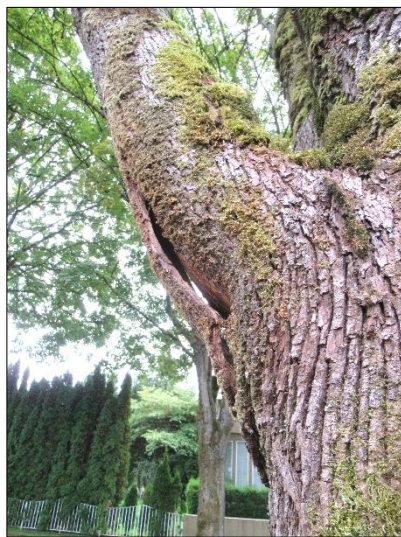
Sept 12/19 – Tree #124  
Fungal conks removed (REMOVED)

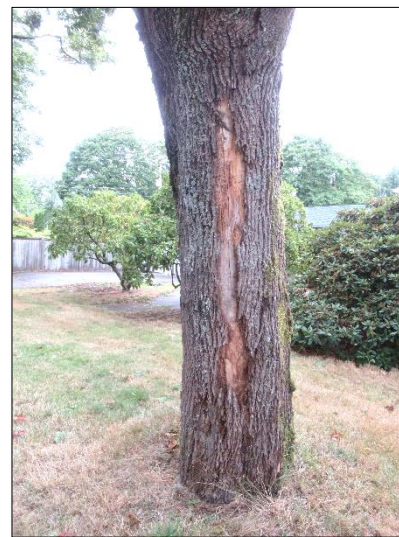
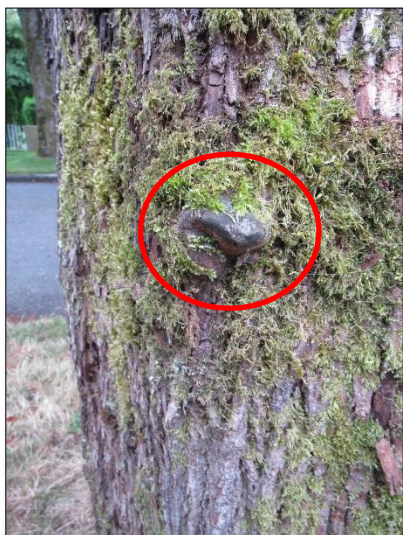
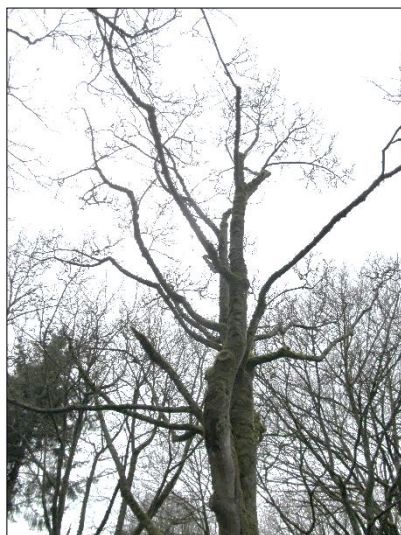
Sept 12/19 – Tree #124 (REMOVED)

| TREE # | SPECIES | DBH (cm) | HEIGHT (m) est. | CRZ (ft.) radius | Condition | OBSERVATIONS & RECOMMENDATIONS |
|---|---|---|---|---|---|---|
| 124 | Maple ( <i>Acer sp.</i> ) | 60 | 16 | 12.4' | Declining | This tree has been removed.<br><b>RECOMMENDATIONS:</b><br>No further action required. |

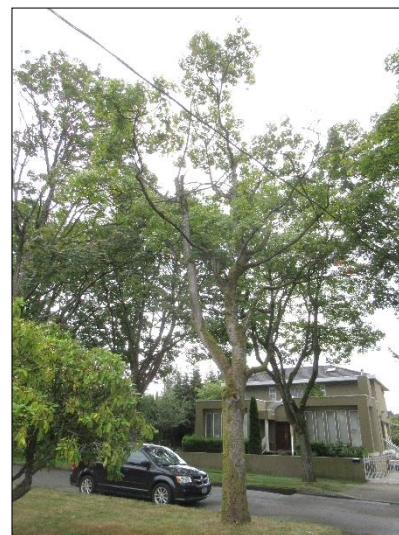
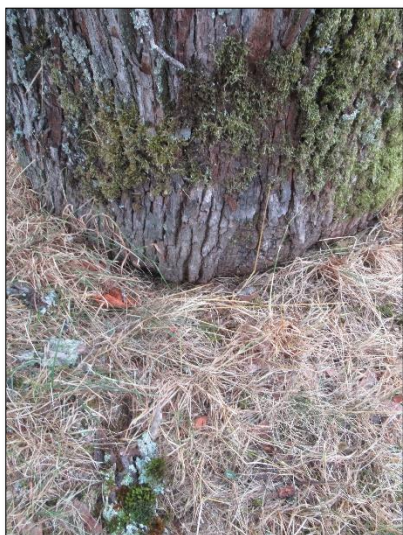
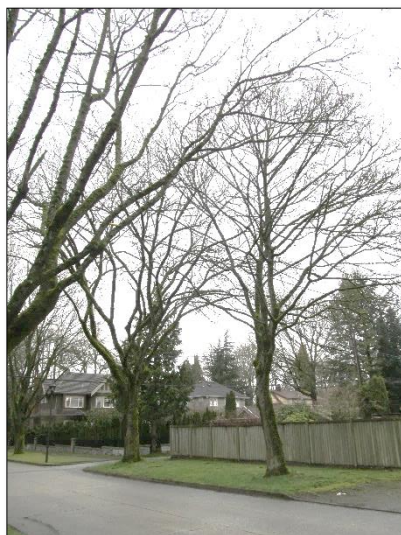
April 6/17 – Tree #125

| TREE # | SPECIES | DBH (cm) | HEIGHT (m) est. | CRZ (ft.) radius | Condition | OBSERVATIONS & RECOMMENDATIONS |
|---|---|---|---|---|---|---|
| 125 | Maple ( <i>Acer sp.</i> ) | 52 | 14 | 10.7' | Declining | This tree belongs to the City. It is in decline. It lacks basal flare, which is indicative of a grade change. The crown has been reduced at multiple heights and cut back on all sides to contain; the pruning sites have not callused over, and decay is present. The crown is sparse, and it lacks vigor. There is extensive large dead wood and branch dieback throughout the canopy, which has begun to fail. The base of the stem is swollen; it appears there is a root girdled and embedded around the stem. There is an existing driveway 6ft from the west side of the stem. The Critical Root Zone radius is 10.7ft. This tree is 13.5ft from the south property line; the Critical Roots do not encroach into the subject site.<br><b>RECOMMENDATIONS:</b><br>Request inspection by the City Parks Board. This tree is in decline; therefore, its removal should be considered. |
