July 2, 2026  
PG8011-LET.01 Revision 3

**Forum Investment and Development Corporation**

**Subject: Geotechnical Desktop Slope Stability Assessment**  
Proposed Residential Development  
530 Brisebois Cres. & Part of 265 Centrum Blvd.  
Ottawa, Ontario

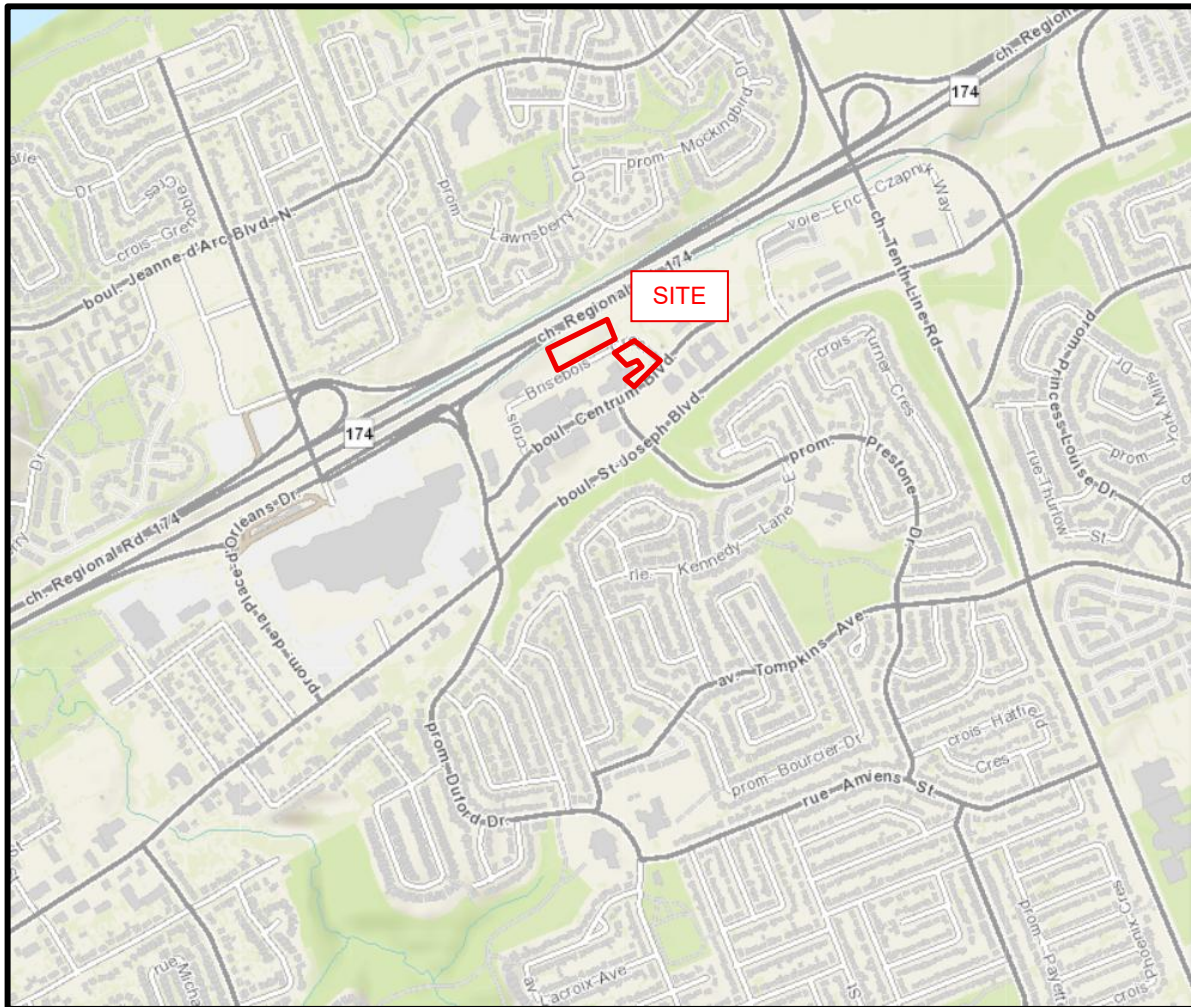
## FIGURE 1

## KEY PLAN

Based on our review of available reports and site plan documents, it is understood that the proposed development will consist of a multi-storey community centre building and several mid- and high-rise residential buildings. It is understood that the proposed buildings will be provided with one level of underground parking. The approximate site location is shown in the attached Figure 1 – Key Plan.

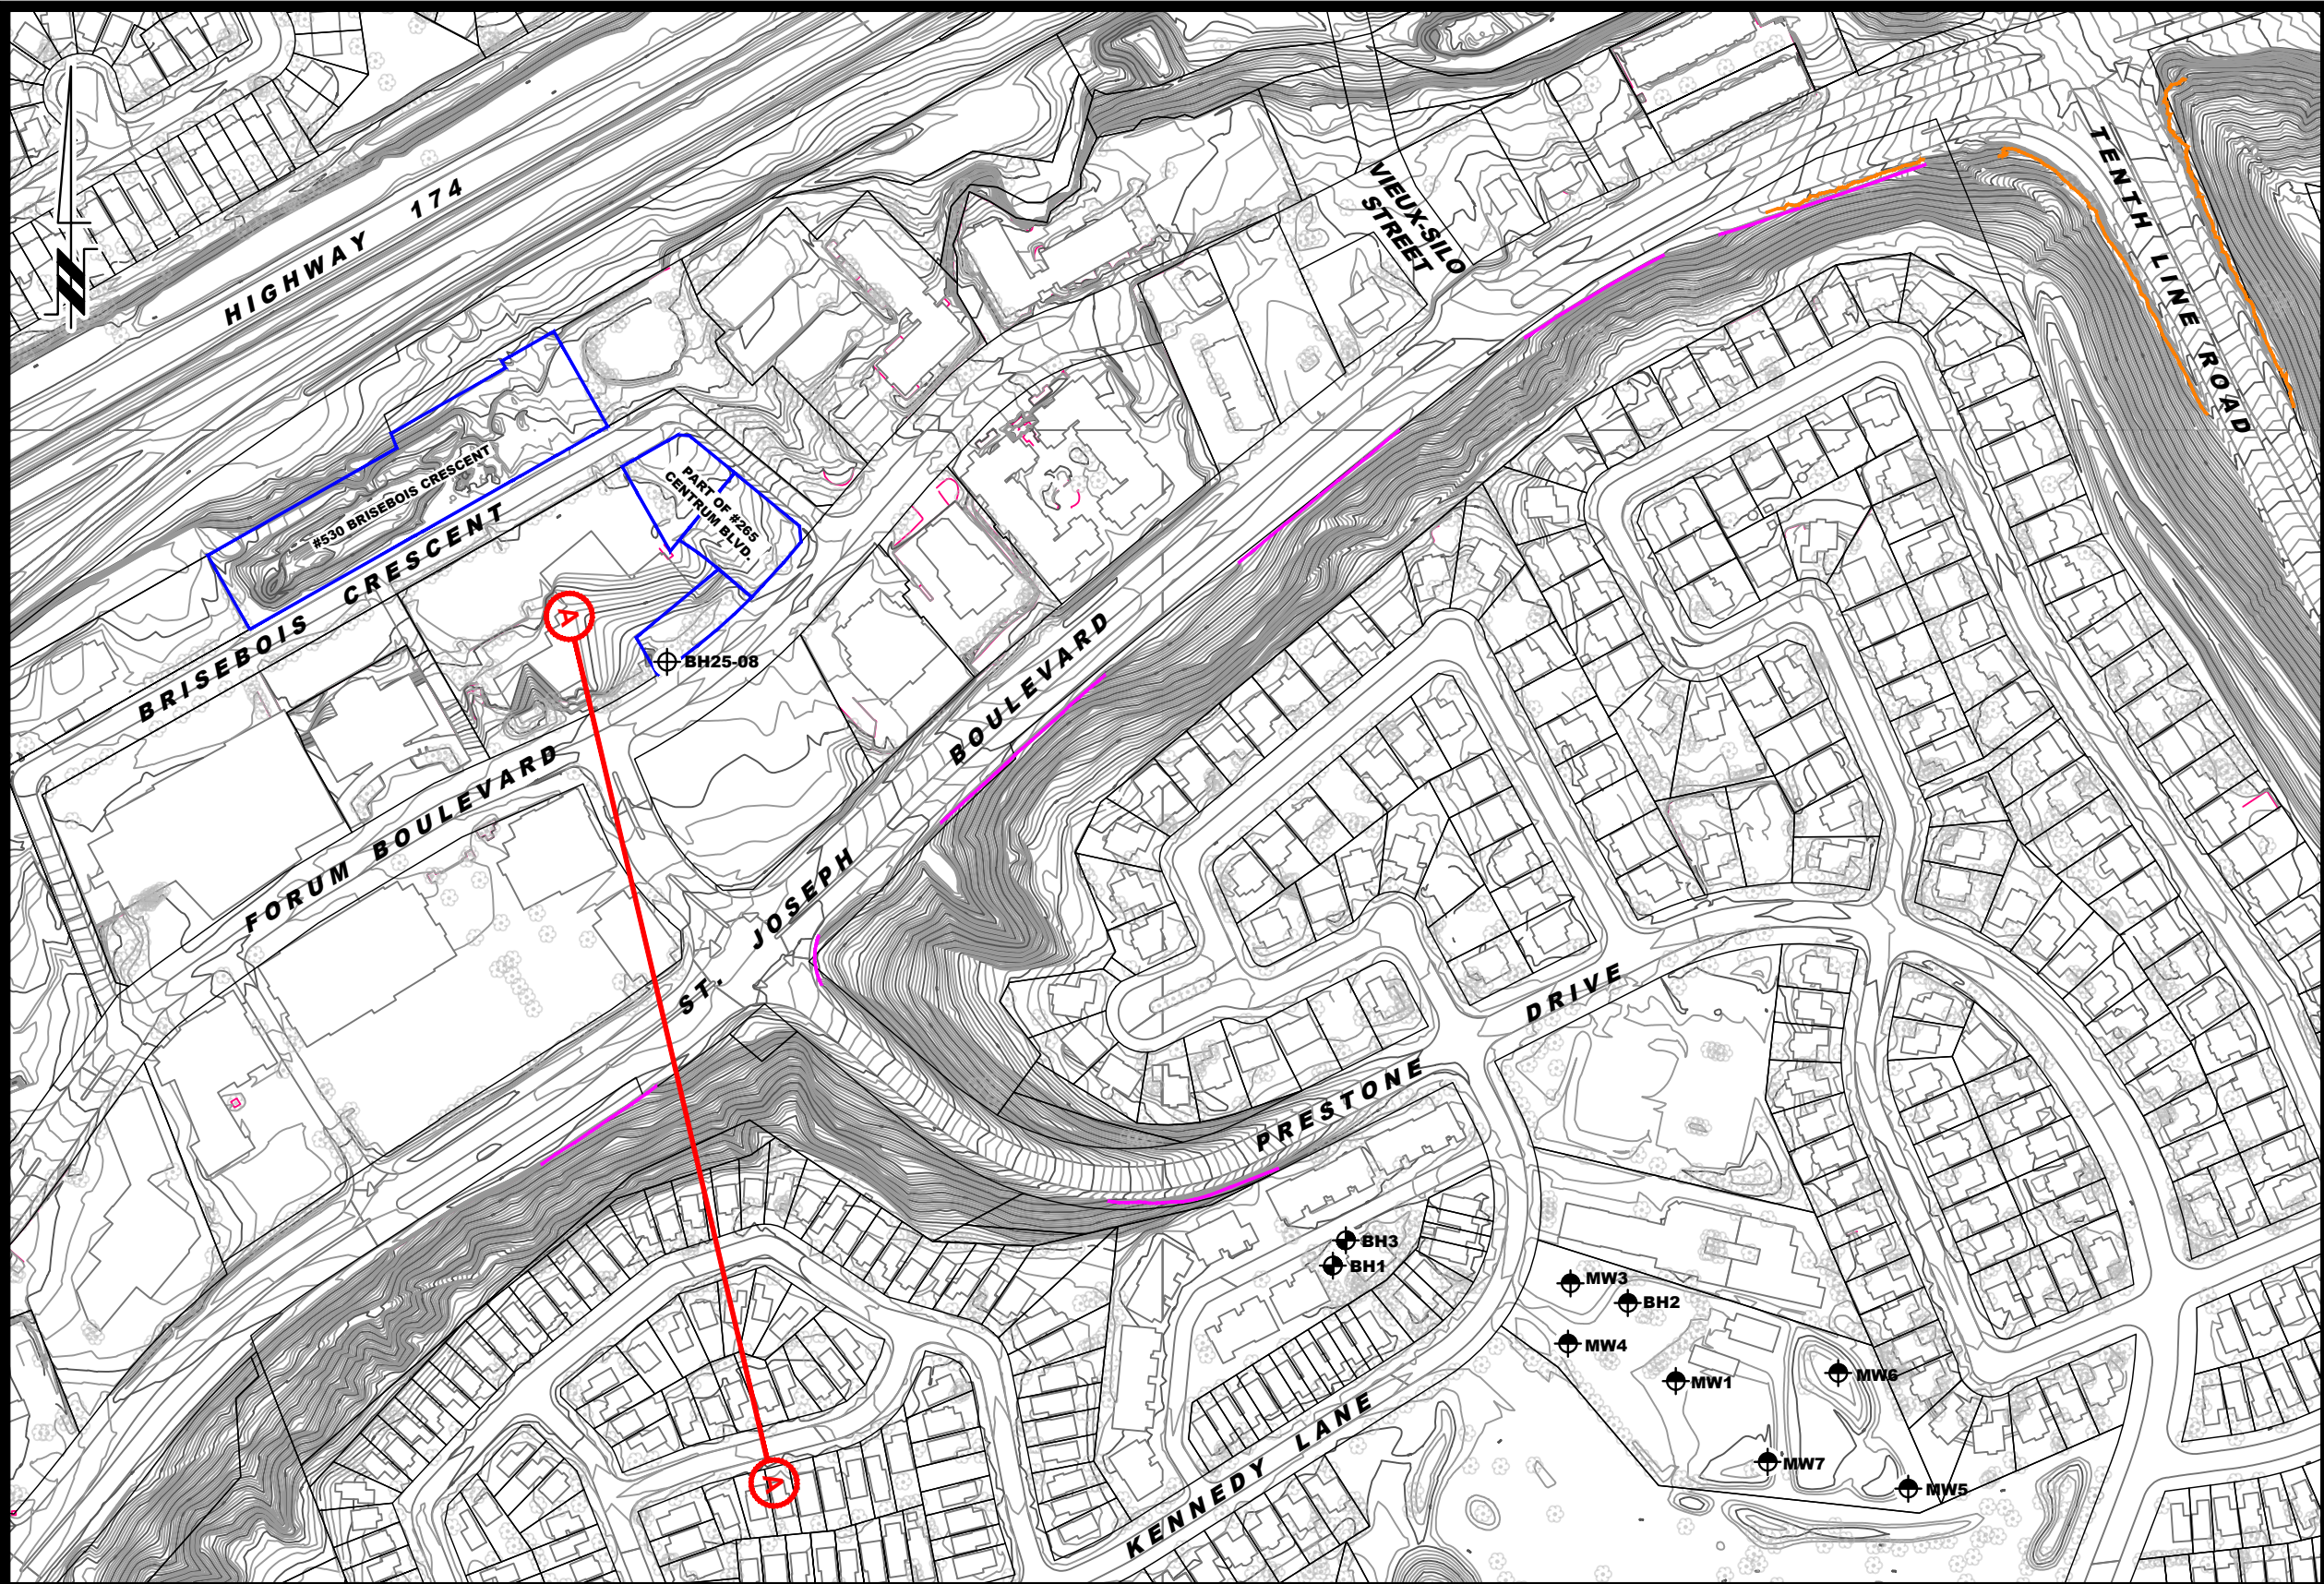
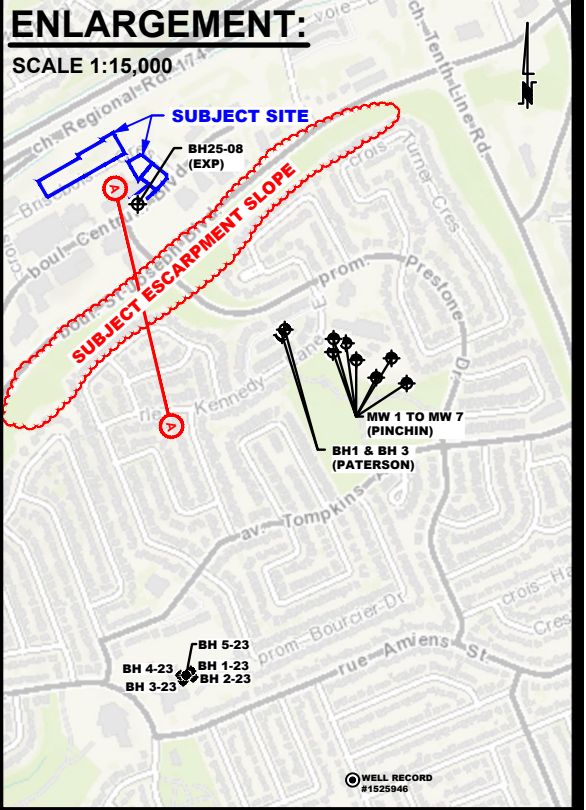
| Checked by: | NFRV | Dwg. No.: | <b>PG8011-1</b> |

- LEGEND:**
- EXISTING BOREHOLE LOCATION BY OTHERS (EXP, 2025)
  - EXISTING BOREHOLE LOCATION (PATERSON GROUP, 2023)
  - EXISTING BOREHOLE LOCATION BY OTHERS (PINCHIN, 2021)
  - EXISTING BOREHOLE LOCATION (PATERSON GROUP, 1984)
  - WELL RECORD BORING LOCATION
  - SLOPE STABILITY CROSS-SECTION LOCATION
  - EXISTING RETAINING WALL
  - BEDROCK OUTCROP
  - SUBJECT SITE BOUNDARY
- NOTE: TOPOGRAPHIC CONTOUR DATA DEPICTED HEREIN ARE BASED ON 1:1000 SCALE LIDAR DIGITAL MAPPING DATA (2015)

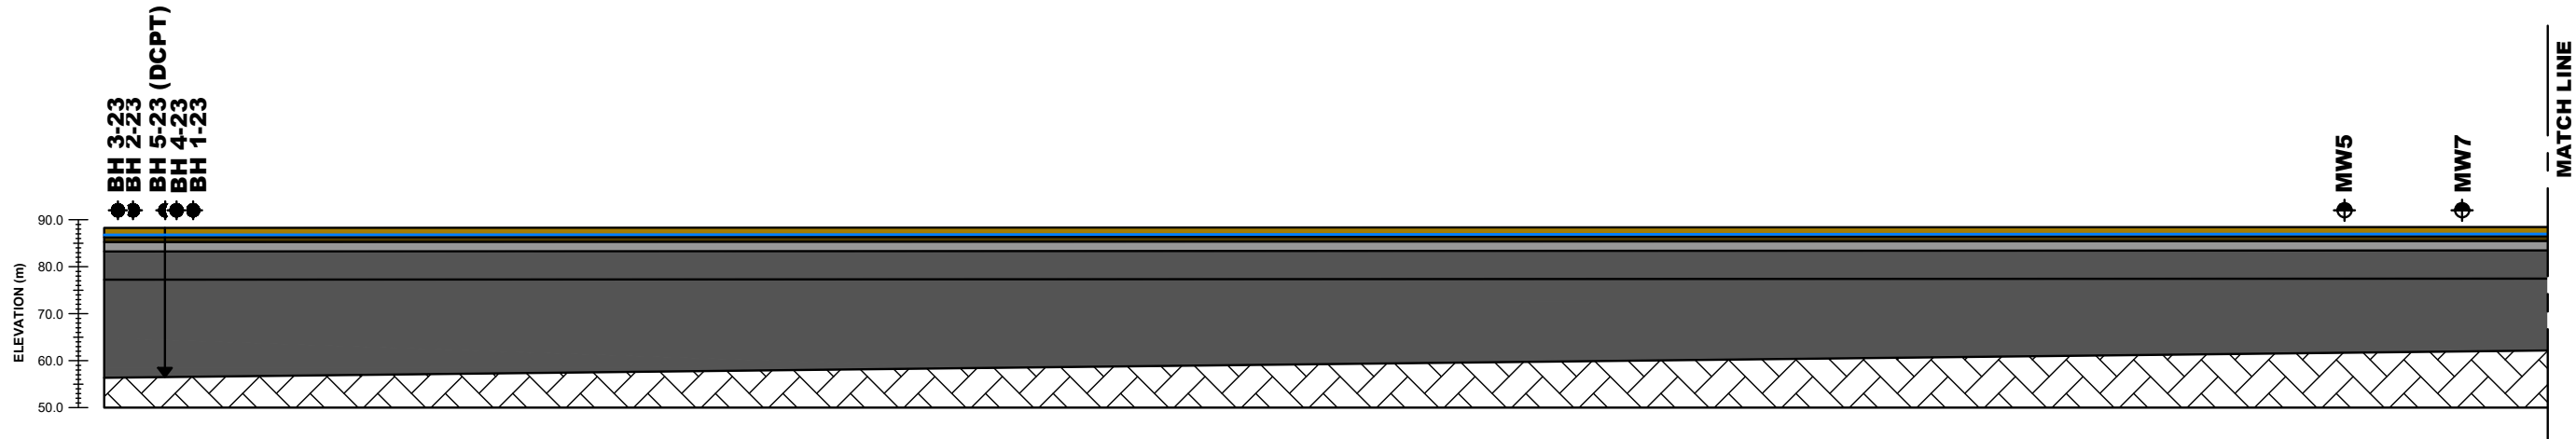
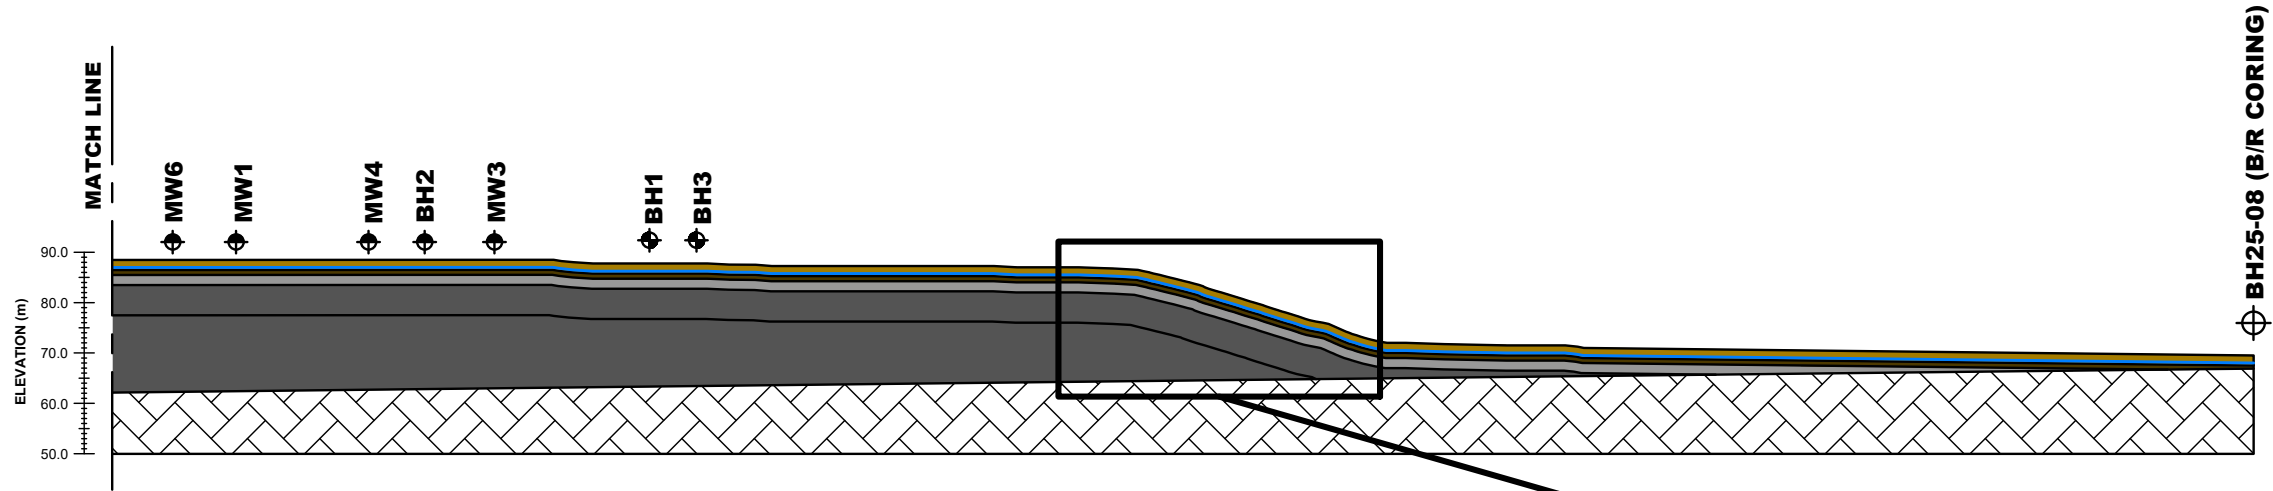
- EXISTING BOREHOLE LOCATION BY OTHERS (EXP, 2025)
- EXISTING BOREHOLE LOCATION (PATERSON GROUP, 2023)
- EXISTING BOREHOLE LOCATION BY OTHERS (PINCHIN, 2021)
- EXISTING BOREHOLE LOCATION (PATERSON GROUP, 1984)
- BROWN SILTY CLAY CRUST
- BROWN SILTY CLAY
- STIFF TO FIRM GREY SILTY CLAY
- FIRM GREY SILTY CLAY
- BEDROCK
- LONG-TERM GROUNDWATER TABLE (1.5m DEEP)

ENLARGEMENT (SCALE 1:600)

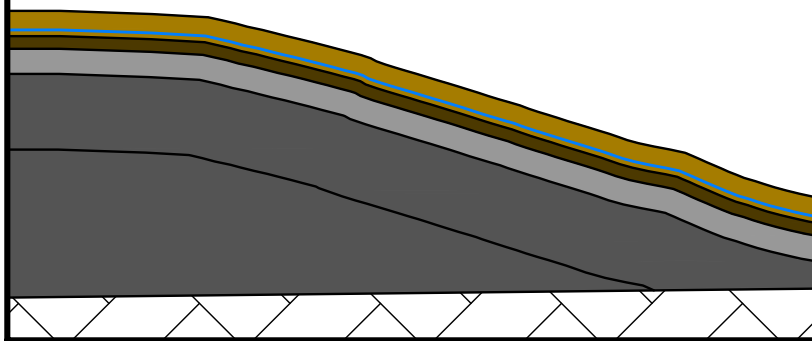
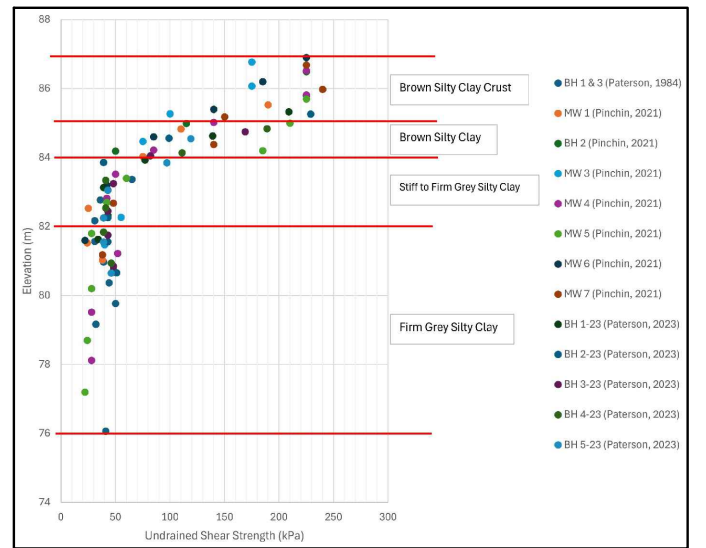
FIGURE 1: UNDRAINED SHEAR STRENGTH vs. ELEVATION

- THE GRAPHICAL REPRESENTATION ABOVE OF THE UNDRAINED SHEAR STRENGTH VALUES ( $S_u$ ) RECOVERED THROUGHOUT THE LOCAL SILTY CLAY DEPOSIT WAS CONSIDERED WHEN EXTRAPOLATING THE SUBSURFACE CONDITIONS.
- THE GROUNDWATER TABLE WAS CONSIDERED AT A DEPTH OF 1.5m FROM THE EXISTING GROUND SURFACE BASED ON THE SHALLOWEST RECOVERED GROUNDWATER LEVEL MEASUREMENT (PINCHIN, MW6, 2021).
- THE BEDROCK SURFACE WAS EXTRAPOLATED CONSIDERING THE BEDROCK CORING DATA PROVIDED FROM BH25-08 (EXP) AND THE REFUSAL TO DCPT FROM BH 5-26 (PATERSON)
