VIDEO CAMERA INSPECTION REPORTS

**116 – 118 CARRUTHERS AVENUE
LYNDALE - STONEHURST
OTTAWA**

PRE CONSTRUCTION

**STORM
APRIL 6, 2026
AQ-4841B**

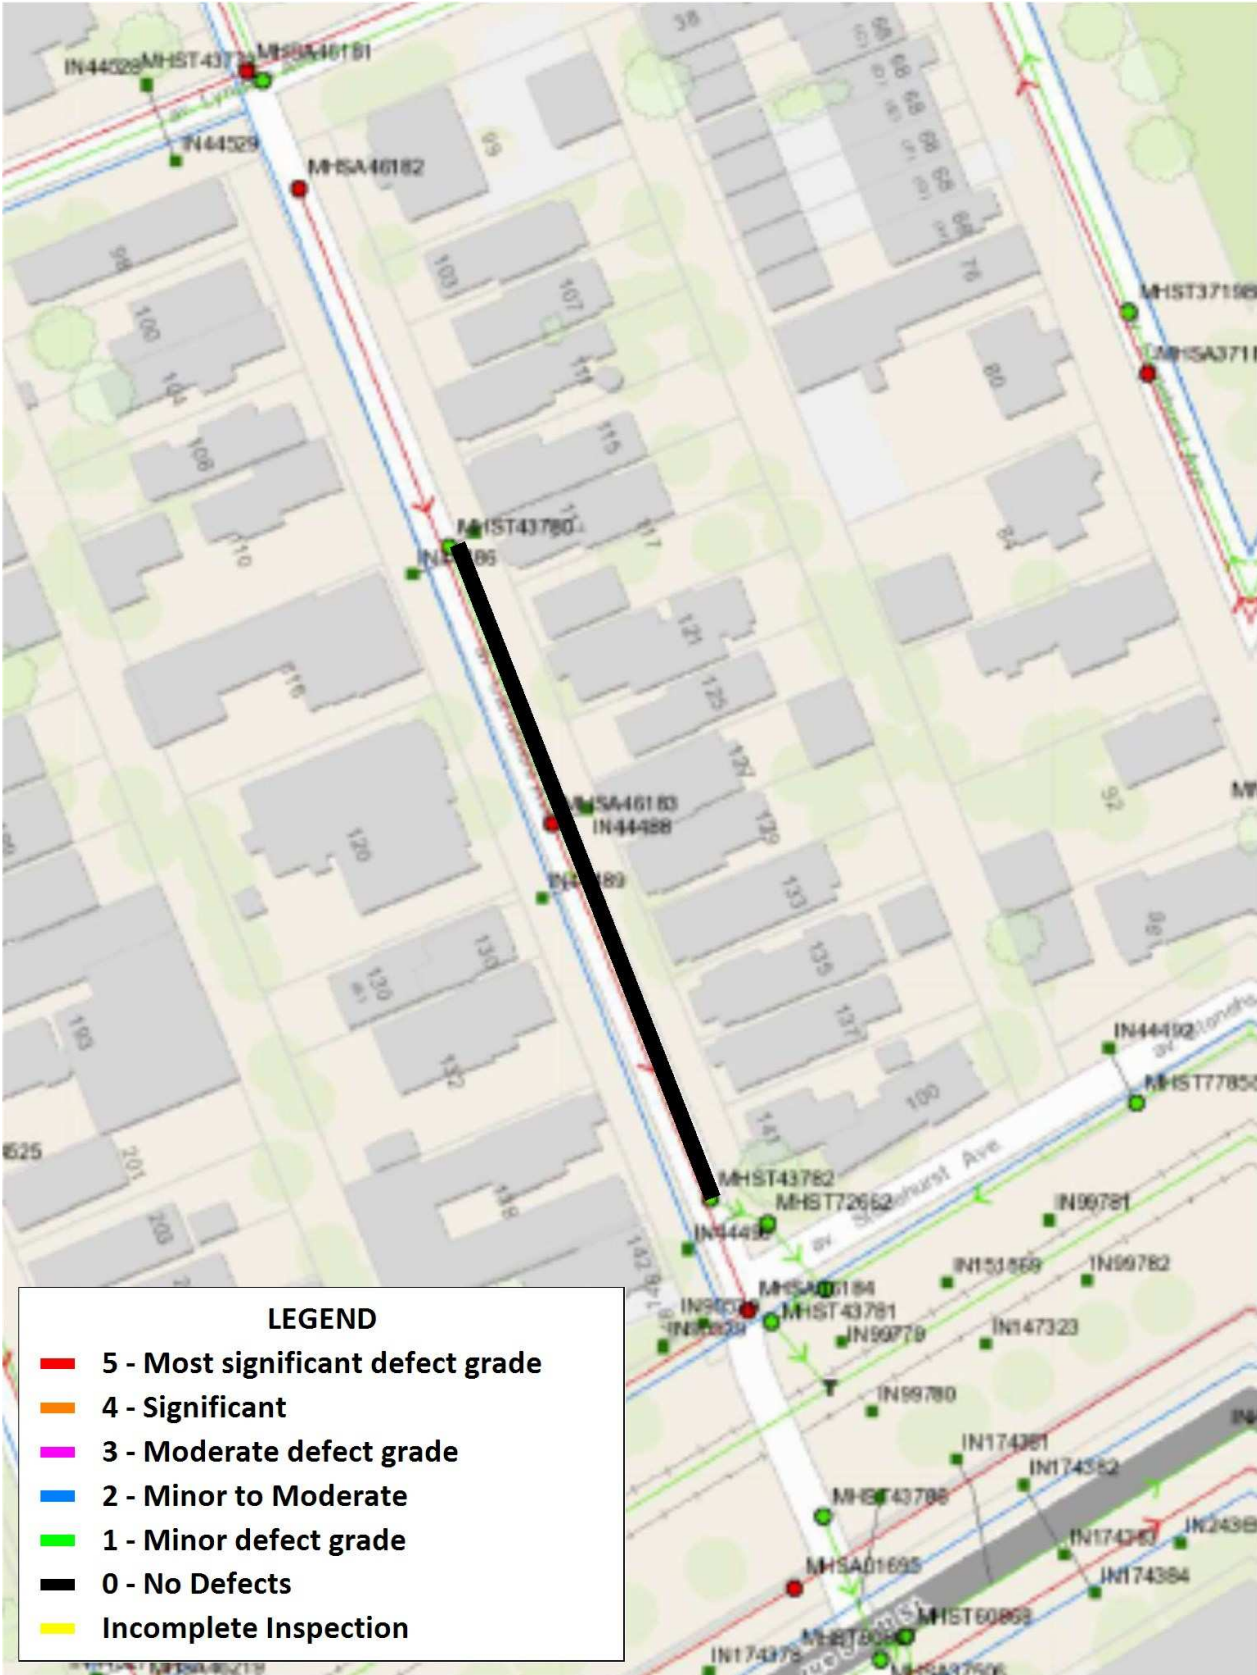
O&M rating map

0 - No Defects (1 of 1 items)

Score	Quick	Index	Structural	Pipe	Upstream	Downstream	Street	Page
0	0000	0	0	STM51095	MHST43780	MHST43782	CARRUTHERS AVE	9

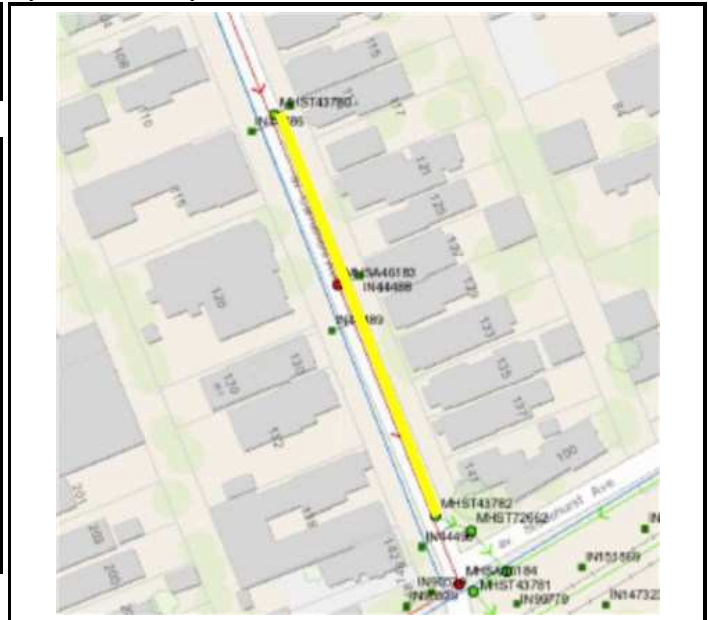
Pipe location map

Road: CARRUTHERS AVE
Crossroad: LYNDALE AVE
Drainage Area:
City: Ottawa
Location: Secondary roads
Location details:
Owner:
Road segment:
UPSTREAM DOWNSTREAM
Easting (X): **Easting (X):**
Northing (Y): **Northing (Y):**
Elevation (Z): **Elevation (Z):**
GPS Accuracy:
Coordinate System:
Vertical Datum:

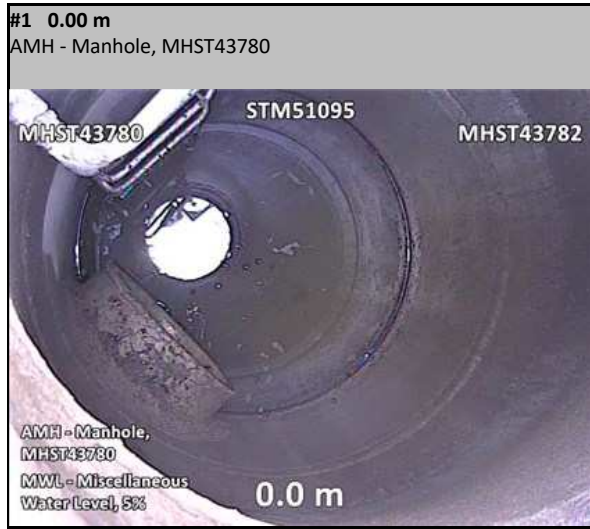
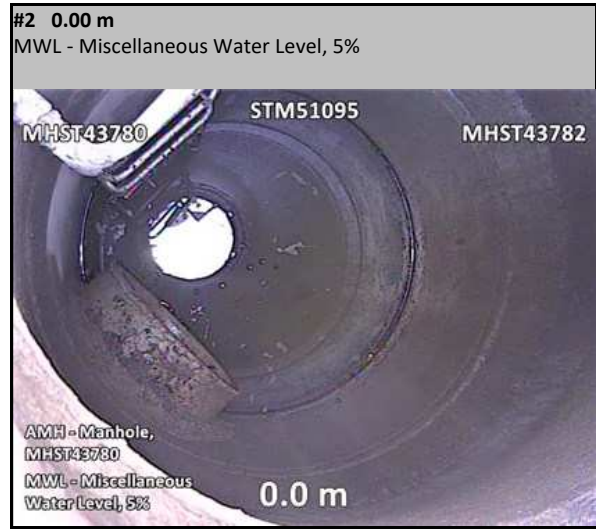
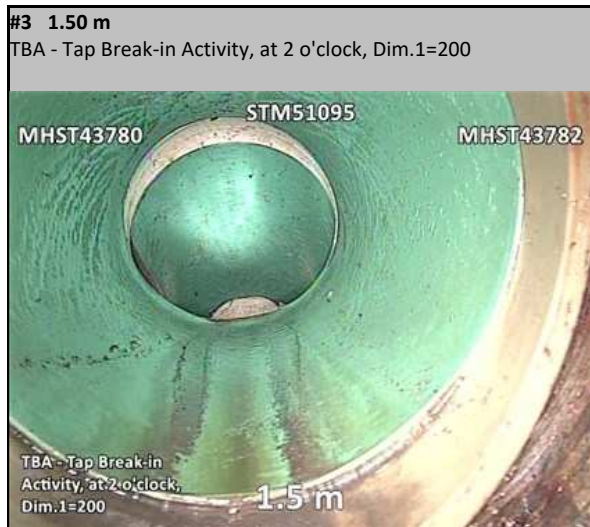
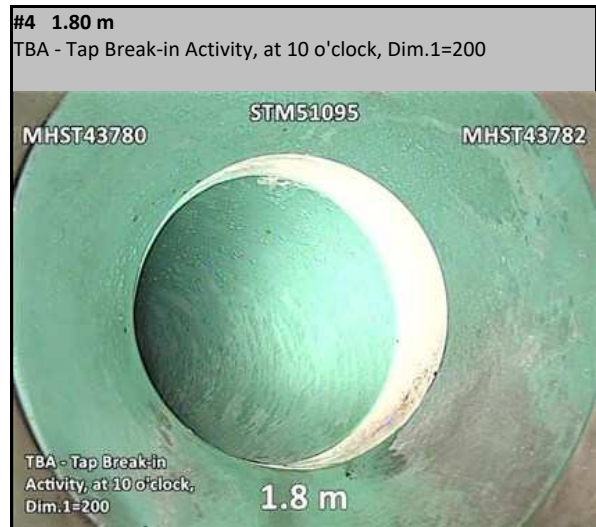
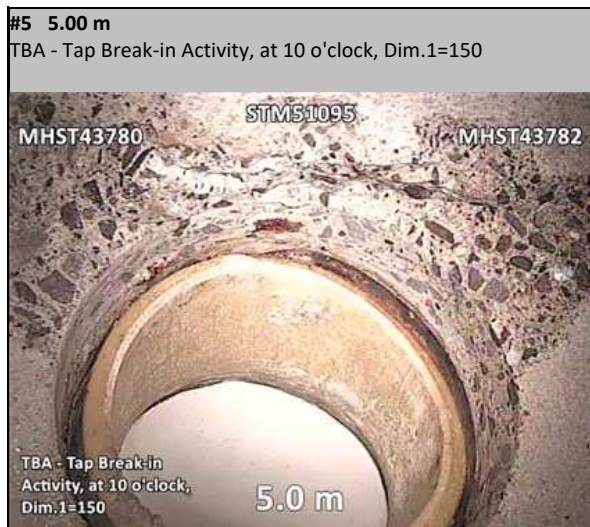
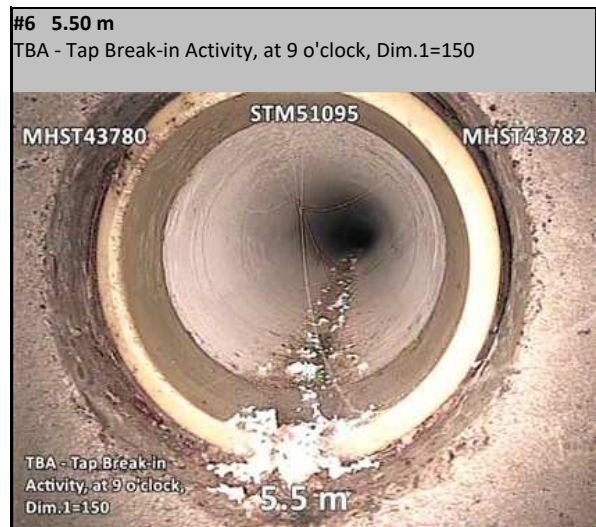
Pipe Pictures

Pipe: STM51095	Direction of inspection: MHST43780 --> MHST43782
Direction of flow: MHST43780 --> MHST43782	Direction: Direction of flow

Pipe Use: Stormwater Pipe	Surveyed Length: 75.500
Height: 375	Total length: 75.3
Width:	Joint length:
Shape: Circular	Rim/Inv.:
Material: Concrete Pipe (non-reinforced)	Grade/Inv.:
Lining:	Rim/Grade:
Coating Method:	Rim/Inv.:
Year Constructed:	Grade/Inv.:
Year renewed:	Rim/Grade:
