**Re: Geotechnical Investigation Report: Proposed Mixed Use Development  
57 Lakewood Drive, Vancouver, B.C.**

## **1.0 INTRODUCTION**

We understand that a mixed-use development is proposed for the above referenced site. The proposed development will comprise of up to 7 stories of above grade structure constructed over two levels of below grade parking with an anticipated excavation depth of up to 9 m. We understand that the construction will be of reinforced concrete and that the proposed structure will be constructed close to property lines on all sides.

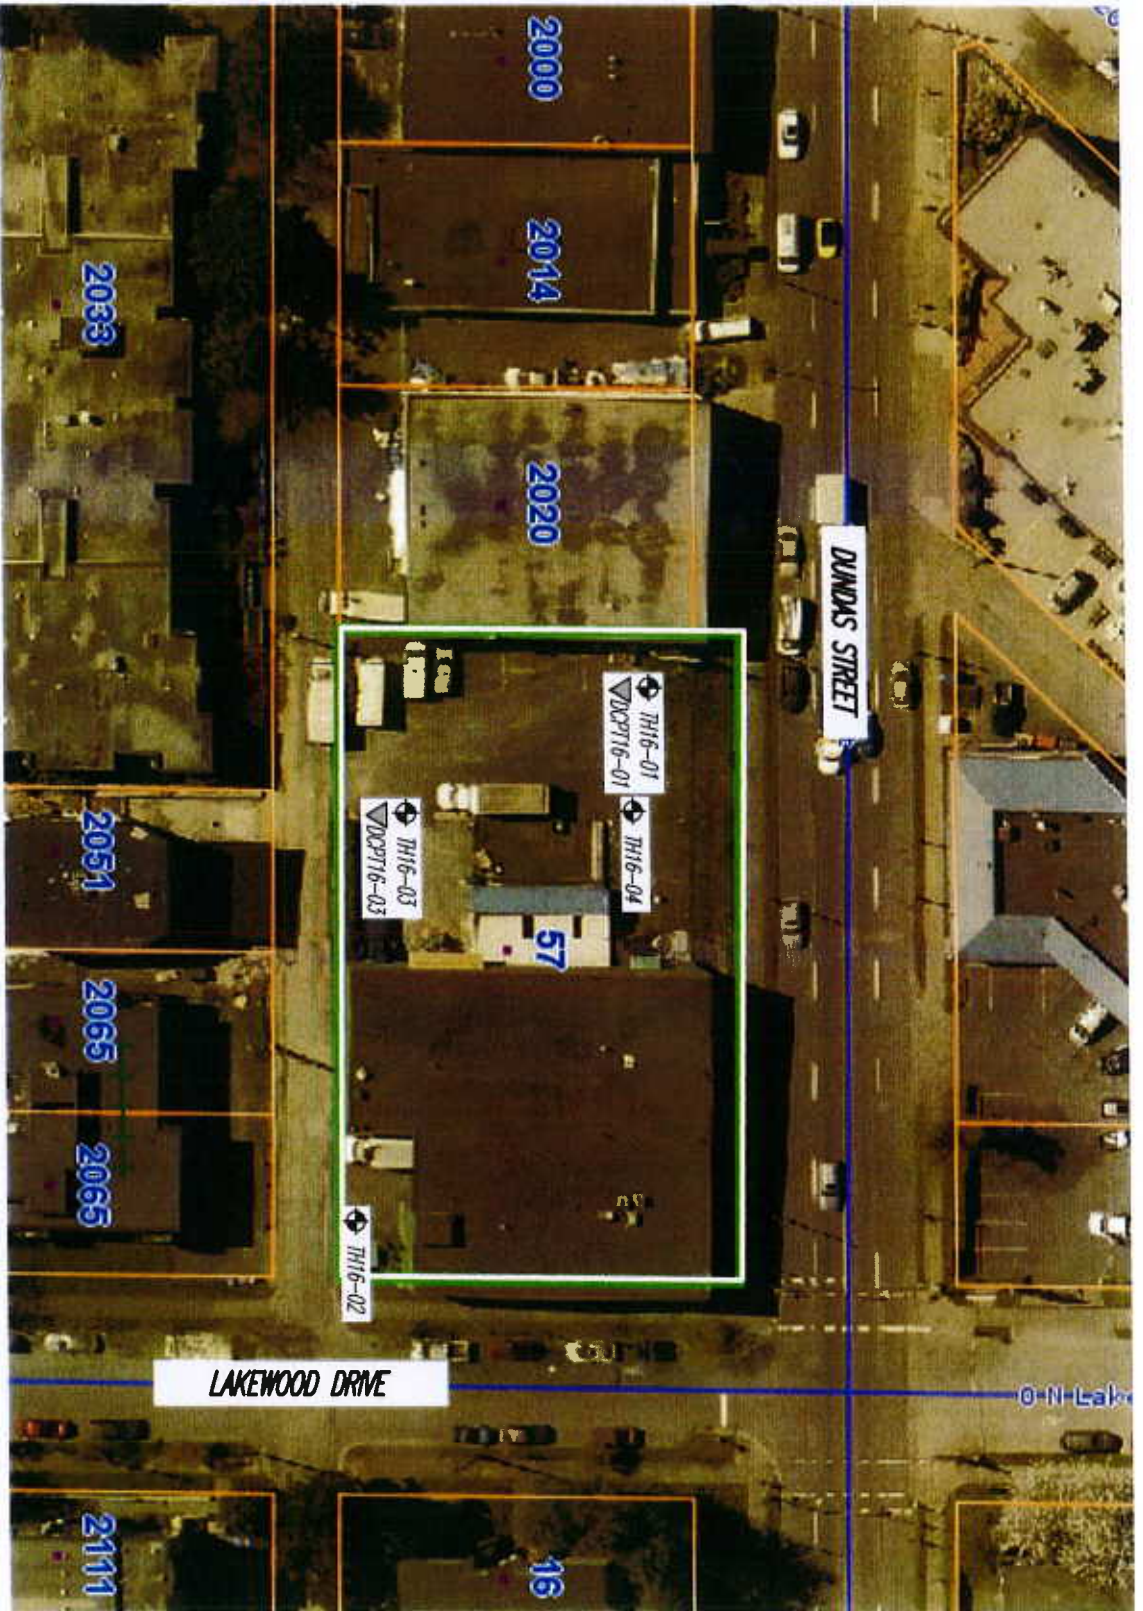
# **LEGEND:**

- TH17-# - TEST HOLE (TH) LOCATION
- DPT17-# - DYNAMIC CONE PENETRATION TEST (DPT) LOCATION
- SITE BOUNDARY
