ALBERTA LAND SURVEYOR'S REAL PROPERTY REPORT

Lot(s) 25  
Block 166  
Plan 221 1300

| MUNICIPAL ADDRESS:<br>1308 Colgrove Avenue N.E.<br>Calgary, Alberta ("the Property") | Jody E. Clarke, A.L.S. |

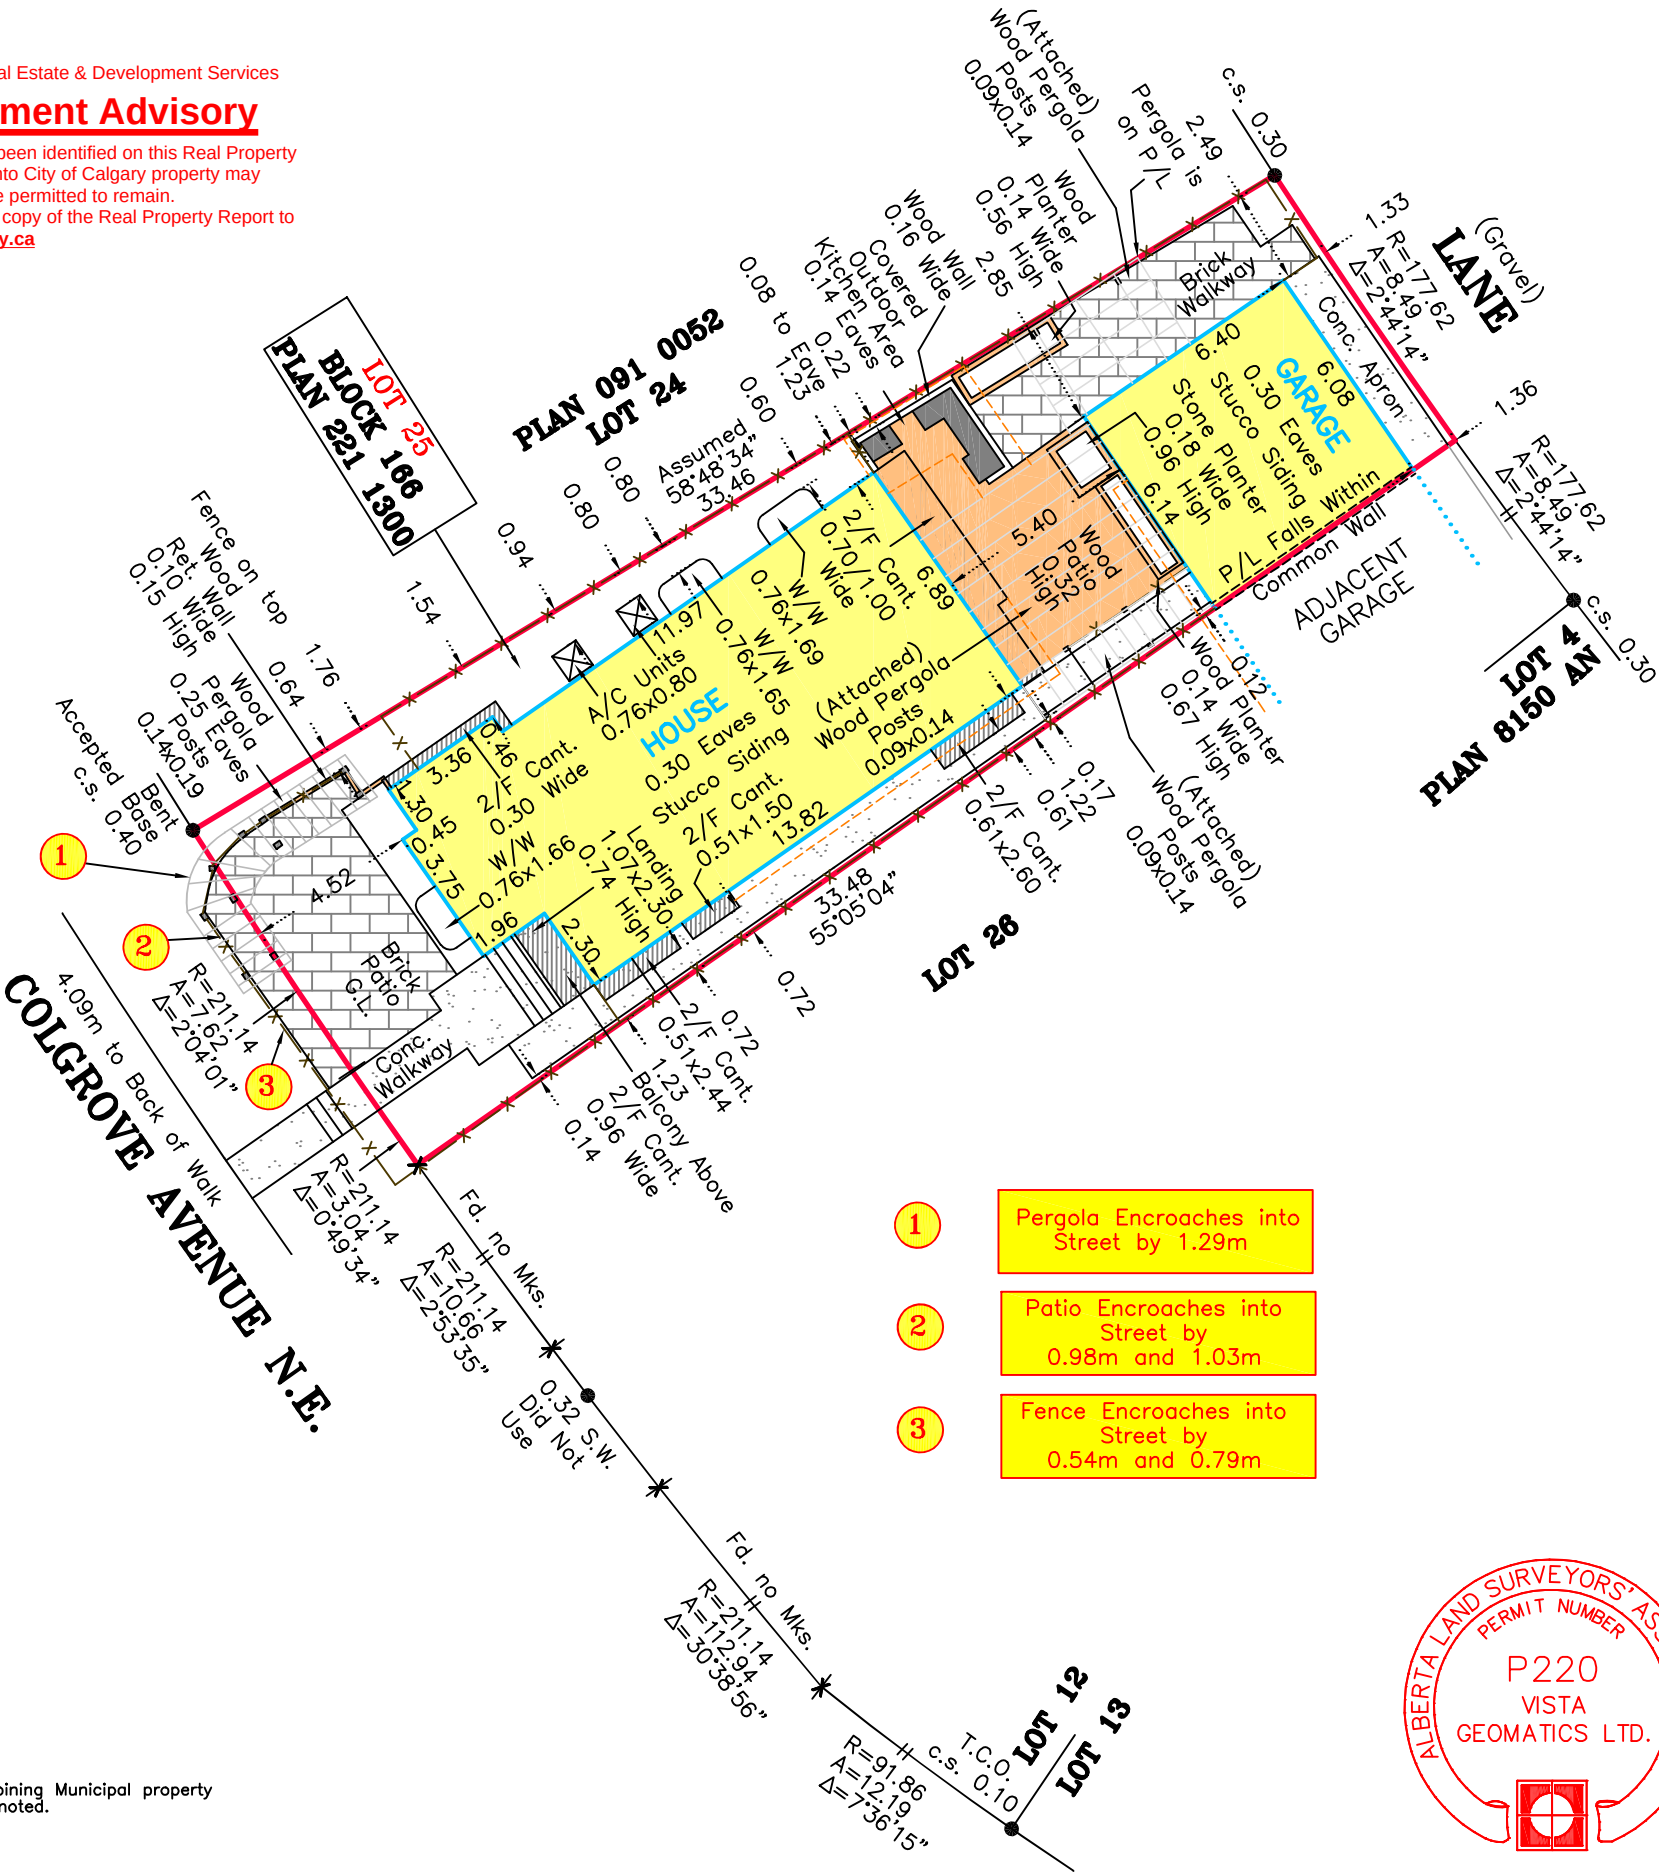
- The improvements are entirely within the boundaries of the Property, except as shown;
  - No visible encroachments exist on the Property from any improvements situated on an adjoining property, except nil; and;

- 1 Pergola Encroaches into Street by 1.29m
- 2 Patio Encroaches into Street by 0.98m and 1.03m
- 3 Fence Encroaches into Street by 0.54m and 0.79m

An encroachment(s) has been identified on this Real Property Report. Encroachments into City of Calgary property may require authorization to be permitted to remain. Please scan and e-mail a copy of the Real Property Report to [encroachments@calgary.ca](mailto:encroachments@calgary.ca)
