# ALBERTA LAND SURVEYOR'S REAL PROPERTY REPORT

LOT 3  
 BLOCK 4  
 PLAN 841 0122

6910 26TH AVENUE N.E.  
 CALGARY, ALBERTA

**DATE OF SURVEY:** April 24th, 2026

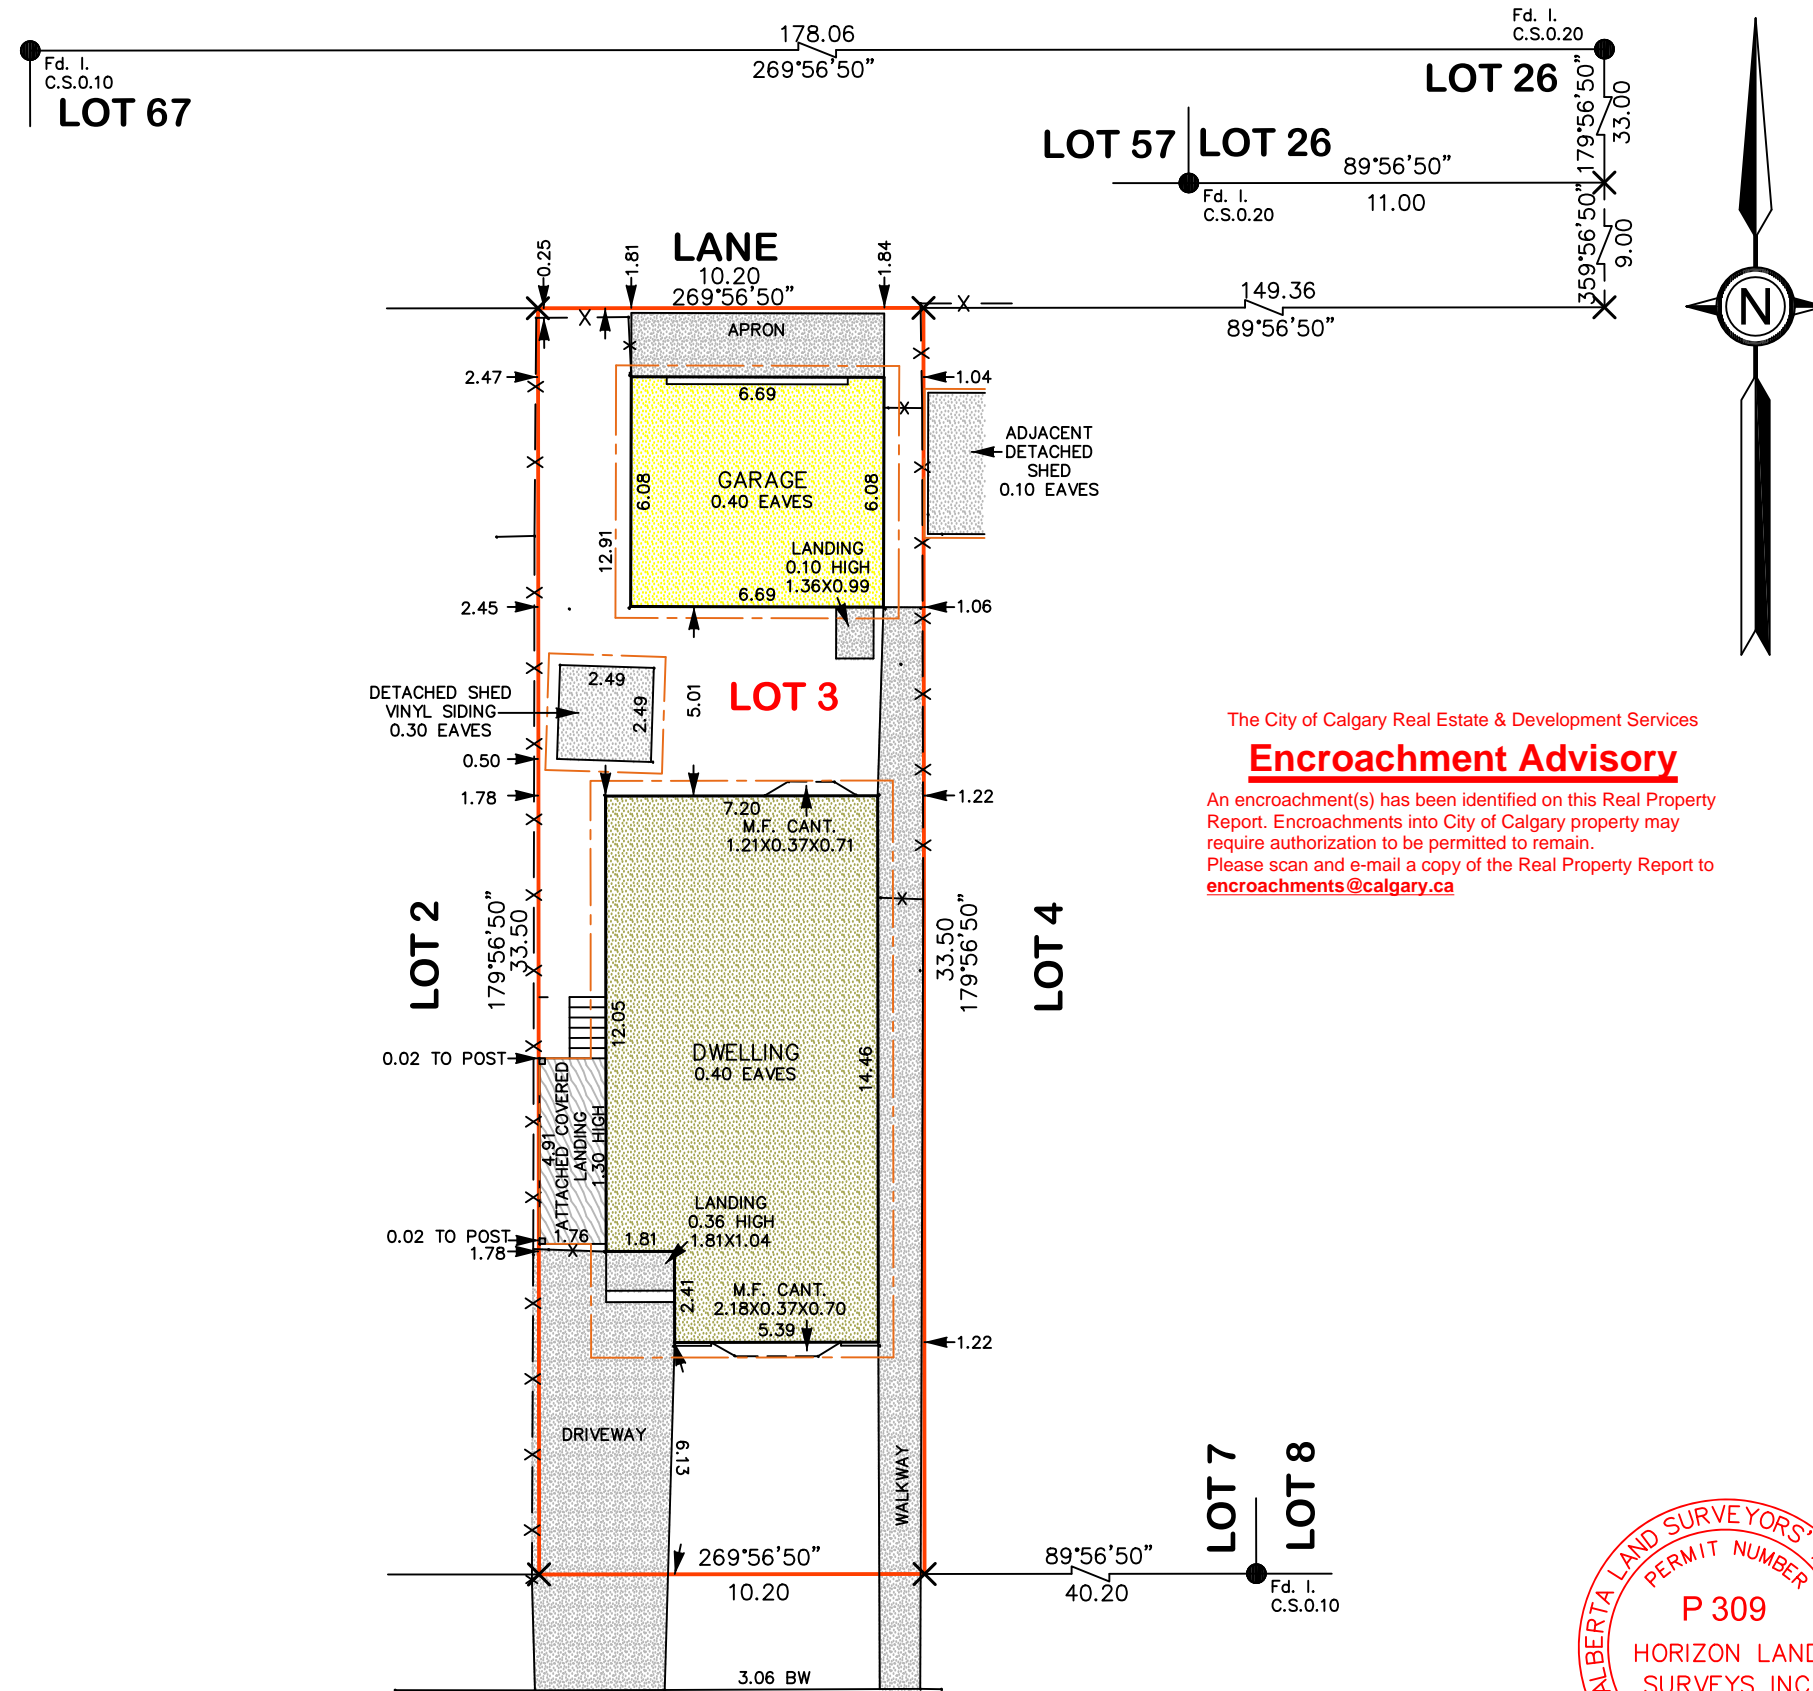
An encroachment(s) has been identified on this Real Property Report. Encroachments into City of Calgary property may require authorization to be permitted to remain. Please scan and e-mail a copy of the Real Property Report to [encroachments@calgary.ca](mailto:encroachments@calgary.ca)

- Unless otherwise specified, the dimensions shown relate to distances from Property boundaries to foundation walls at time of survey.
- Distances are in metres and decimals thereof; Lineworks and dimensions outside of the Property are not to scale; All eaves are measured from foundation to fascia unless otherwise noted; All fences are within 0.20 metres of the property lines unless otherwise shown.
