**Phase One Environmental Site Assessment
1052, 1060, and 1064 St. Laurent Boulevard
Ottawa, Ontario**

GEMTEC Project: 103499.002

Performance Mazda Ottawa
1469 Youville Drive
Orleans, Ontario
K1C 4R1

August 8, 2025
GEMTEC Project: 103499.002

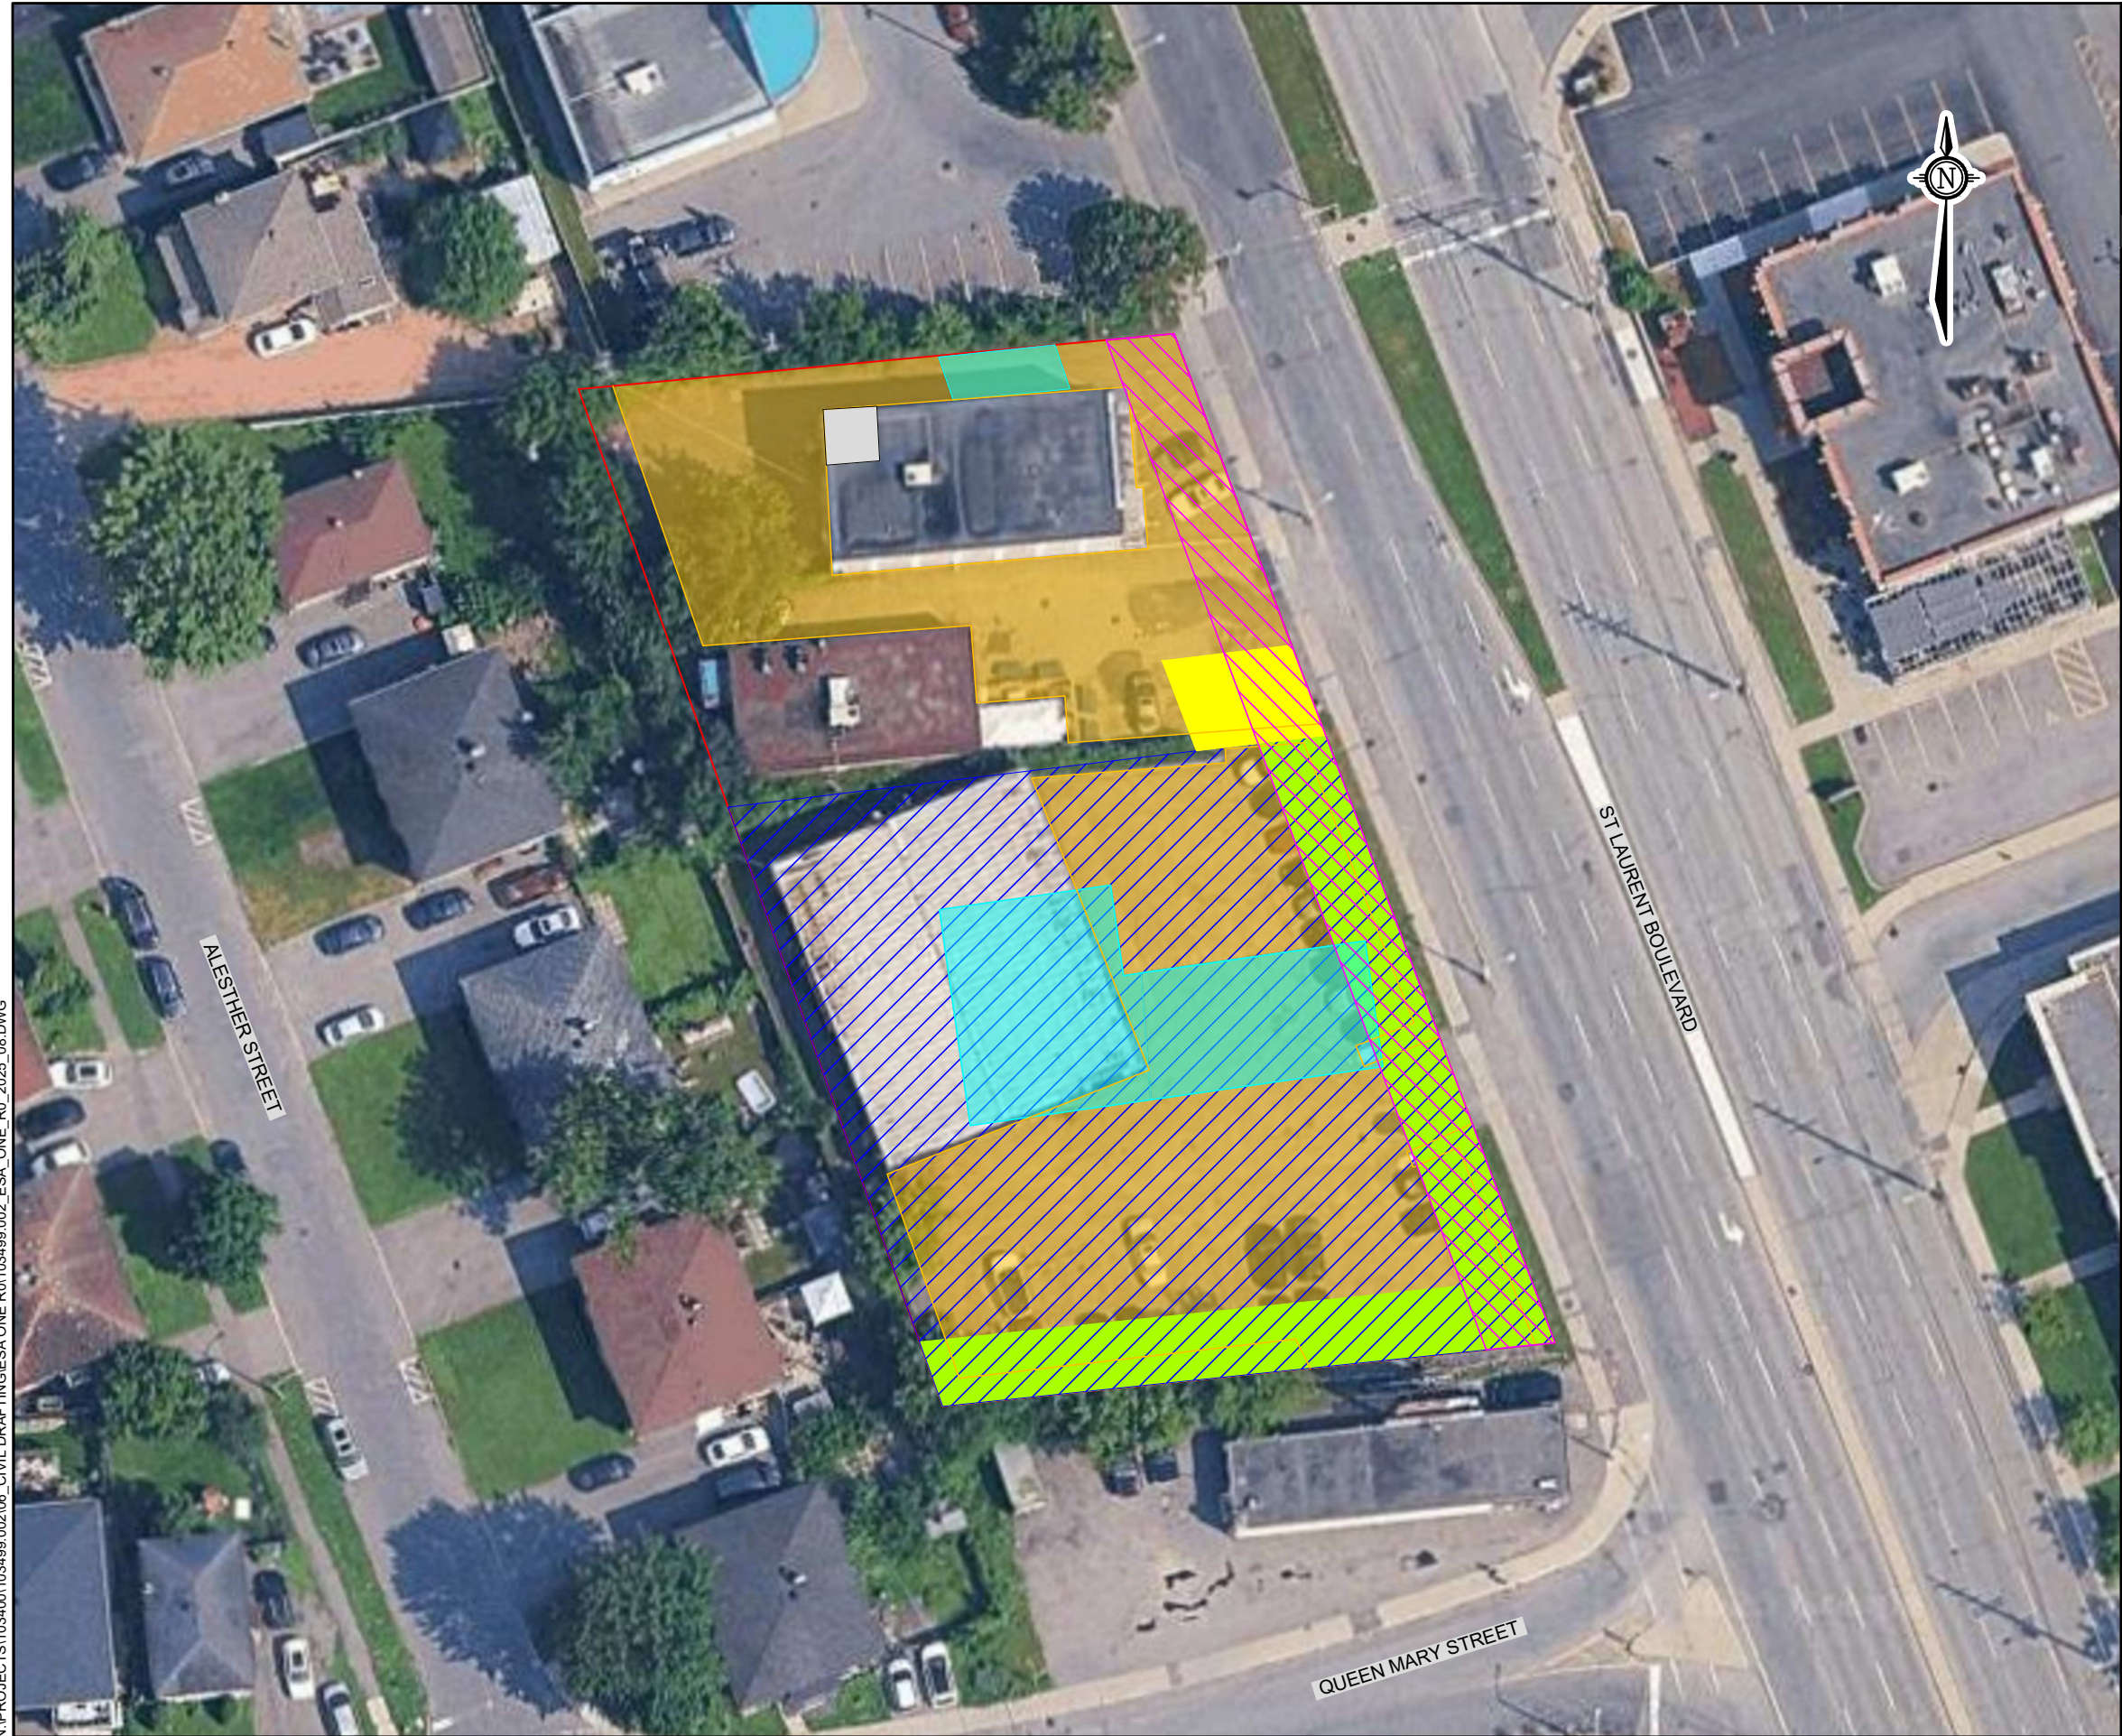
LEGEND	
	PHASE ONE PROPERTY BOUNDARY
APEC #1	AREAS OF POTENTIAL ENVIRONMENTAL CONCERN
APEC 1	Presence of a former AST
	APEC 2 Area of known soil contamination
	APEC 3 Automotive Shop with ASTs and Oil Water Separator
	APEC 4 Presence of former retail fuel outlets and garages (off-site and upgradient)
	APEC 5 Likely presence of fill material related to former structures.
	APEC 6 Road salting activities during the winter months on-Site.
	APEC 7 Road salting activities during the winter months along St. Laurent Boulevard.

Based on the findings of this report, a Phase Two ESA is recommended to confirm the presence of absence of COPCs within the APECs. A Phase Two ESA would be required to support an RSC filing.

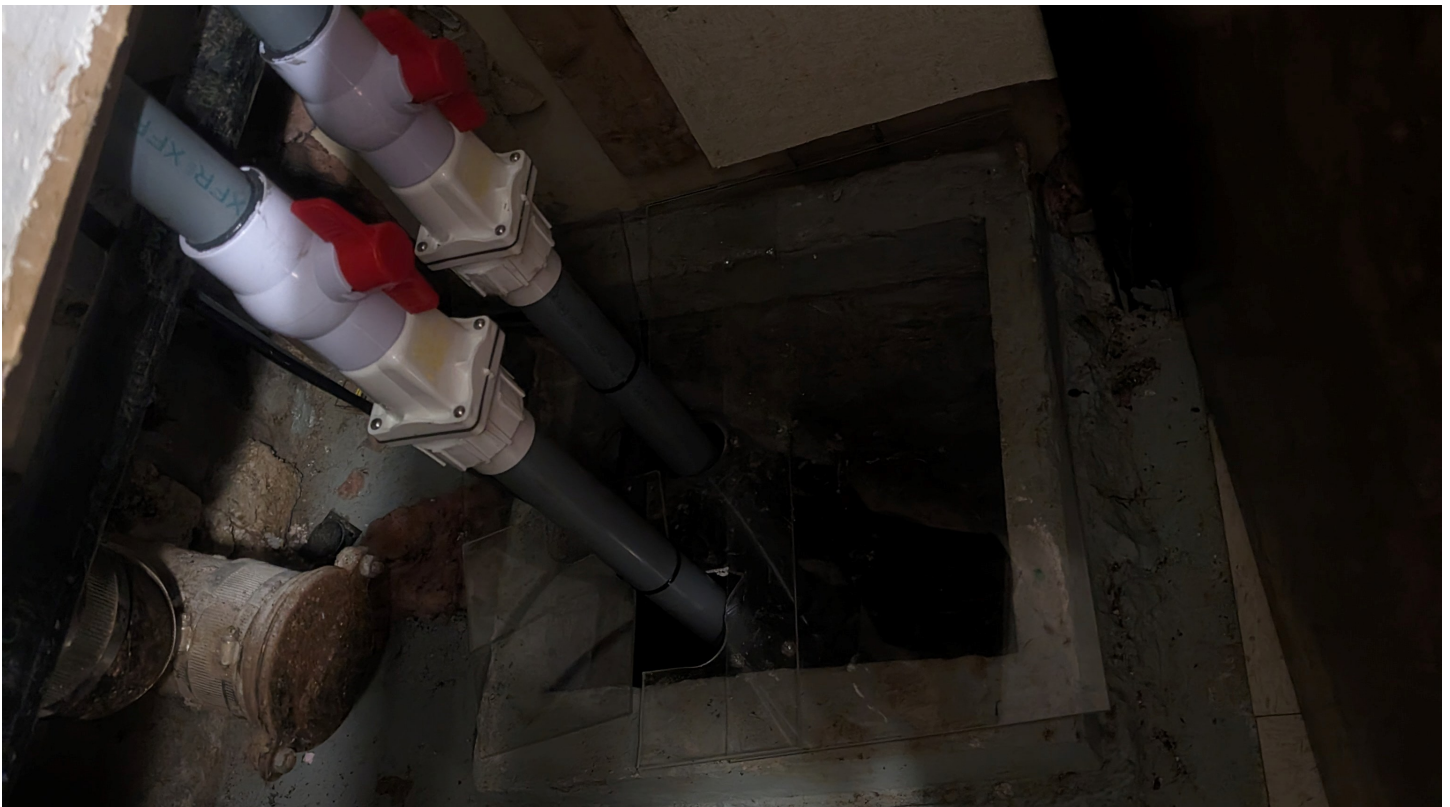
Photo 4 - Looking north towards a sump pit inside the basement of 1052 St. Laurent Boulevard.

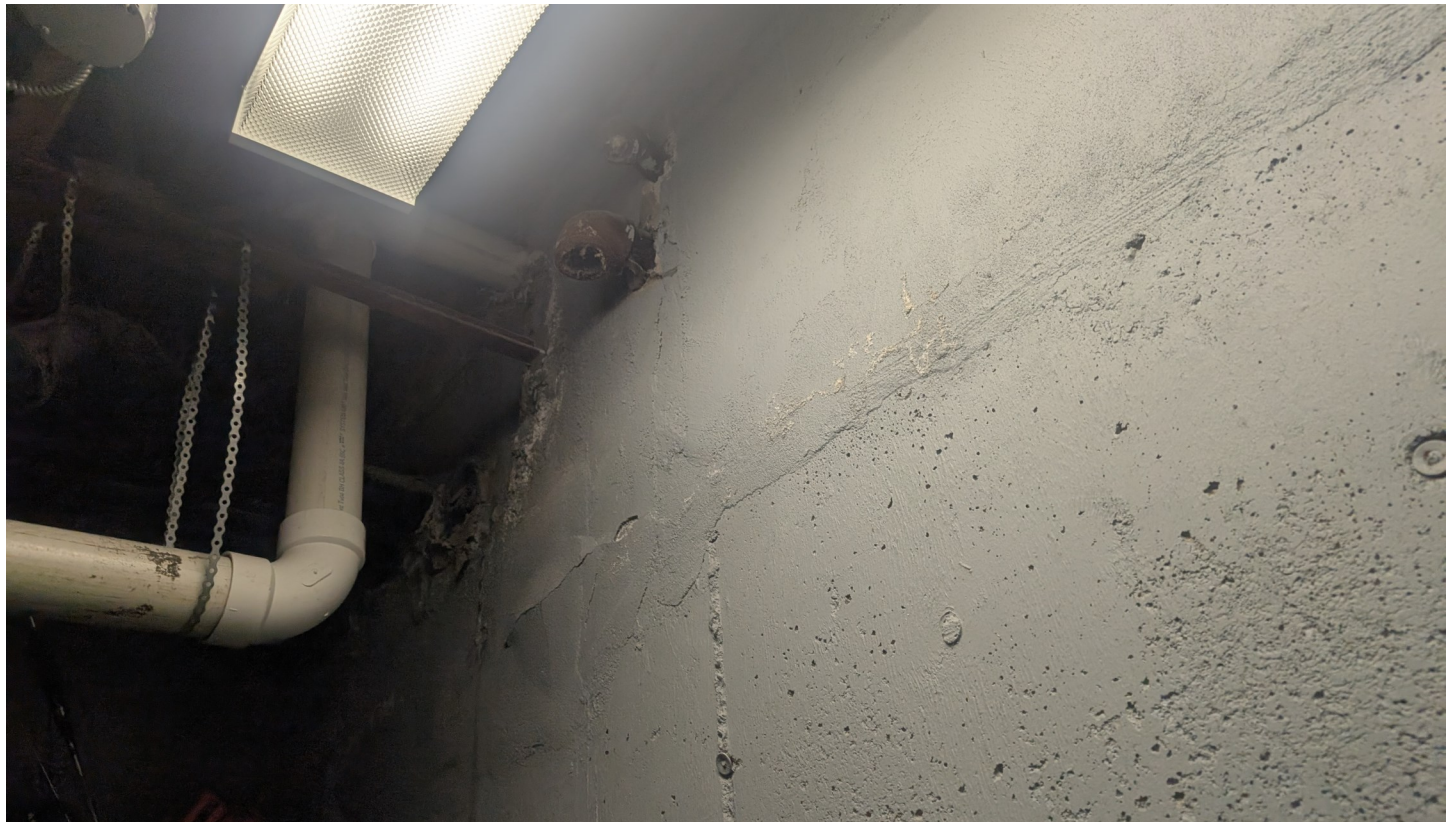
Photo 6 - Looking west towards the west building line where two pipes (likely vent pipe and fill pipe) were located.

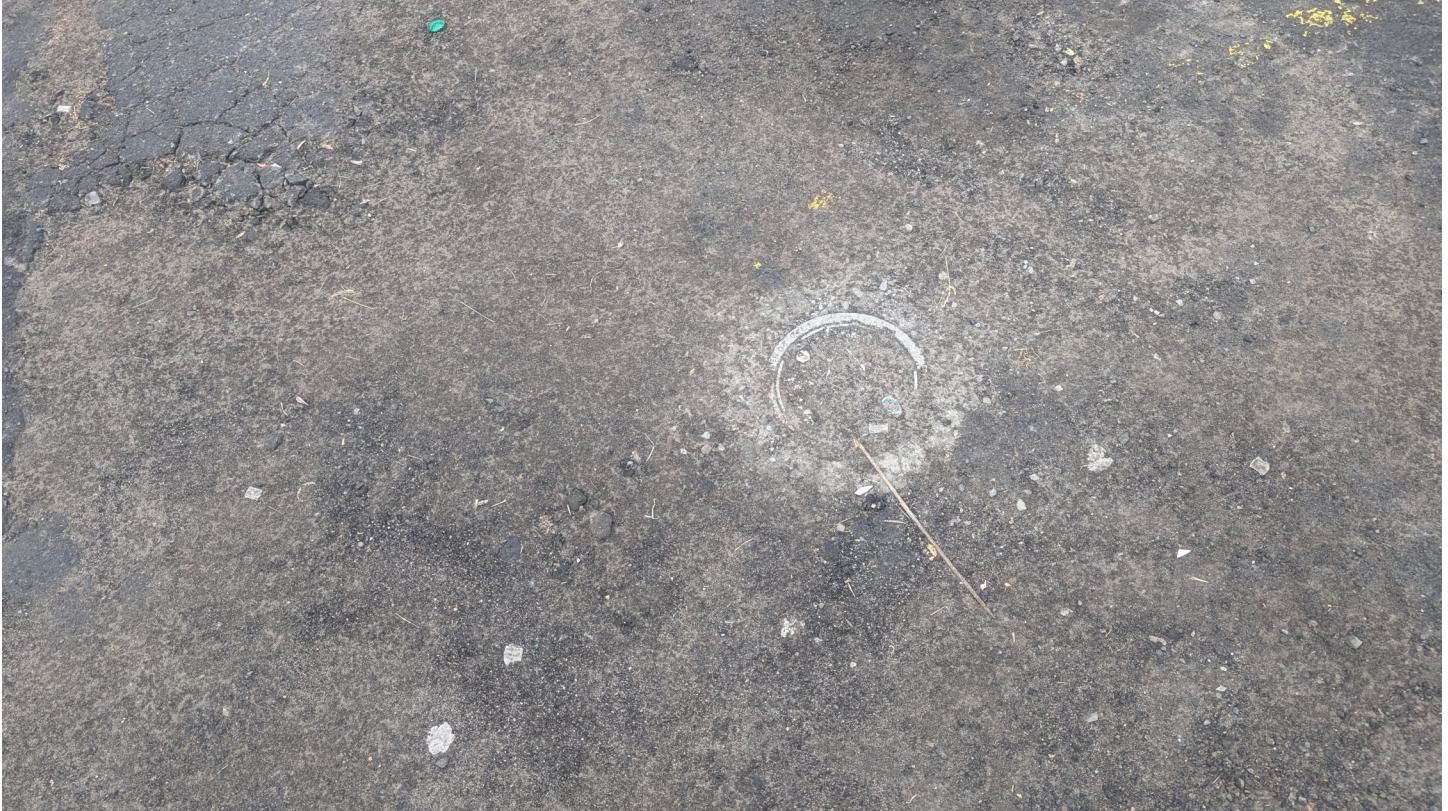
Photo 9 - Looking north and towards a monitoring well installed at the Site as part of GEMTEC's 2024 intrusive investigation.

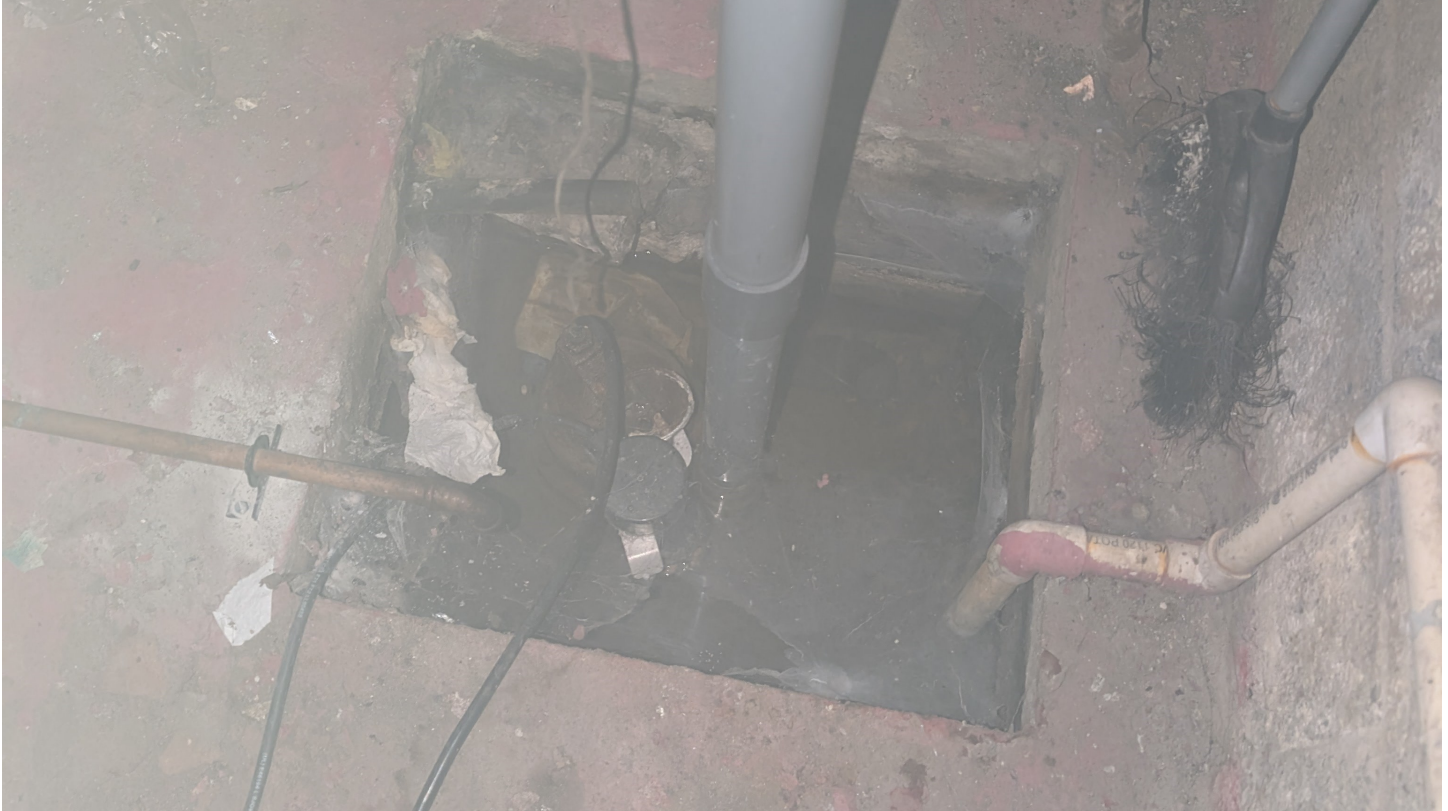
Photo 11 - Looking west/southwest at the sump pit located in the basement of 1060 St. Laurent Boulevard.

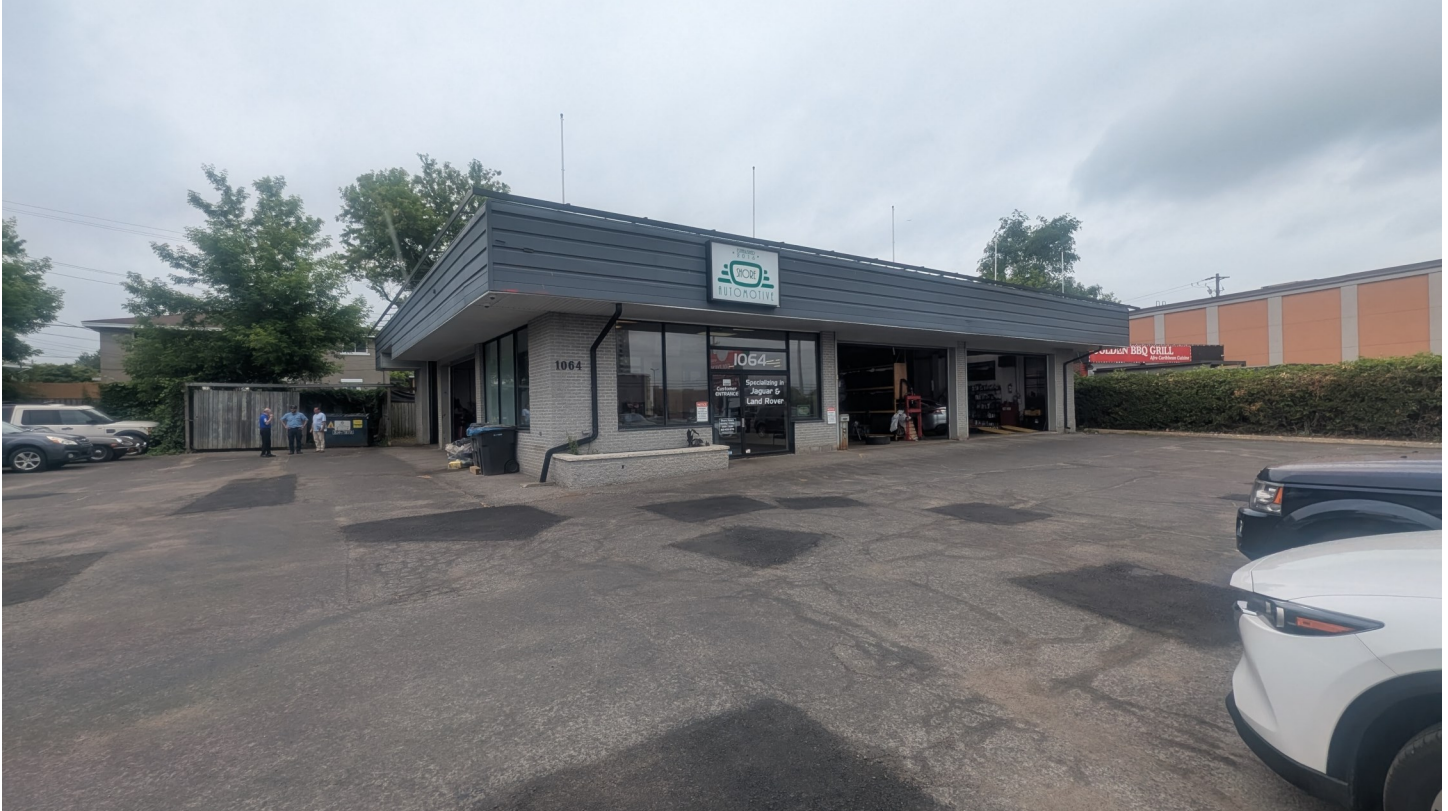
1064 St. Laurent Boulevard was developed with a one-storey automotive shop/garage. This structure was built in 1980s. This structure had concrete slab on grade with no basement. The concrete slab had floor drains that discharged into an oil water separator. Several ASTs and workbench storage tanks for engine oil were present along the northern and the western building line of this structure. No evidence for a former AST or UST was observed for 1064 St. Laurent Boulevard.

Photo 13 - Looking northwest towards the automotive shop/garage at 1064 St. Laurent Boulevard.

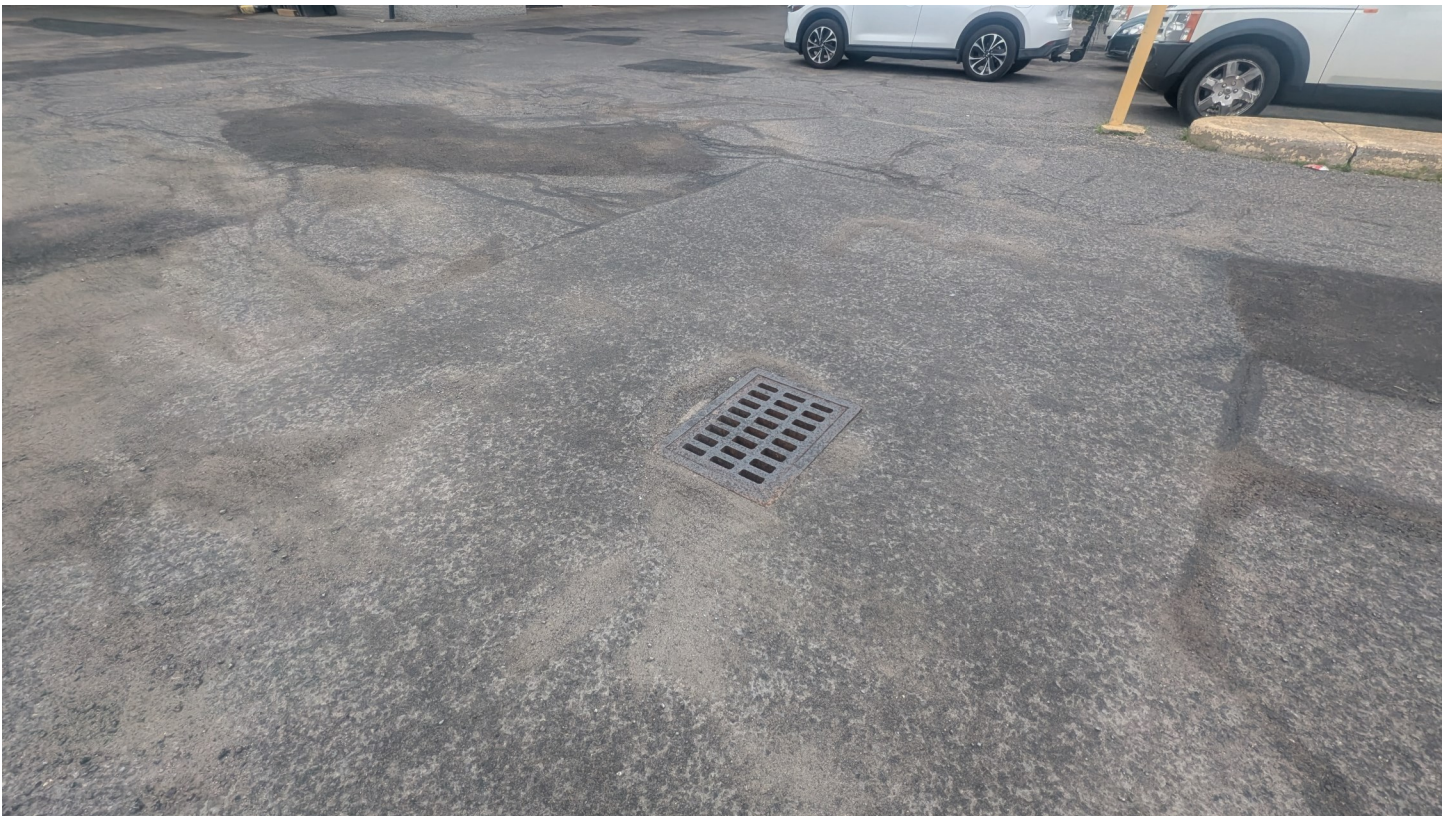
Photo 14 - Looking north/northwest towards the catch basin at 1064 St. Laurent Boulevard.

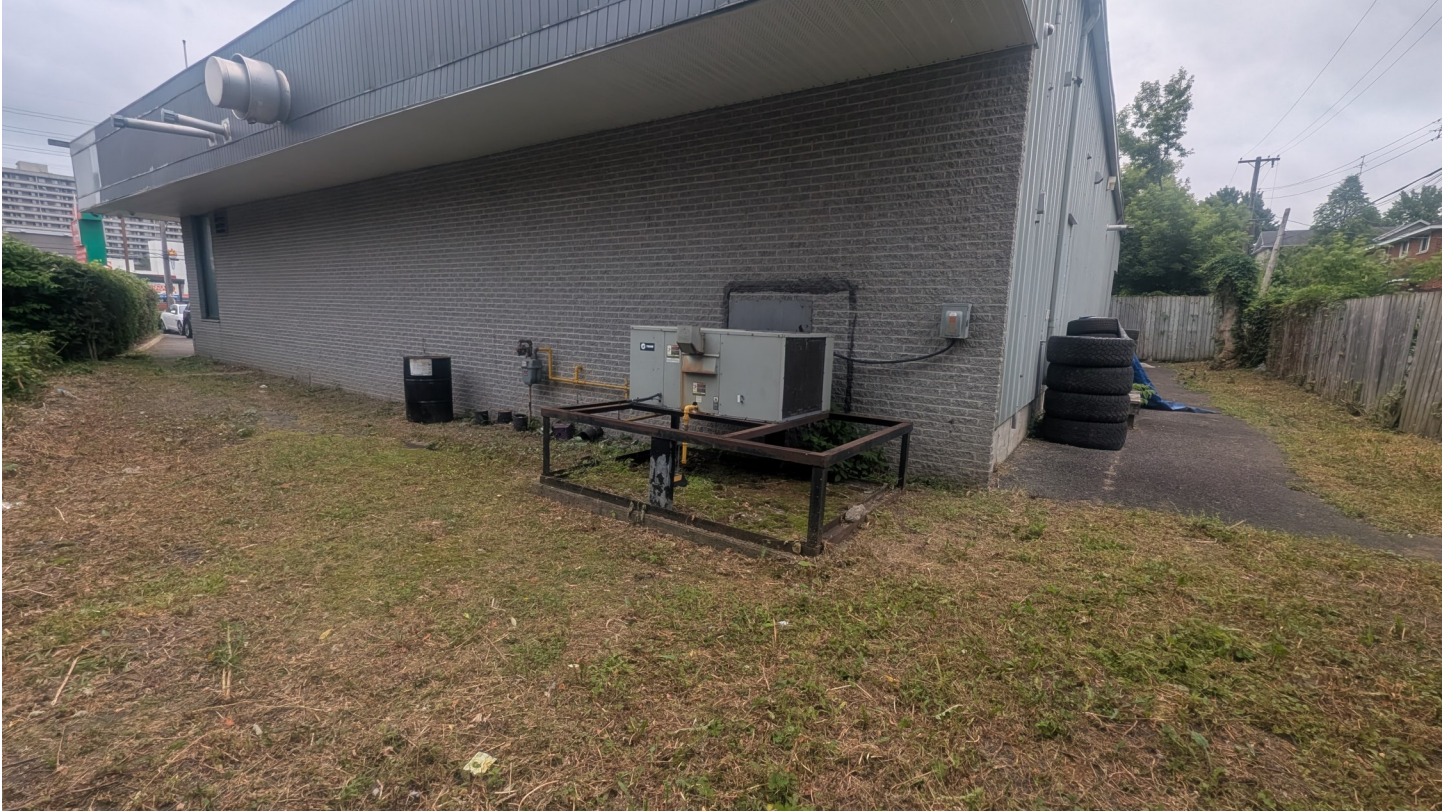
Photo 17 - Looking southeast towards the natural gas meter and air conditioning unit for 1064 St. Laurent Boulevard.

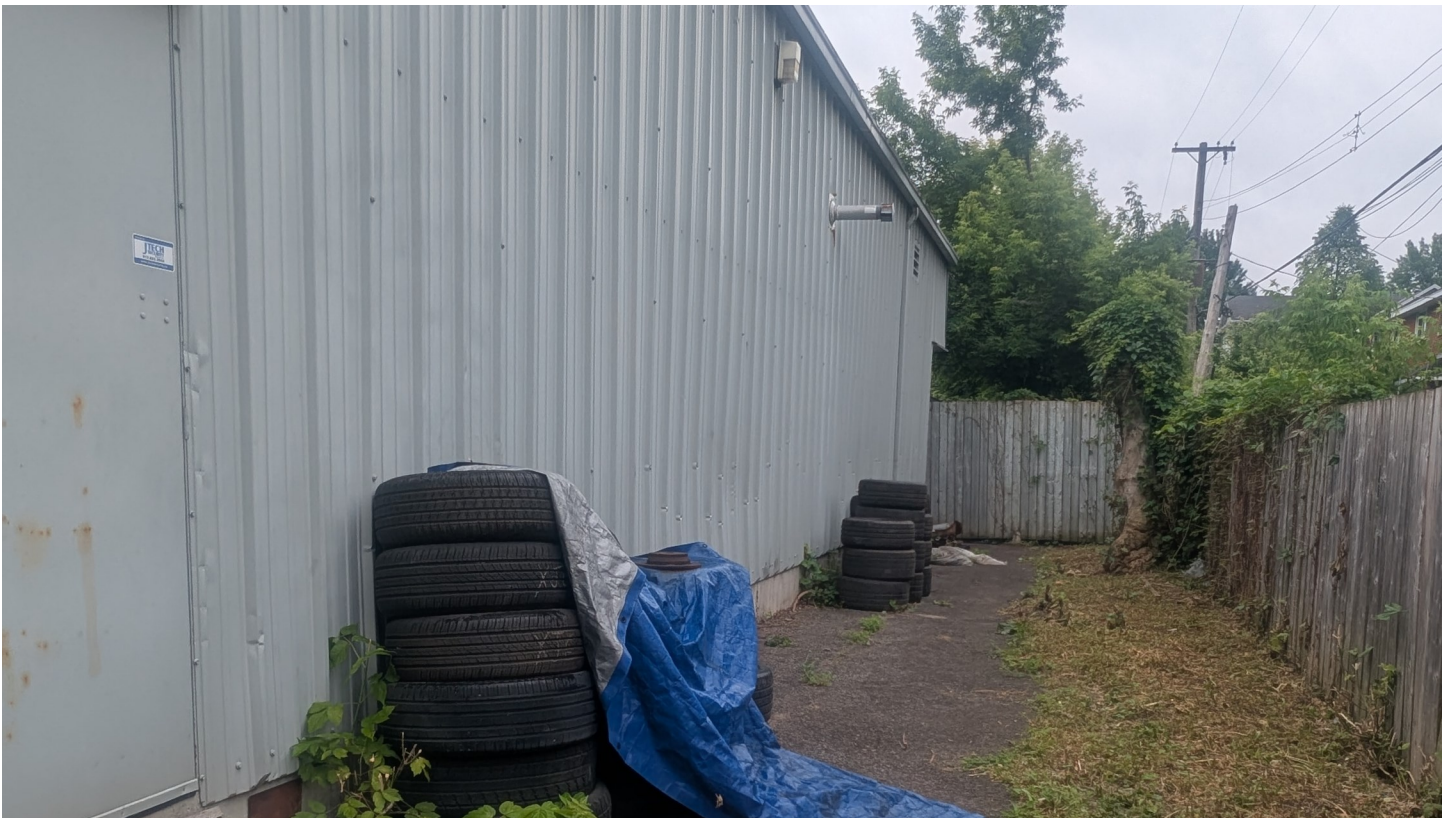
Photo 18 - Looking south along the western building line of 1064 St. Laurent Boulevard. Several tires were stored along the building line.

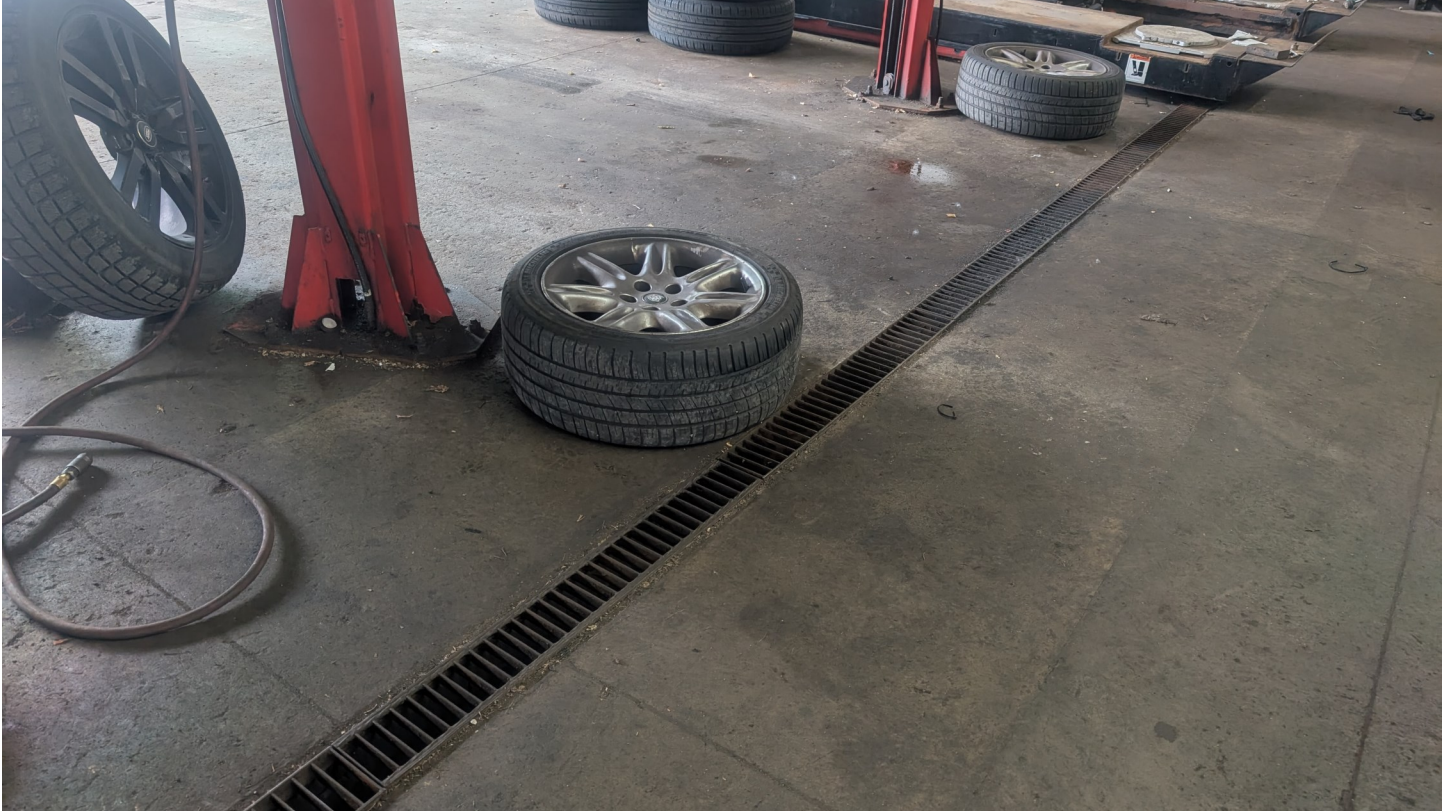
Photo 19 - Looking south/southeast towards the floor drains which discharge into the oil water separator at 1064 St. Laurent Boulevard.

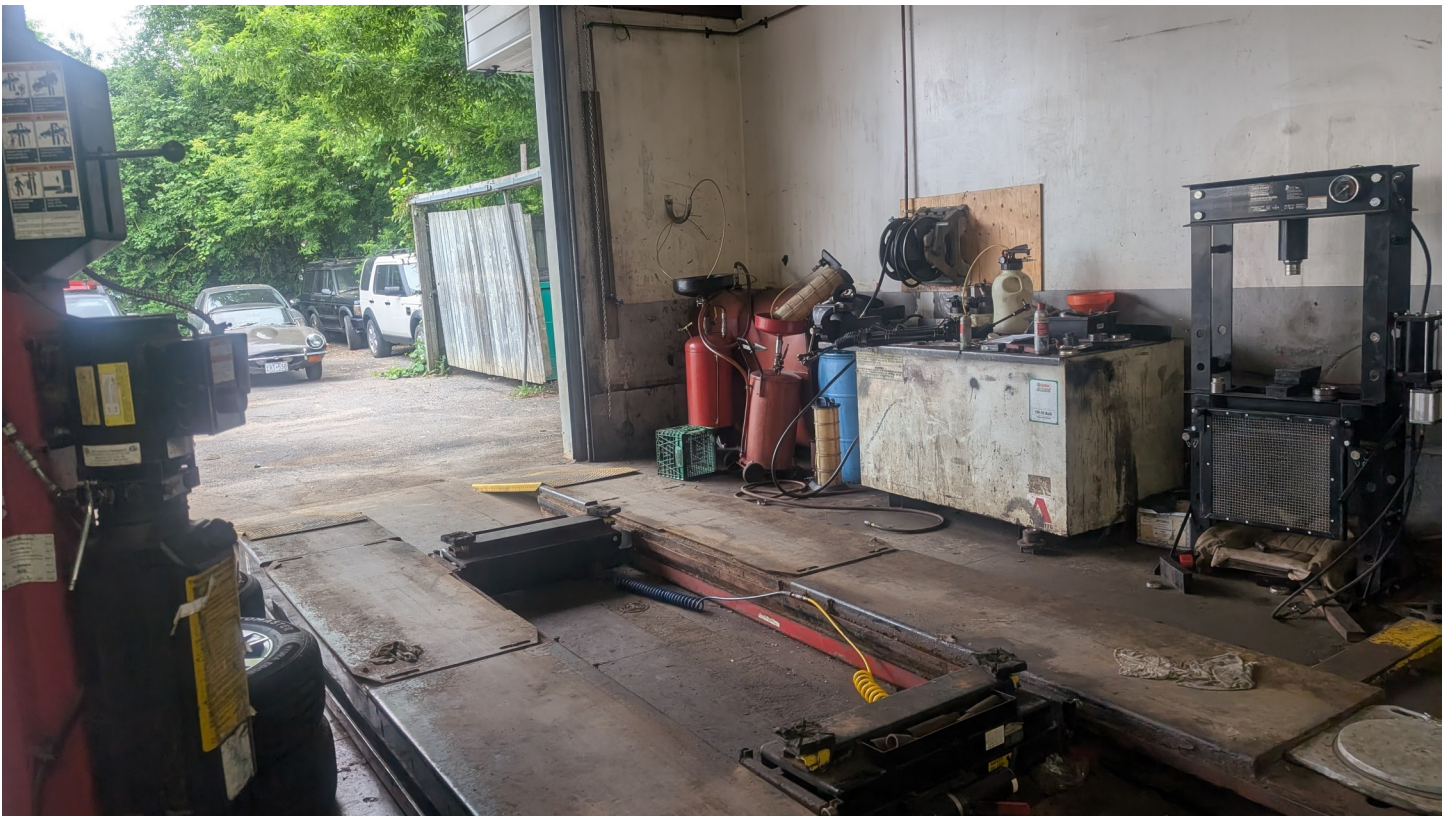
Photo 20 - Looking south towards the west building line of 1064 St. Laurent Boulevard. Waste oil AST and work bench tank can be seen along the building line.

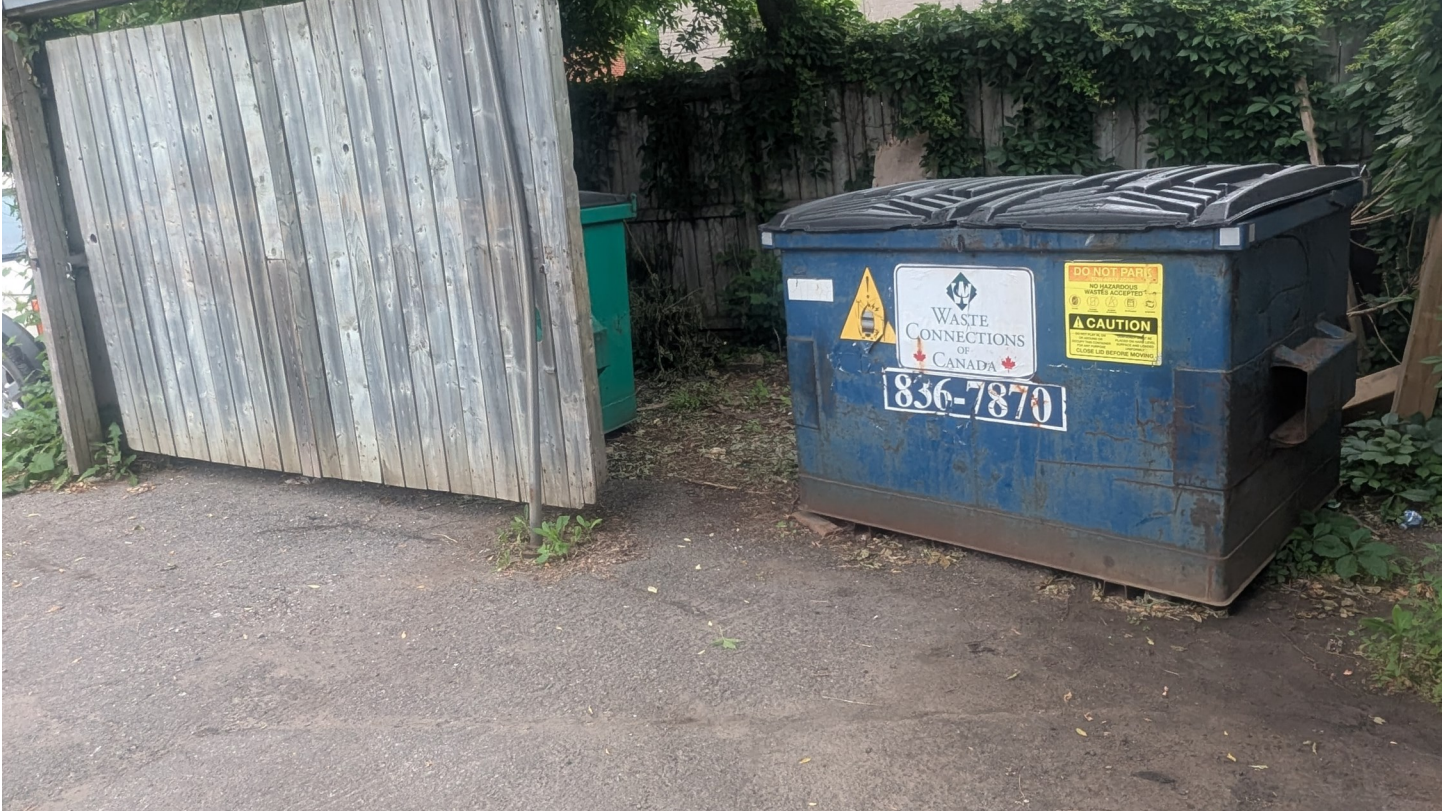
Photo 21 - Looking southwest towards the waste disposal area for 1064 St. Laurent Boulevard.
