# Geotechnical Investigation Report – 1209 Michael Street North, Ottawa

March 17, 2026

Prepared for:  
Inside Edge Properties

Cambium Reference: 23852-001

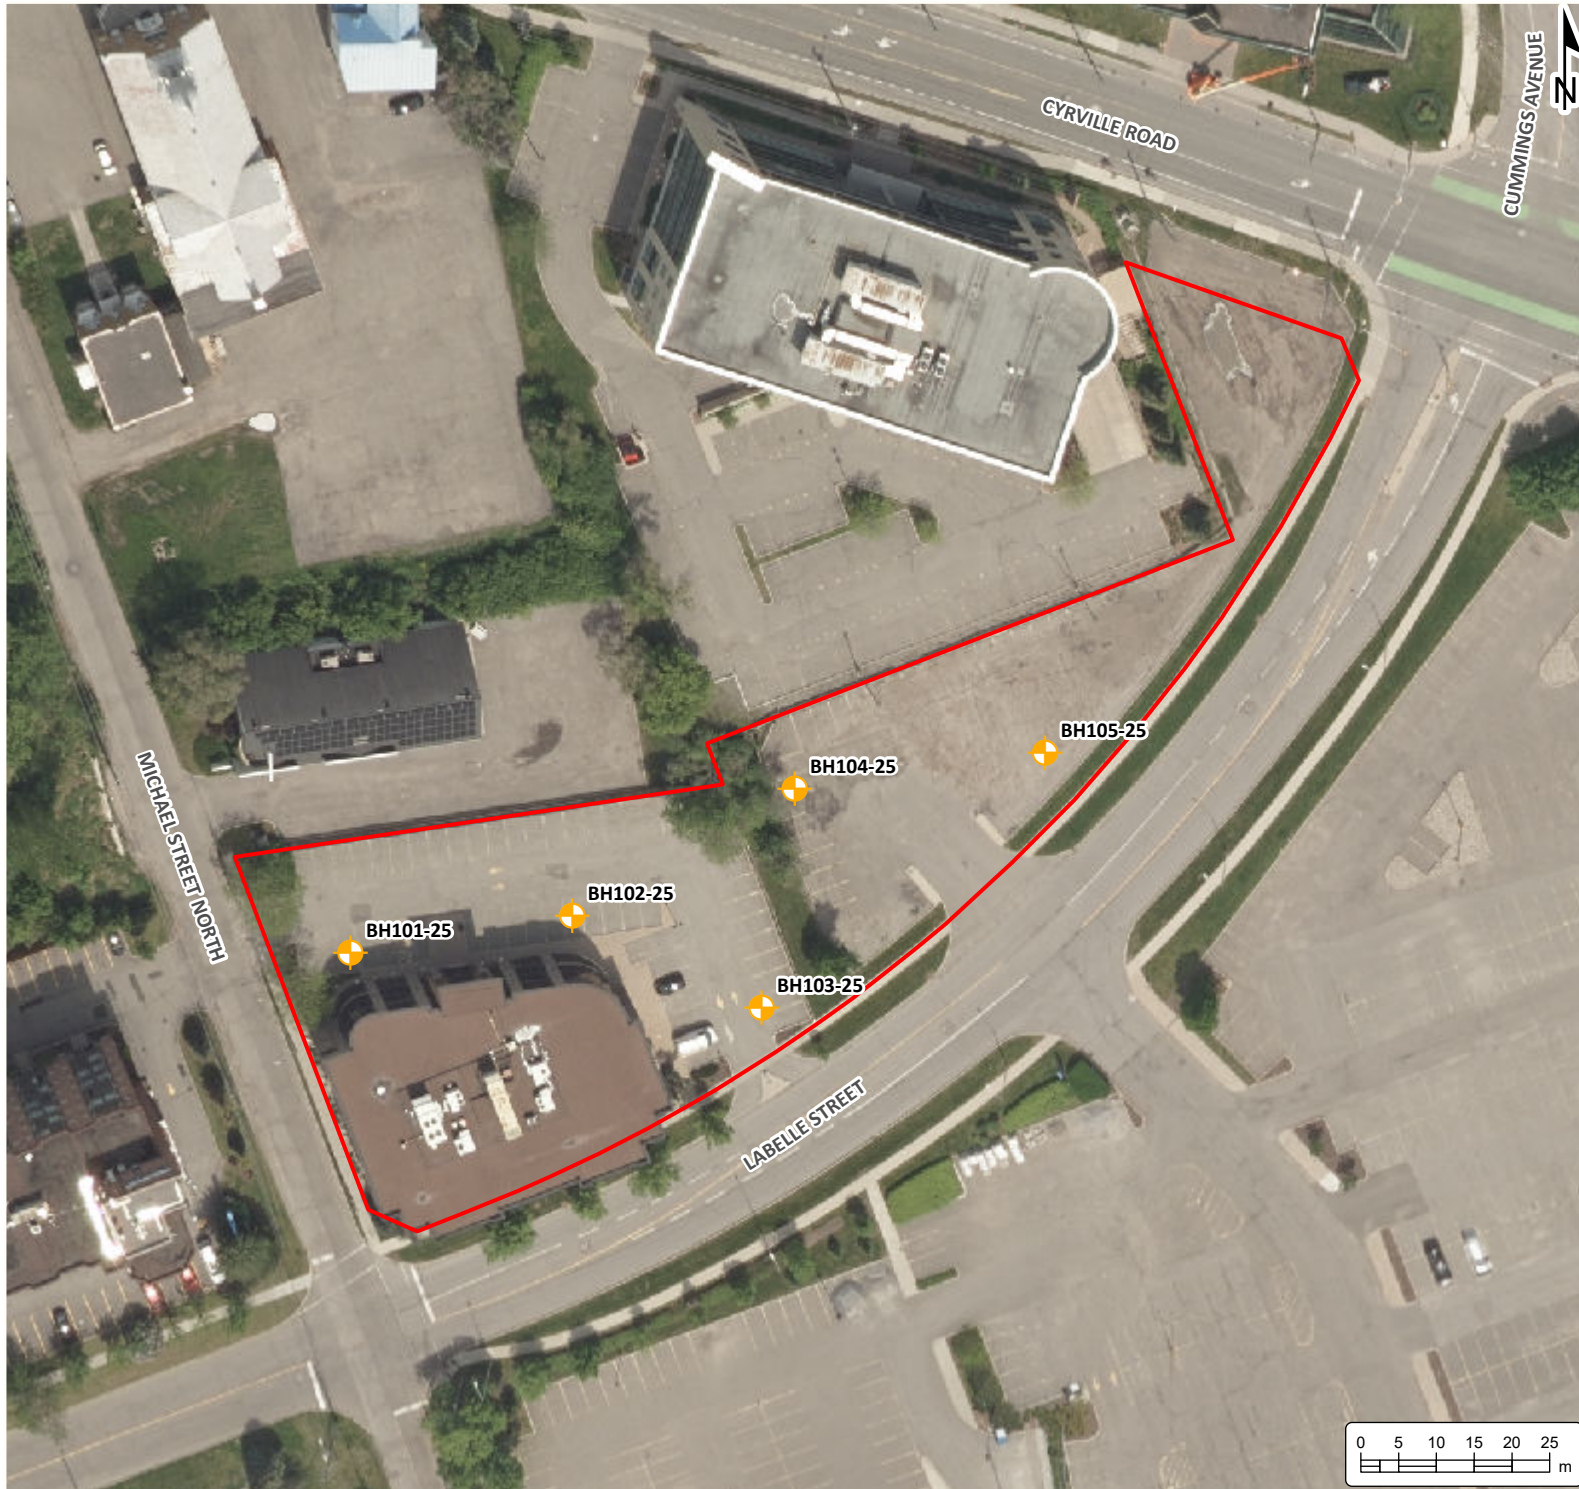
A borehole investigation was carried out at the site on November 3 and 4, 2025 to assess subsurface conditions. A total of 5 boreholes, designated BH101-25 through BH105-25, were advanced in the approximate locations shown on the attached Figure 2, to a maximum depth of 8.6 m below ground surface (bgs).

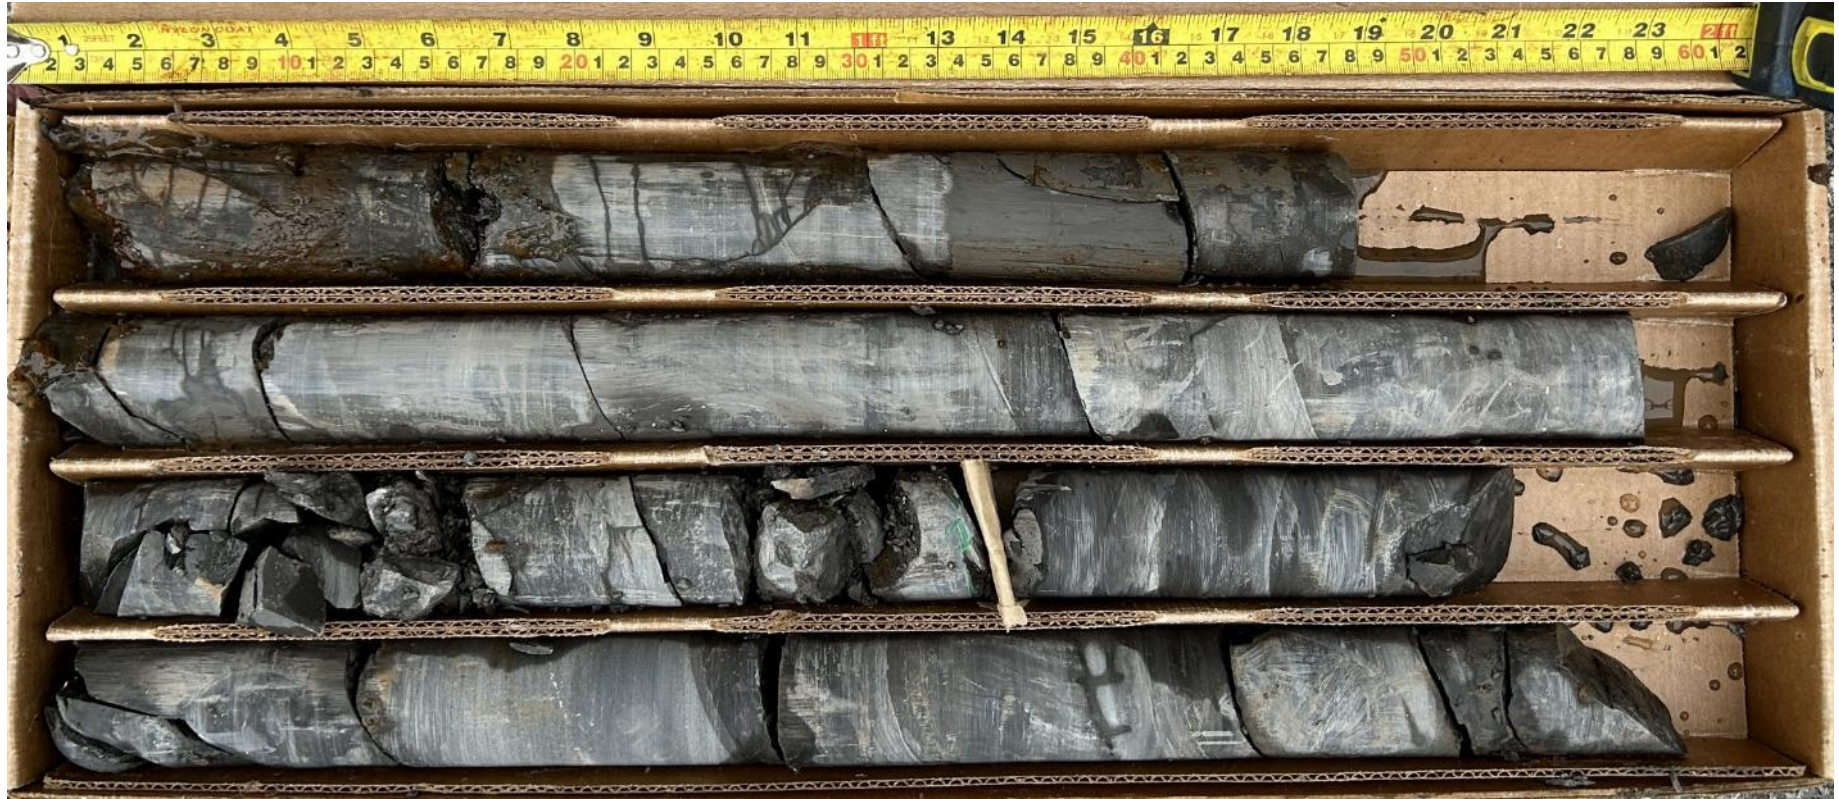
BH101-25  
 Cored length of 2.57 to 4.75 mbgs  
 Core Box 1 of 3

The bedrock appeared to consist predominantly of grey to black shale, which ranged in quality from very poor to good, generally increasing in quality with depth. In general, the upper 0.3 to 1.5 m was weathered to highly weathered, and brown to grey in colour. Bedding measurements varied from approximately 25 to 60 degrees from horizontal with occasional calcite infilling. A clay seam was observed within borehole BH103-25 at depth of approximately 4.0 mbgs.

The borehole and rock core logs are provided in Appendix A. Site soil and groundwater conditions and our geotechnical recommendations are presented in the following sections of this report. Rock core samples were photographed prior to packaging and the photos are provided in Appendix B.
