## **Phase II – Environmental Site Assessment**

1200 Baseline Road  
Ottawa, Ontario

Prepared for Zena Investment Corporation

**Report: PE6468-2**

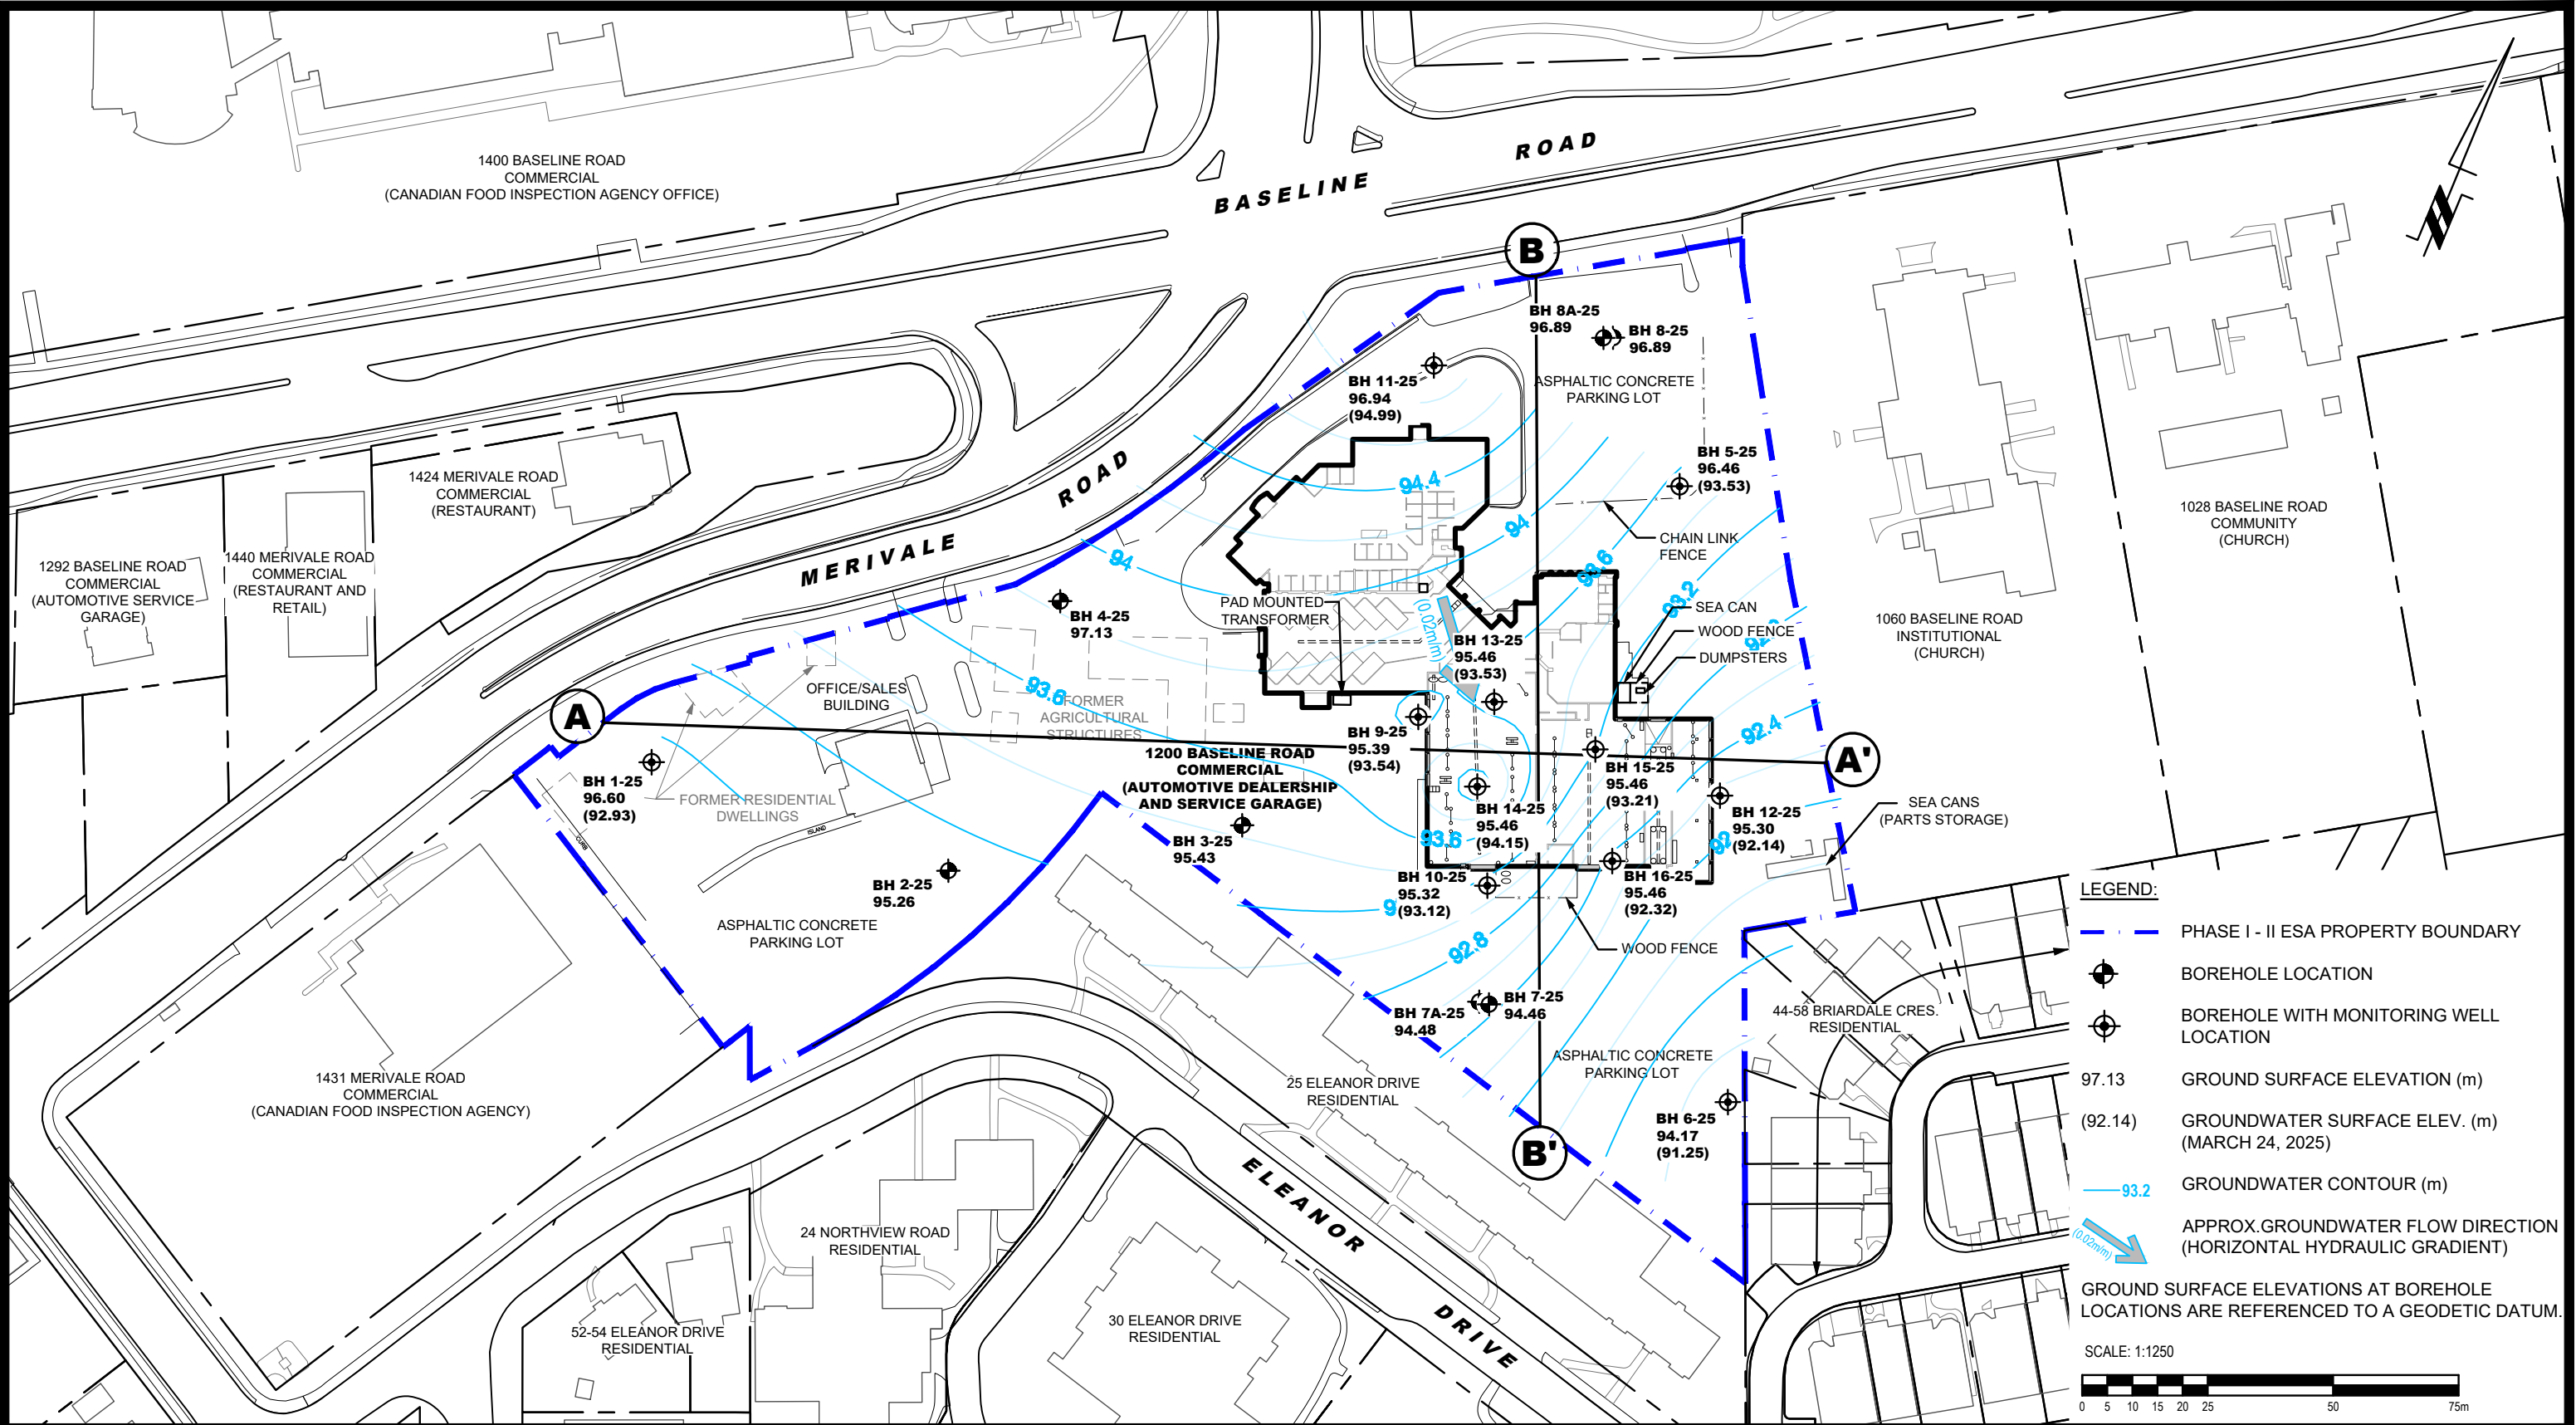
Using the groundwater elevations recorded during the sampling event, groundwater contour mapping was completed as part of this assessment. According to the mapped contour data, illustrated on Drawing PE6468-3 – Test Hole Location Plan in the appendix, the groundwater on the Phase II Property was calculated to flow in a southerly direction. A horizontal hydraulic gradient of 0.02 m/m was also calculated as part of this assessment. It should be noted that groundwater levels are expected to fluctuate throughout the year with seasonal variations.

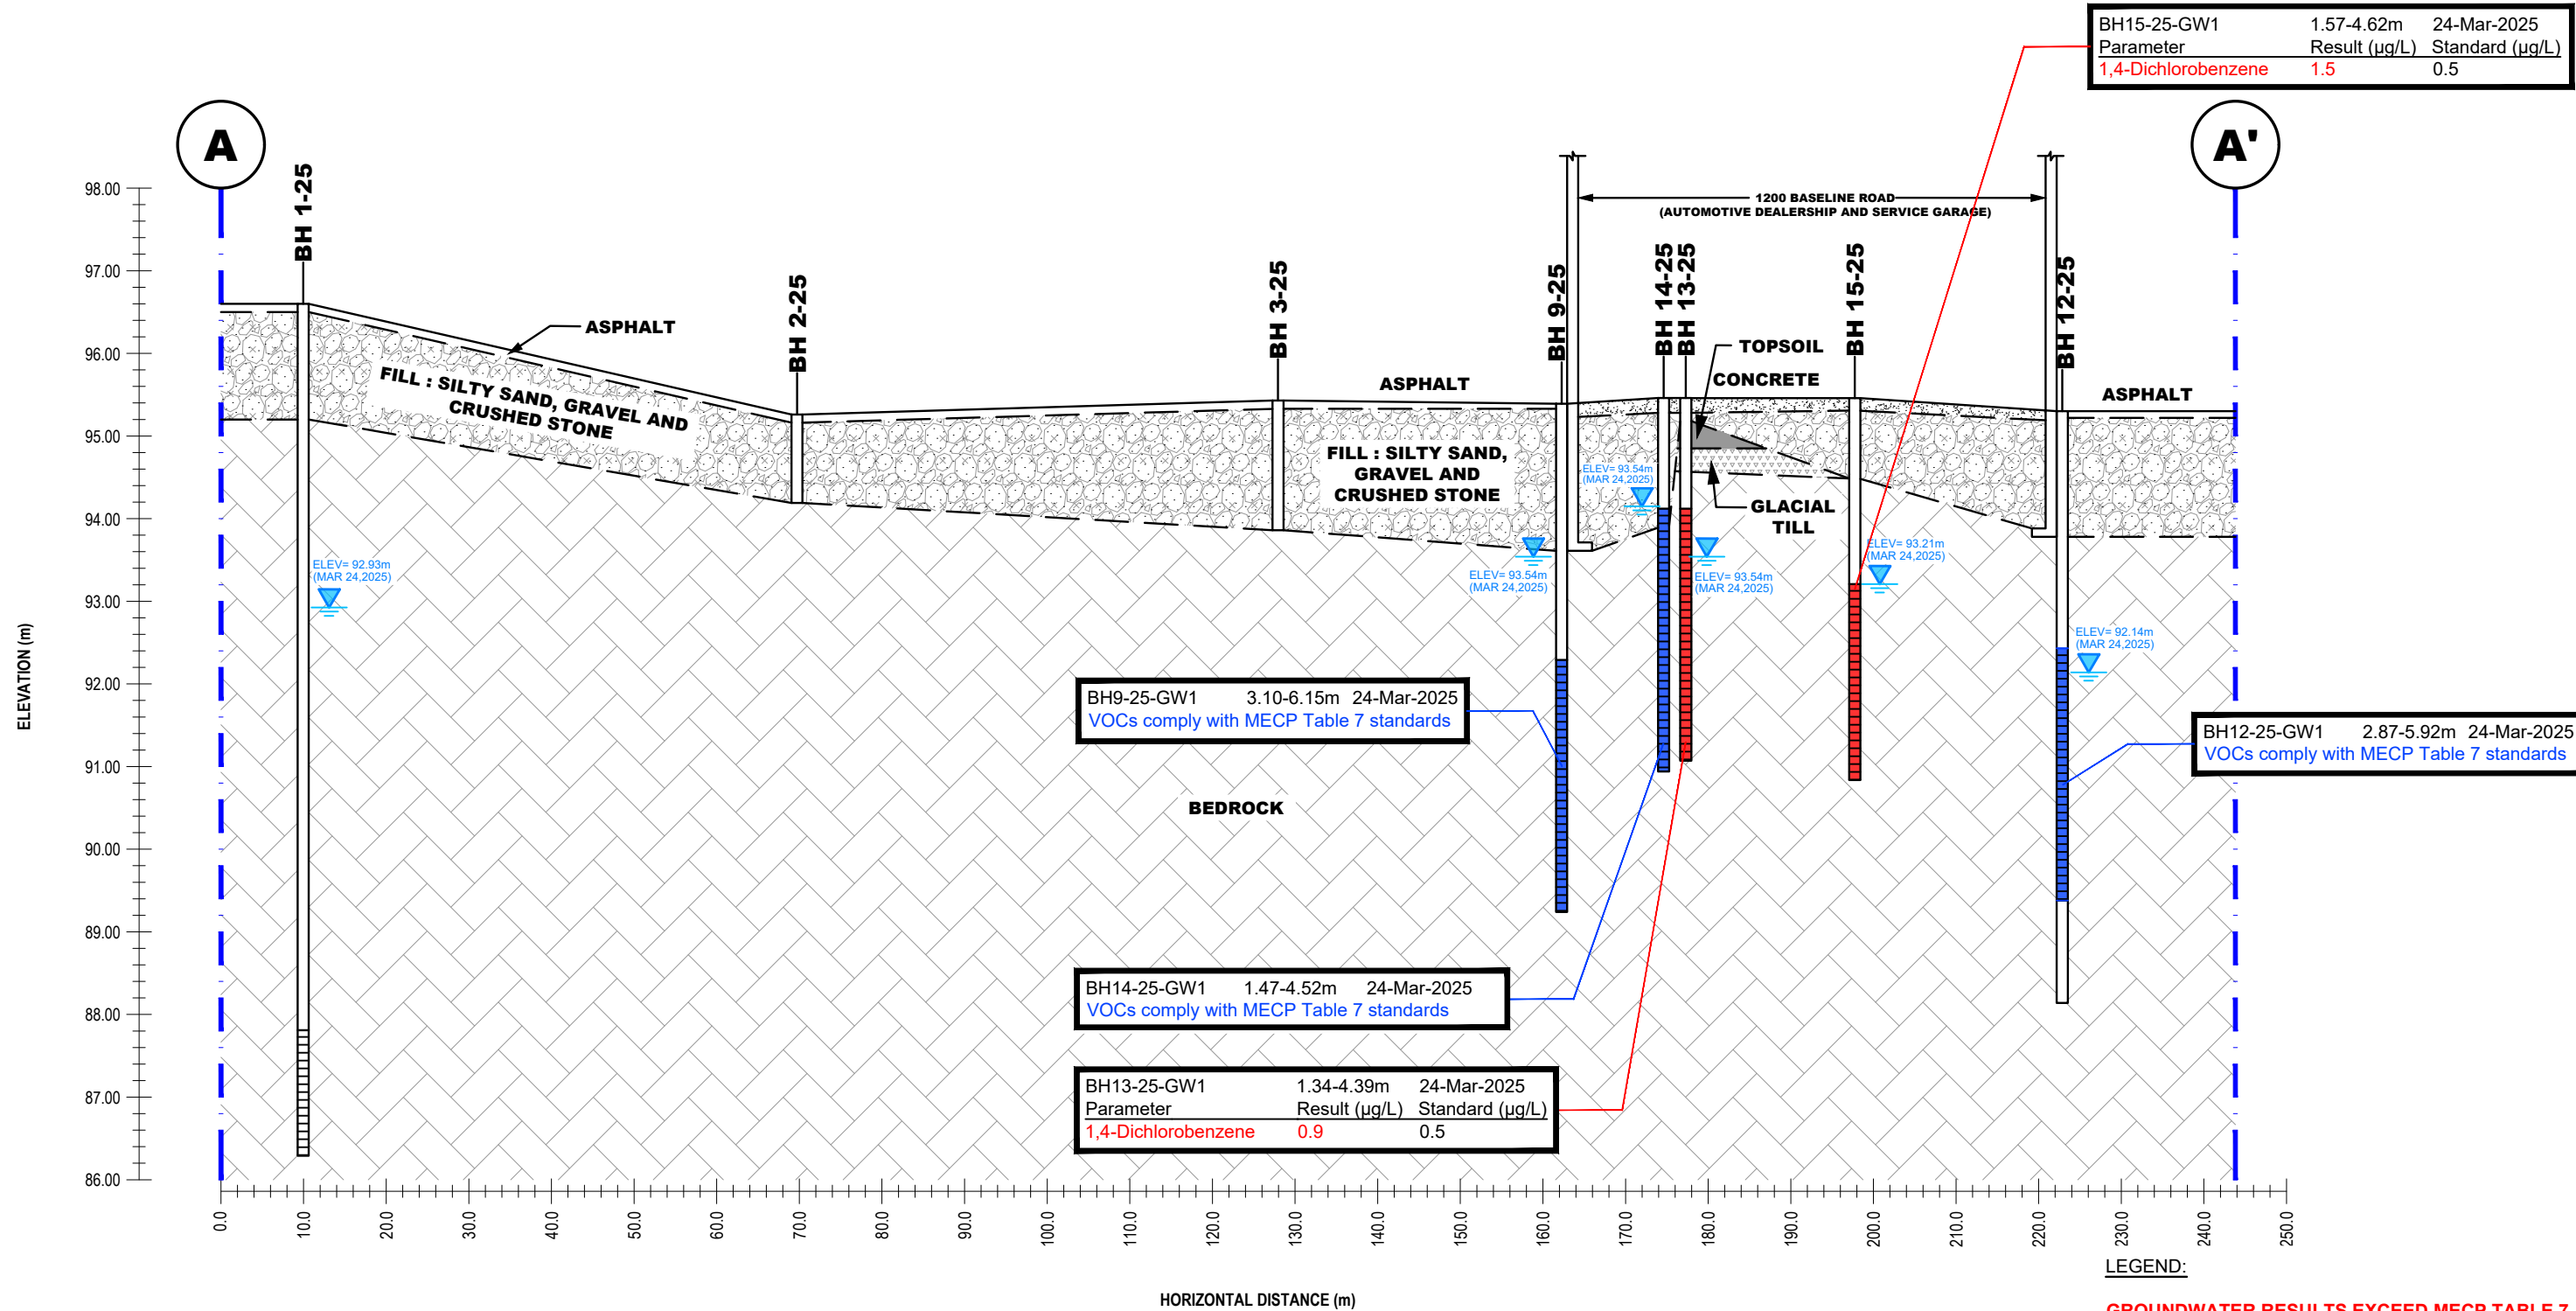
| Checked by: | JA | Dwg. No.: | PE6468-12A |

Groundwater present beneath the northern portion of the service bay area in the automotive service garage building on the Phase II Property is contaminated with VOCs (1,4-dichlorobenzene) above the MECP Table 7 Residential standards. The origin of these contaminants is unknown but may be the result of cleaning or deodorizing chemicals used historically during vehicle servicing, or from on-site janitorial supplies that may have been introduced to the groundwater via leaky floor drains, conduits and/or oil water separators.

GROUNDWATER RESULTS EXCEED MECP TABLE 7 STANDARDS

Groundwater impacted with BTEX, VOCs and PHCs was identified on the Phase II Property and is suspected to be the result of on-site commercial activities resulting in the identified APECs on the RSC Property. Prior to the redevelopment of the Phase II Property, it is recommended that impacted groundwater be further assessed. Monitoring wells with impacted groundwater are recommended to be resampled to confirm the presence and concentrations of these contaminants. If the presence of impacted groundwater is confirmed, the extent of these impacts should be further delineated.

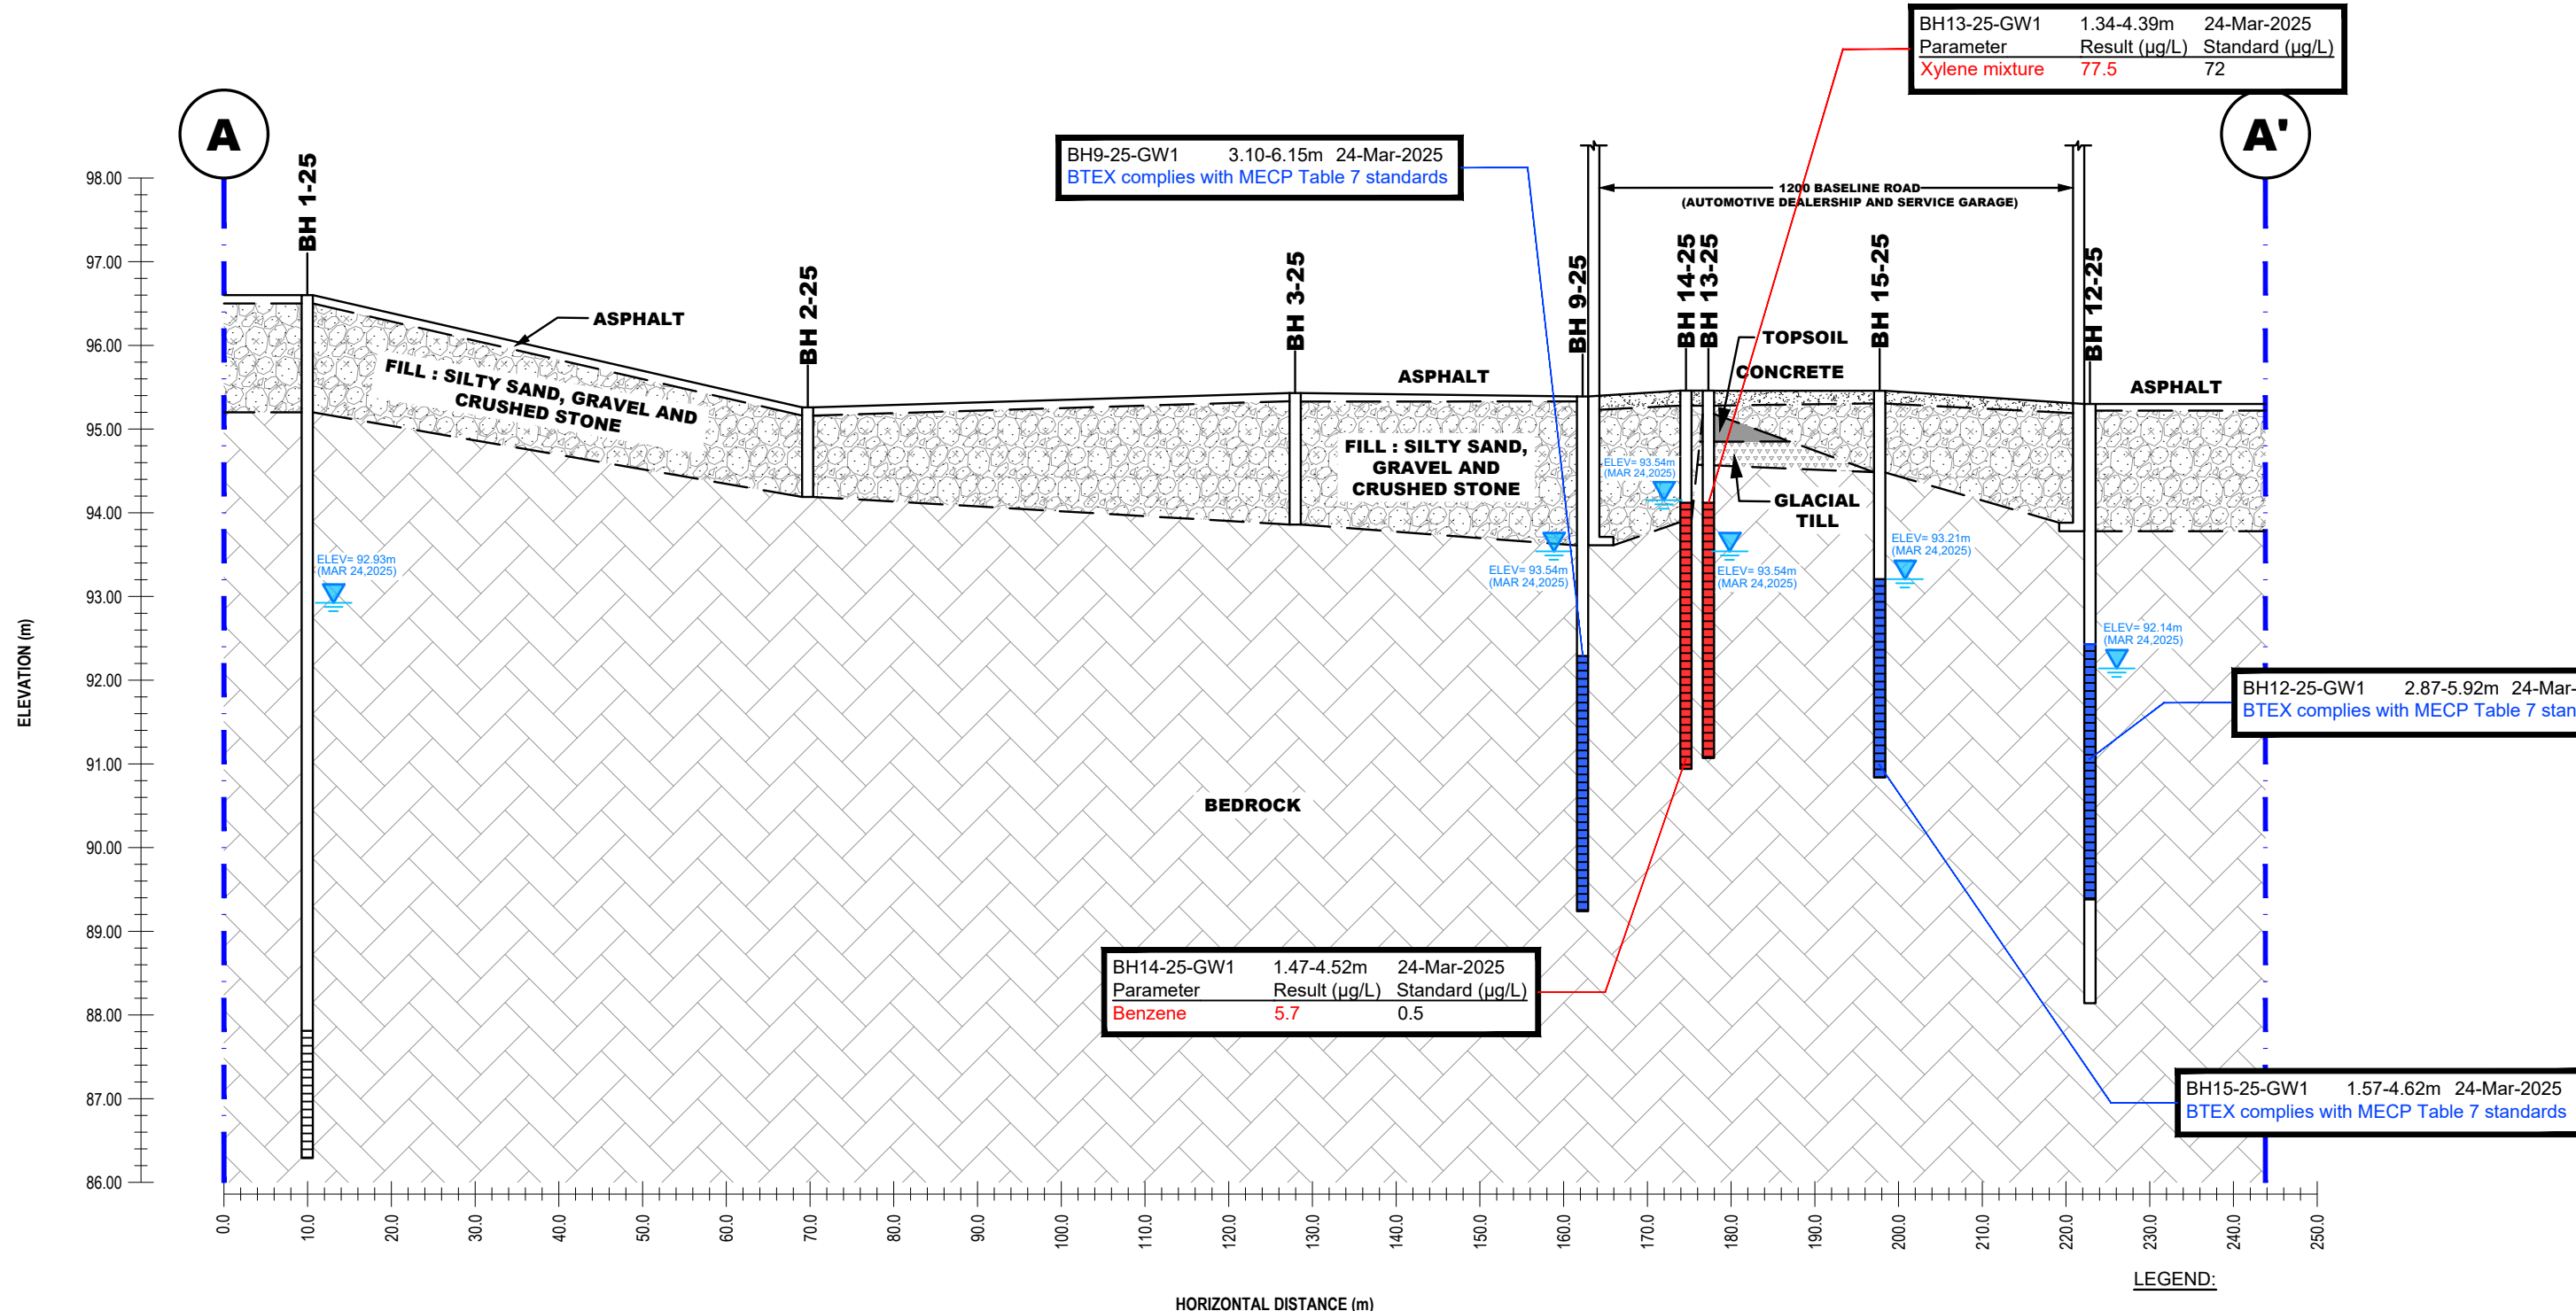
| Checked by: | JA | Dwg. No.: | PE6468-13A |

It is unknown where BTEX, VOC and PHC contamination in groundwater encountered within or immediately adjacent to the service bay area of the automotive service garage originated, but it could be the result of spills related to on site petroleum-derived product storage tanks in these areas, and from on-site janitorial supplies that may have been introduced to the groundwater via leaky floor drains, conduits and/or oil water separators.

GROUNDWATER RESULTS EXCEED MECP TABLE 7 STANDARDS
